JOHN MOORE HERITAGE SERVICES

**ST MATHEW'S CHURCH,
ST MATHEW'S CLOSE,
WALSALL
ARCHAEOLOGICAL WATCHING BRIEF**

JUNE 2015

JMHS Project No: 3286
Site Code: WASM 15

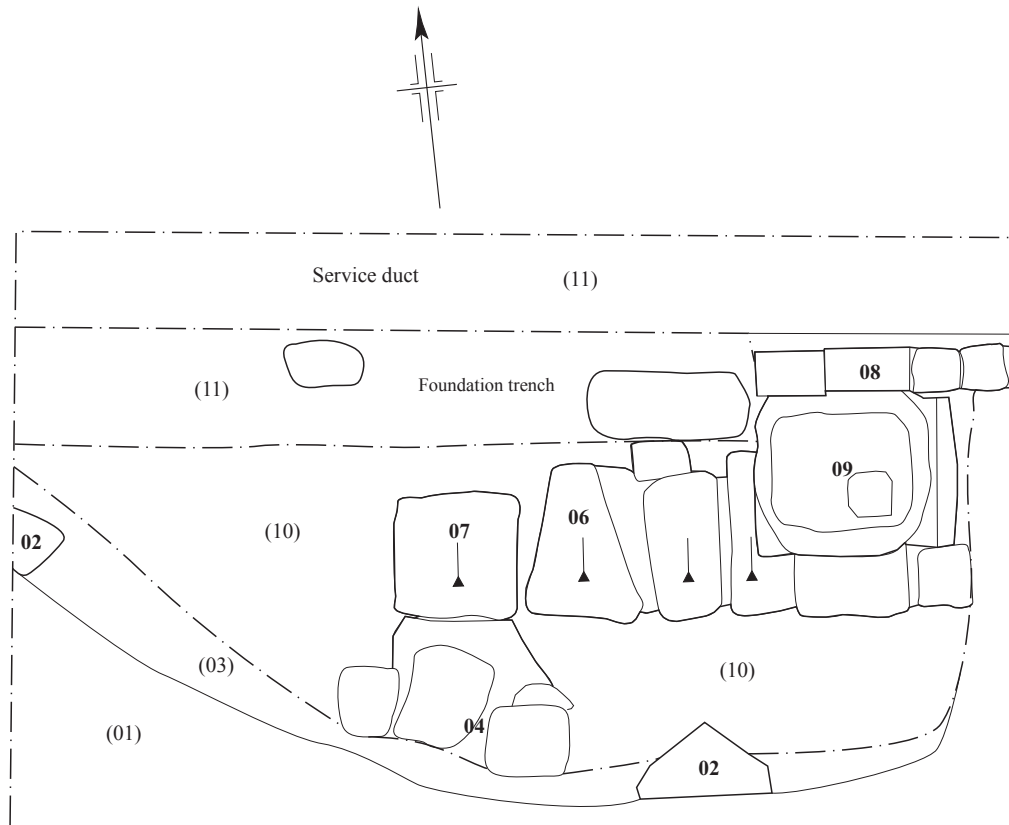
Trench Plan

The lowest layer excavated was coarse dark red brown and black sandy layer (11). This was the lowest layer and was deeper than 0.25m. The cuts to several wall foundations were dug into this layer (Fig. 2, Trench plan).

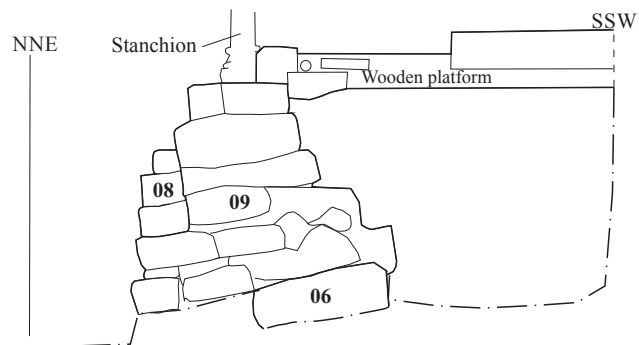
Elevation of masonry structure 09

Wall **05** abutted a stone and brick platform **09** (Fig 2, Elevation; Plate 2 & 3). This was a platform to an iron stanchion which supported the ceiling on the underside of the north aisle gallery. The platform was constructed from seven layers of brick and stone slabs and stood 0.55 high. It was built directly onto wall **06** and the inclination of this wall appeared to have caused the platform to lean towards the north.

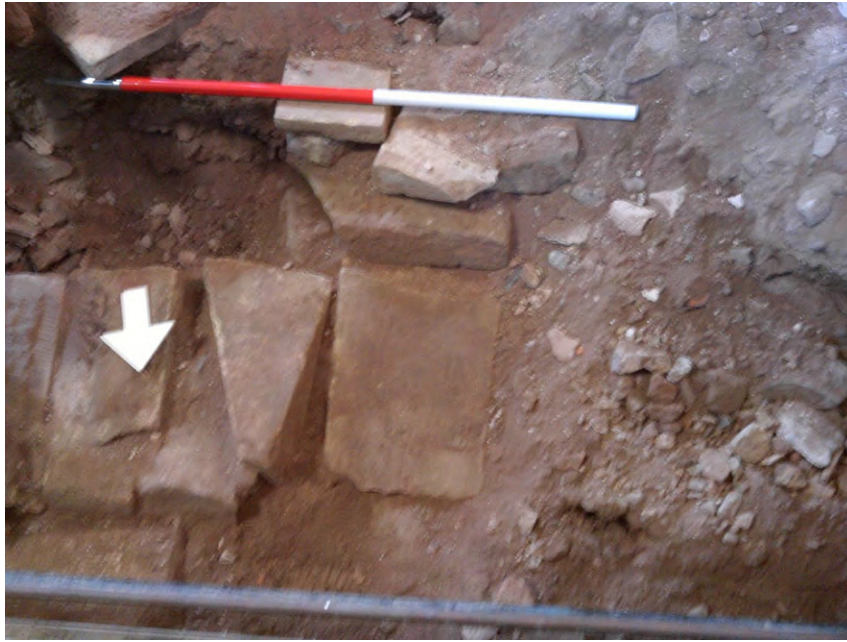
Cut 12 was the proposed foundation cut to wall **07**. Wall **07** was around 0.4m high above the limit of the excavation and was 0.35m wide (plate 1). The revealed wall length was 1m and extended southwards beyond the limit of the excavation. The northern corner of the wall was constructed from two large, half square, smoothly dressed blocks. These blocks had been cut on the diagonal and then one block was laid on the other to form a square. The upper block measured 0.5m at its longest point and was 0.35m wide.

Above these blocks was a more roughly hewn large stone slab which was between 0.08 and 0.1m thick. Running perpendicular from the north corner of this wall, towards the east, was wall **06** (Plate 1 & 2). The height of this wall above the lower limit of the excavation was between 0.12 and 0.25m. The wall was greater than 1m in length and 0.65m wide. The wall was formed from rectangular blocks that had been cut on the diagonal and squared blocks. The wall was inclined towards its northern edge.

top of the rubble and was also visible laid on top of wall **07** (plate 1). The floor was around 0.1m thick and was fragmentary; it appeared to have been patched with stone. Above this layer was a 0.1m layer of pink sand and rubble (03). Above this was the remains of another fragmentary stone slab floor which was also very patchy (02). The layer was around 0.06m thick and had been in-filled with rubble and stone between the gaps. Above this was a 0.1m thick layer of sand and fine rubble (01), this layer was below the current slab flooring.

Plate 1. SSW view of walls 07 & 06 & Floor layers 04 and 02

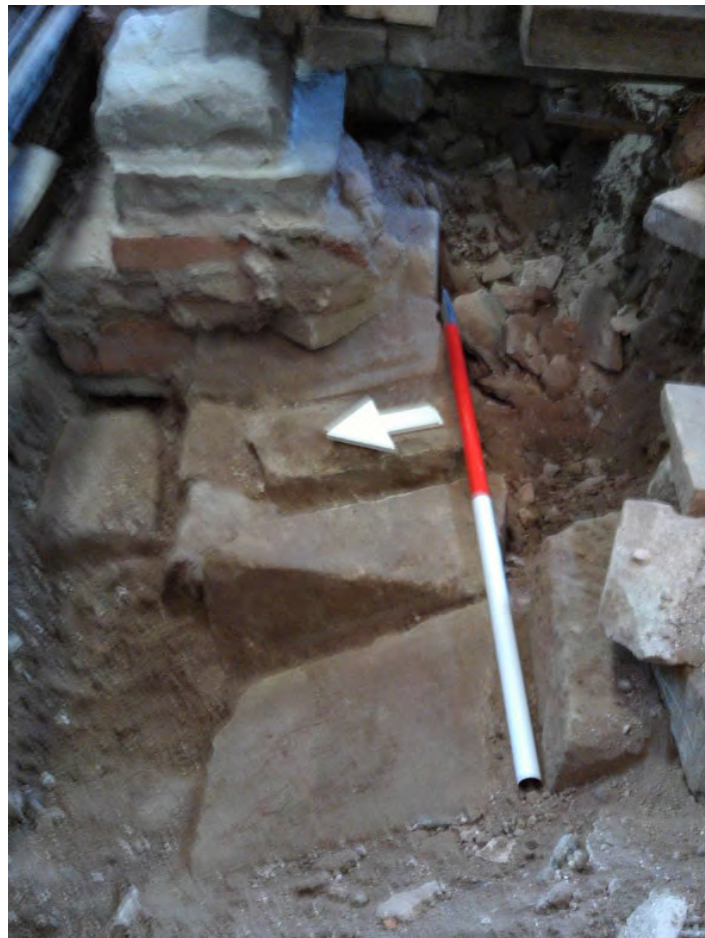
Plate 2. ESE view of wall 06 and stanchion pad 09

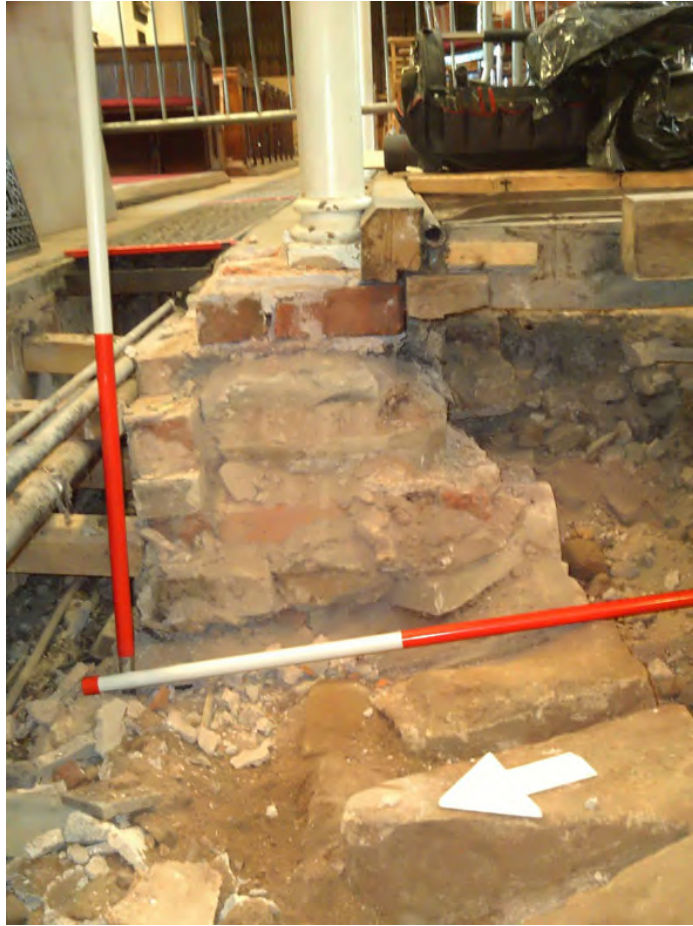
Plate 3. Elevation of Stanchion pad 09

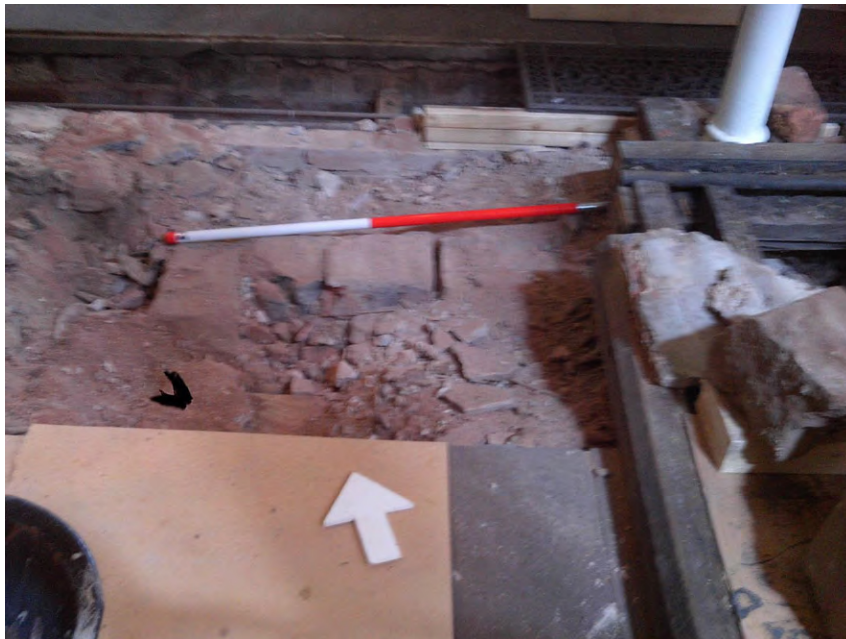
Built on top of the stone wall **06** was wall **05** (Plate 4). The wall was constructed from dark red bricks that had been laid on their faces across the width of the wall in a rowlock. They were bonded with lime mortar and topped by stone blocks that were laid along the length of the wall and secured to the bricks with mortar. The blocks were 0.35m to 0.4m in length and were 0.2m wide. The height of **05** was between 0.25m and 0.3m.

Plate 4. NNE view of wall 05.

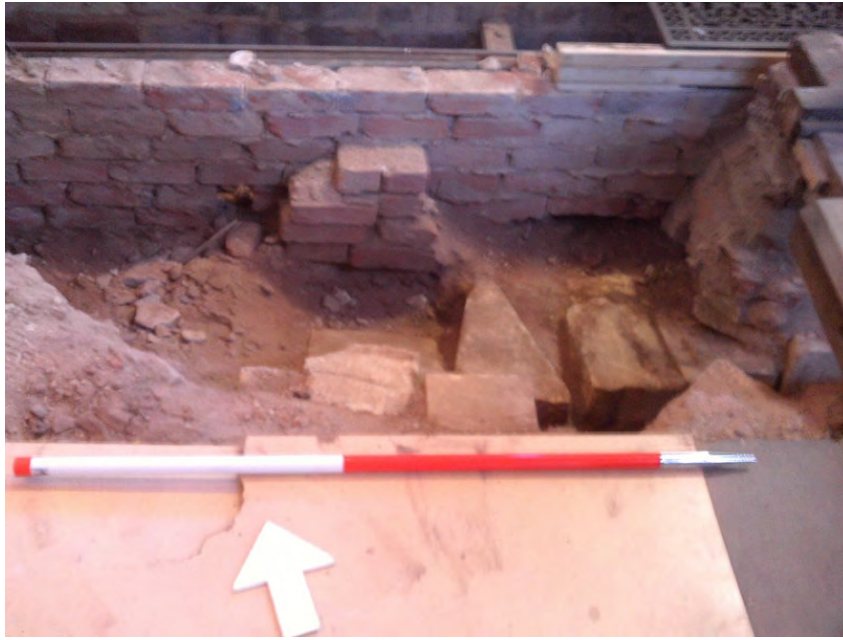
Across the northern part of the trench was the wall to the Victorian service which ran east to west, **08** (plate 5). It was six to seven courses deep and was laid in a third bond style. The wall was only one brick wide except in the middle of the wall where a buttress projected 0.11m out from the wall on its south face. The buttress was 0.33m wide and was built up to the northern end of wall **07**. Wall **08** was built along the Northern edge of the stone and brick pad **09** and was tied into the outer bricks of its construction. This wall was 0.6m high and appeared to be built directly onto the sand layer (11); any cut for the wall was shallow and not discernable.

Plate 5. NNE view of wall 08.
