**30 BELSIZE GROVE
LONDON**

HISTORIC BUILDING INVESTIGATION

MAY 2008

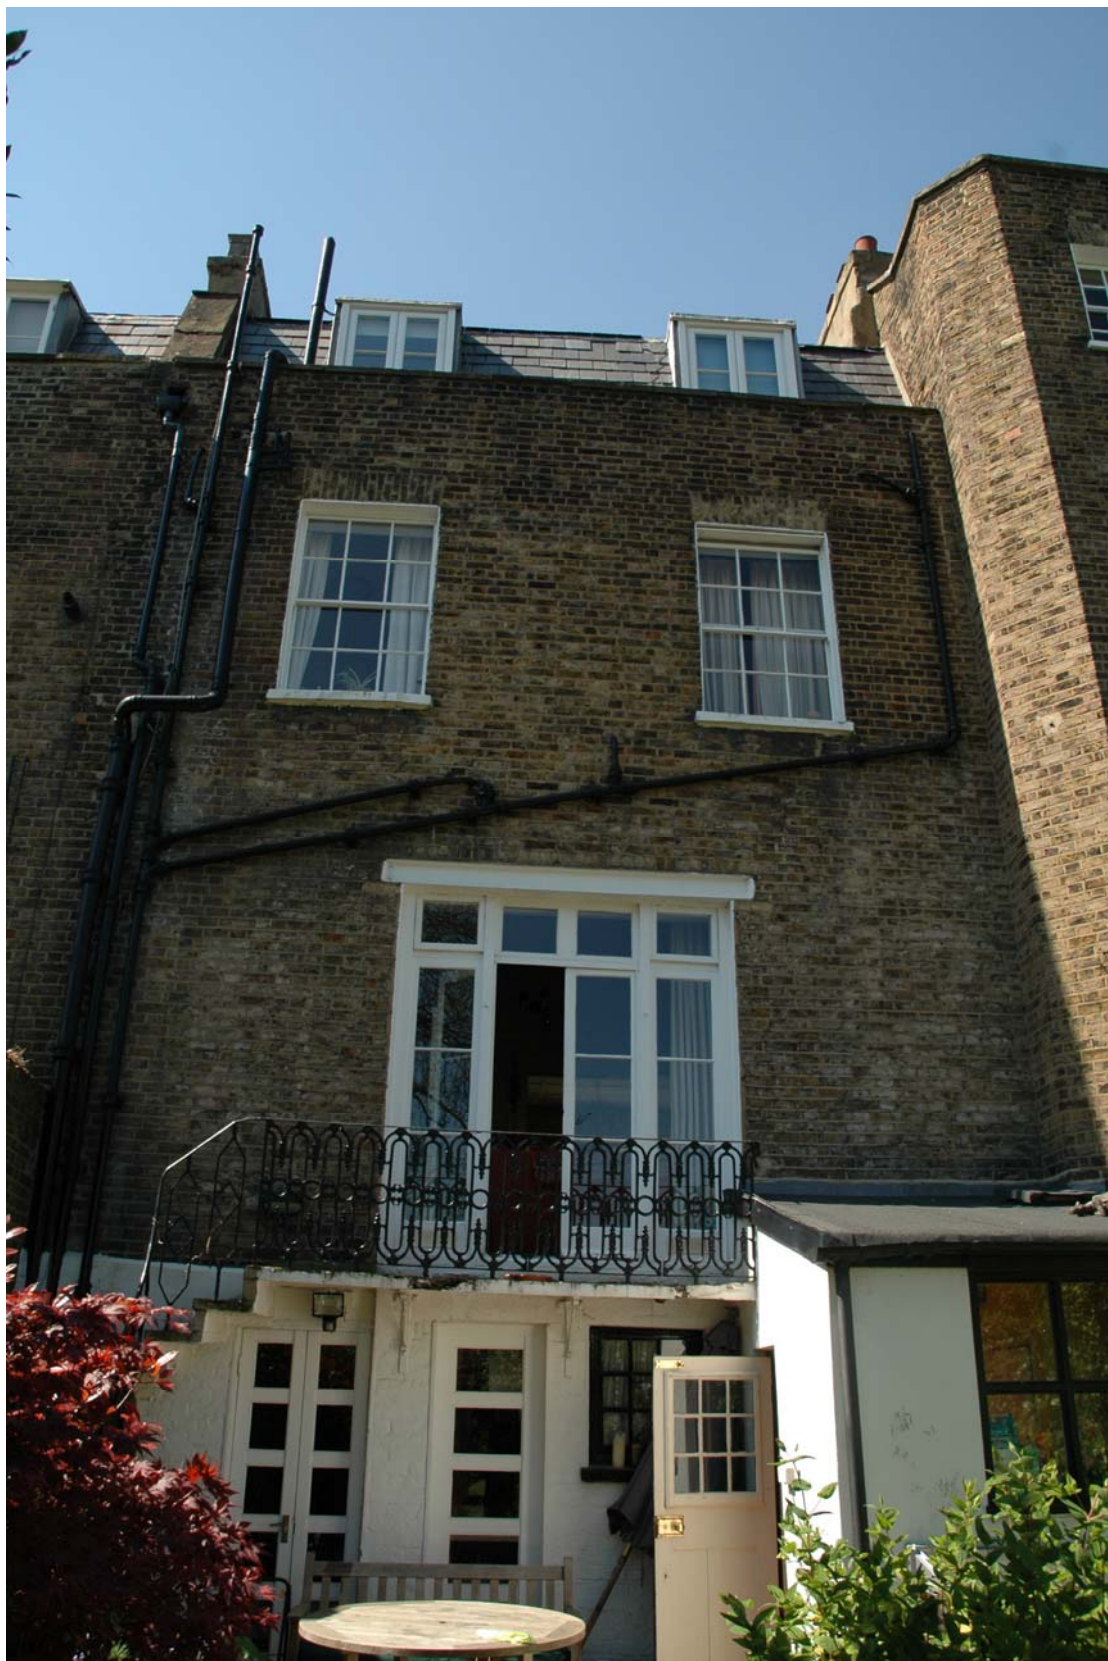
There have been alterations to the rear of the house, which is plain brick in Flemish bond and no stucco, except for the basement which is covered in white render. The

balcony at ground floor level is an original feature, but the stone stairway that leads from it to the garden has been moved in the past from the north end to the south end. This can be seen by the difference in the railings pattern and by the added brick skin beneath the stairs from which to cantilever the steps. Had the stairway been original, the stairs would have been set into the rear wall of the building during construction. Evidence for the original position of the stairway has been obscured, if not obliterated, by the addition of the present kitchen extension. It is possible that the stair is the original that was moved, but there is no evidence to suggest that is the case other than the quality of it and the fact that stone was used as in the floor of the balcony rather than an iron structure.

The rear fenestration is largely original, except for the insertion at some point of a steel lintel above the ground floor French window. The greatest alterations have taken place at basement level where only one original window survives. Where the original doorway from the service entrance stood, there is now a modern door which may have been inserted later. The brickwork is confused by the addition of the brick skin to support the moved stairway.

The door from the study is clearly modern, as is the narrow full-length window. The small sash window is, however, original. The staircase and balcony give the best clues. The staircase seems to have descended originally on the right hand side and was moved to make way for the extension, presumably because the extension was for the kitchen from which it leads. The evidence for the turning of the staircase can be seen in the fact that a brick skin has been added to the rear wall of the house to hold the cantilevered stone stairs, rather than being built into the original brickwork as is the case with the stone balcony. There is also a clear break in quality and design between the original balcony ironwork and the later staircase ironwork.

The brackets supporting the stone balcony are original, though the right hand one of the three was removed to build the kitchen extension. This would have balanced with the width of the window above.

Figure 1: The rear of the property

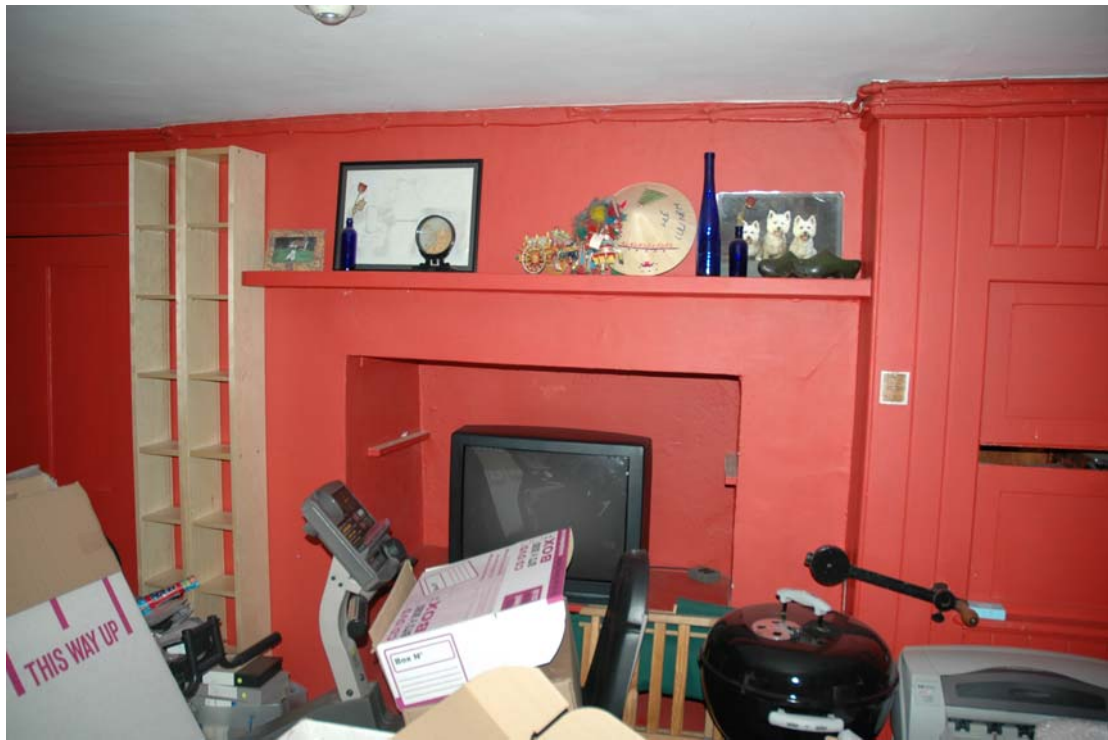
cupboard is on the right hand side of the stair. These two cupboards are original features, as are all the divisions of the rooms at this level. The original kitchen has been much altered, not least by the removal of the kitchen to the floor above.

There is nothing left of the original kitchen range, though a cupboard to the left of it might be original.

Figure 2: The basement front room, formerly the kitchen

There is no doubt that this is the area of greatest proposed internal alteration. The alteration will erase the service area of the building. But this is no longer a service area and its historic use is now obsolete. The house needs to be habitable and the low level of the ceiling and the half-basement construction make it a dark and cramped space that cannot be used for its original purpose nor yet for any modern living. There is a record of the service area as it has survived, but it no longer suits its purpose. The dropping of the floor level in itself will result in no serious damage to the historic fabric of the house, the original flooring having been lost long since. It will not alter the balance of the building on the exterior as it will not be visible. It is only the positions of the walls and doors that will be lost by the proposed alterations, and if recorded this will be no serious loss. The space has to become usable or it will always be left empty and may suffer somewhat by neglect.

The suggestion that this alteration will have an effect on the hearth and fire surrounds is not applicable as these do not survive. Skirting boards and architraves can be kept and re-used if necessary.

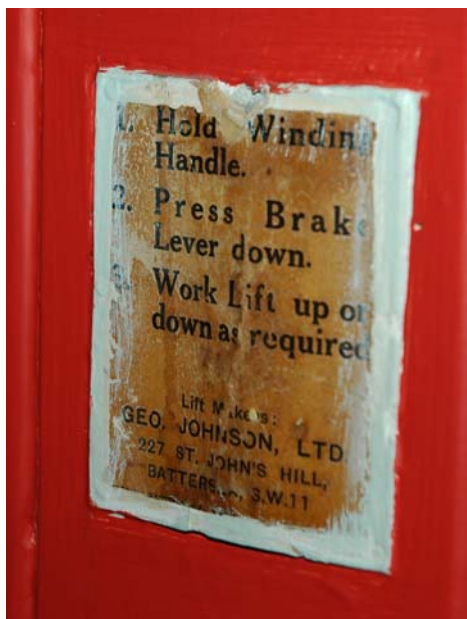
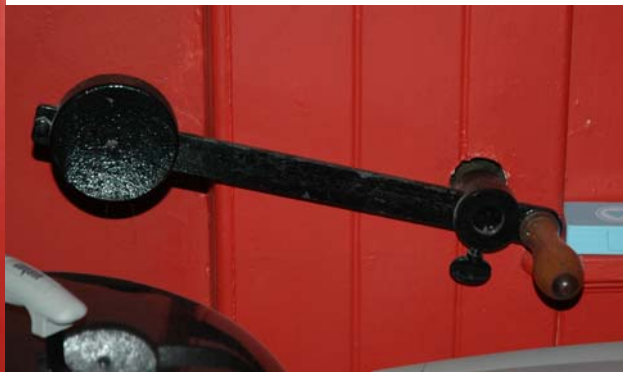
Figures 3 and 4: The instructions and winding handle for the dumb waiter

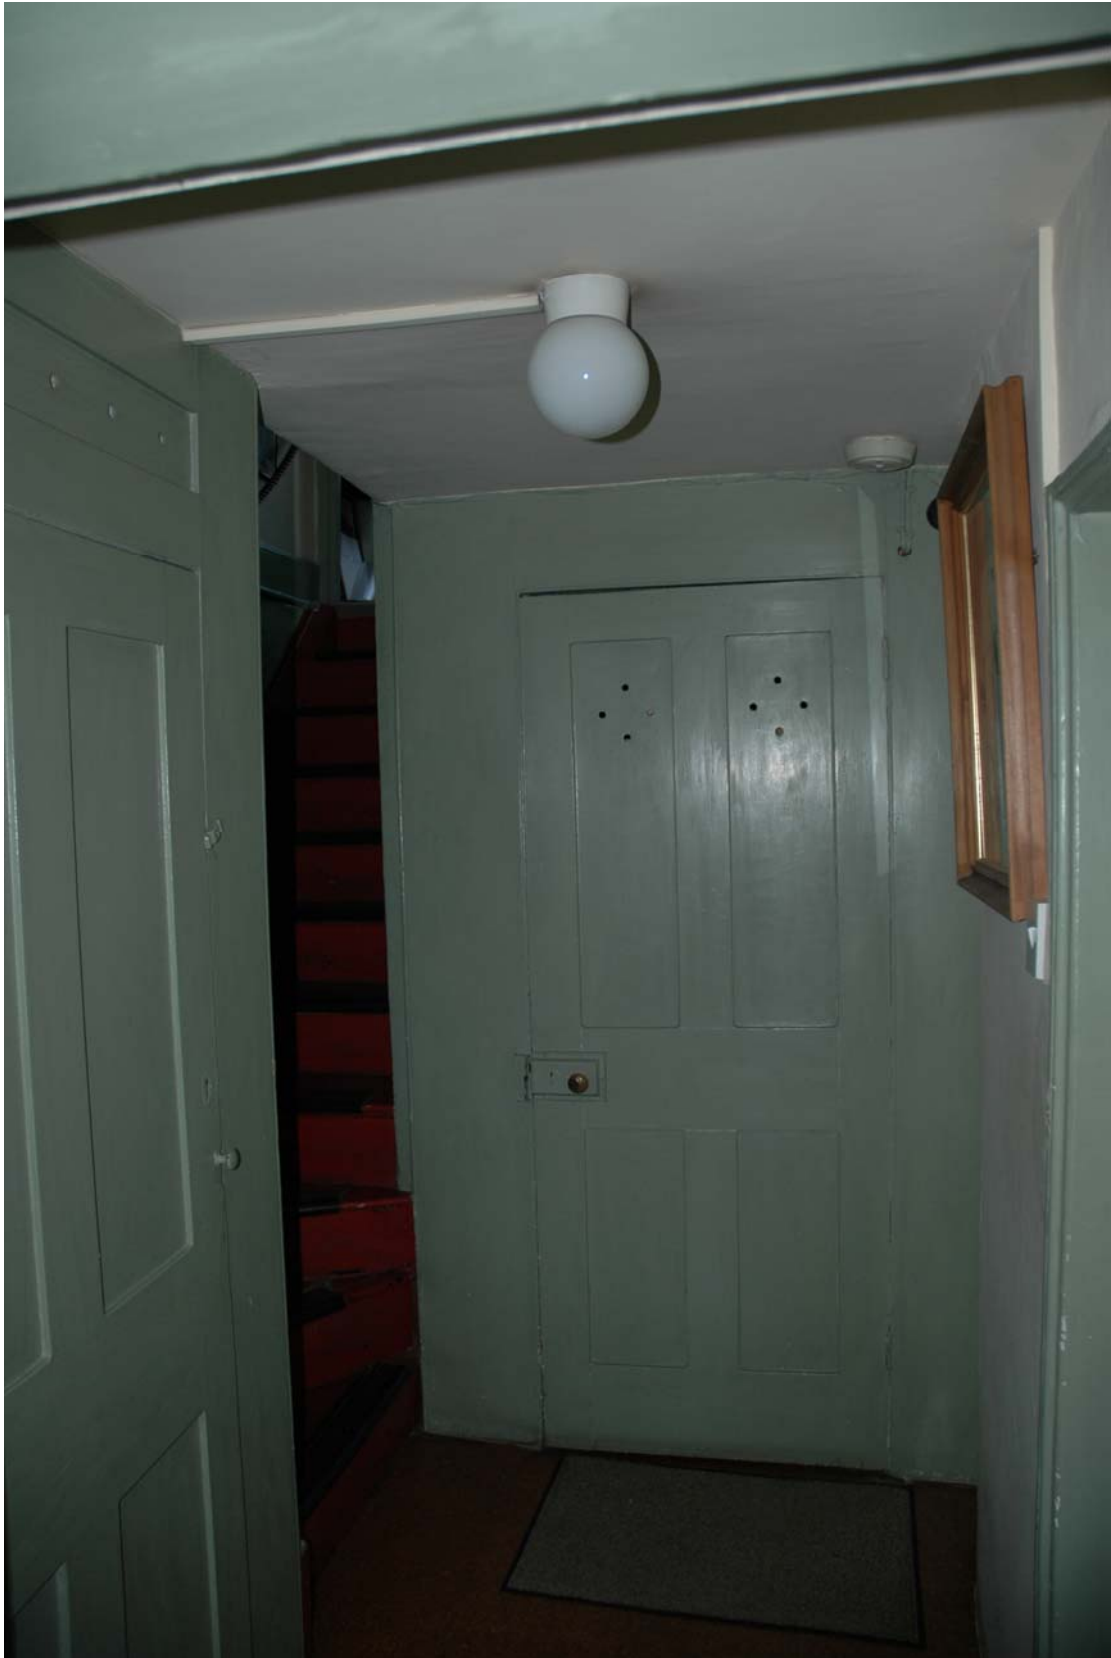
The front door opens into a small porch area with an arch separating it from the narrow hall. The panelled-off service stair, to the right on entry, descends to the basement though it has lost its original door.

Figure 5: The basement lobby and service stair

It would, however, be a pity to lose the original service stair and there appears little reason why this should be necessary.

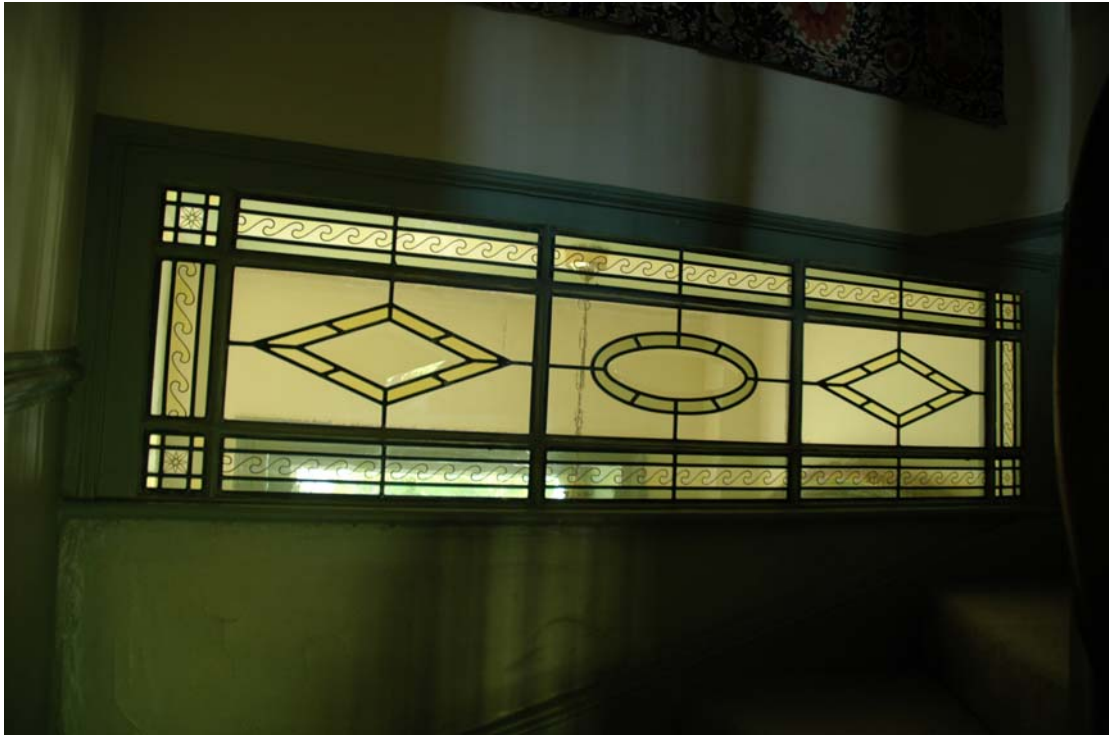
There are two bedrooms on the first floor. The principal bedroom at the front of the house has a small dressing room with decorative coloured glass on its internal wall to give borrowed light to the otherwise unlit stair. This feature is repeated on the floor above for the same reason. The smaller rear bedroom has a curious entrance arrangement doorway, with a double architrave and storage shelf above. This may have been a double door at one point, a feature used to give added privacy to the occupants.

Figure 6: The decorative coloured glass window giving borrowed light to stair

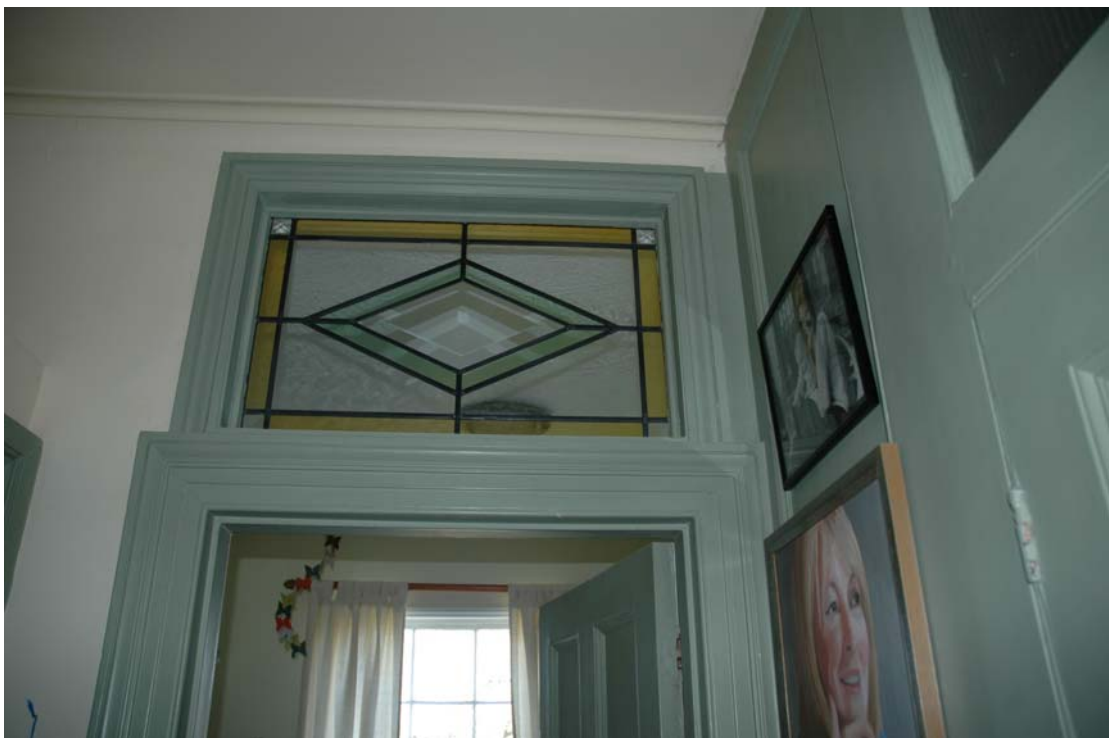
The bathroom door is surmounted by decorative coloured glass, an original period feature to give borrowed light from the bathroom window to the stairwell.

Figure 7: The decorative coloured glass above the current bathroom door on the first floor

The first floor alterations involve switching the positions of the second bedroom and bathroom to create an en suite arrangement for the principal bedroom. This would involve the removal of the decorative glass above the current bathroom door, which would alter the feel of the building, particularly the stairwell. If this proves necessary the panel should be moved to the new door position. The piercing of the wall between master bedroom and secondary bedroom would not greatly alter the feel of the principal bedroom and the damage done to the historic fabric of the building will not be excessive. No house can survive without alteration as lifestyles change and the fabric changes with it.

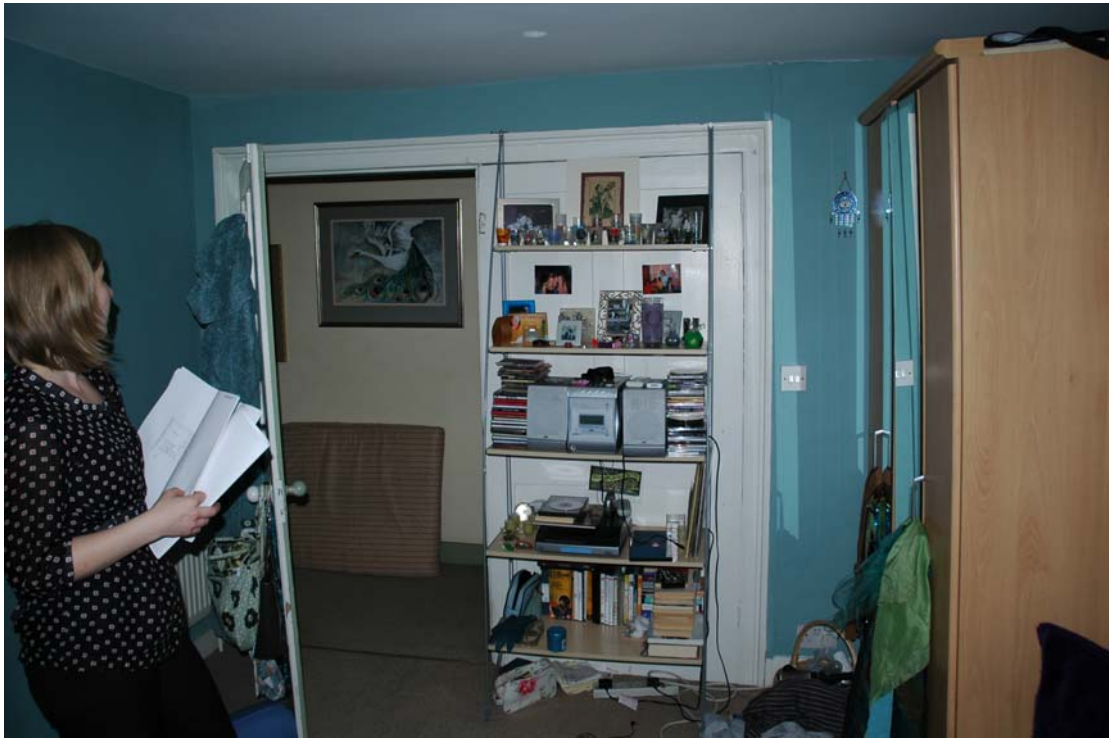
There are currently three bedrooms, the two principal of which were linked by a broad double-leaf door. Half of this has been sealed shut and a modern plasterboard partition added to create a short passage into the front bedroom. The front room has its own dressing room giving borrowed light onto the stairwell. All of this suggests that it is unlikely that this was ever service accommodation, but more likely the nursery. There is a blocked door between the two rear bedrooms, but it is not possible to judge if this was an original feature.

Figure 8: The double door on the second floor

There have already been alterations carried out at this level. The replacement of the modern partition is not important, but it would be a shame to lose the double door feature and an attempt to keep it should be made.
