JOHN MOORE HERITAGE SERVICES

The survey of a barn
at
KINGFISHER COTTAGE, WESTBROOK,
Boxford
BERKS

K A Rodwell

July 2007

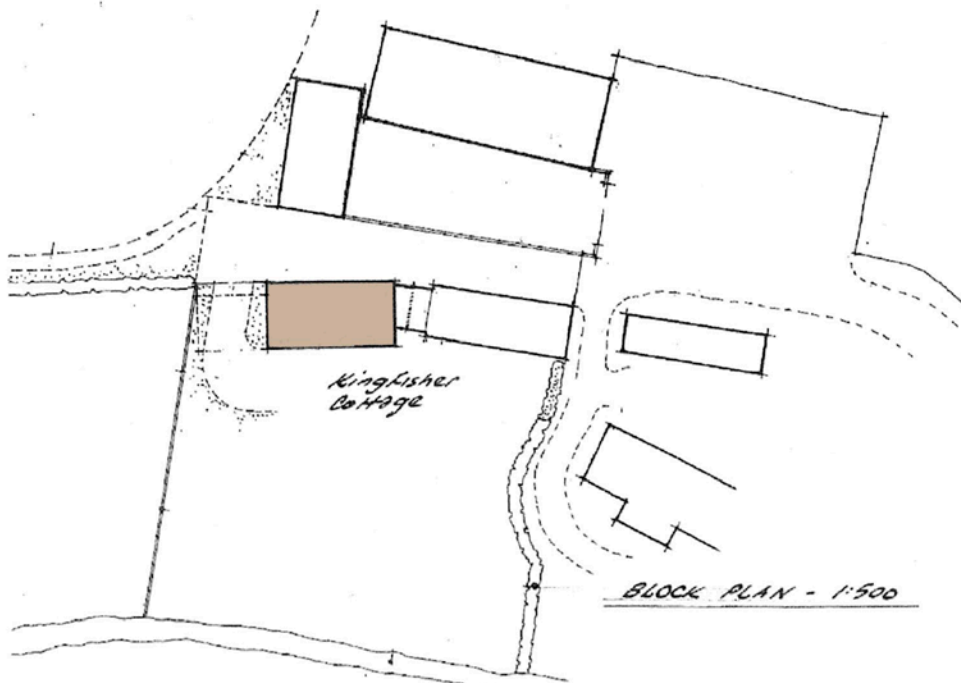
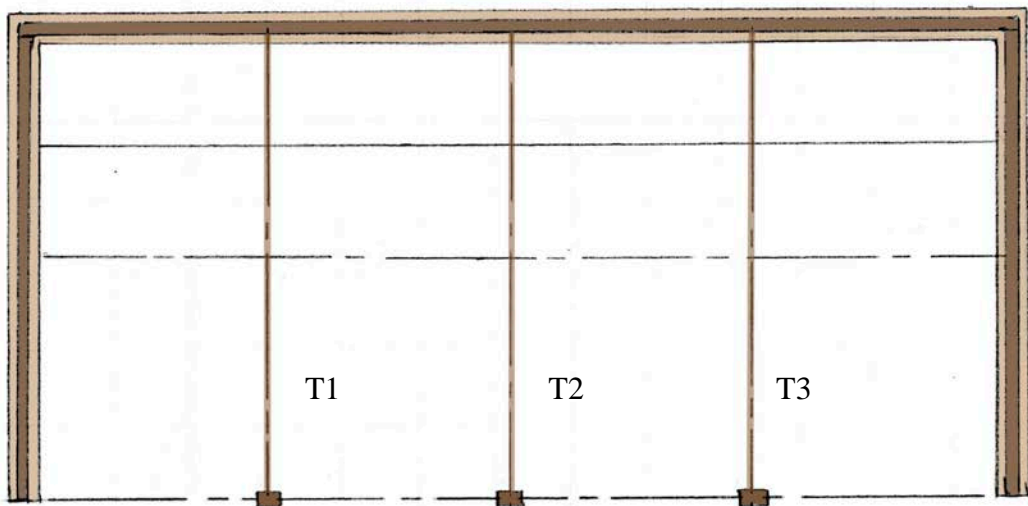
Fig 2

Plan
(scale 10m)

Section
(x2: scale 5m)
K A Rodwell

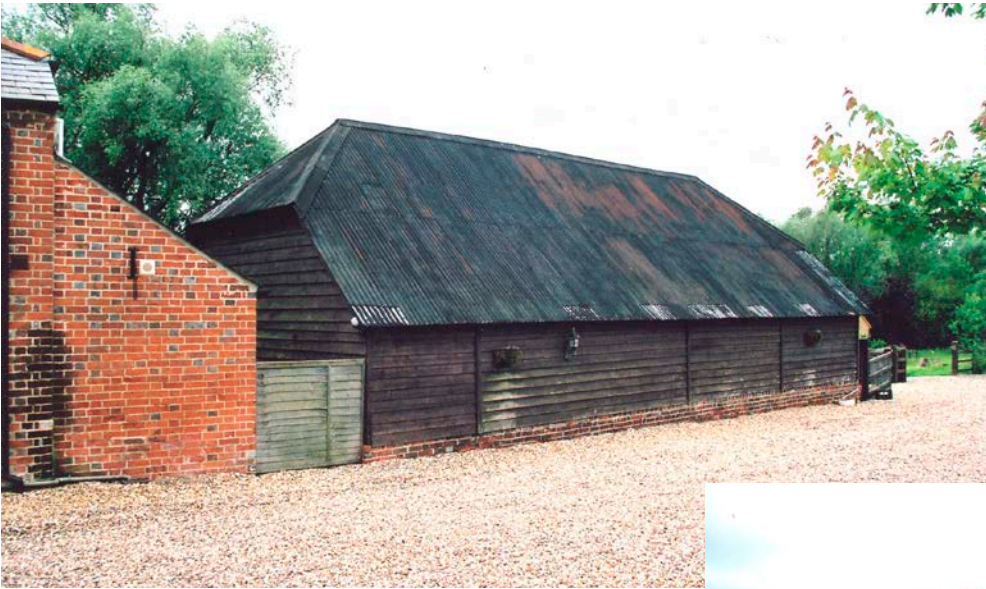
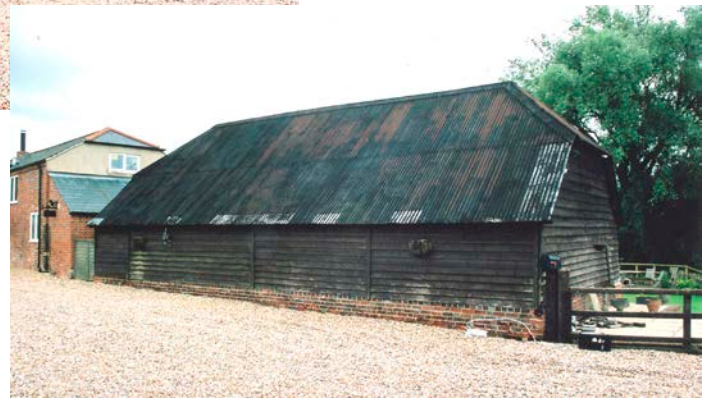
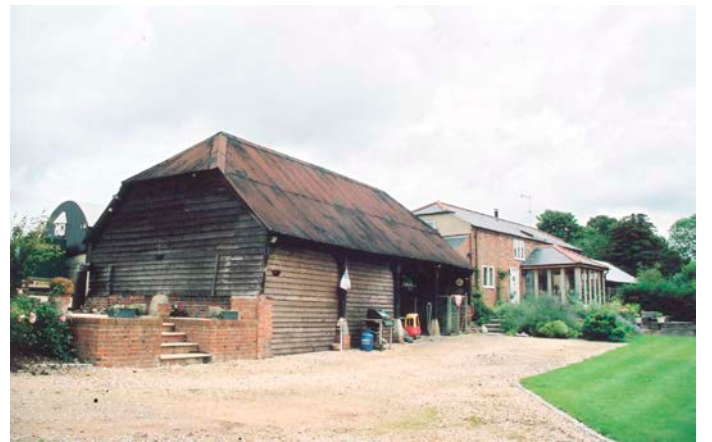
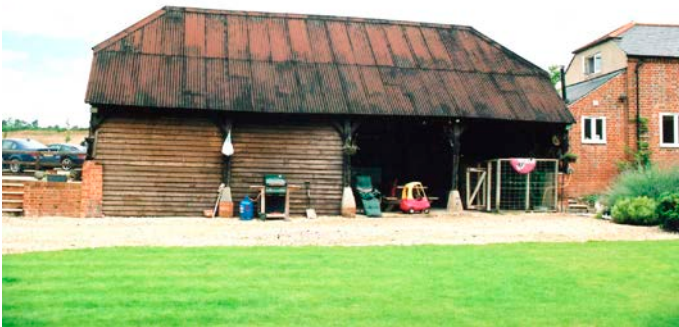
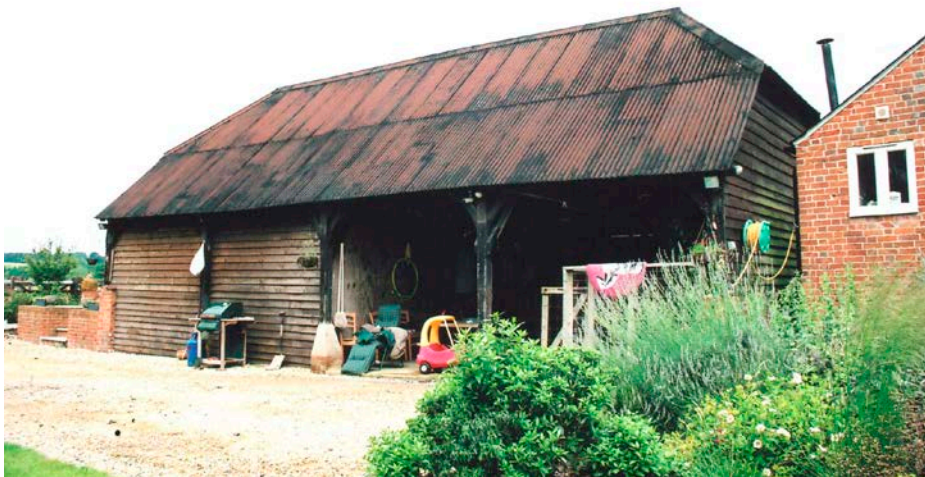
Fig 3 Exteriors
(clockwise from top)

From the north-east

From the north-west

From the south-west

From the south-east

From the south

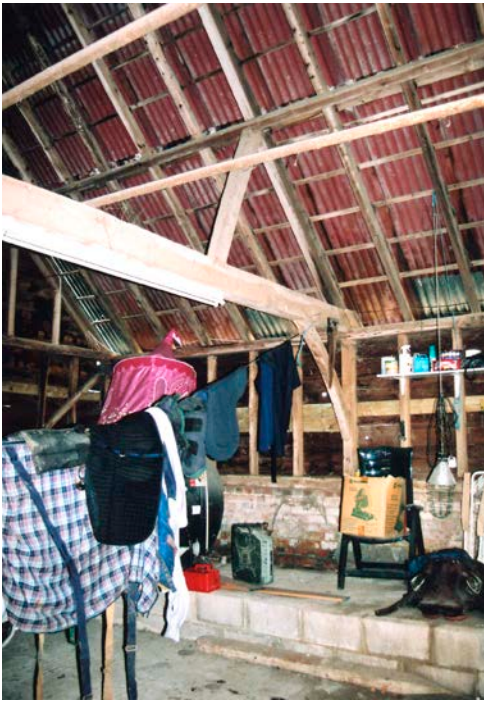
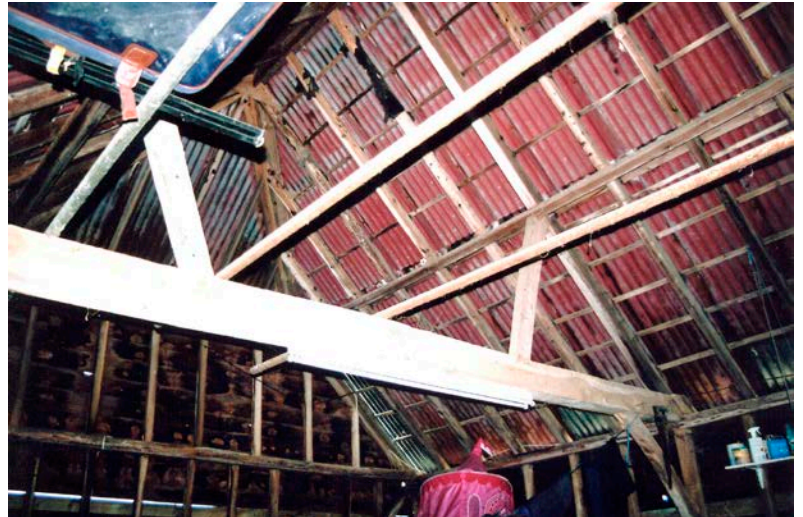
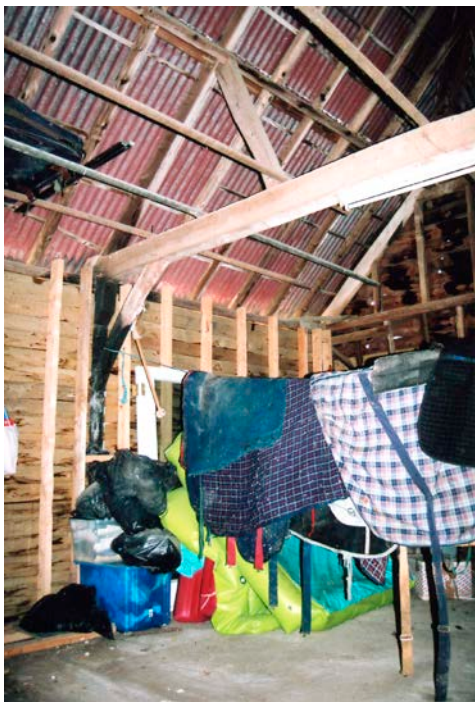
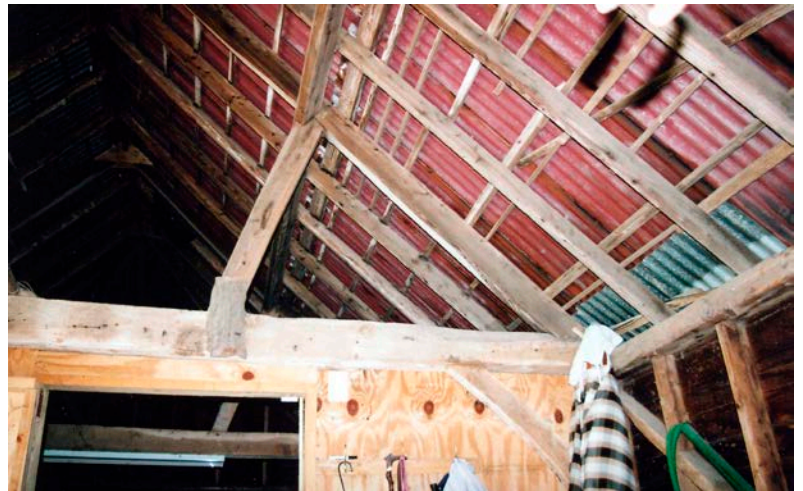
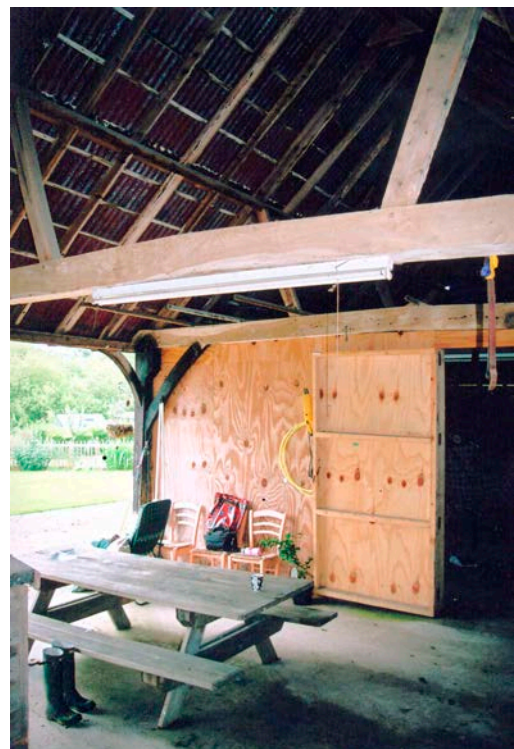
Fig 4 Interior

Truss 1 and north-west corner

Truss 1 and west end of roof

Truss 2 north side

Truss 2 south side

Truss 1 and south-west corner

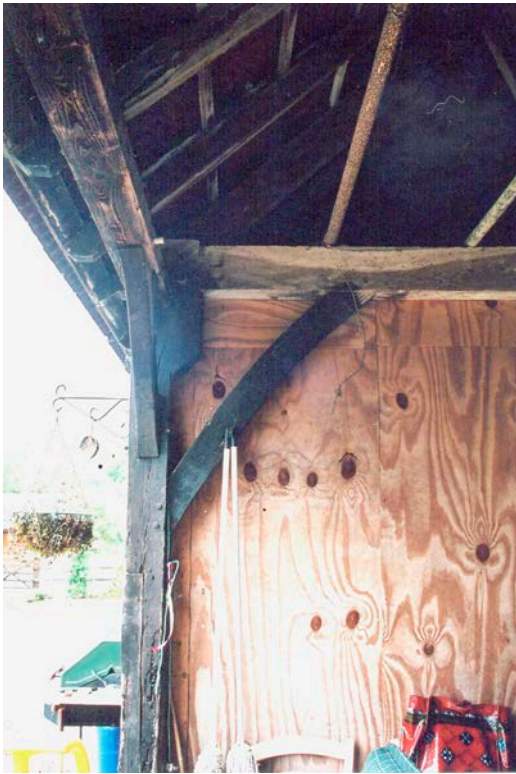
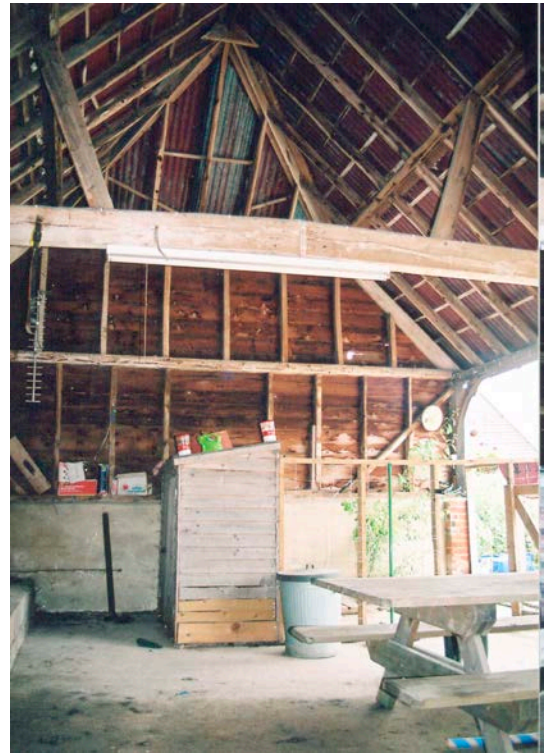
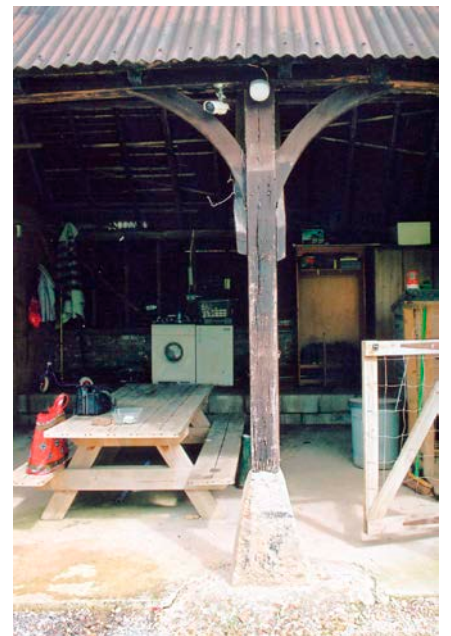
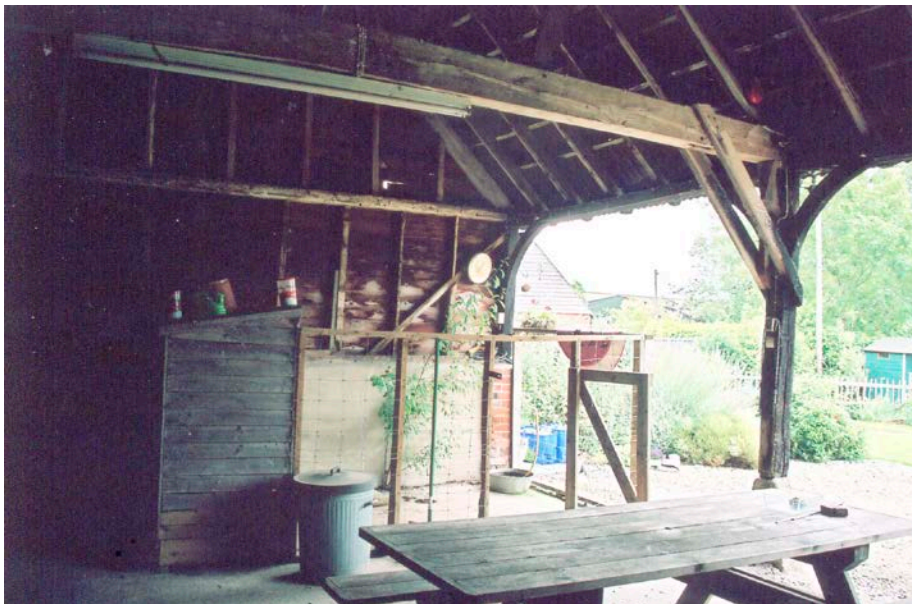
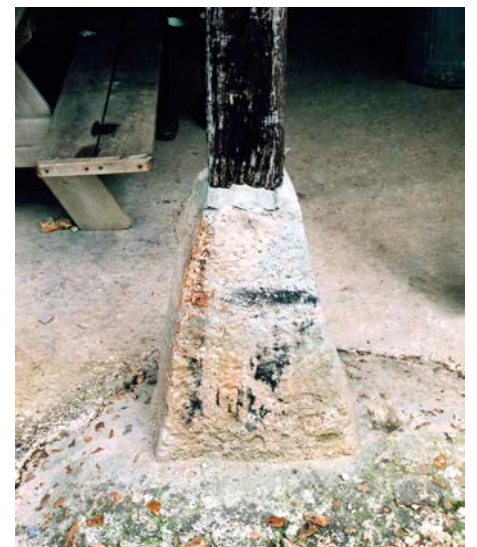
Fig 5 Interior
(clockwise from top)

wall-frame is infilled with a single tier of studwork between the cill beam and the wall plate, which has scarf joints at intervals. The gables have a double tier of studs bisected by the wall plates and there are straight corner braces. The majority of timbers are original but several curved braces are missing, particularly from T3.

Jowled post detail, truss 2

Truss 3 and east end of roof

Post detail, truss 3 with braces to wall plate

Detail of stone post base, truss 3

Truss 3 and south-east corner
