The structural history
of
DANDRIDGE'S MILL
EAST HANNEY
OXFORDSHIRE

K A Rodwell
for
JOHN MOORE HERITAGE SERVICES
July 2007

THE STRUCTURAL HISTORY OF DANDRIDGES MILL, EAST HANNEY, OXFORDSHIRE

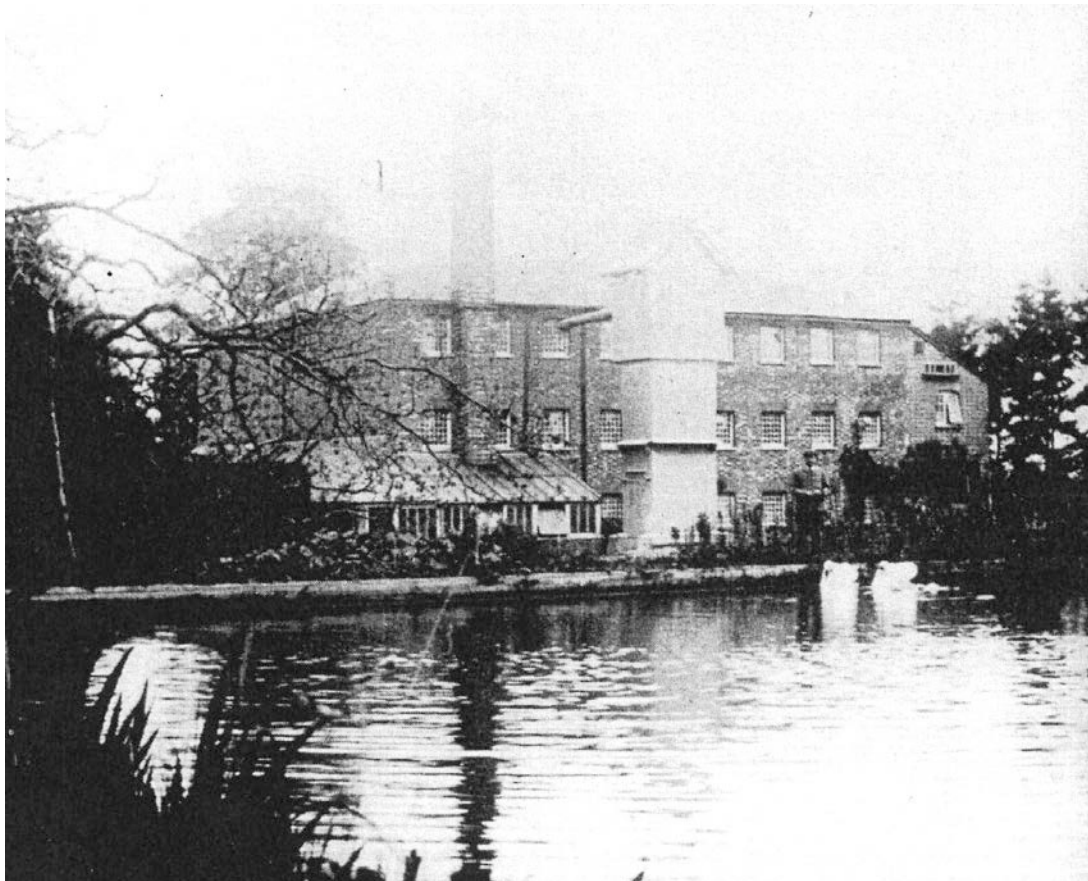
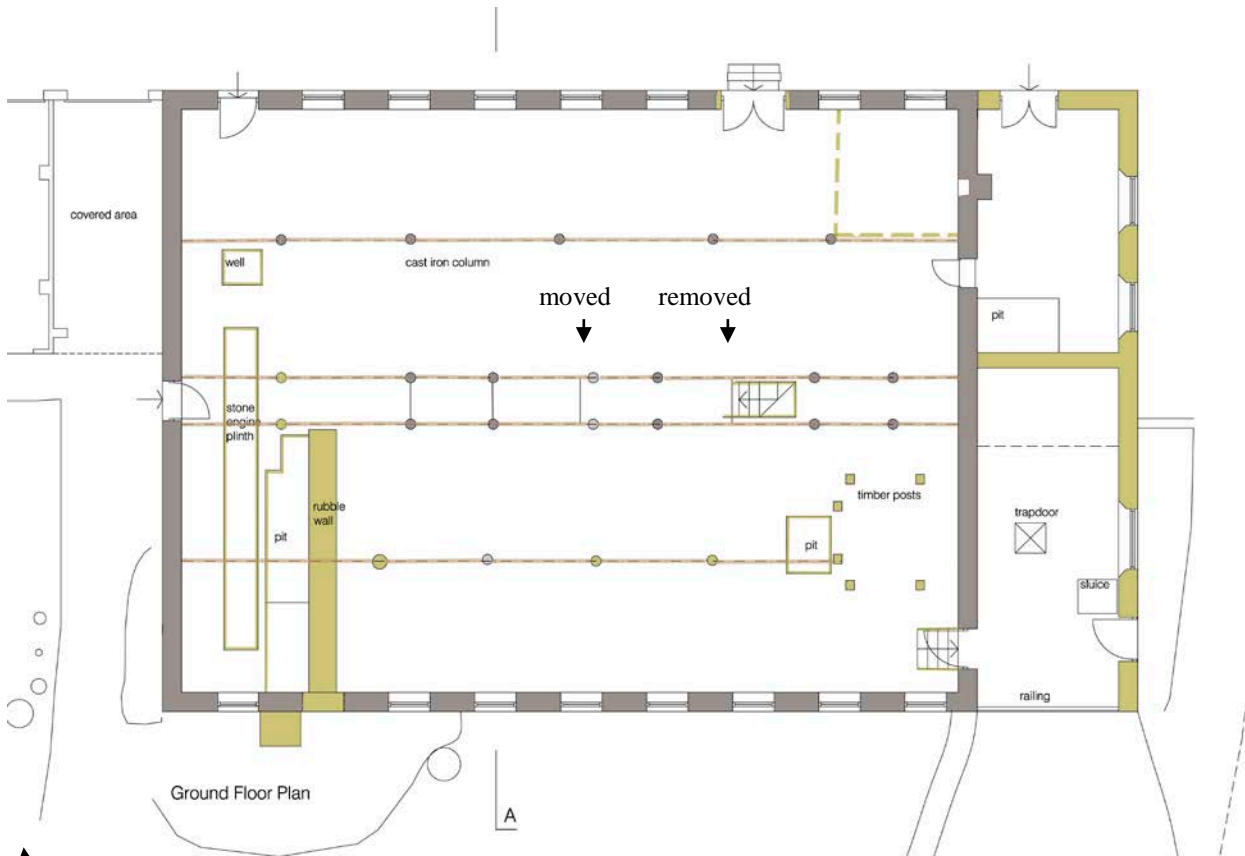
Fig 2
Ground floor plan

The original flagged stone floor has recently been exposed by the removal of a 19th century boarded floor set some 0.3m higher; this has provided a benchmark for assessing the relative age of internal features. The doors in the west wall and in the north-west corner predate its installation and have been shortened at the base. The adjoining staircase against the west wall has also been modified. The double door further east is associated with the raised level and so is the stair in the centre of the range; it has a heavy bulbous newel at first floor level and probably dates to the late 19th century. In the southern half of the building there are emplacements for mill machinery close to the east wall associated with the wheel and later the turbine. In the south-west corner there was an enclosure for a steam engine behind a partially demolished brick wall, comprising a monolithic stone engine bed on a brick base and an adjoining pit; to the west there was a passage with an external door and to the north a well. A small room was partitioned off in the north-east corner, indicated by a fireplace in the east wall and differential paint finishes; this is a secondary alteration.

The north ceiling beam is carried on six cast iron columns 0.15m in diameter with heads cut down from the paired arches used in the central row. They have square base-plates which are set on the flagged floor and likely to be original to the building. There are

seven pairs of columns in the central row, all but one cast as a single unit with a flat connecting arch and a semi-circular upstand hidden by the ceiling beams. They are set on individual rectangular slabs within the floor and are original to the range. One pair (indicated by the slab and bolt holes) has been removed to insert the stair and another has been moved slightly from its original position. At the west end there are two individual columns which predate the wooden floor but may be secondary.

There are only four columns supporting the south ceiling beam, all likely to be replacements; one is a length of flanged piping and two of the others are associated with the raised floor level. The beam is truncated at the east end and replaced by several massive wooden posts set on brick sleeper walls at raised floor level and associated with former machinery; two are set on the edge of a brick-lined pit. The first floor joists to the south of this ceiling beam have been reinforced with additional timbers.

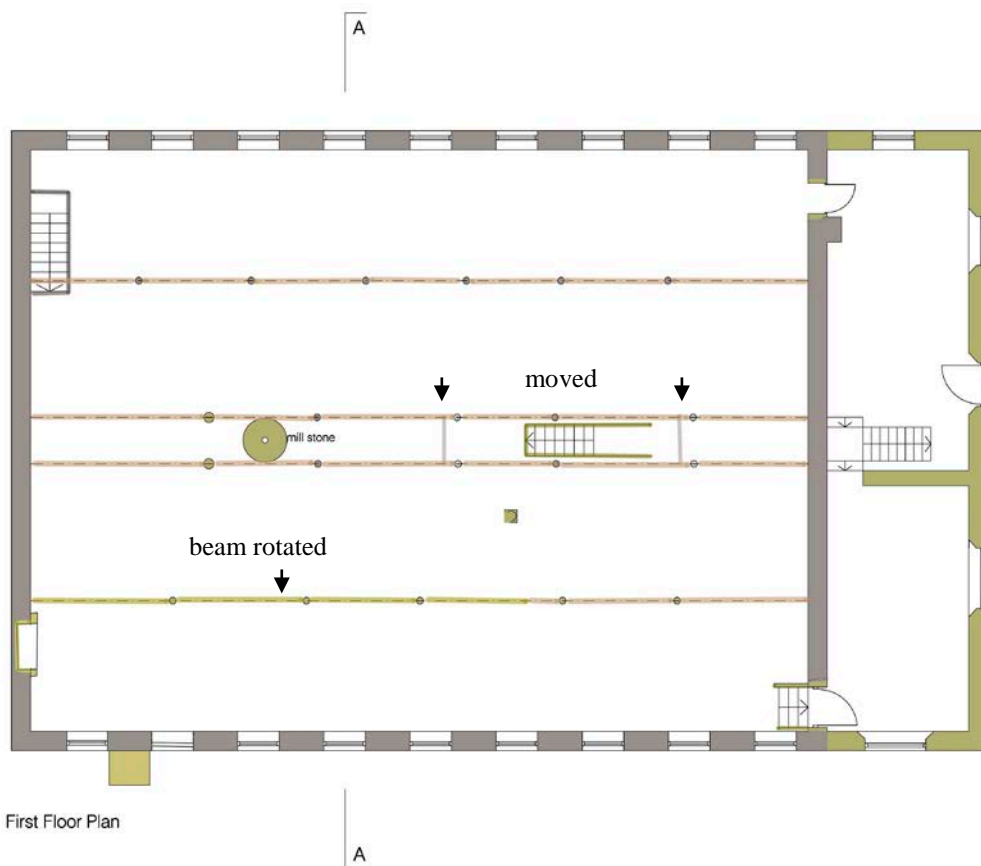
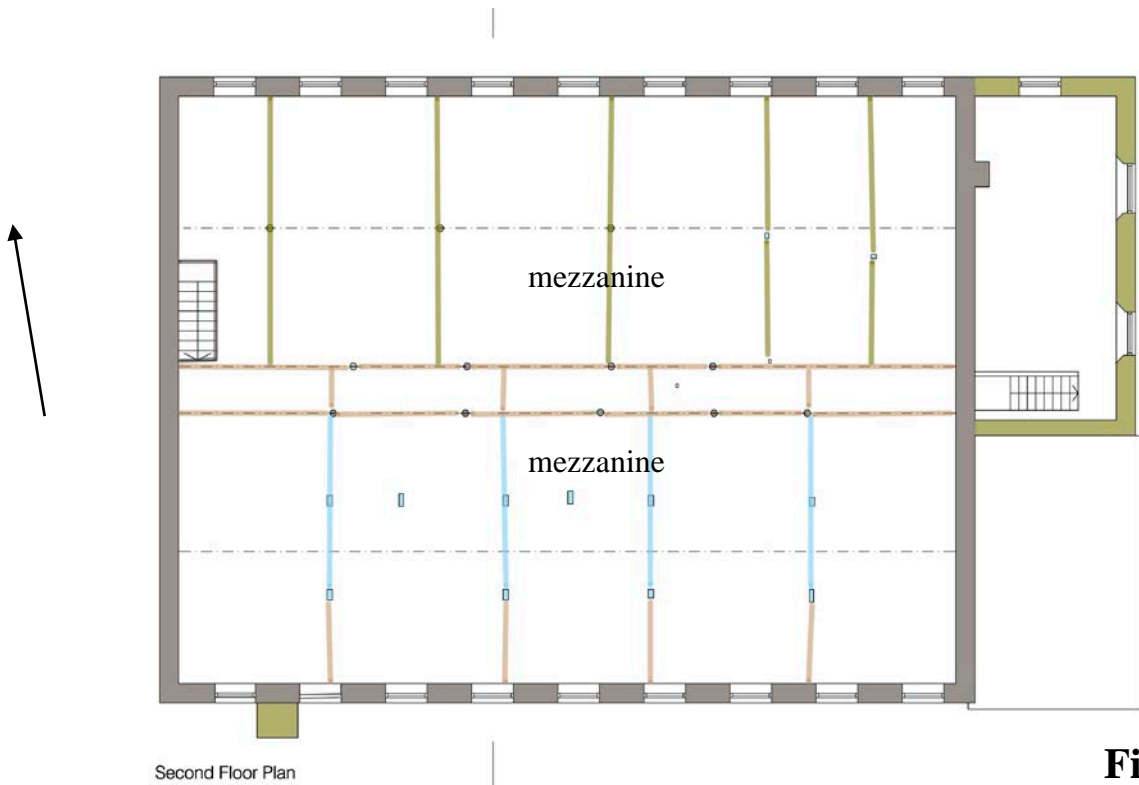
Fig 3
Top floor plan

There is no longitudinal beam on the north side of the building; instead three thin cast iron columns support tie beams to the roof trusses. These are set into the north wall between the windows and replace the original roof structure which had tie beams at a higher level (partially extant on the south side); the filled sockets are visible in the north wall above window lintel level. These secondary tie beams carry queen posts and a single tier of purlins. There is a ridge board and pairs of common rafters are yoked at intervals; these correspond to the original truss positions and not to the extant roof. A mezzanine floor (of unpainted timbers) has been inserted into the roof-space and the secondary tie beams reinforced; the columns support these widened beams on heavy intermediate blocks.

There are no columns in the southern half of the building where they have been replaced by pairs of rough reused wooden posts which supported a mezzanine floor. The insertion of this floor truncated the original roof trusses which survive next to the south wall where there appears to have been a corridor. The tie beams are set into the south wall above the continuous window lintel and have raking queen posts to a single purlin. This carries an original common rafter roof with yoked pairs over the tie beams. The truncated ends of the beams are secured to the later posts by iron plates.

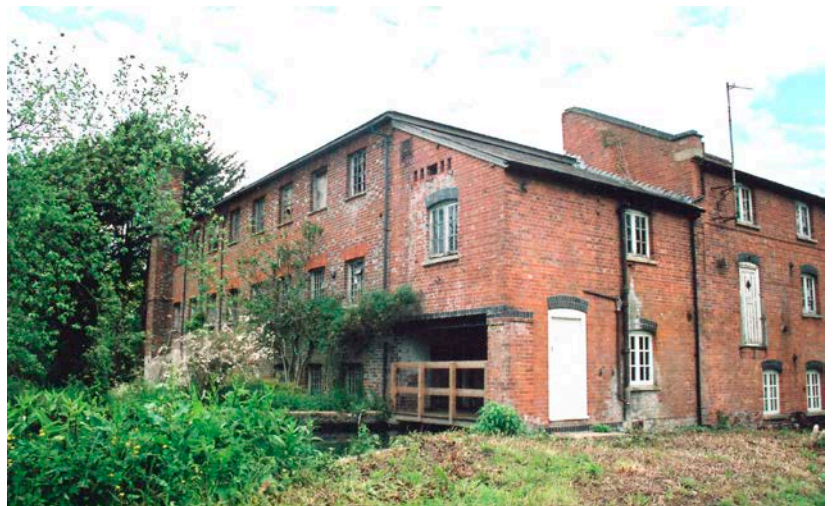
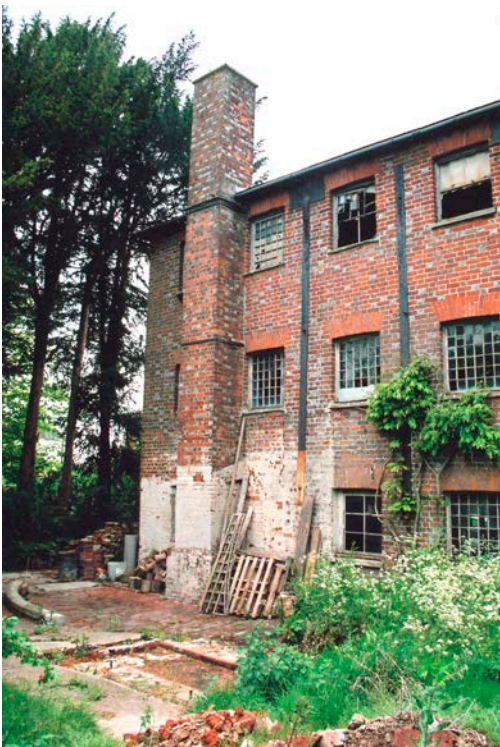
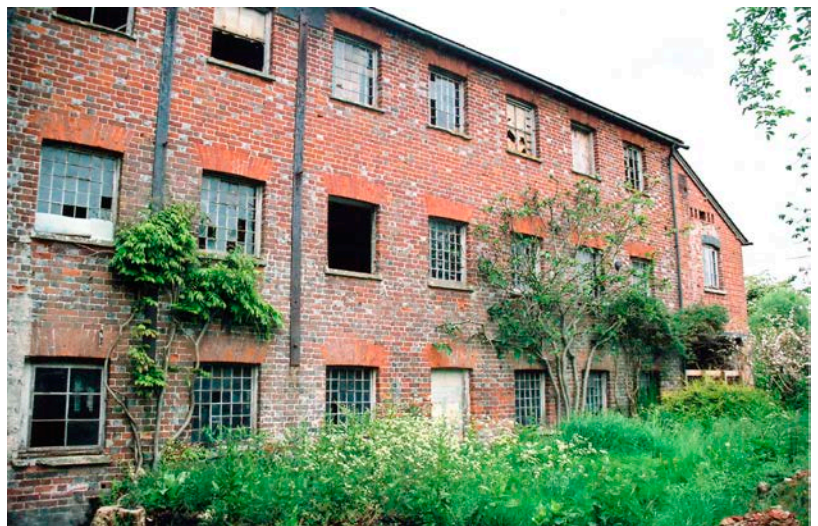
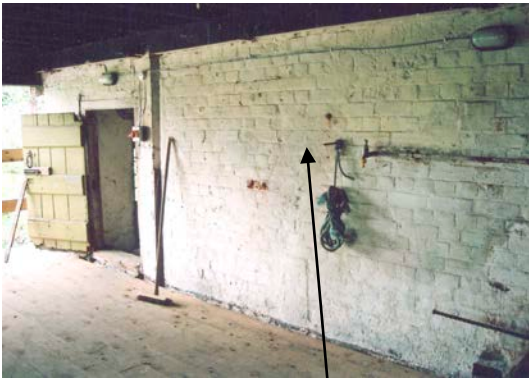
Fig 5

The north elevation is largely as built with an original door at the west end. The raised double door towards the east end replaces a window and has an arched grey brick head matching the eastern extension. Across the width of the original building between the first and second floor windows there is a painted band with shaded black lettering reading 'DANDRIDGE BROS. MILLERS, MALTSTERS, HAY, STRAW, CORN & SEED MERCHANTS'. Between the top floor windows west of centre there is a brick dated 1820, incised and filled with lime mortar, surrounded by a series of initialled bricks, B.H, R.C, B.L, J.B and C.S.

The south elevation is largely as built; some window frames are missing (but seem to be stacked internally), one has been reglazed, another turned into a door and a third blocked. This adjoins the brick chimney to the engine house, a later addition secured to the wall by iron bands; the adjoining wall has been reinforced with three long vertical iron plates between the windows. An old photograph (Fig 1) shows that there was a part-glazed lean-to on this corner of the building, indicated by painted brickwork. This extended onto the west wall, otherwise blind apart from an original central door.

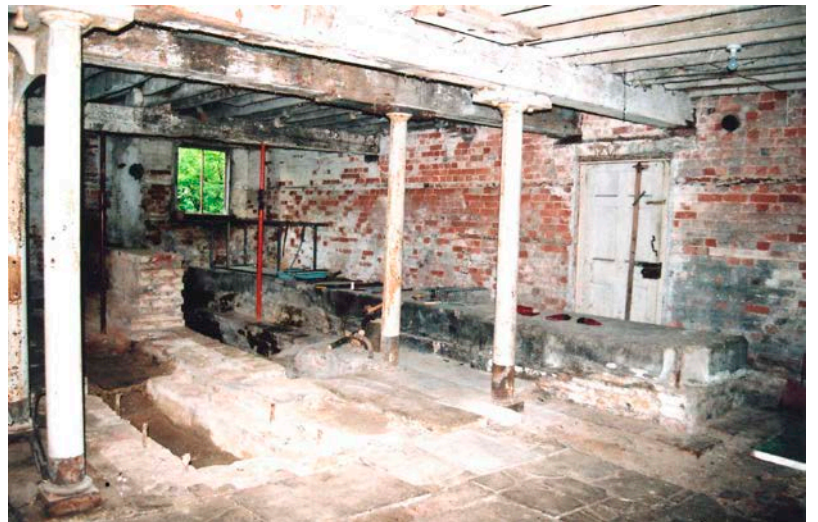
Ground floor looking east with original columns

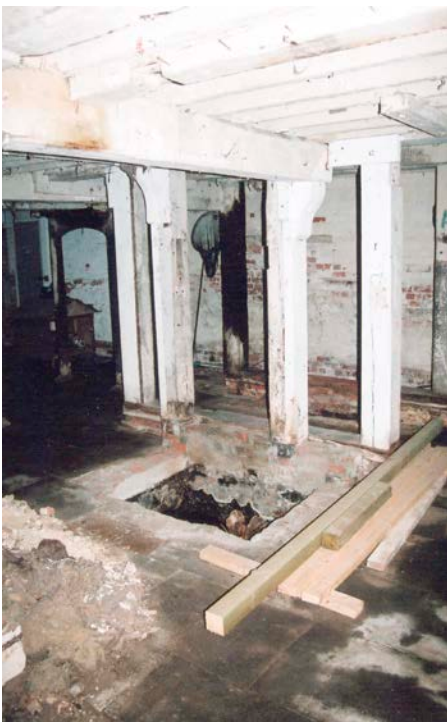
Ground floor, engine bed in south-west corner

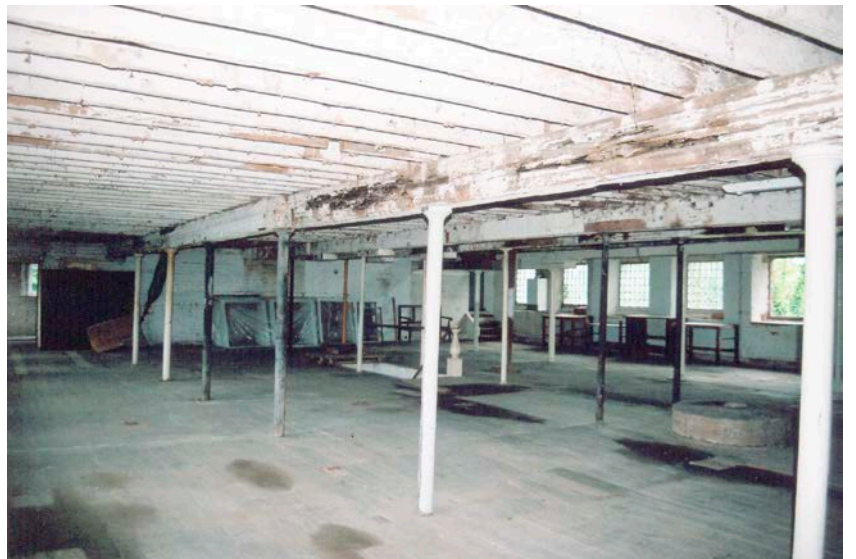
First floor looking south-east; original columns in foreground

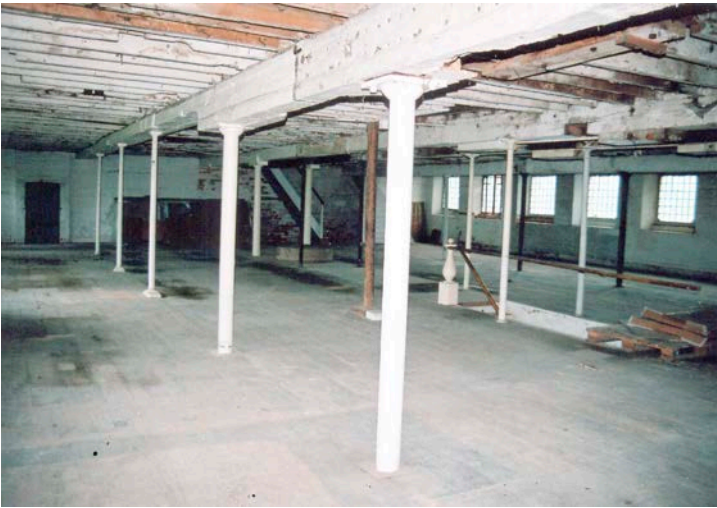
Ground floor, secondary posts in south-east corner

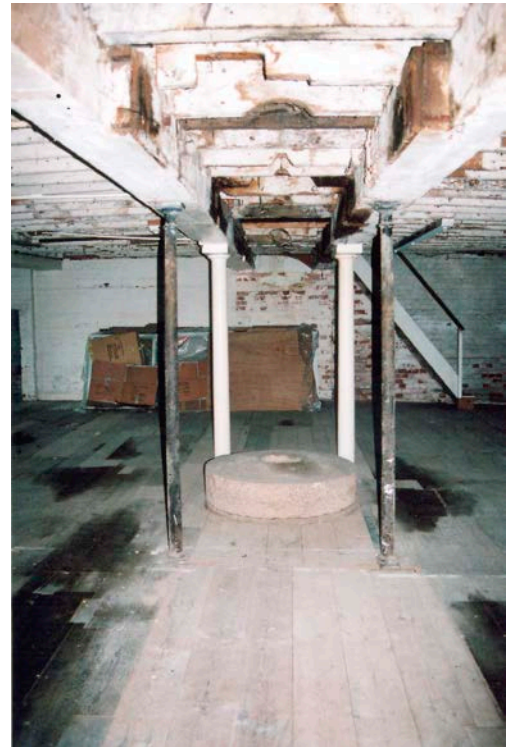
The east end of the south beam is edge-set like its northern counterpart with the same evidence for reuse. However the remainder has been cut and rotated through 90° so that the striated face has become the underside of the beam and the overall depth has been reduced. The five columns are all replacements associated with this modification; three are thin (0.08m diameter) but the two at the east end, supporting the joined and reinforced edge-set beam, are more substantial (0.12m diameter); they do not line up with the other rows of columns.

First floor looking west showing rotated beam

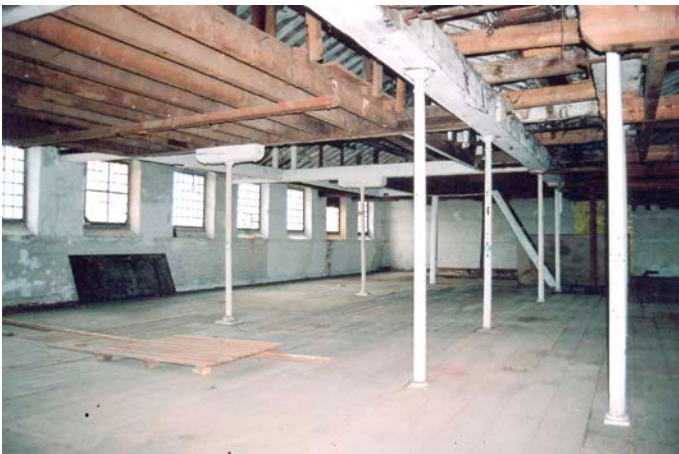
This level has a wooden floor of old boards with evidence for previous fixtures and machinery; there was a large hatch immediately south of the central stair. Limited areas have been patched with modern boards including the floor around a pair of millstones set on the floor between the western pairs of central columns. Evidence for associated mill machinery or hoppers is lacking so that it is uncertain whether they are in their working position. There is a small fireplace built into the south end of the west wall but no other evidence for an enclosure in this corner. The stair to the top floor is against the west wall, probably its original position; it has a plain closed string and a handrail without balusters.

First floor looking west, millstones

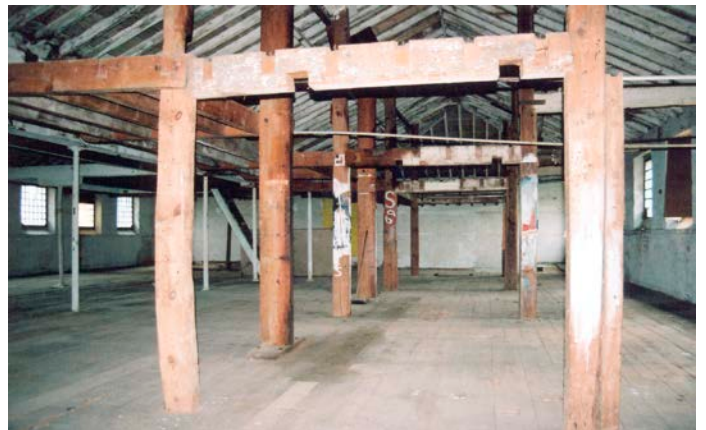
Top floor, mezzanine structure on south side

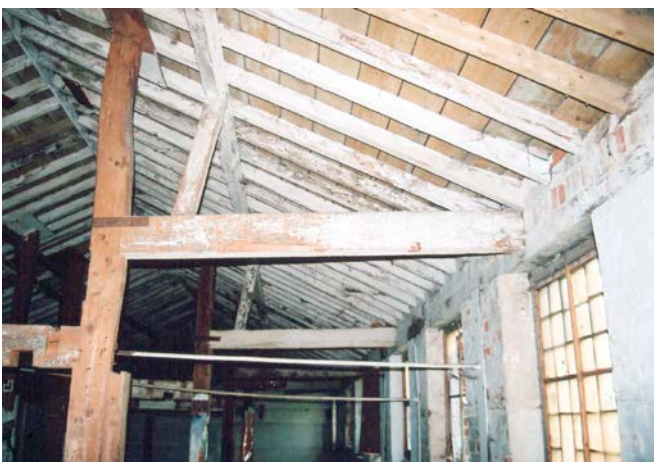
Top floor, mezzanine structure on south side & original roof

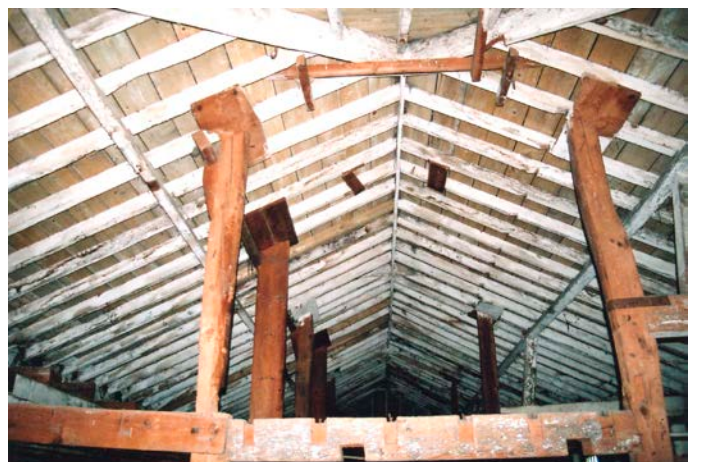
Top floor, original tie beams truncated by mezzanine structure on south side
