The investigation of a barn
at
DAIRY FARM, HIGH STREET
CHINNOR, OXFORDSHIRE

K A Rodwell
for
JOHN MOORE HERITAGE SERVICES

May 2006

THE INVESTIGATION OF A BARN AT DAIRY FARM, HIGH STREET CHINNOR

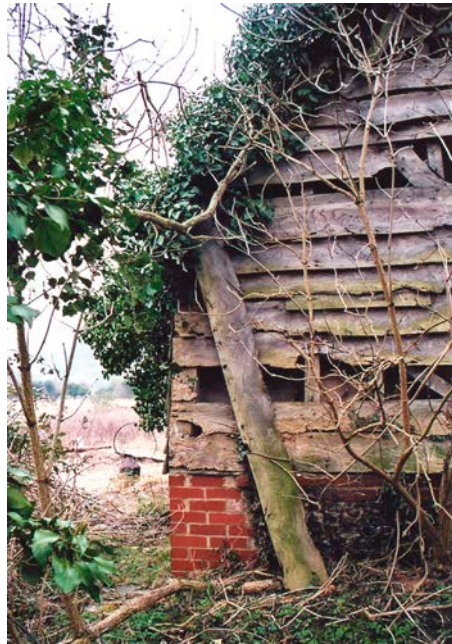
11

Bay 1 –Truss 1 which formed the NW end of the building sat on a dwarf wall, 0.7m high, of flint rubble with brick dressings, rebuilt on the NE corner. It was the only

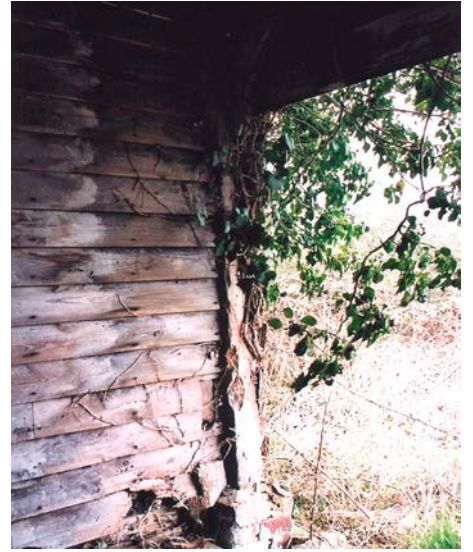
19

Bay 2 – This had opposed doors and modern weather-boarded walls. Truss 2 NE had an original base; truss 3 was cased in modern boarding and had a carpenter's mark VI on the NW face.

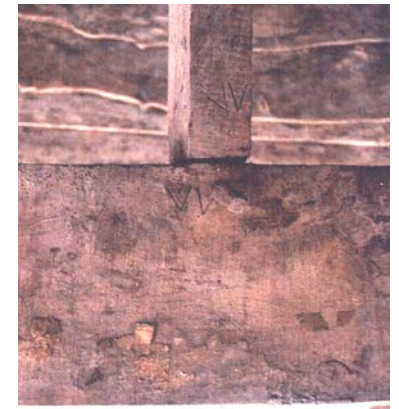
46

Bay 3 – The modern boarding continued into this bay which was open at the SE end. Truss 4 had carpenters' marks V and VV on the NW face.

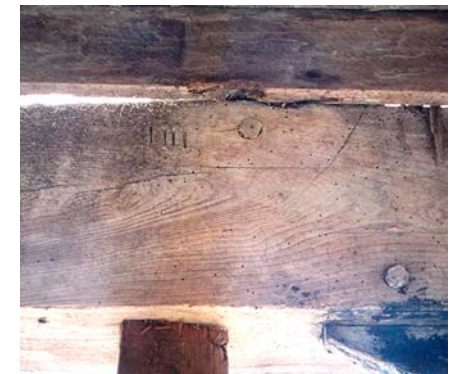
47

Bay 4 – the SW side was void and the NE side part boarded. The NE post to Truss 5 was missing and the gable partly infilled with boarding. There were carpenters' marks IIII on the NW face and mortices in the SE face for the braces to the demolished part of the structure.
