**AN
HISTORIC BUILDING ASSESSMENT
OF
PYRTON MANOR,
PYRTON,
OXFORDSHIRE**

*On behalf of
FPD Savills*

JULY 2004

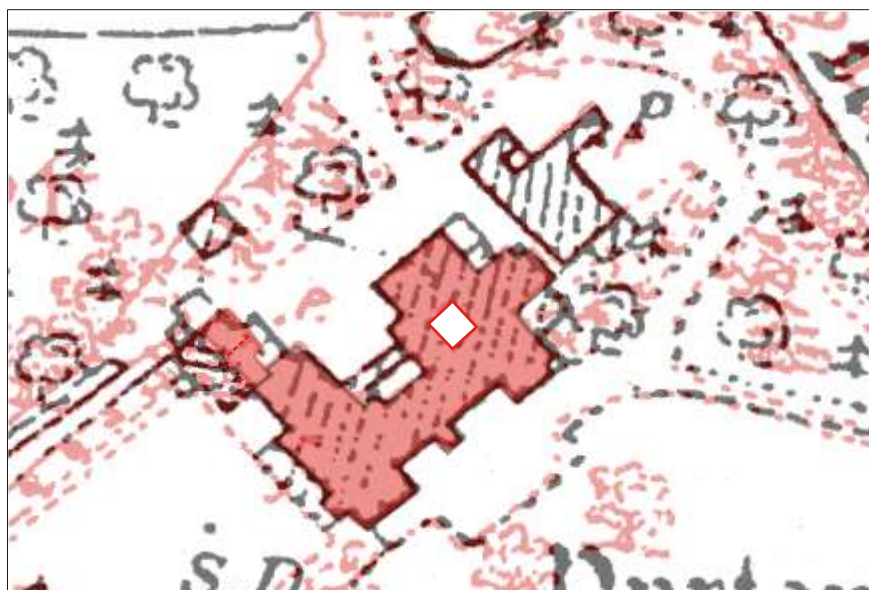
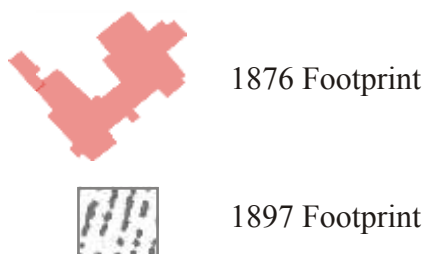
Figure 2: Superimposed Ordnance Survey maps of 1876 and 1897

- 4.2 The First and Second Edition Ordnance Survey maps show an additional extension to the north elevation of the building at the eastern wing. These extensions no longer exist but traces of their whereabouts and impact on the building fabric are still discernable on the northern fenestration. Changes to the south-western wing also took place between the issue of the first edition in 1876 and the 2nd edition in 1897: with additional construction at the northern end towards the east resulting in a more regular plan. The current workshops appear to have been added sometime after 1897. The stable blocks appear to have remained in a similar configuration over time, with only a protruding arm, extending eastward, reduced in length after 1897.

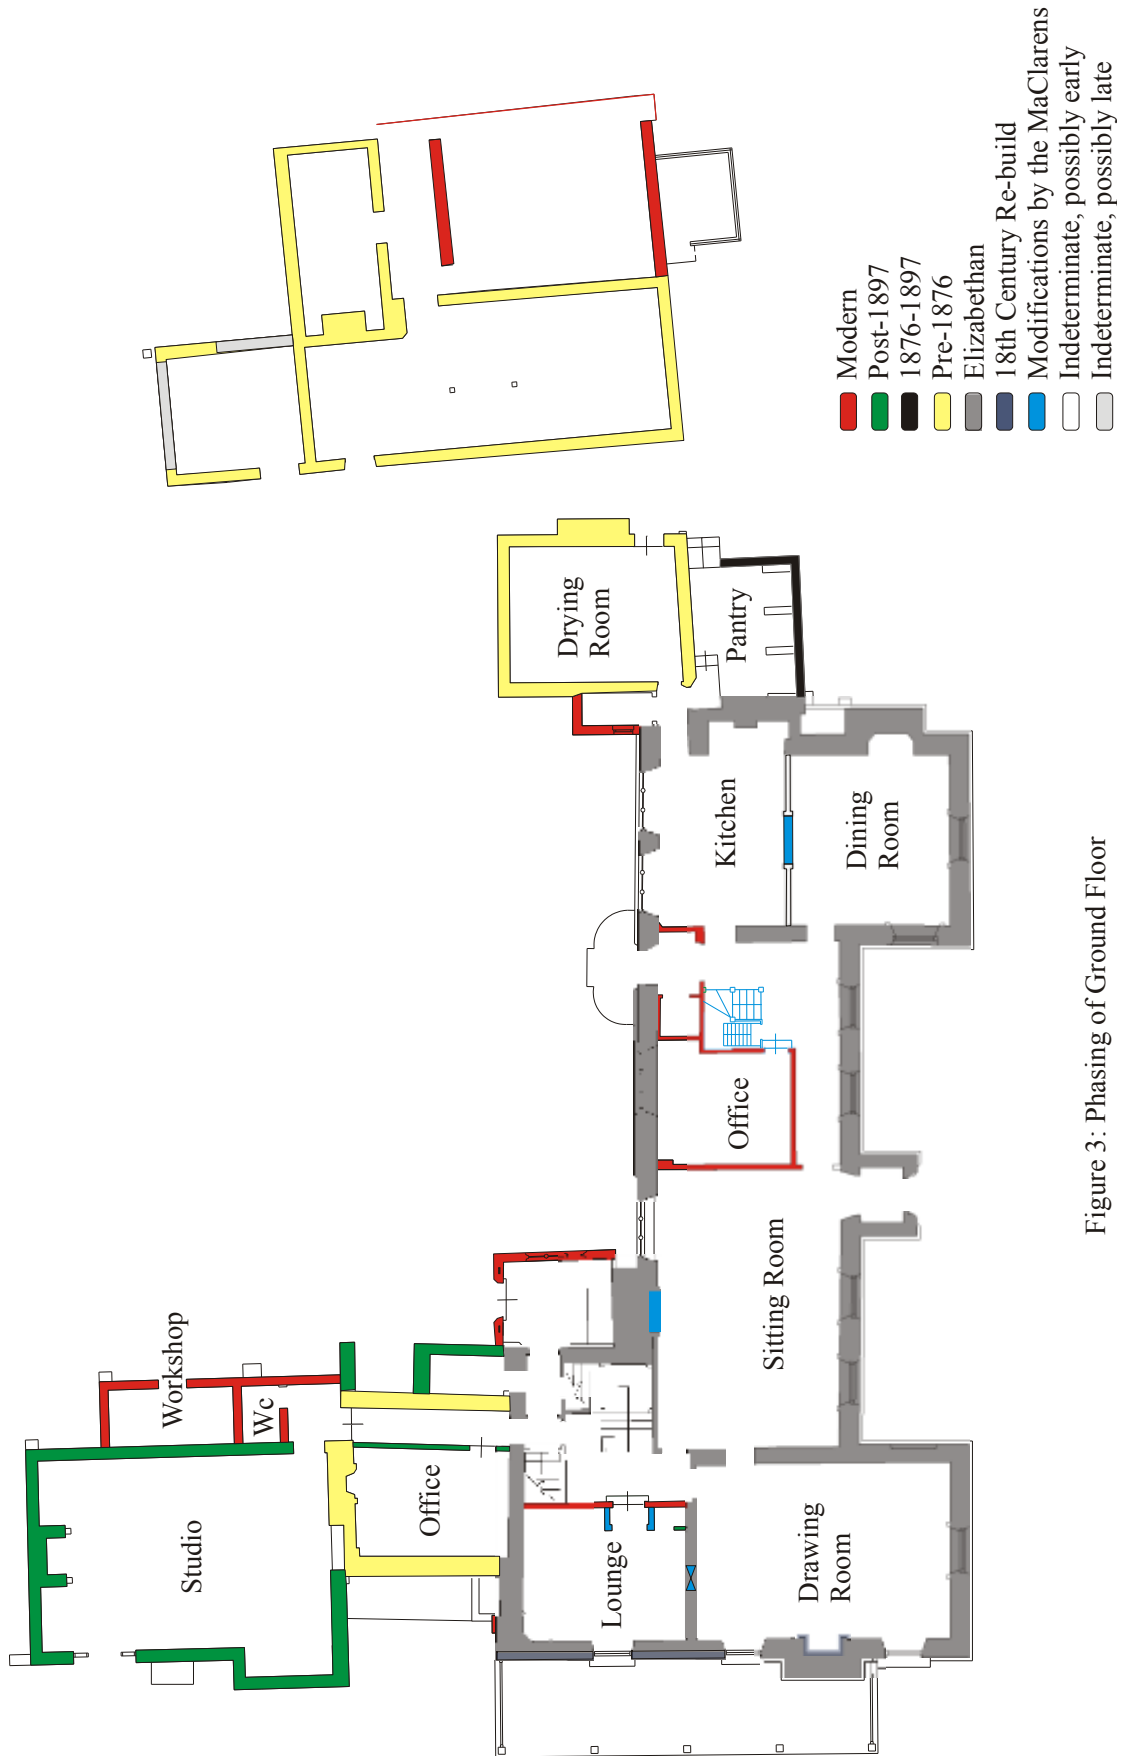
Figure 3: Phasing of Ground Floor

The current proposal for this wing includes the removal of the workshop, as mentioned above; the workshop appears to be housed in an extension of 20th century origin.

A new window opening is proposed for the east wall of the current studio, this area of the building appears to have been constructed post 1897.

A doorway is proposed in the wall between the current studio and office. From the map evidence it is clear that the office building was in place by the issue of the first edition Ordnance Survey map in 1876 but is a later extension to the Elizabethan fabric. The building has been subject to modification over time: there are blocked openings and repairs incorporating modern brick. The drip-mold over the first floor window is of brick rather than stone as can be seen elsewhere on the earlier building fabric.

Alterations proposed for the current lounge involves the removal of clearly modern partitions situated at the eastern side of the room. The proposals include plans to remove the current porch situated at the junction of the western wing and the central range. This porch is of modern origin and may have been inserted as part of the alterations carried out in the 1960s.

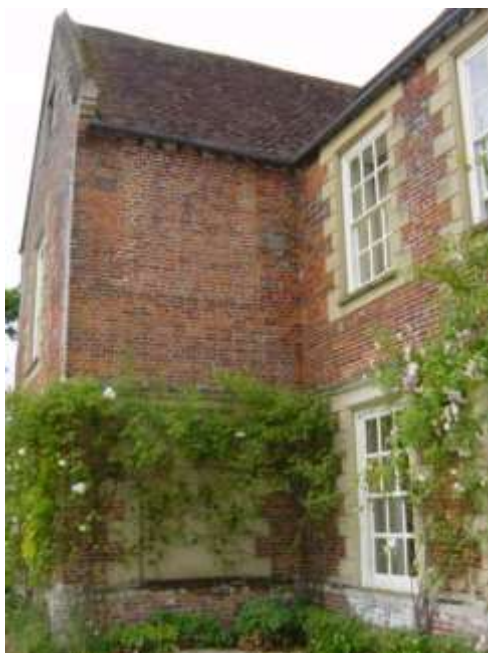
The current Drawing room proposal is for the re-instatement of a blocked window. It is clear from the exterior finish of the elevation that the window has been blocked; the surrounding stucco is still *in situ* as are the equivalent windows on the opposite wing including the first floor window that was re-instated by the MaClaren family as part of Listed Building Consent in the 1980s. The windows are shown on a drawing of the building in the Victoria County History (Vol 8) depicting the property as it was c. 1820.

Plate 1: Blocked windows both of which are proposed for re-installment

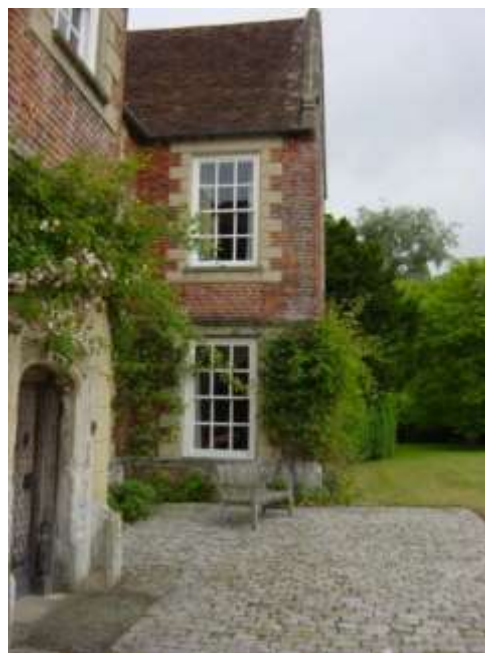
Plate 2: Re-instated upper window as part of the 1980s alterations

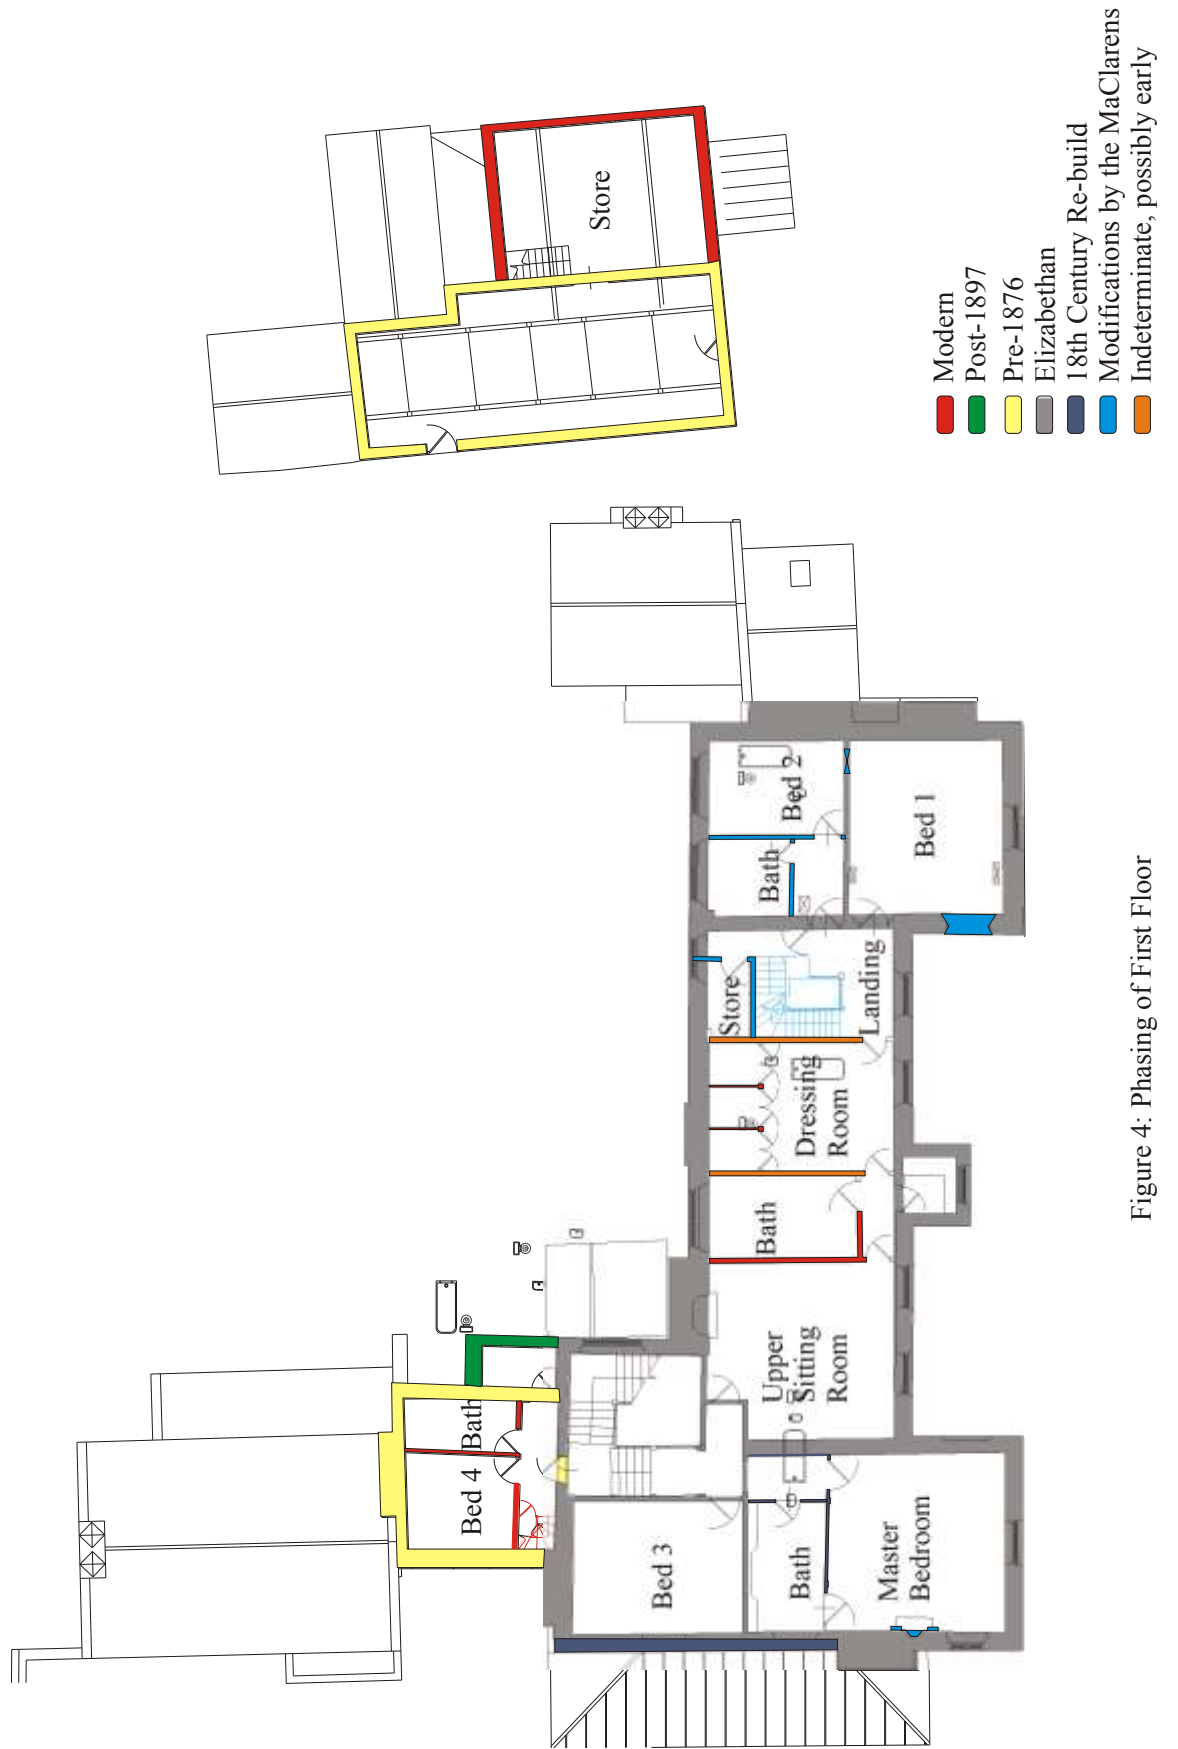
Figure 4: Phasing of First Floor

Bedroom 4 is housed in the small extension abutting the northern gable end of the main western wing. It is proposed to retain the current staircase. Internal partitions are earmarked for removal. The current staircase was inserted in this location by the MaClarens, as was the partition that currently bisects the lights in the window. The partitions within this room alter the original proportions of the room.

The proposals for bedroom 3 involve the re-instatement of a currently blocked fireplace. It is also proposed to block the access from the stairway to bedroom 3 and to construct an alternative point of access in the partition wall between B3 and the current bathroom. The doorway proposed for blocking has 17th century detail in line with the staircase and other doorways in this location. The new access is to be through a wall that may have been inserted as part of the 18th century repairs and modifications. Proposals to remove the panelled partition in the corridor and the partition between the bathroom and master bedroom would impact upon 18th century detail, although it is unclear whether the panelling is *in situ* originals or installed as period features at a later date. The extent to which the corridor panelling forming the eastern wall of the bathroom is an *in situ* original is in doubt. The moulding on the rail below the door handles is different on either side and fixed at conflicting heights.

The chimneypiece within the master bedroom is also earmarked for replacement. This is clearly of modern origin and is an insertion by the MaClaren family during their programme of works. The Victoria County History lists a 'moulded stone fireplace', which is clearly no longer *in situ*.

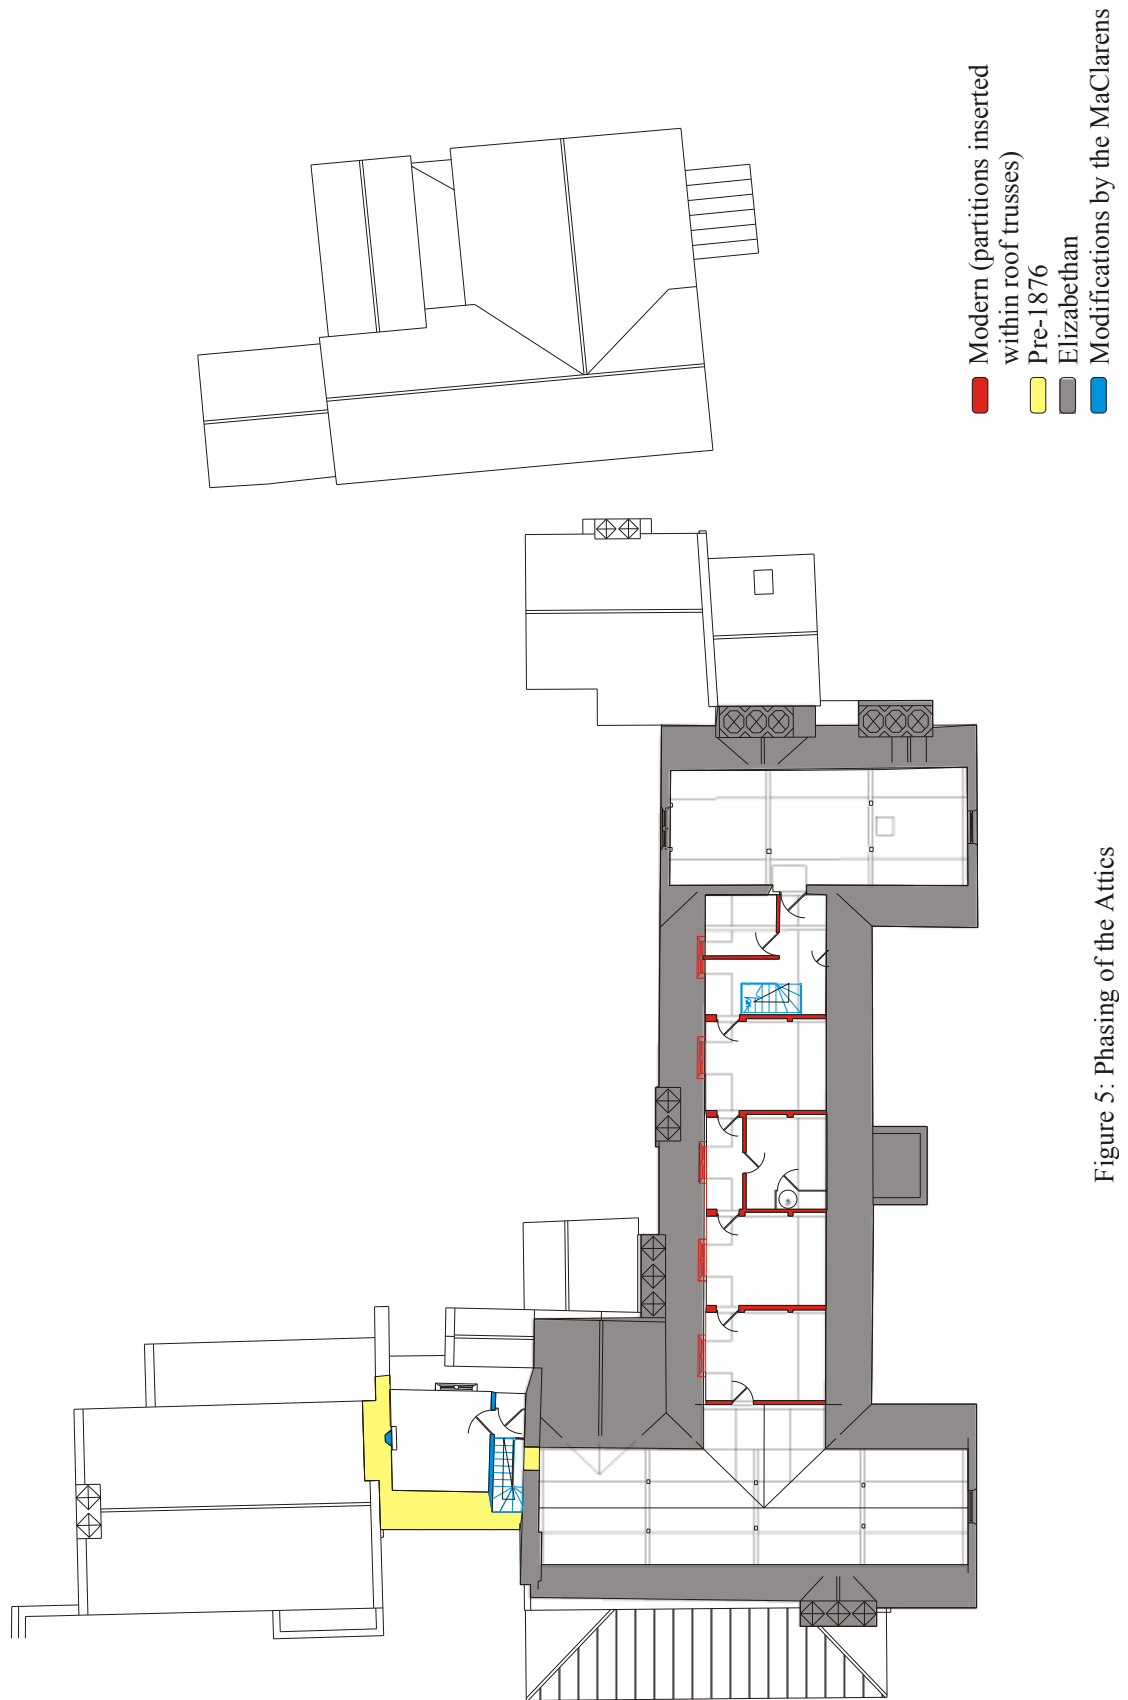
Figure 5: Phasing of the Attics

The staircase proposed from bedroom 4 in the first floor to bedroom 6 in the second floor within the northern extension abutting the south-western wing could impact upon original floor structure should any survive. This area was not investigated during site assessment but the current staircase, again an insertion by the MaClarens in the 1980s, allowed inspection of the floor structure during the works. Mrs MaClaren has stated that the majority of the floors throughout the house, the exception being the *in situ* 17th century staircase, had no original floor boarding. The survival of joists and beams is unknown.

Where the staircase is proposed to enter the attic from the current bathroom in the first floor, the lath and plaster ceiling will be impacted upon. From the inspection within the attic, the north-south orientated beam in the proposed staircase location has been replaced and does not sit well within the east-west binder. The origin of such alterations and repairs is unknown, but may be the results of modern, 20th century maintenance.

The casement windows in both attics are proposed for replacement with sash windows to match the other windows in the southern fenestration. That the southern elevation of the building is later and more altered than the northern fenestration is clear. However, the casements are the earlier of the two window types, the wooden mullions are ovolo in form and probably 18th century in origin, the internal wooden frame is a modern replacement. The glazing bars are early but the glass is a single pane with lead strips rather than individual leaded lights.

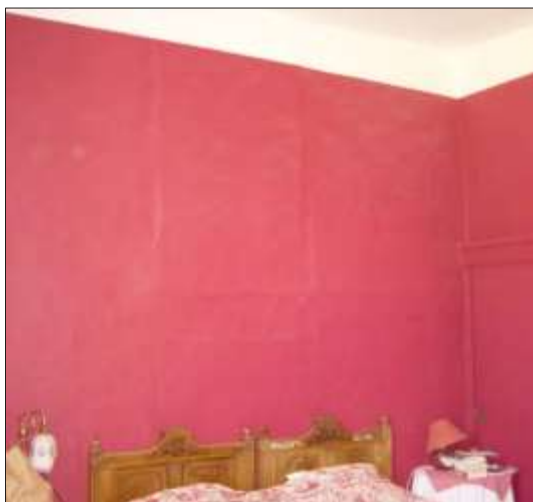
The structure of the partitions on either side of the dressing room was clearly visible through the wall finishes. Ghosts of the timber construction were outlined and Mrs MaClaren provided information regarding the structure prior to the decoration carried out under her direction. The partition walls in this location include plaster with horsehair and are clearly earlier in origin than the partition between the bathroom and sitting room, and may be part of the 18th century programme of works. The origin of the partition between the sitting room and bathroom is unknown and no hints were visible in the finish of the wall. In comparison with the clear structural indications visible in the dressing room walls, the smooth clean finish of the bathroom partition suggests a late insertion, probably as part of the alterations carried out in the 1960s.

Plate 3: Ghosts of timber construction visible through Wall finish.
