HISTORIC BUILDING ASSESSMENT

34 UPPER HIGH STREET,

THAME, OXFORDSHIRE

AUGUST 2005

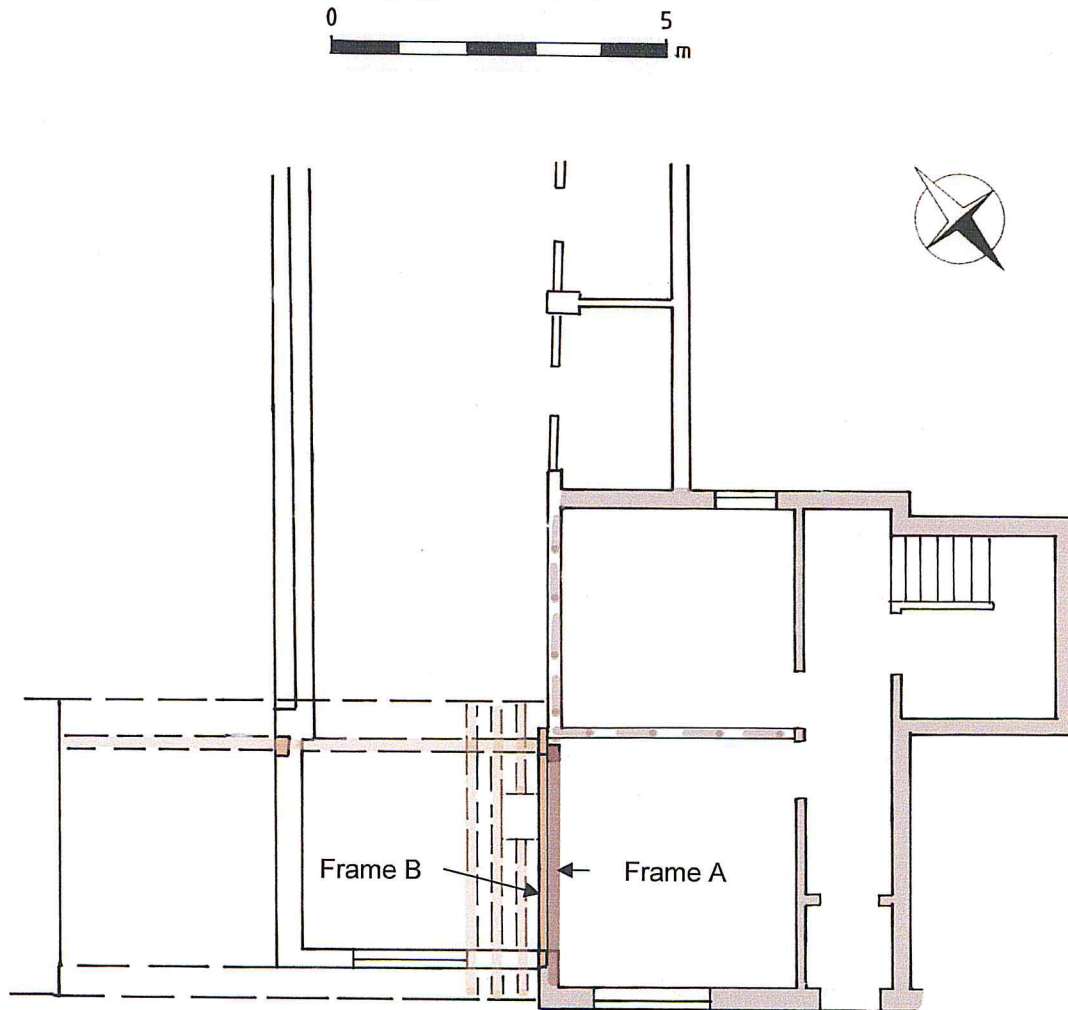
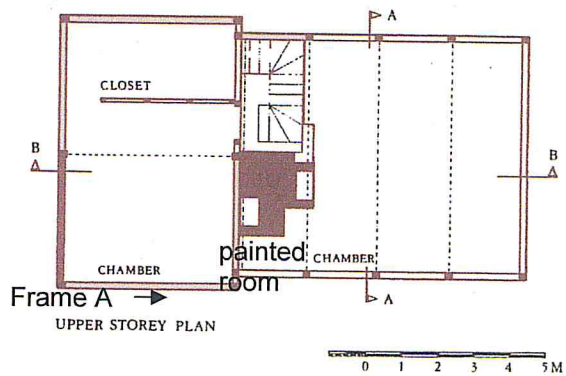
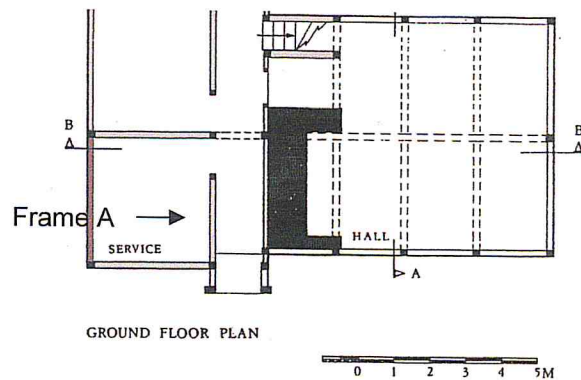
Fig 2

Ground floor plan showing position of frames and exposed first floor joists. 16th century cross wing outlined in brown. Modern walls in outline

Ground and first floor plans from *Oxoniensia*, figs 2 & 3. 16th century cross wing outlined in brown

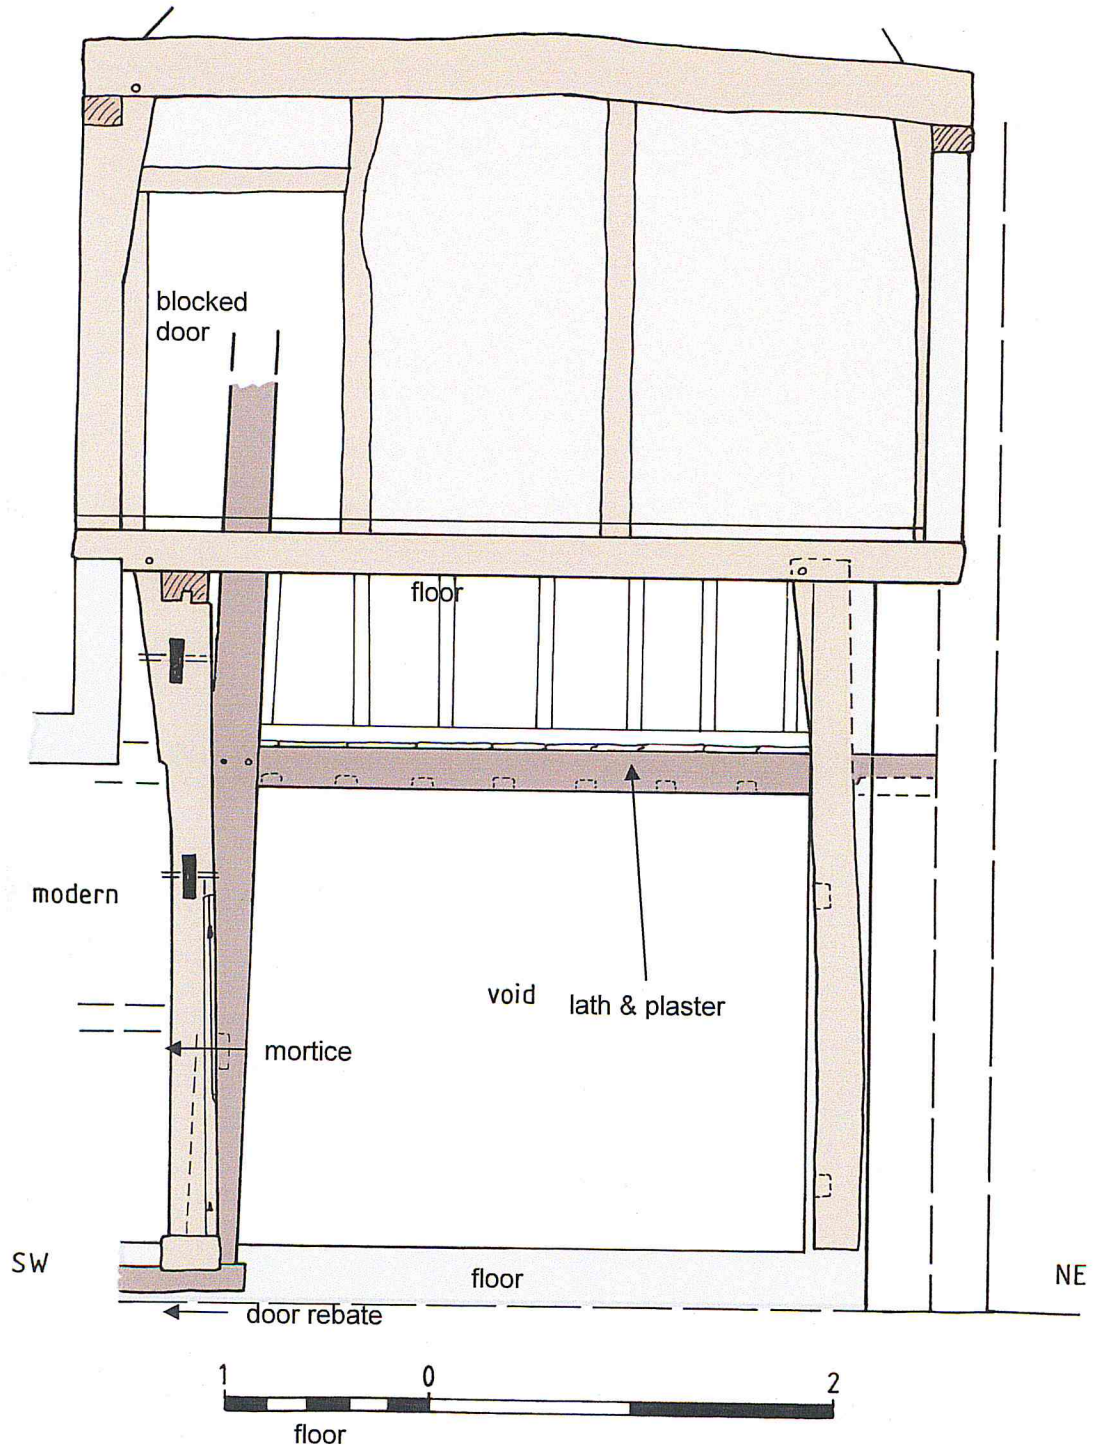
Fig 3

Frames A (dark brown) and B (light brown) from the south-east.
Wattle and daub – pink Modern walls and floors - grey

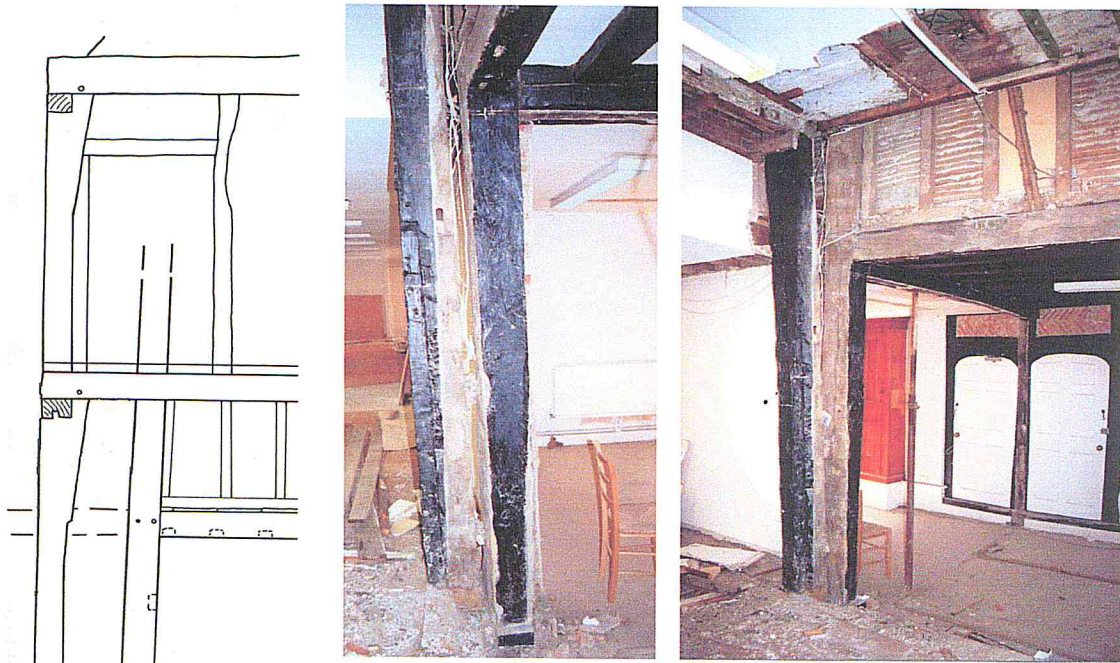
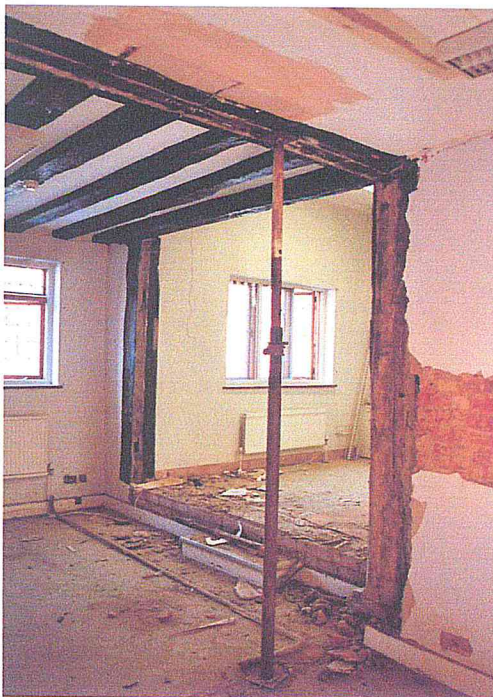
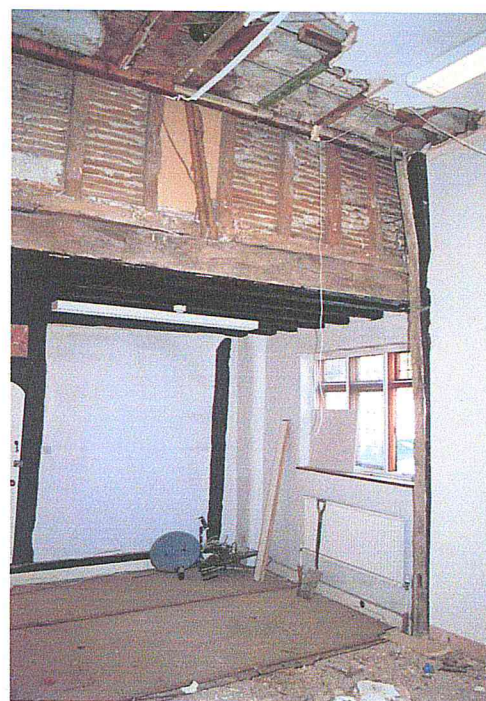
Fig 4 (clockwise)
Frame B showing the corner post reversed with the jowled head facing inwards
The junction of frame B (left) & frame A (right); frame B is rebated for a door
Frames B (foreground) & A looking west; 16th century doors in the background
Post of frame B looking north; lath and plaster infilling frame A at first floor level behind
Frames A (foreground) & B looking east

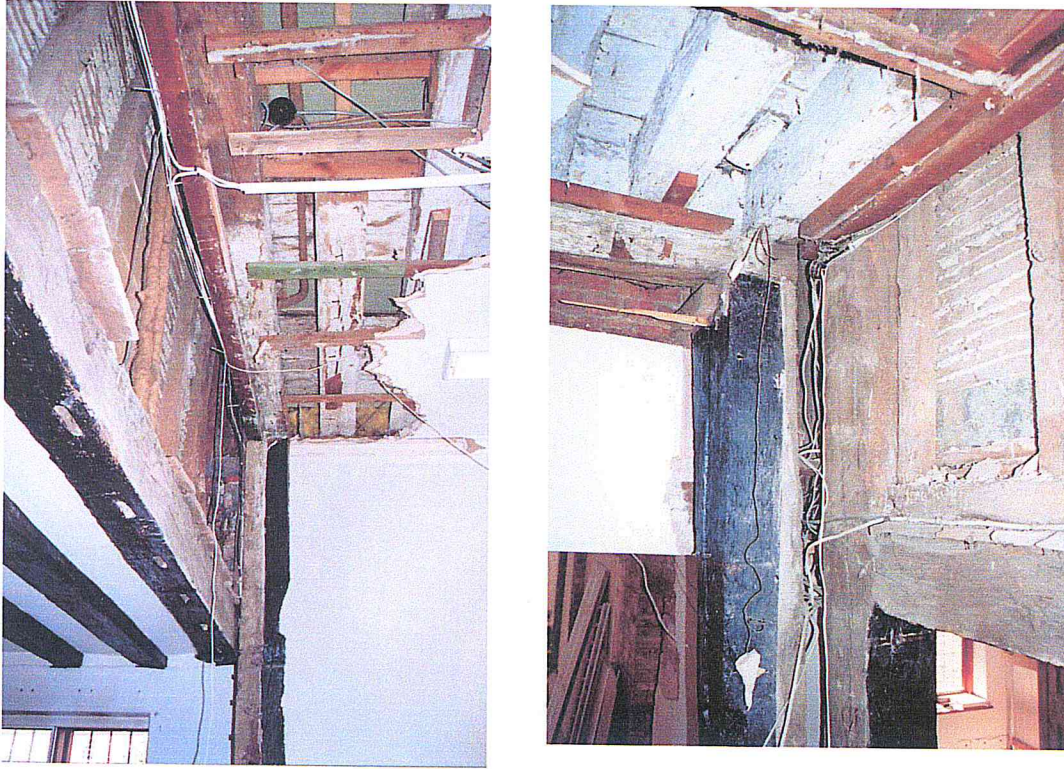
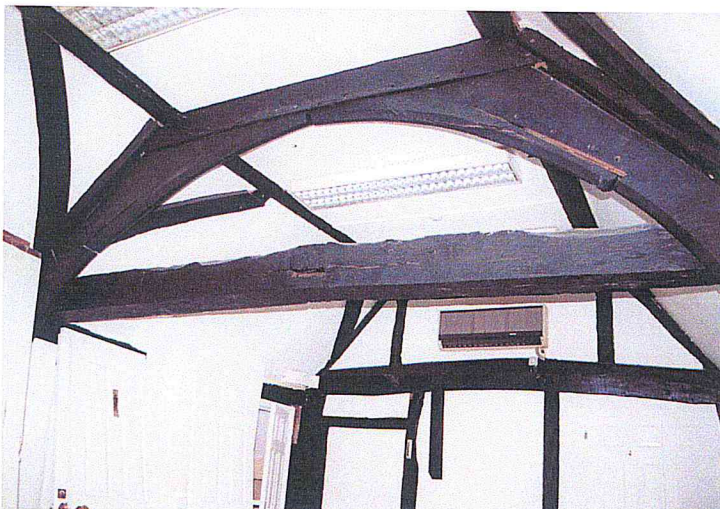
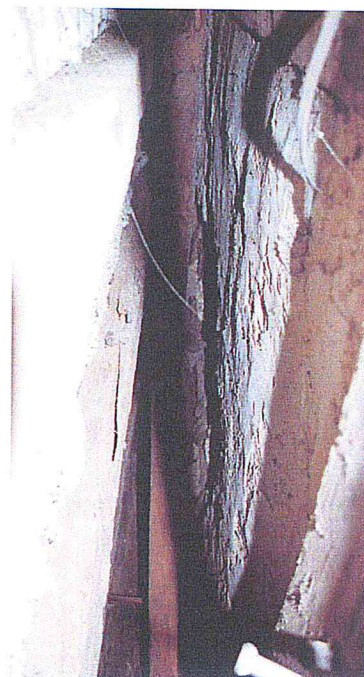
Fig 5 (clockwise)

faced inwards to match the other. It appears to have been rotated about the axis of the pegged joint to the girthing beam; if reversed (Fig 5) the tenoned joint for the wall plate would be in the correct position and the mortices in the south-east face would relate to the missing part of the building. The style of the carpentry, particularly the roof truss, suggests a 15th century date for this building.

Junction of frames looking north-east; A to left with stud mortices in soffit of beam. B to right with exposed ceiling joists cut by later hatch
Head of frame B with ceiling joists and tie beam looking south-west
Looking up into gap between frames; A to left with curved brace centre bottom. Frame B to right with finished wattle and daub face
First floor room looking towards frame B with arch-braced truss and later floor beam in foreground
