JOHN MOORE HERITAGE SERVICES

**AN
HISTORIC BUILDING ASSESSMENT
OF
COURT FARM,
LITTLE HASELEY,
OXFORDSHIRE**

*On behalf of
Mr & Mrs Meadon*

AUGUST 2005

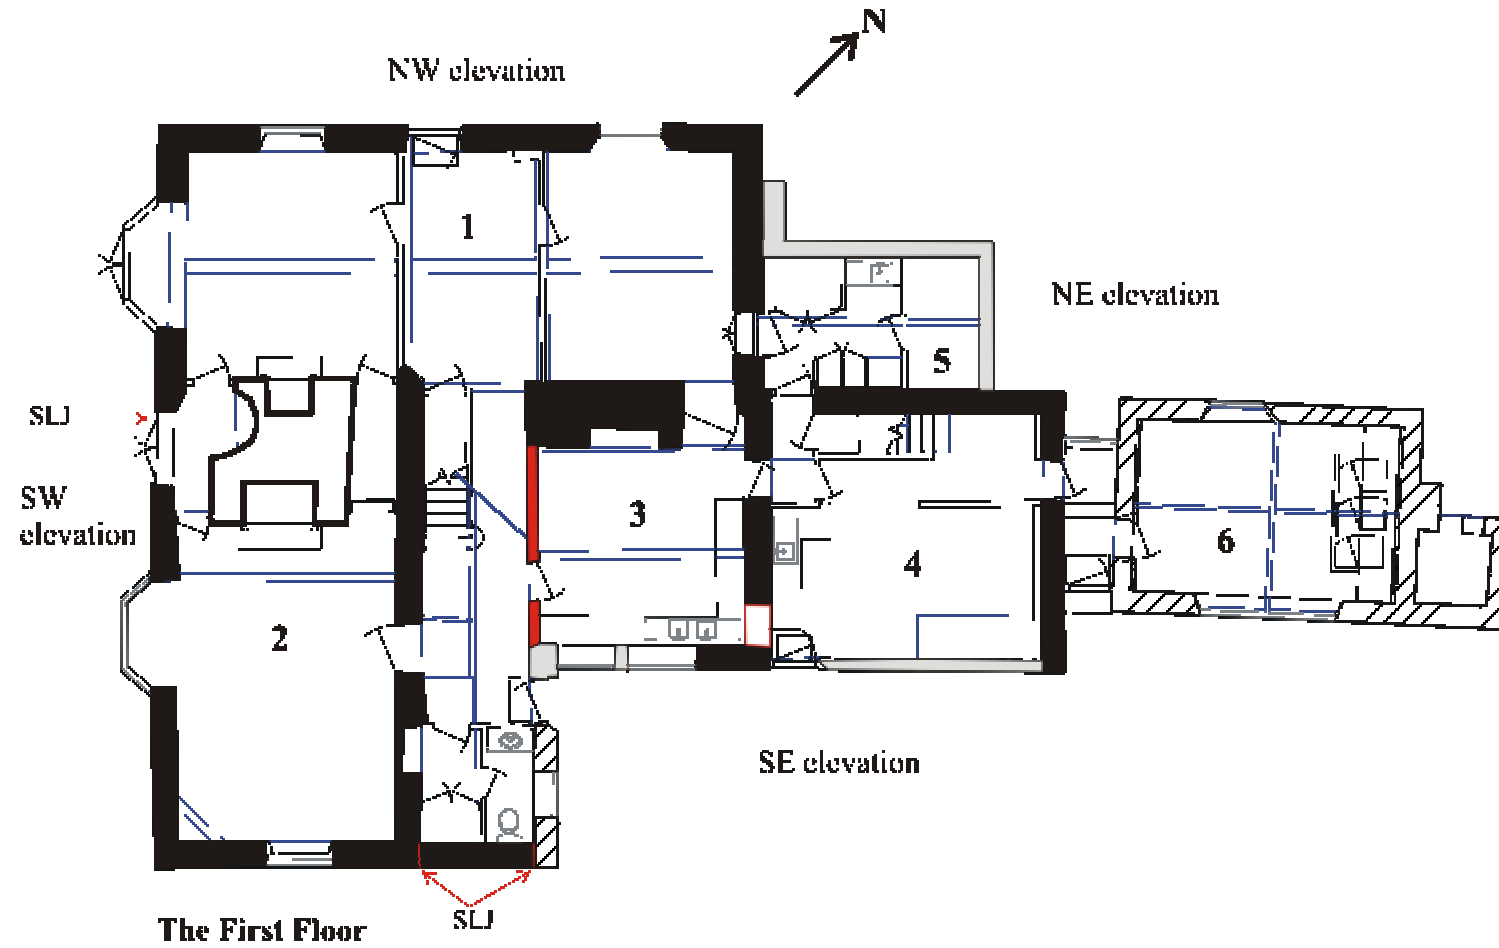
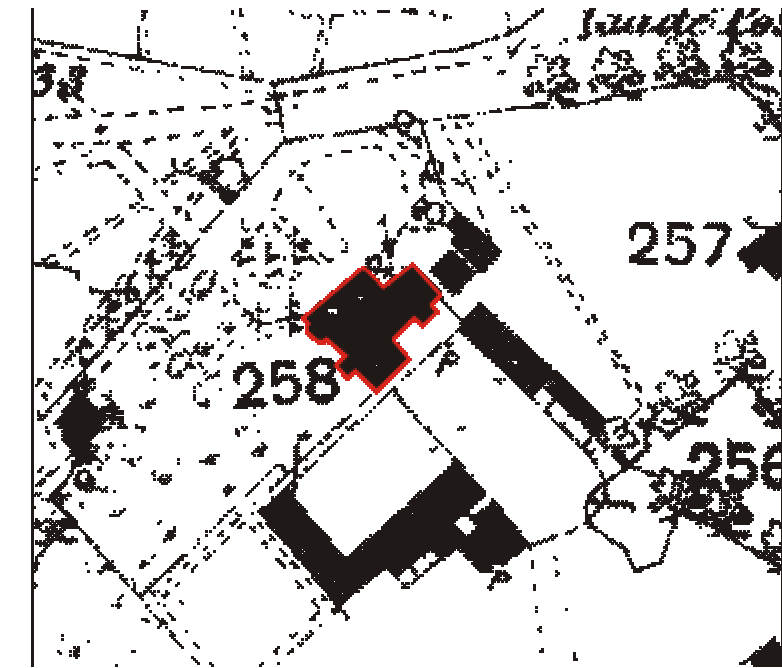
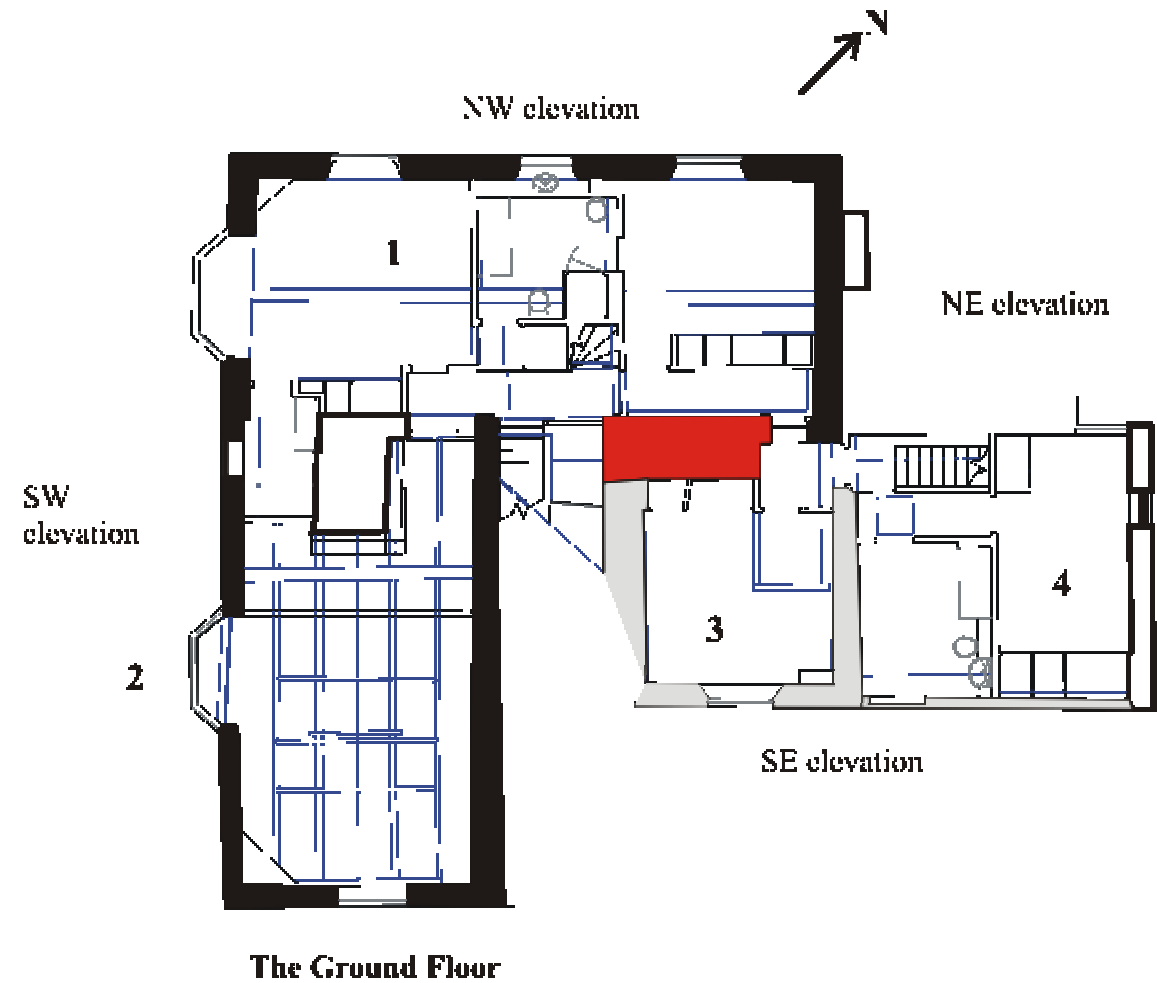
Figure 1: The main construction materials utilised, with numbers to identify parts of the property discussed in the text including a detail of the First Edition Ordnance Survey map (1881)

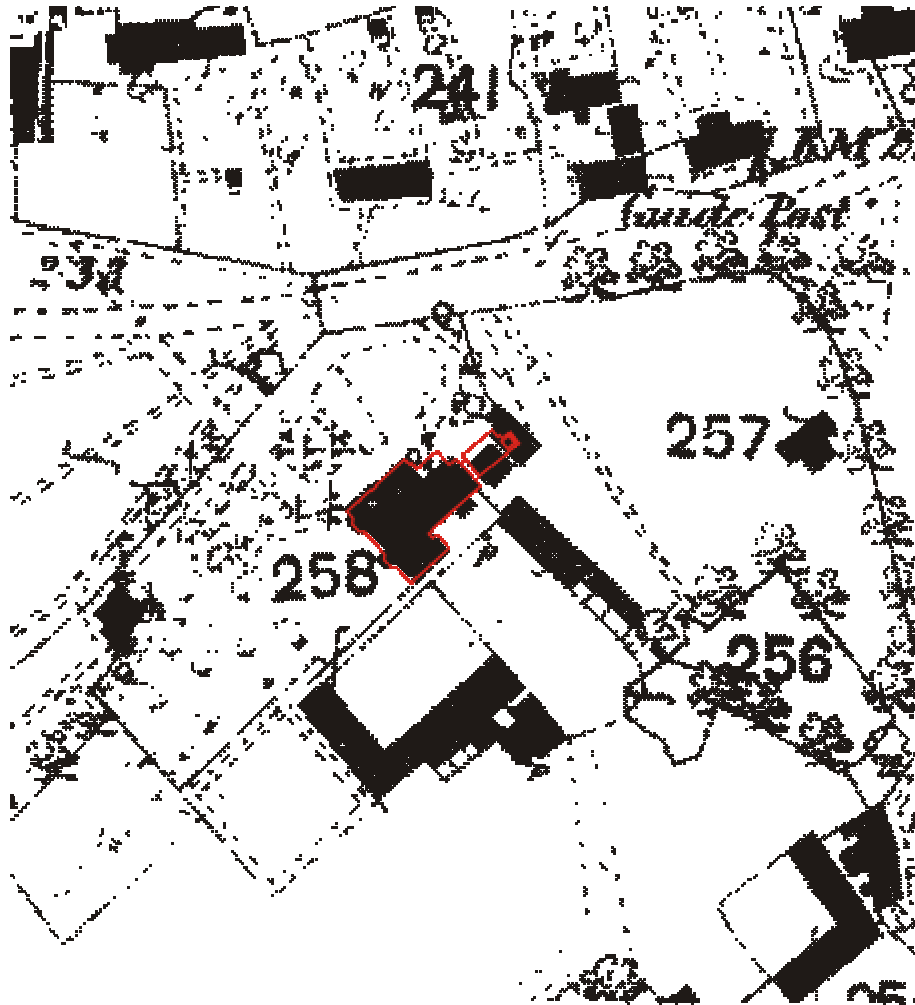
This building was constructed of limestone rubble, however, the southeastern elevation is a modern replacement – perhaps as part of the 1968 programme of works. The remaining walls are post – 1919 in origin as they are not shown on the Ordnance Survey map of this date. The map shows a far different arrangement of buildings in the location of building (6), and it is suggested that the limestone rubble used in the construction of the current build may have been re-used from the demolished remains of the earlier structures (Figure 2).

Figure 2: An overlay of the current site survey with the 1881 edition OS map: It should be noted that some vagaries will occur with mapping of this date and scale (originally 25"). However, the general outline of the building tallies with the OS mapping but the current ancillary build (6) is in an entirely different location and orientation to those shown.
