**AN  
HISTORIC BUILDING RECORD  
OF  
THE FORMER SMITHY,  
SMITHY COTTAGE,  
8 OTMOOR LANE,  
BECKLEY  
OX3 9UX**

*On behalf of  
Mr P. Sims*

**MARCH 2005**

**Site Code:** BESC 05  
**JMHS Project Number:** 1526

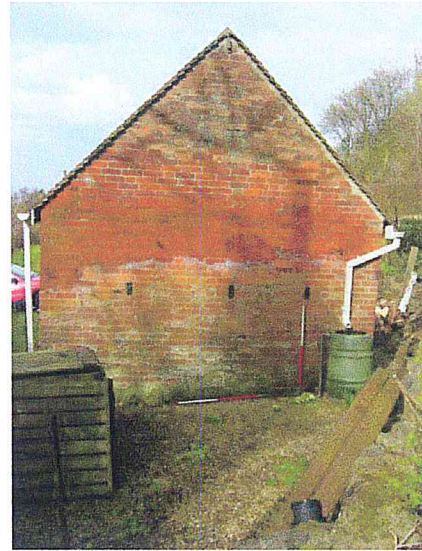
The building is shown on the first edition Ordnance Survey map of 1876. Structures abutting the southern side of the building were pigsties (now demolished). Indications of the former location of the sties can be seen on the fabric of the gable (Plate 1, Figure 3).

Plate 1: Southern gable showing iron-work associated with pigsties

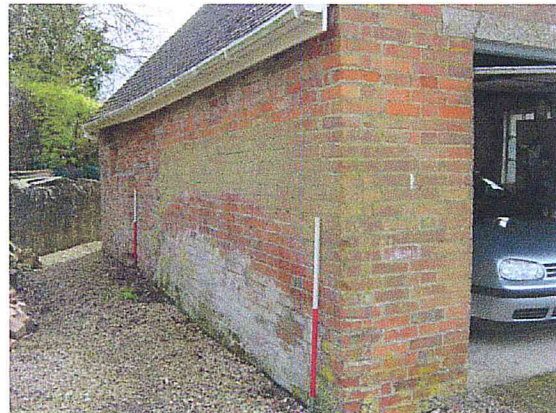
However, no provision was made for the revetment of the newly created earth bank and by 1981, the earth had slipped down slope coming to rest on the east face of the Smithy, reaching the rafters and severely distorting the structure (Plate 2). Partial repairs were carried out 1977, with additional works involving the removal of the slipped earth against the east wall, creation of a concrete floor in the interior of the building, and reinforcement to the internal face of the south wall completed by 1985.

Plate 2: The distorted east wall

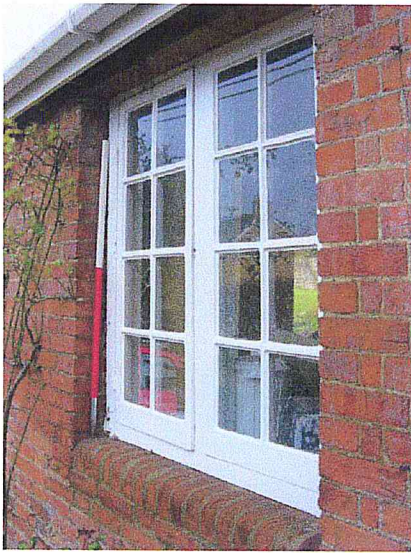
There are two windows *in situ* on the western elevation, both 19<sup>th</sup> century casements within original openings; the window ledges to the exterior face are of bull-nose bricks (Plate 3).

Plate 3: The casement window showing bull-nose bricks in window ledge

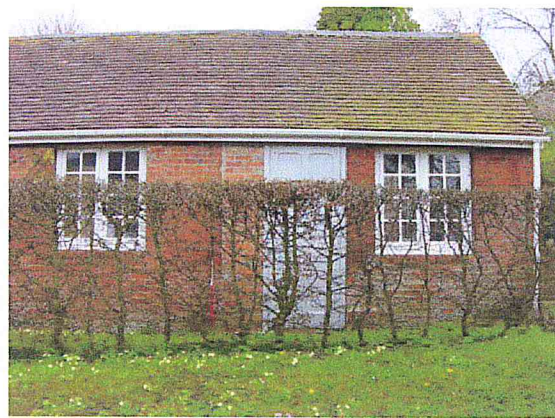
The doorway situated south of centre is a later insertion into part of an original wider opening; later brick infill reducing the size of the doorway from 1.50 m to 1.00 m can clearly be seen in the building fabric (Plate 4). A doorway opposite (1.3 m wide) and adjacent window opening (1.10 m wide by 0.80 m in height), situated in the eastern wall of the building, had also been filled in but was still visible in the current fabric (Plate 5, Figure 3). A further ‘step’ (Figure 3) was recorded adjacent to the window opening, measuring 0.46 m wide by 0.40 m in height. The function of the ‘step’ is unknown, although it may have derived from ventilation and lighting requirements of the later repair and re-building of this area.

Plate 4: The west elevations showing brick infill in reduced doorway.

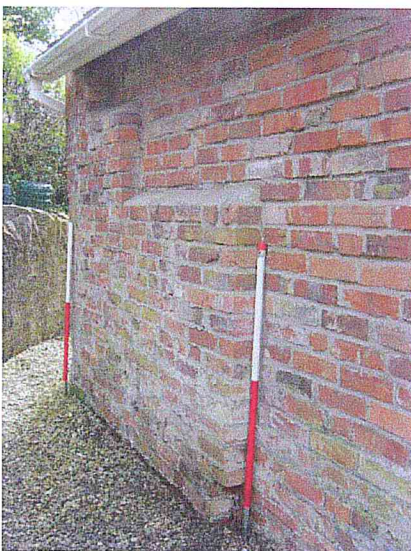
The village residents remember sledging down the gentle slope to the rear of the Smithy prior to the extensive landscaping of the 1950s, in addition to horses being led into the Smithy from the lane, and following shoeing, out of the opposing doorway and up the hill (Mr P. Sims, *Pers. Comm*). Traces of the edge of the blocked doorway can be seen in the fabric of the east elevation, at the southern end (Plates 2 and 5, location also shown on east elevation in Figure 3).

Plate 5: The southern end of the east elevation showing blocked former doorway and window locations

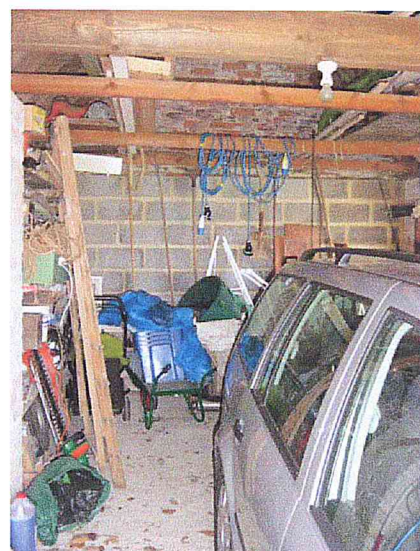
Plate 6: The 1980s breeze-block reinforcement of the southern gable wall

5.3 The floor is of concrete laid down in the 1980s. Internal features are few due to the re-use as garage accommodation and to the extensive repairs required due to the distortion caused by the land slippage. Of original features, a brick plinth survives to the foot of the internal face of the east wall, some 230 mm in height and 70 mm width (Plate 7). A brick column (0.40 x 0.46 m) can also be seen abutting the interior face, but no function was discernable, and it may have been reinforcement or support rather than a surviving early feature (Plate 7). The southern internal face below the gable was reinforced with a wall of breezeblock by the current owner as part of the programme of repairs carried out in the 1980s (Plate 6).

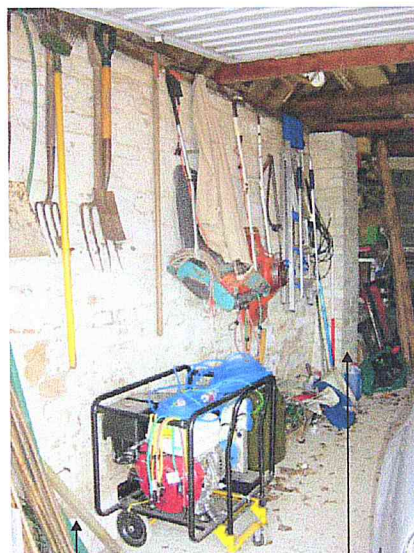
The Brick Plinth

The Brick Column

Plate 7: The interior of the east elevation
