## ***Summary***

A historic building survey was carried out prior to demolition of 316 Woodstock Road, Summertown. The survey established that the house had been subject to few interior and exterior modifications throughout its 105 years. The main alterations involved the division of space to create two distinct units or flats. A significant finding of the survey was the high rate of survival of the interior features.

Planning permission (application number 02/00855/FUL) has been granted by Oxford City Council for the demolition of the existing house at number 316 Woodstock Road, Summertown, Oxford and the subsequent construction of 12 flats. The building was considered to be of local architectural significance, and it is for that reason that condition 12 of the consent required that a drawn and photographic record be made of the building prior to demolition.

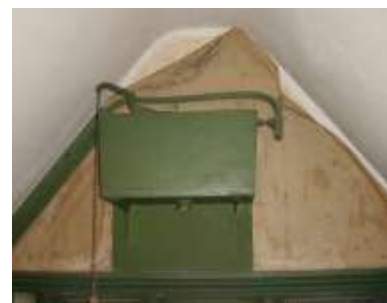
P  
Plate 3

The cistern room contains the original wooden, lead lined cistern as was originally installed in the house at time of construction (Plate ?). The window behind the cistern also remains unchanged. The cupboard in the southern corner of the room, adjacent to the door does not appear on the original building plan, but is however an early addition to the room.
