**ROMEYNS COURT,**

**GREAT MILTON,**

**LISTED BUILDING ASSESSMENT**

**MARCH 2004**

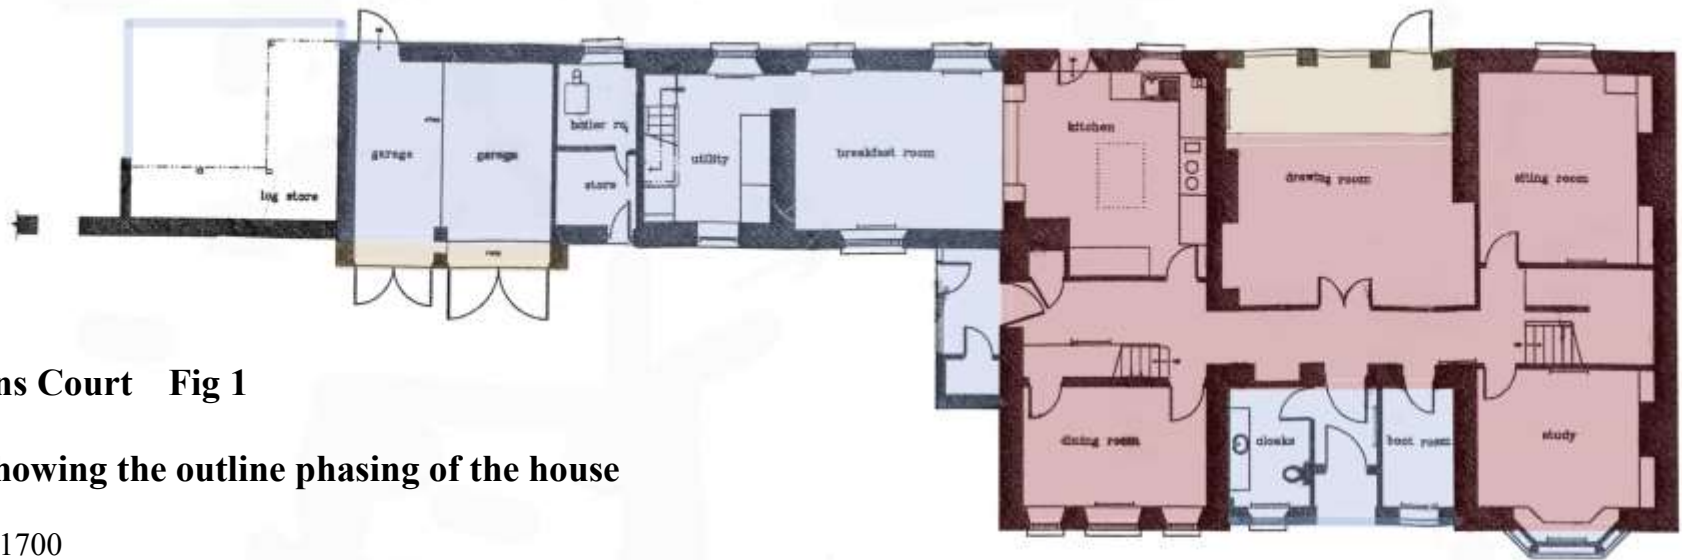
**Romeyns Court Fig 1**

**Plans showing the outline phasing of the house**

- Pink c.1700
- Blue 19<sup>th</sup> century
- Buff late 20<sup>th</sup> century

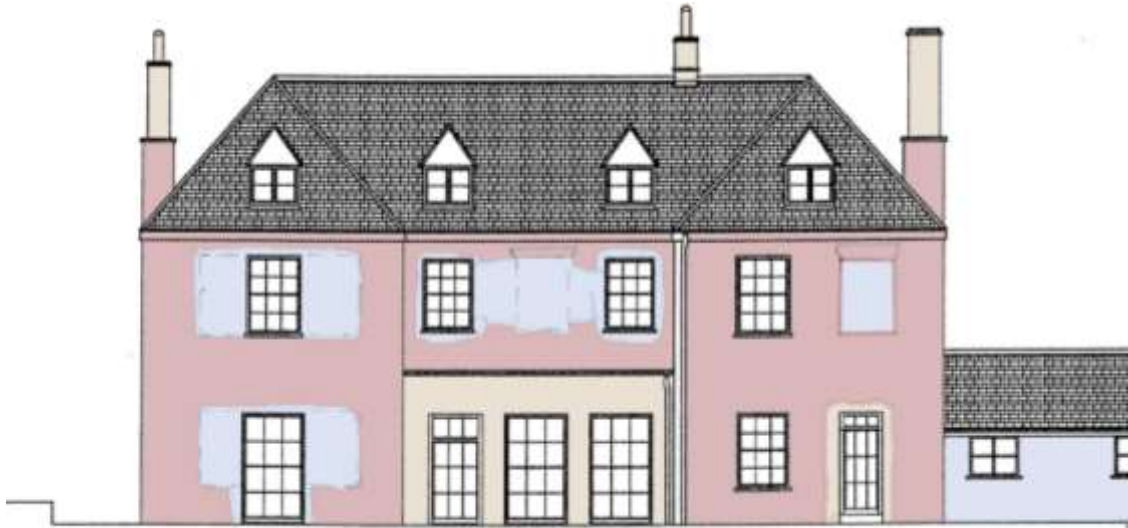
South east elevation showing alterations to windows (blue)

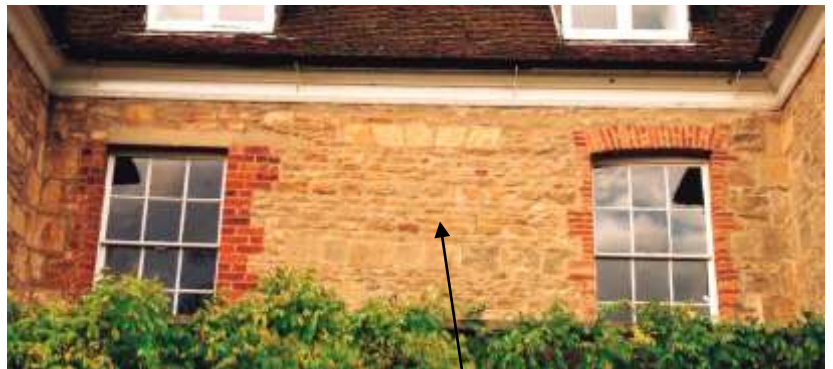
Detail of blocked window

blocked window

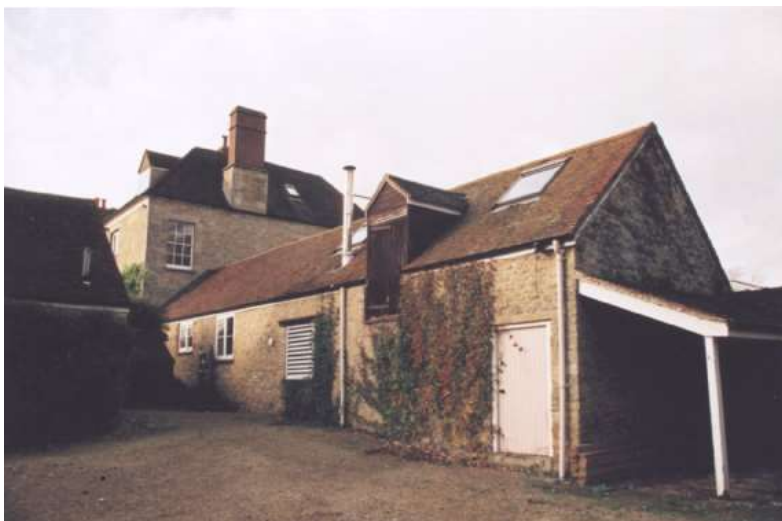
Pentice on site of demolished building; foundations in foreground

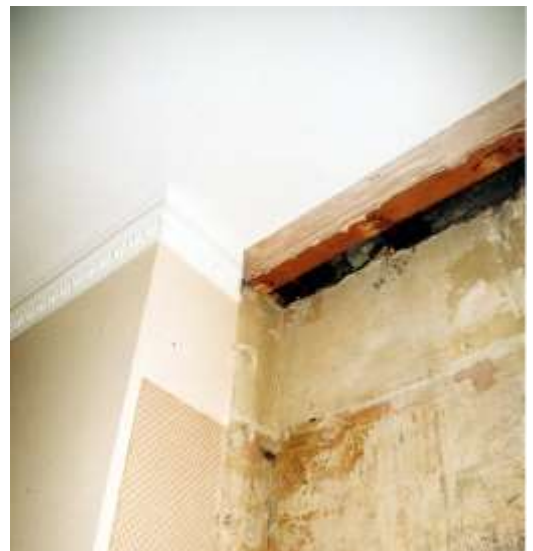
Dressing room to bedroom 1 showing blocked doors and position of previous partition

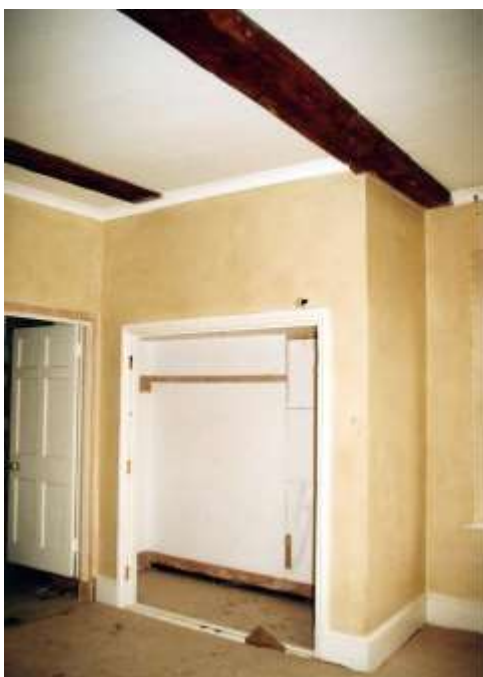
Cupboard in bedroom 2 replacing chimney breast; original ceiling beams exposed
