**BUILDING INVESTIGATION AND PHOTOGRAPHIC RECORD**

**OF THE AIR RAID PRECAUTIONS SHELTER**

**ST CHRISTOPHER'S FIRST SCHOOL,**

**JUNE 2004**

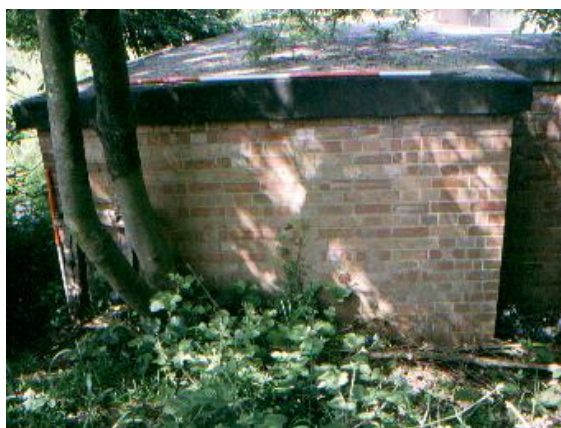
Plate 1: Detail of construction materials

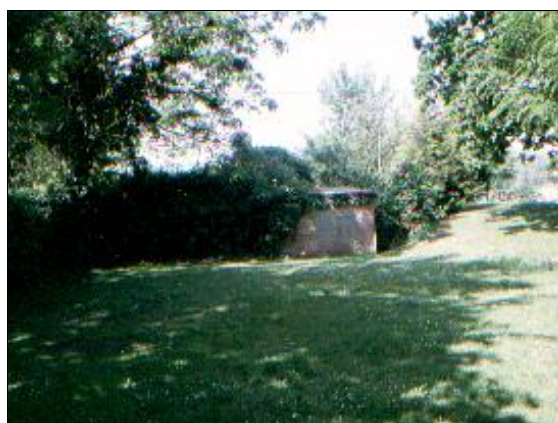
Plate 2: View of the northern block (B6) and adjacent bank (taken from the east) showing remains of a bank formed by excavation of a trench into the naturally sloping ground.

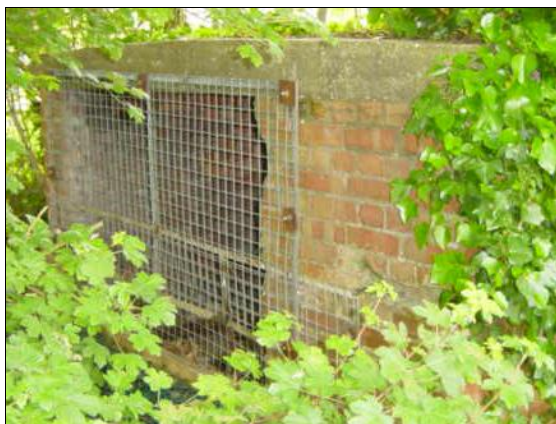
Plate 3: External view of the inaccessible eastern end of the shelter (B8).

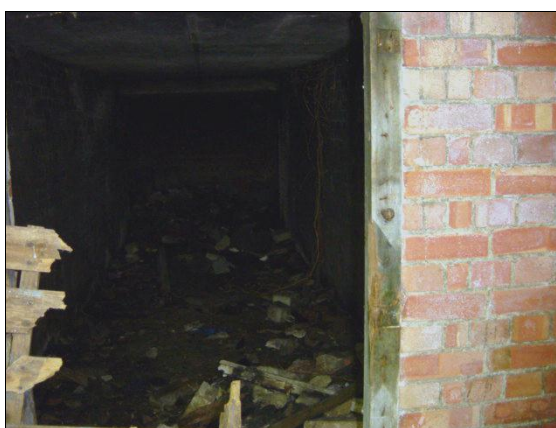
The last two blocks at the eastern end of the shelter (B7 and 8) were inaccessible: the original doorway was no longer in situ and a wire mesh had been fixed across the opening. There was also no possible access into these two blocks from the interior. This was due to breeze block infill at the junction of blocks B6 and 7 (Figure 3). Flash photography was carried out through the mesh fixed to the external elevation and a picture of the interior obtained (Plate 4).

Plate 4: View into the inaccessible eastern end of the shelter (B8). The interior as far as could be determined, been stripped of any original features and a large quantity of debris and refuse littered the floor.

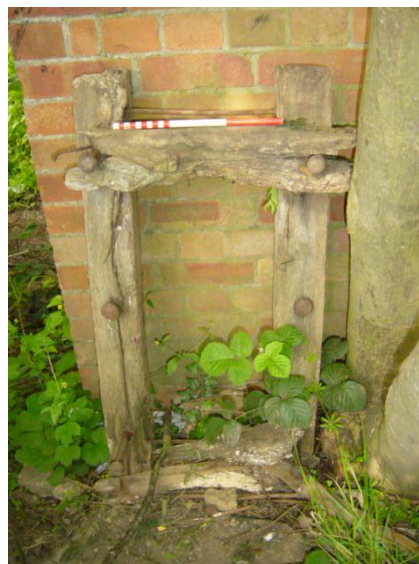
A ladder that had originally provided access to the roof was the remains of an original feature observed on the exterior of the building (location shown on Figure 2). The remains were in poor condition, but the substantial bolts used to fix the vertical and horizontal members together had survived in good condition (Plates 5b and c). The ladder comprised timbers 0.10 m by 0.09 m in section. The maximum width of the timbers was 0.46 m and height was 0.88 m. There were originally three rungs, but the central timber was missing. The rungs were set 0.30 m apart and were fixed to the vertical members with iron bolts. The bolts were very substantial: 0.20 m in length, 0.04 m diameter head and 1.5 cm diameter shaft. Iron ties were fitted behind the rungs to strengthen the ladder. The ties were fixed with 1.5 cm square headed bolts at either side and the tie itself was 0.73 m in length. The base of the ladder had been set in concrete

Plate 5a: Ladder *in situ*

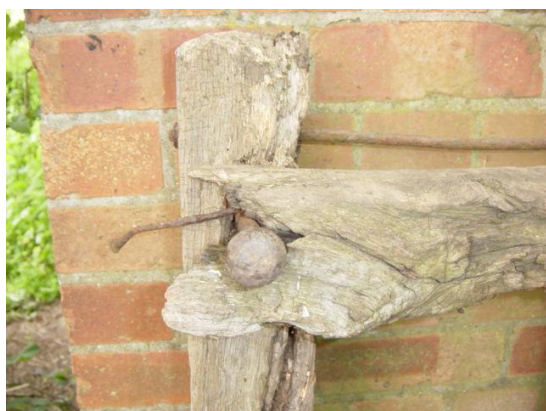
Plate 5b: Detail of bolt from front

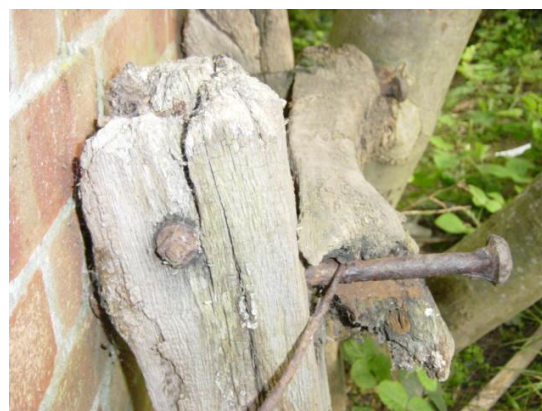
Plate 5c: Detail of bolt from side

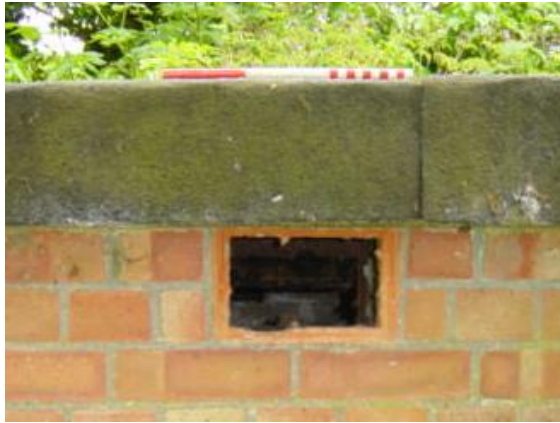
Further original features of the structure where the ventilation bricks (0.24 m wide x 0.15 height). On the external face, where visible, they had been broken through and only fragments remained (plate 6a). Most vents on the exterior had been fitted at a later date with modern metal louvers (Plate 6b).

Plate 6a: Remains of broken  
- through ventilation brick

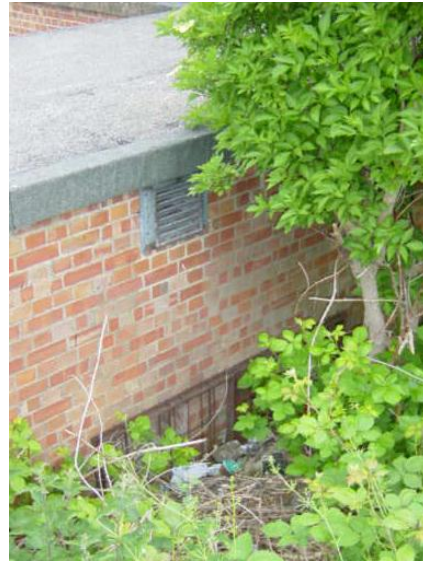
Plate 6b: Metal louver over vent and  
grille covering two blocked openings

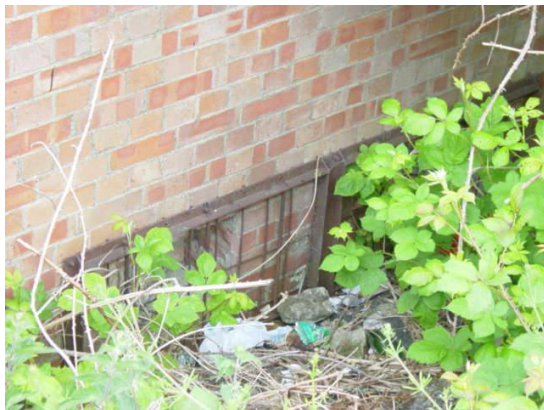
Two metal grilles were also visible bolted to the external face of the southern east-west orientated block (Plates 6b-d). The grilles measured c. 0.98 m in length by 0.47 m deep and were fixed directly adjacent to each other. The purpose of the grilles was to cover two rectangular openings 0.50 m by 0.38 m let into the fabric of the building. The openings had been filled in on the internal face; no trace was detectable from the interior of the block. The infill was concrete on the eastern opening, to half the depth of the wall thickness. On the western of the two openings, the infill was brick and cement mortar.

Plate 6c: Grille in situ taken from roof  
of adjacent western block

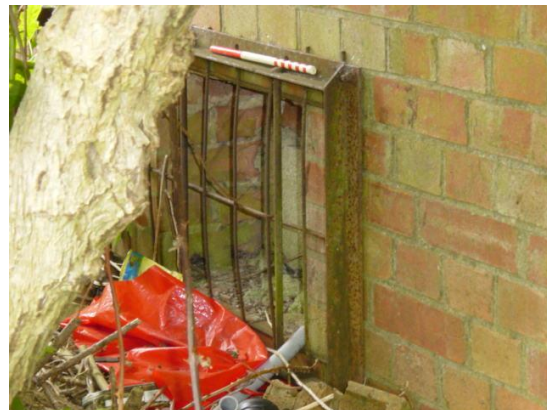
Plate 6d: Detail of eastern grille with  
cement blocking

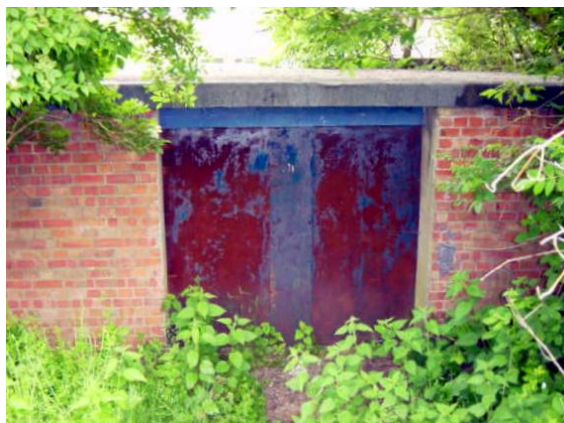
A modern modification to the structure was the creation of a wider entrance to allow equipment to be stored with ease. A double sliding door was fitted on the south face of block B2 (location on Figure 2). This door was a later addition, the edges were the bricks had been broken through to create the access had been finished with a cement render (Plate 7). The door measured 1.97 m wide by 1.89 m in height, and was situated 1.35 m from the east end of the block. In addition to this, a further modern feature had been added to the building in the form of an extension abutting the west side of B5, demolished prior to the survey. This extension appears to have provided a toilet block and a bar facility: for the latter, a portion of the original shelter wall had been reduced to half its original height.

Plate 7: Double sliding door

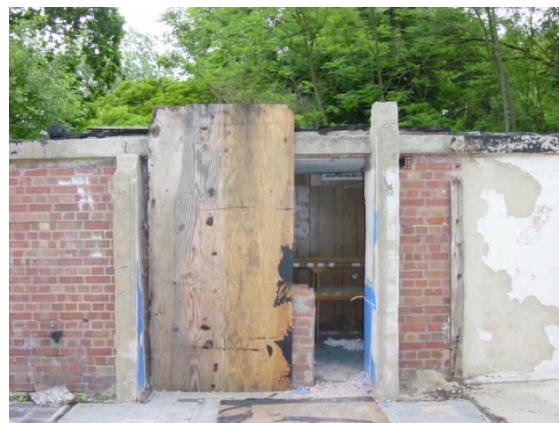
Plate 8: Modifications to create bar and access

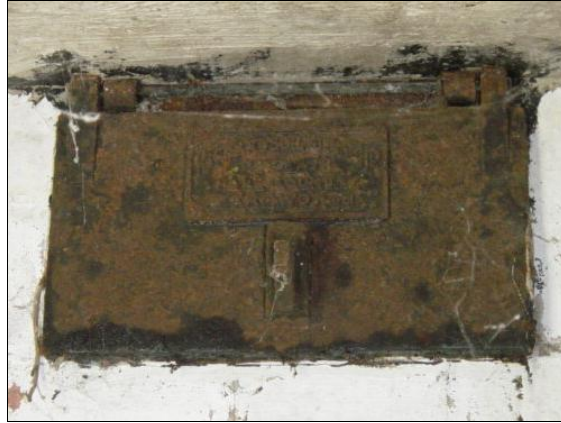
The majority of the internal fittings were recent in origin, the result of alterations to turn the shelter into a storage facility suitable for holding sub-aqua and boating equipment. Straps were fixed to the walls and storage shelves fitted. The early internal features comprised electrical apparatus. Light switches, a heater, fuse box and the remains of a makeshift extractor were still *in situ*. In addition the vents visible from the exterior had been fitted in the interior with hinged iron covers over the square holes in the brickwork. The covers could be opened to varying degrees or closed as required. The vents were situated in the locations marked on Figure 2 and were part of the original construction.

Plate 9: Closed vent in interior

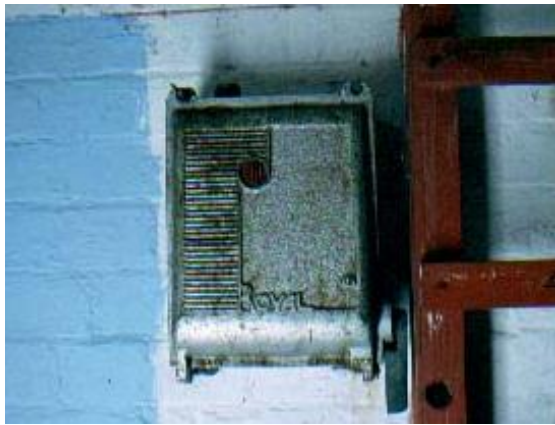
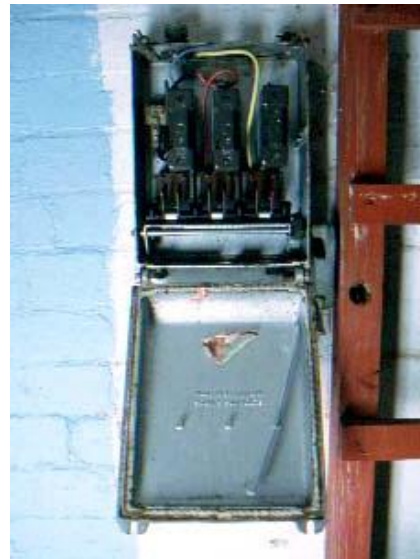
The fuse box *in situ* on the western wall of the southern block (B1) had been re-wired in line with modern standards.

Plate 10a: External view of fuse box

Plate 10b: Internal View

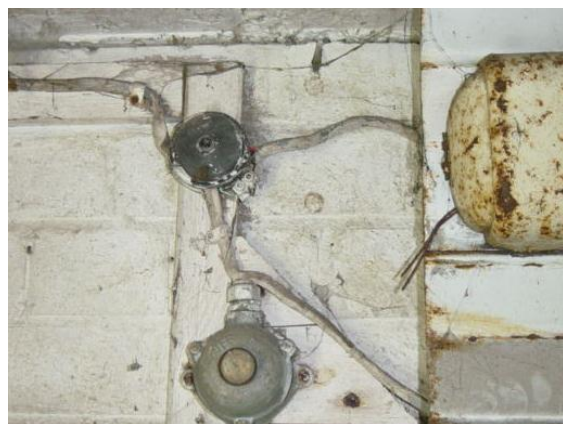
The light switches and cables shown in Plate 11 were remains from an earlier phase in the use of the building. The switches were not original, the lighting may have come from hurricane lamps in the first instance, although mention of a battery operated power supply was made in the school managers minute books. The whole building was re-wired at a later date and sockets set into the ceilings to provide anchors for cable.

Plate 11: Detail of switches, junction box and cable

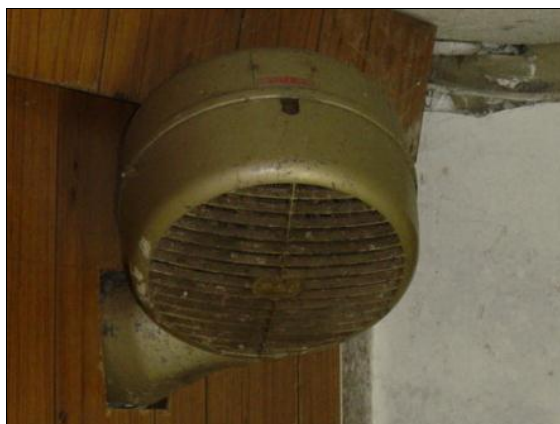
The wall mounted fan heater (Plate 12) is again early, but probably not original to the shelter. The much later panelling in the eastern wall of block B5 had been cut to accommodate the *in situ* heater.

Plate 12: Wall mounted fan heater

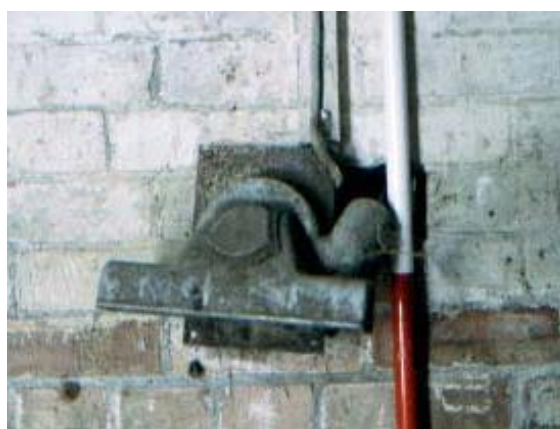
The improvised extractor shown in Plate 13 was constructed using a vacuum cleaner head. The model of vacuum cleaner is not known but closely resembles other models in use in the years prior to the Second World War. The feature may be original and *in situ* but no information could be obtained for similar items in other shelters for the same period.

Plate 13: Extractor made from vacuum cleaner head
