# **BUILDING RECORDING**

# THE SAW BARN, MANOR FARM, CHURCH STREET, HAMPSTEAD NORREYS, WEST BERKSHIRE

JMHS Project No: 1967 JMHS Site Code HMMF 09

## **Building Recording**

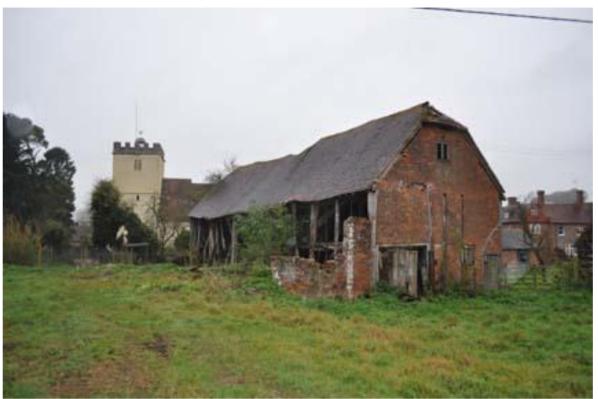
Plate 1: The west and south façades

The west façade of the building is the main elevation; it contains a large central opening; the central one of five bays (Fig. 4, plate 1). This is the original barn opening. The wall to the north of that consists of a brick dwarf wall with a timber sill beam. There are the remains of two bays on this side. The main posts forming the box frame truss are braced in the side walls, with each panel having three upright stud posts, some of which cross the bracing timbers from the sill beams. This produces an Eastern English panelling tradition called vertical panelling. This wall would previously have been covered with weatherboarding, but most of this has now gone. On the south side there are a further two bays, which appear wider. A brick dwarf wall is evident here also, but the surviving timber frame has less surviving members. There are three beams supporting the truss and two middle stud beams. The wall (if it can still be called that) is in a bad state of repair, the wall plate is visible that supports the base of the frame for the roof over which is a red clay peg tile hipped roof.

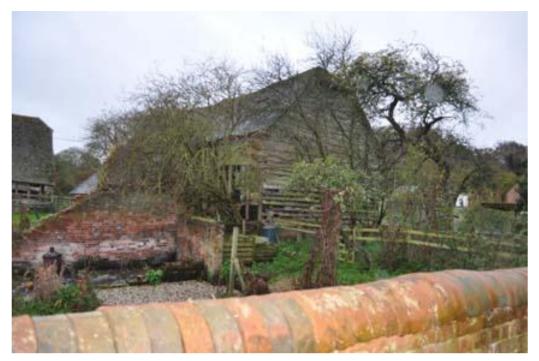
Plate 2: North façade

The north façade of the barn is a hipped gable end with a brick dwarf wall surmounted by a timber frame with external weatherboarding (Fig. 3, plate 2). The wall plates protrude under the eaves. On the left side of that façade it is apparent that timber framing and a section of weatherboarding continue thus indicating that the Ordnance Survey maps for 1877, 1899, 1912 and 1974 were correct in that the aisle or lean-to structure on the side did previously extend along practically the

whole length of the east side. It should be noted that the brick dwarf wall does not include this aisle extension.

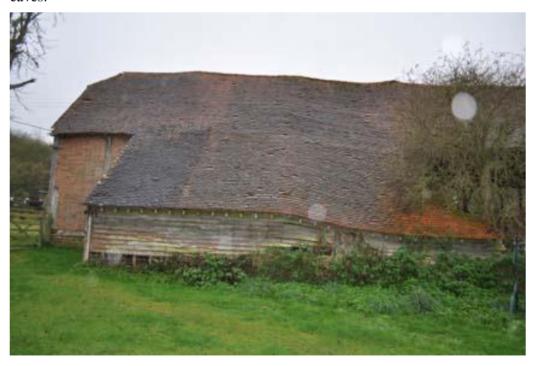
Plate 3: East façade

The east façade of the saw barn consists of a number of different components (Fig. 4, plate 3), although from the evidence this is only a recent result. The northern two bays of the main building are now visible with the remains of a dwarf brick wall on which a sill beam is located. There are a number of timber uprights including the main posts in the trusses and a number of stud posts. The weatherboarding is particularly fragmentary here, but does continue under the wall plate and eaves.

The central section of the east elevation shows the side aisle with as a low timber framed wall with weatherboarding. The timber framing extended into the ground and it is for this reason that it is beginning to rot and then slump.

The tiled roof is hipped and extends lower in the central area to cover the aisle or lean-to component. The roof continues at the same steep pitch. Slumping of the roof is evident on the northern three bays.

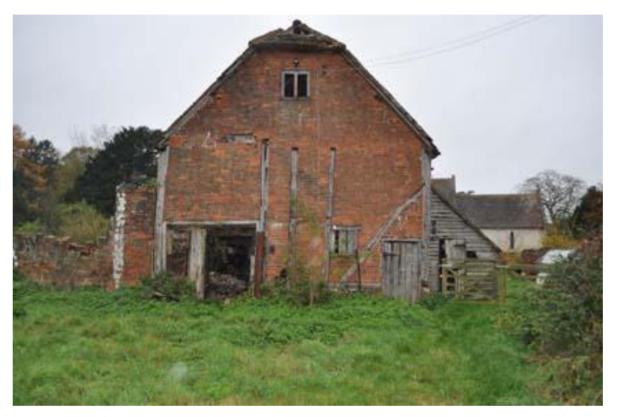
Plate 4: South façade

The south façade is a hipped gable end (Fig. 3, plate 4). It is predominantly constructed of brick in predominantly a Flemish bond fashion. The external truss posts survive but parts of their associated framework have gone. Inside each of the two truss posts at ground level are the remains of two doorways. The one on the east side is narrow with a plank door with wooden frame. On the west side there is a wider doorway with part of a plank door and wooden frame. Above this door is a poor attempt at a segmental arch decidedly lacking in its execution. Between the doors are the remains of a sill beam. Other surviving timber frame features include a brace between the sill beam and east post and three stud posts. There is a small part of the tie beam showing also. Below the hipped roof there are the remains of a mullioned timber window.

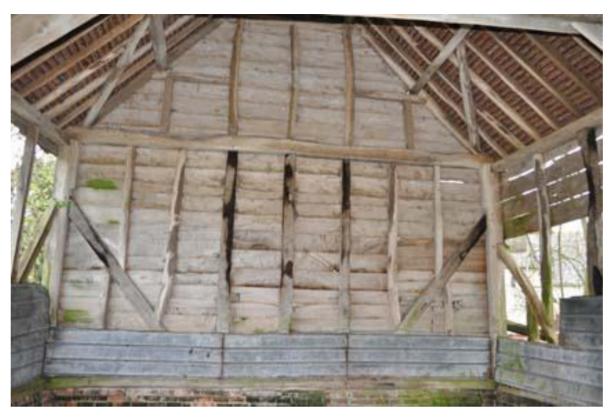
Plate 5: Interior north wall

The interior of the Saw Barn falls into two distinct units. The northern three quarters of the barn or the three northern bays remain open as part of a barn (plates 5-7). The three bays contain the remains of four main trusses, supported by braces along the line of the sill beams. The upper part of the trusses contain a tie beam with a collar beam and queen struts, then there are interrupted collar beams and -princess struts. These timbers show signs of using timbers with chamfering and uncut timber faces. There are braces between the tie beams, which are sawn and have no chamfers, these undoubtedly later additions. Some of the trusses contain windbraces, to stabilise the purlins and principal rafters. The two northern bays were enclosed, with the dwarf brick wall, with sill beams, post beams, stud posts and braces. The surviving walls at the north end are of weatherboarding, those on the east and west have all but been lost. The central bay on the north side is open; on the south side the aperture has been blocked by what forms the remains of the south aisle or lean-to. On the south side of the middle bay the inside wall is formed mainly by wood planking, while the lower part has been replaced by corrugated sheeting. There is a door on the east side floor level and a planked door centrally corresponding to a floor layer in the other part of the barn.

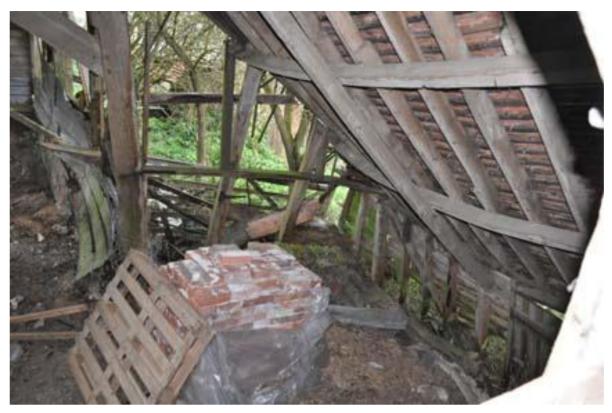
Plate 8: Interior of barn aisle

The lean-to structure, blocking the east opening of the central bay (plate 8), has a series of main posts with stud posts, principal rafters and passing braces. The sill beam would have lain on the ground, in this component it has partially rotted. There is a small panel door. The southern part of the lean-to is a contained unit separated by wooden panelling not lapped weatherboarding. This adjoining part of the aisle has a similar method of construction and roofing. The wall that it is
