A Historic Building Assessment  
of  
**GRANGE FARM**  
SHIPTON LEE, QUANTON  
Buckinghamshire

October 2006

**A HISTORIC BUILDING ASSESSMENT OF GRANGE FARM  
SHIPTON LEE, QUANTON, BUCKS**

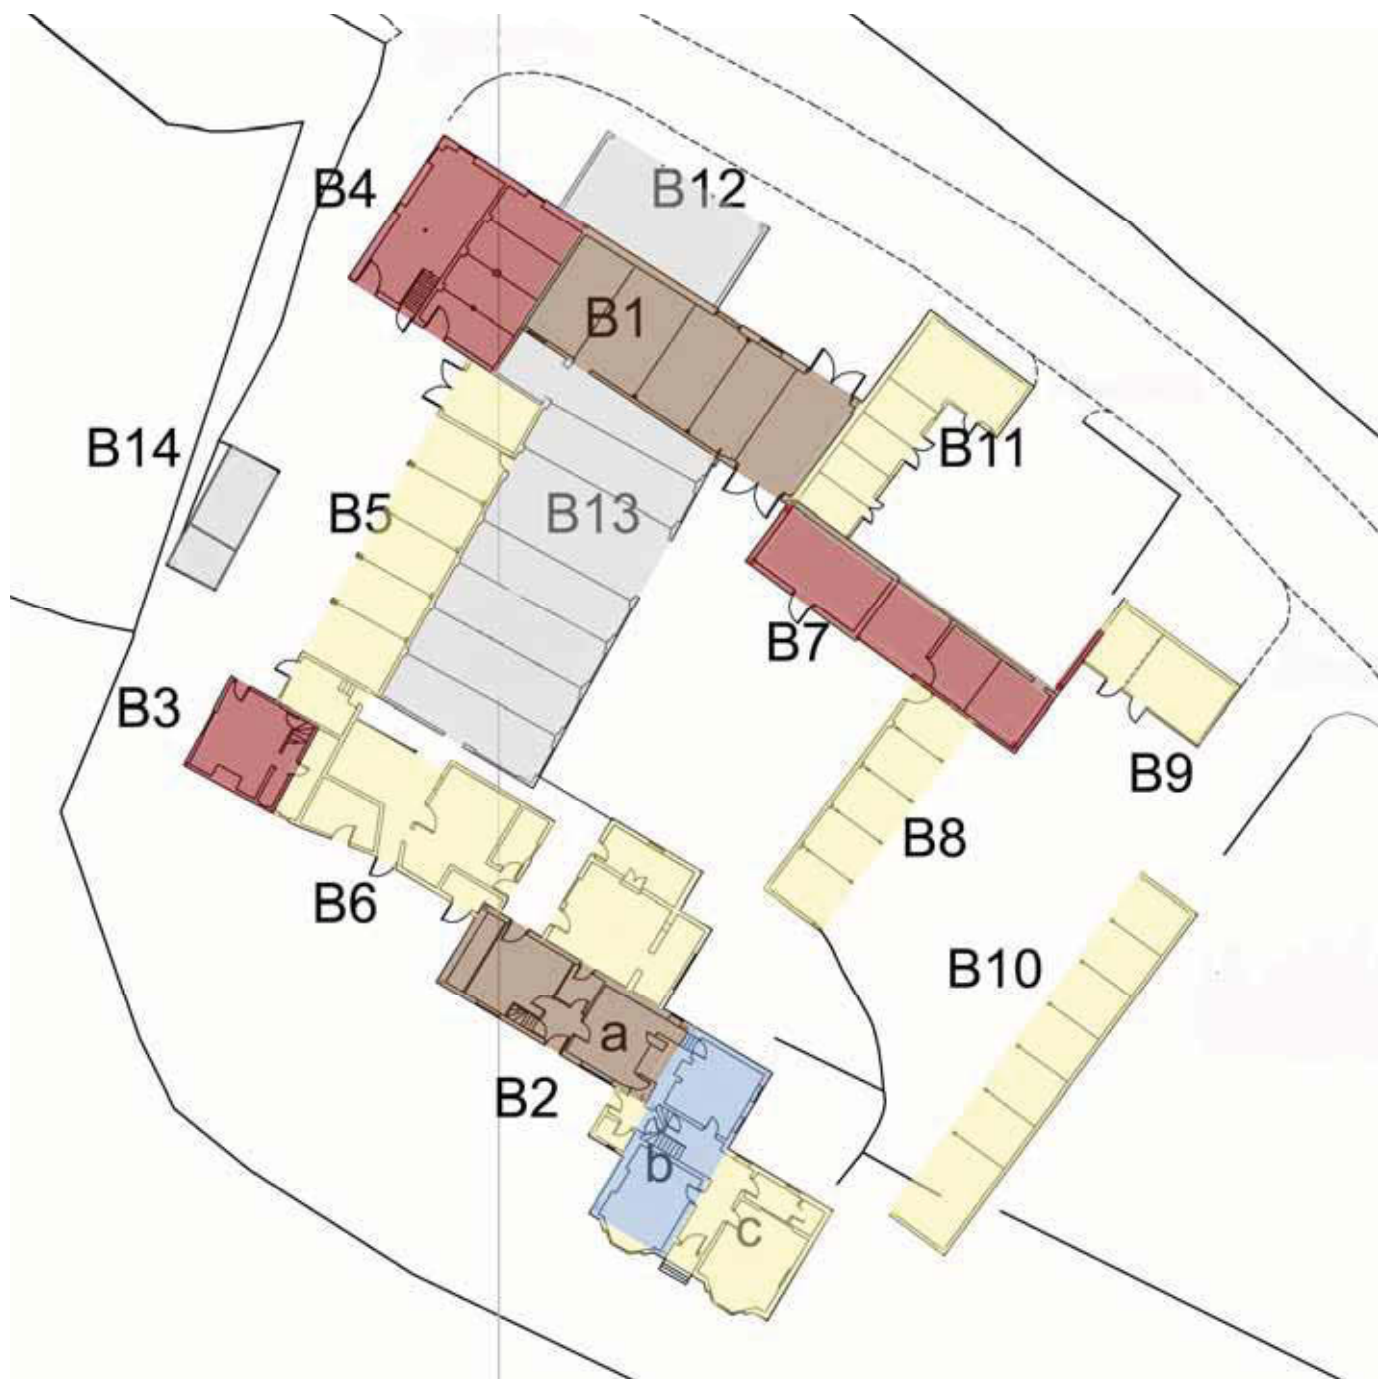
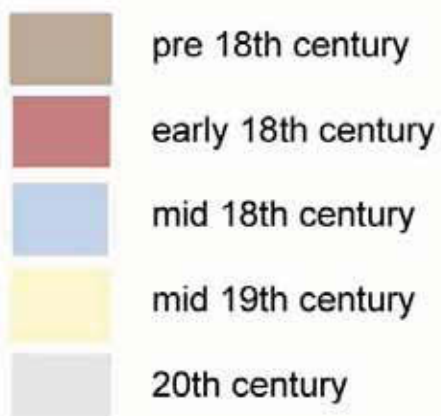
**Figure 1**

Site plan showing buildings phased according to period
