**STATEMENT OF SIGNIFICANCE &  
IMPACT ASSESSMENT**

**UPPER PARK FARM,  
BECKLEY, OXFORDSHIRE**

**NGR SP 57246 11417**

**NOVEMBER 2015**

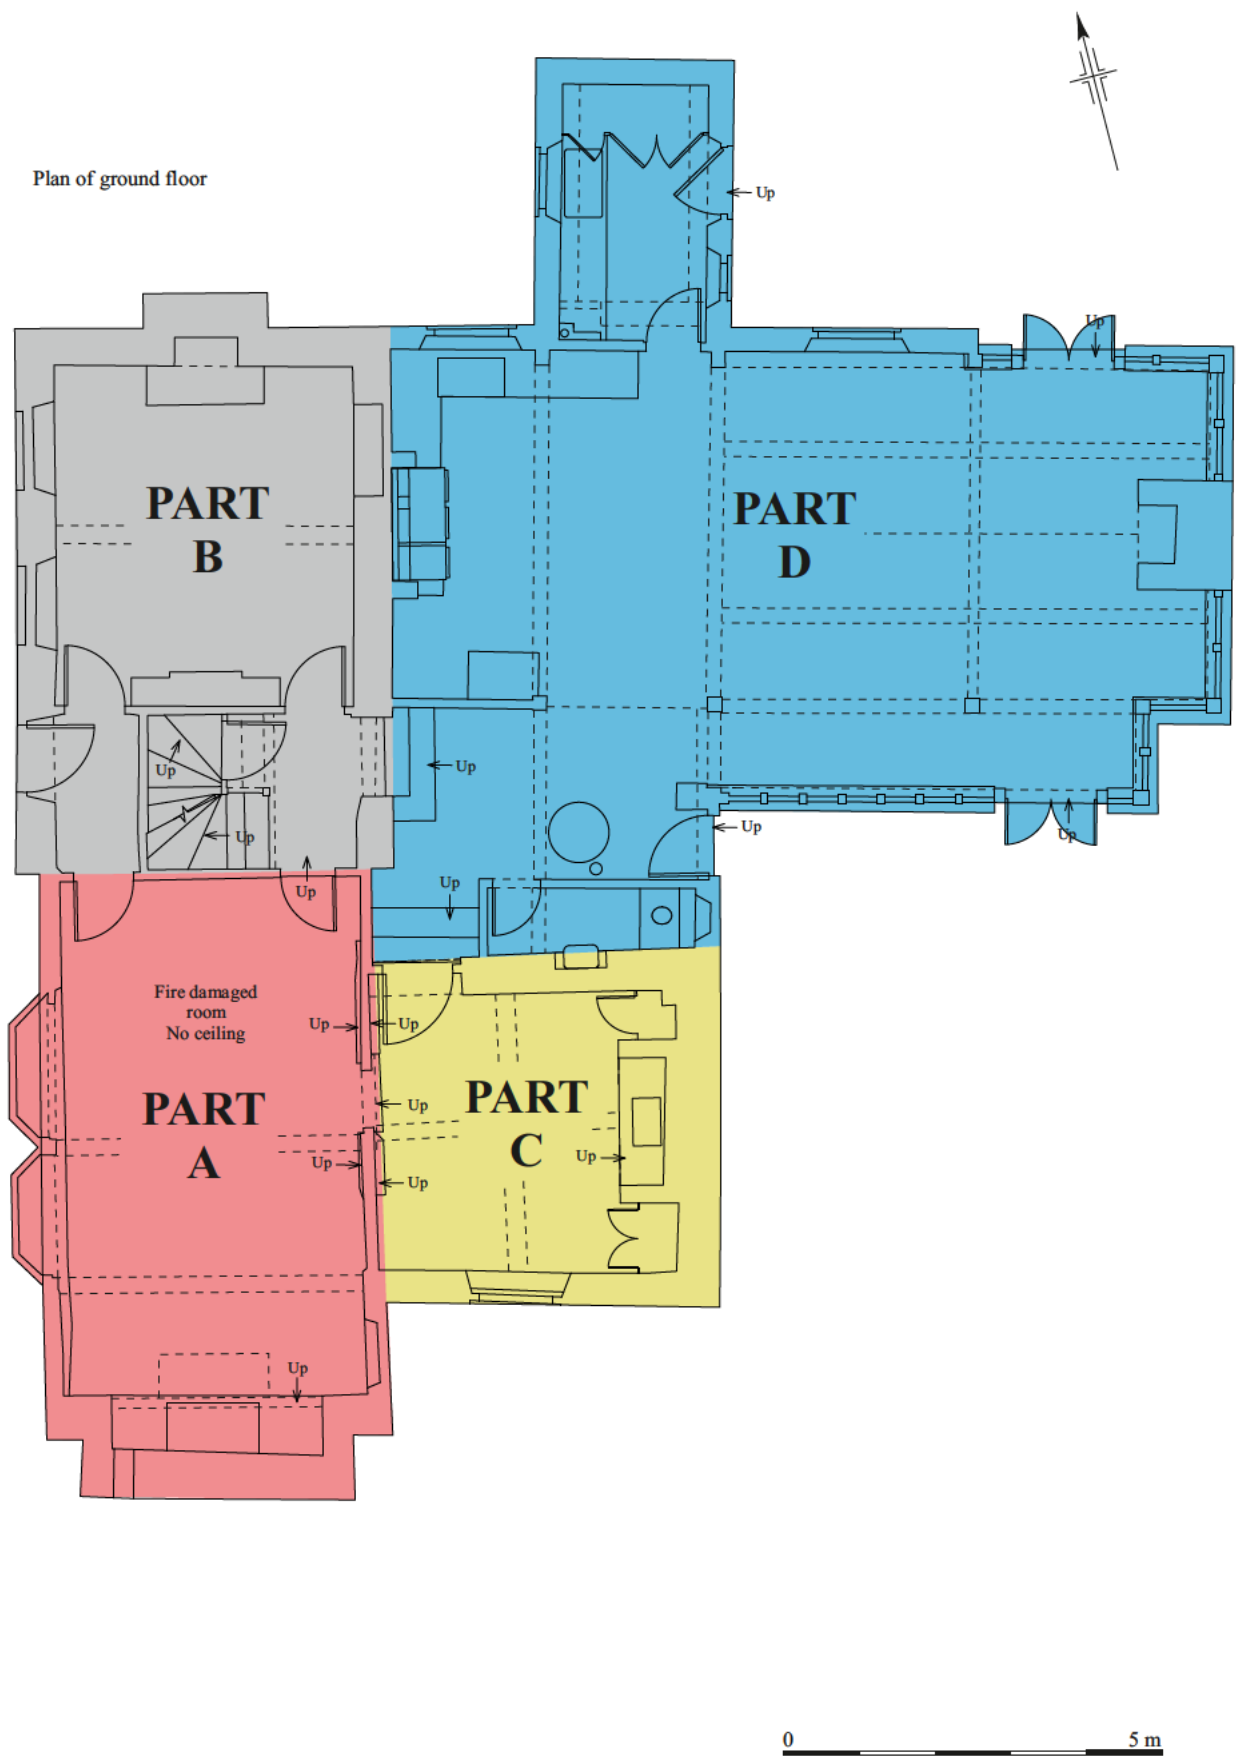
Figure 2: Ground floor showing major areas of development

The current building is a structure with four main components, two of which are located in the Front Range and two to the rear of the building. These have been categorised as parts A to D (Figures 2-3). The south part of the Front Range (part A) is a two storey structure with timber framing and brick infill and with a significant gable end chimney on the south side. The roof is of clay tile. The north part of the north range is a two and a half storey addition (part B), which has a gable end chimney at its north end. The structure is of limestone with brick detail. The roof is of clay tile. To the rear on the south side is a further extension of one and a half storeys (part C). This also has a gable end chimney. The extension is constructed of limestone-rubble and has a clay tile roof. The extension to the rear of the north part of the Front Range has a one and a half storey component built in limestone rubble and brick detail (part D). It has a clay tile roof and dormer gables. The second part of this extension is in glass and has a clay tile roof.

Part A is the oldest part of Upper Park Farm, the two cell timber framed section. Within the lounge there is a fireplace that is mentioned in the Historic England building listing. There are three remaining corbels supporting transverse beams, as well as other significant examples of historic timber framed joinery, chamfering of stops, mortise joints, and L-ties. Located between the southern and central transverse beam there is a joist directly in front of the bay window that has three diamond cuts into the underside. These are the location for diamond shaped mullions, which are a primitive feature of Tudor architecture. There is a brief period of use from 1539 to 1567 when these features were used and the windows were essentially unglazed (McCann undated). Dividing rooms F3 and F4 there are two thick studs and six slimmer studs within the wall. It can be observed that the two studs are in fact chamfered door jambs, with a simple chamfered and overhead door arch, which is sandwiched between the two jambs. The door arch is of a particular Tudor style and can be dated to a similar arch type seen in Flintshire dated 1577 (Alcock and Hall 1994 20). The doorway has been closed off and a minor stud placed floor to arch in the centre of the doorway. Room F4 has wide timbers floorboards, which are dark in colour in the room. It is possible that these date from before the late 18<sup>th</sup> century. These features are extremely significant historically, but severely fire damaged.

The damage caused by the fire is mostly based within the northern area of room G5 and room F3. Here the structural report mentions that three of the five frames have been completely destroyed at first floor level and that there is damage to the horizontal ties. Secondary components at the first floor level have also been destroyed (Symonds 2015). Secondary components at ground floor level are considered to be in good condition. The brickwork requires removal and replacement. The two frames on the south side have suffered less damage. This means that due to the damage caused to the timber frame in both the west and east walls of part A of the structure it is proposed here that the walls will be removed and that they will be rebuilt with replacement primary structural elements and an analysis of the secondary elements so that it is possible to establish if these components are structurally sound.

The key dating components here include the horizontal member with the diamond mullion fittings. In this location the features appear to be unaffected by fire but the structural nature of the piece has to be tested for its integrity. The features on the first floor between rooms F3 and F4 are so fire damaged that none can be saved, and a replacement structure is required.

There is a proposal to widen the doorway from room G5 and G4 on the ground floor, which will affect the timber framing as it is now.

The structural report also noted that the floor is suffering from wet rot (Symonds 2015). This means that parts of the floor also require replacement. It is considered to be a result of the fact that the floor level in this part of the building is lower than the ground level on the west side of the building.

The current proposal is to restore the current building, a building of national importance that has been severely damaged by fire. The fire damage has caused significant structural problems (Symonds 2015). The proposal is to repair and make sound and water proof part B of the structure as the initial phase. The secondary phase will tackle the more complicated part A and C of the structure, which appears to require the rebuilding of west and east walls of part A. Primary structural timbers will have to be replaced, while secondary timbers will have to be assessed for structural integrity.

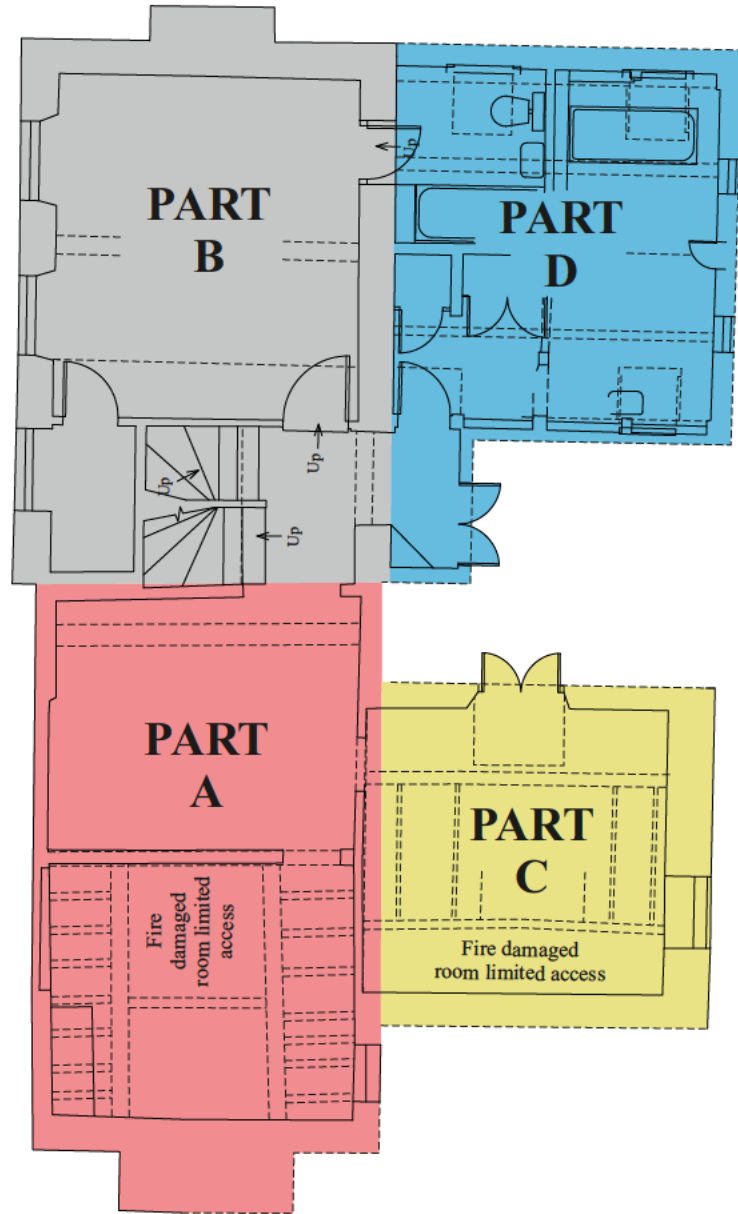
Figure 3: First floor showing major areas of development

The main part of the northern extension is sound, however, there are areas that are damaged and will require replacement. The timber structure between parts A and B will have to be replaced. The principal structural elements are extremely fire damaged and will have to be replaced (Symonds 2015). Analysis of secondary components will have to take place to recognise what is structurally sound and what is not. The roof of part B shows extensive fire damage and will thus have to have various parts of the structure replaced. The cellar door and the historic part of the stairwell is largely intact and just fire damaged.

In Part C there are high quality original chamfered beams and corbels to the ceiling of the dining room. Before the site inspection (Oct 8<sup>th</sup> 2015), plastic sheeting on a raised wooden frame had been placed in both F3 & F5 to provide protection from further material deterioration, however this meant that historically important rooms were inaccessible resulting in incomplete recording of historic features.
