BUILDING RECORDING

UPPER PARK FARM,

BECKLEY, OXFORDSHIRE

NOVEMBER 2015

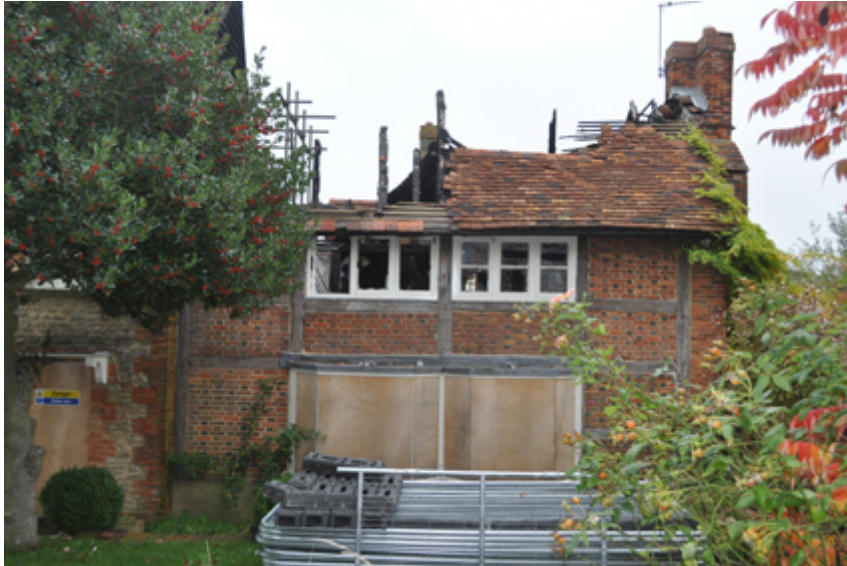
Plate 2: South side of west elevation

An old plain clay tiled roof has been severely fire damaged. The topmost section of roof adjacent to the right end chimney stack has burnt away, with no rafters remaining. Above the second floor window on the right there is a triangular section of roof that remains with the tiles still in place.

A tie beam is visible in the roof line on the front elevation. There is a small gable window in the roof with two windows of six panes, exterior walls covered in wooden cladding, no fire damage visible. The right section of the roof is badly fire damaged, though about ½ of the plain tiles still remain, on top of the charred rafters. Due to fire damage the support to the roof structure is compromised. At the level of the outer wall plate the tiles and roof appear intact up to the top of the dormer window frame. There is some smoke discolouration to the exterior wall above the windows on the first floor level.

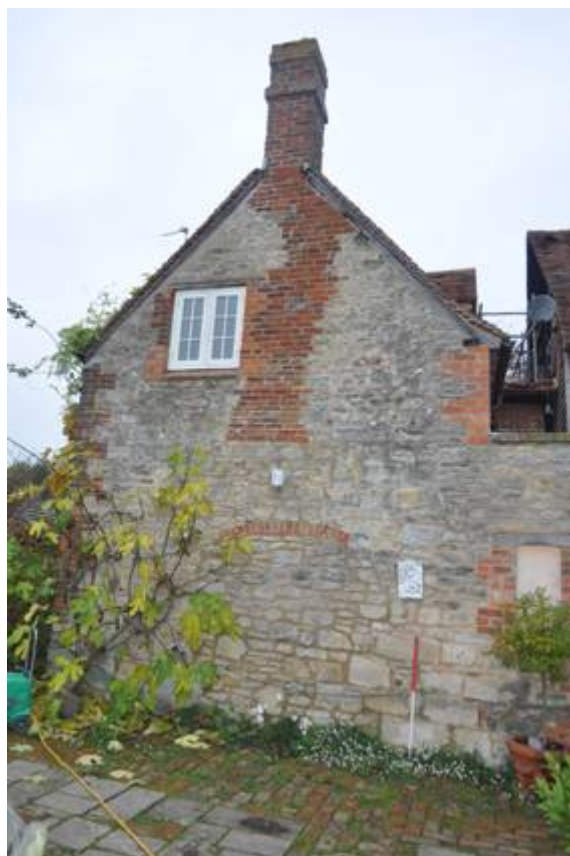
Plate 5: South side of east elevation

weather boarding. The roof above is of clay tile, there is evidence of fire damage and a whole in the roof. On the north end of this range there is a gable end chimney.

On the south side of the east elevation there is a one and a half storey gable end of limestone rubble with brick dressing (Plate 5). A clear delineation exists between the original lime rendered rubble stone and newer coursed stonework. Either side of the chimney appears to be the original lime rendered rubble stone walling. At ground floor level are remains of a relieving arch in brick of segmental form, which probably contained an earlier feature, a door perhaps, but just as likely a fireplace as it is located in the back wall of a fireplace and chimneybreast (Plate 6). To the right hand side a carved stone has been inset. The chimney breast has been rebuilt as can be seen by weathered red brick which follows the line of the chimney from the first floor to the eaves. On the left hand side of the chimney is a window of six panes.

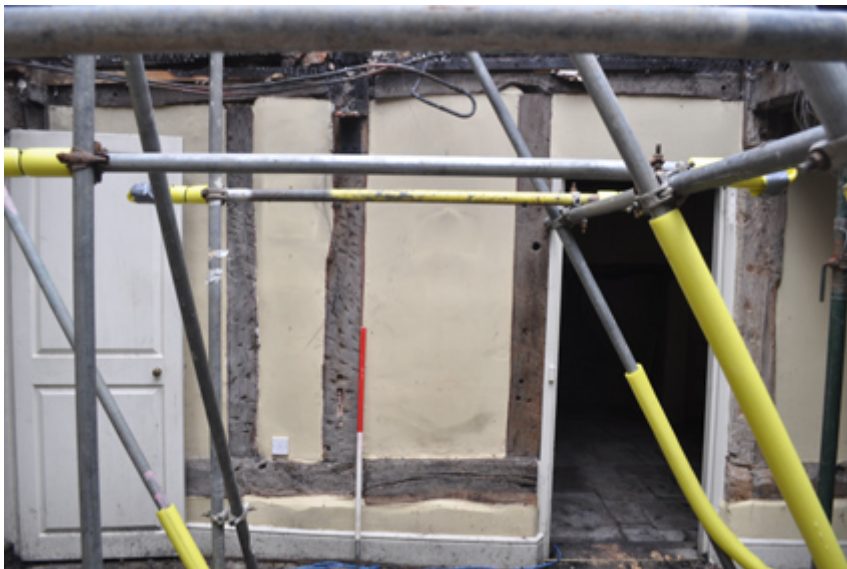
Plate 17: Timbers in east wall of G5

The east wall of room G5 contains several exposed timbers consisting of four common studs, and a sill beam (Fig. 14.E6, 17, Plate 17). Also in the east wall is the connecting doorway between room G4 and G5, which is located within the centre of the wall. There is a small length of sill beam remaining on the other side of the doorway to the dining room (G4) in the south section of the lounge. At the south end of the east wall there is a recessed fixed two light window with transoms. Though much of the ground floor appears to have survived the timber of the upper part of this wall is damaged and structurally compromised (DSA 2015).

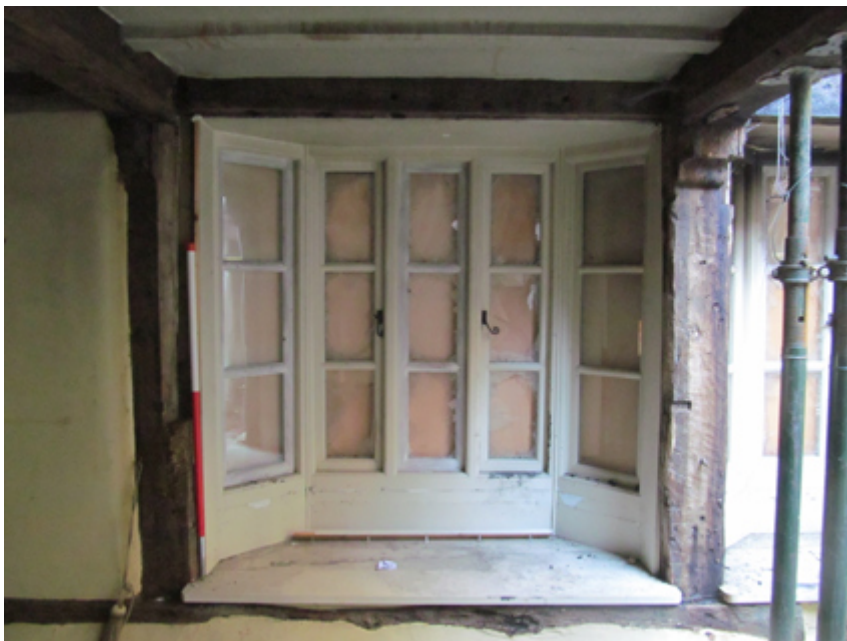
Plate 19: South bay window with cut

There are exposed beams within the west wall consisting of posts and sill beams which appear to be original features (Figs. 14.E5, 16). There are two bay windows in the central area of the west wall of room G5. The south window, which has suffered little fire damage, has a vertical cut on the top of the north edge of the south post, measuring approximately 1m in length (Plate 19).

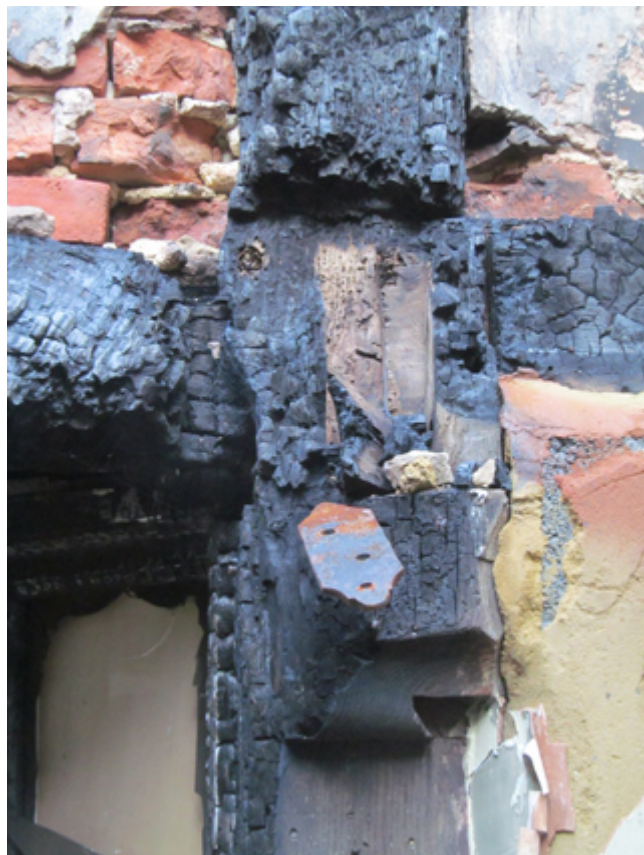
Plate 20: Remains of west north corbel

The north bay window has areas of severe burning that has penetrated through the bottom of the window frame and can be seen externally. The fire has also burned away a portion

of the window sill on the north side. The timber on the inner side of the mid rail above the bay window has been carbonised in the northern part; the lower portion of the corbel on the north side is partially intact (Plate 20).

All of the junctions at this post are severely fire damaged (DSA 2015). The plaster has fallen away in the corners of the infilled sections revealing spalled brickwork and mortar joints. According to the plans drawn up in 1993 by Roderick James Architect, the bay windows are a 20th century addition; prior to 1993 there were two sets of casement windows set within the box frame. In the west wall at the north end an entrance doorway has been removed and infilled with brick. This was done during the building works in 1993, and a new doorway was built in its current position in room G8.

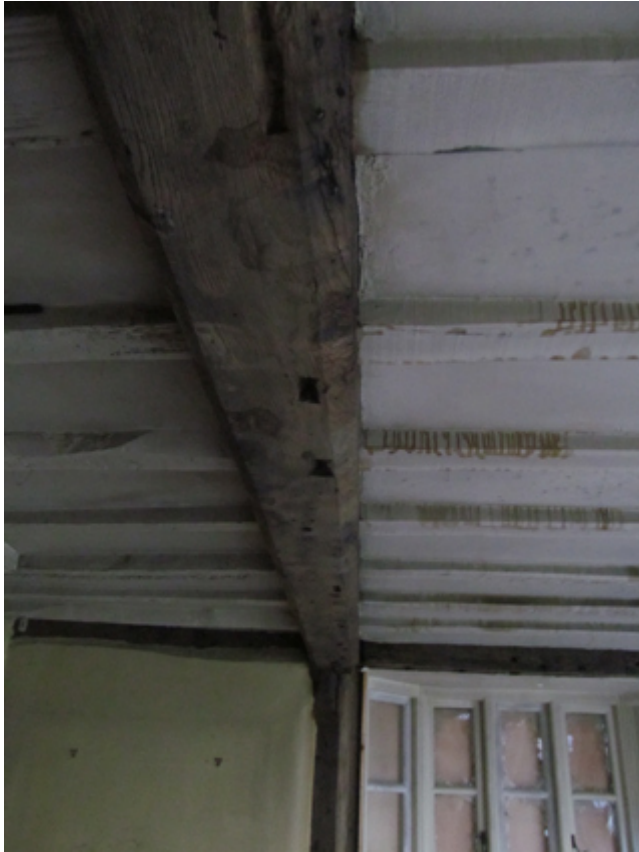
Plate 21: South transverse beam in G5

saw cuts. The joists and ceiling is white painted, with the main beams left unpainted (Fig. 19, Plate 21). There is apparently a little water damage, as evident by the marks where the water has travelled through the ceiling cavity onto ceiling and beams.

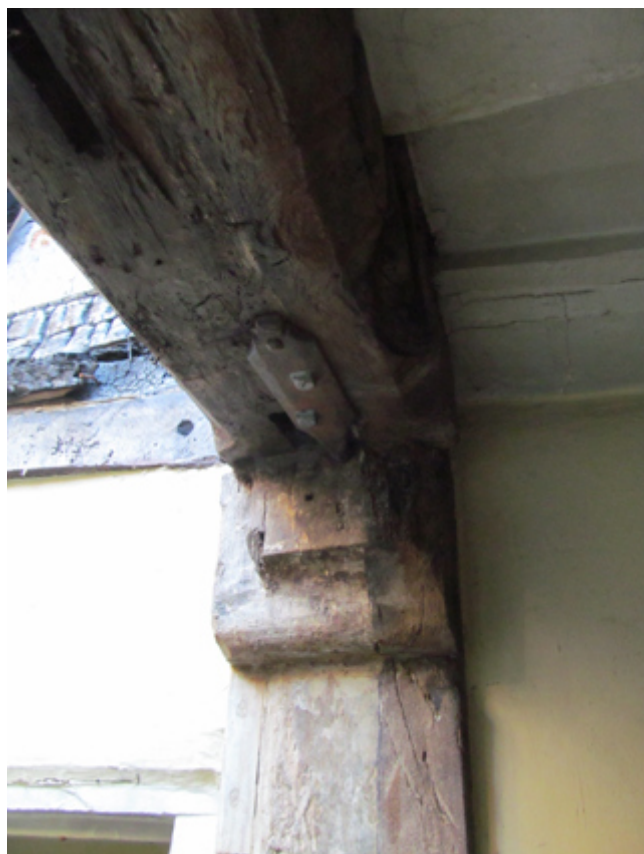
Plate 24: East central corbel

The central transverse beam contains corbels and a chamfered beam (Figs. 17, 19, Plate 24). The corbel and lower portion of the post appear intact, but viewing from the right hand side (RHS) it is apparent that there is severe fire damage to the post's corbel on the east end. There is approximately 80mm of scorching into the 200mm depth of the post (DSA 2015); this damage travels above ceiling level and on the exterior of the axial beam and plate. Both the transverse beam and plate joining into the west frame are severely burned on the outer and inner sides.

This transverse beam is bowed in the centre and supported by two closely spaced props at the west end, a third centrally placed and a fourth at the east end underneath a historic vertical crack approximately 500mm from east end. This is pinned together with a fishplate, secured with three square headed bolts (still galvanised). There are two, one in the east and one in the west, wrought iron L-ties (no date) inserted into the posts and undersides of the transverse beam. The beam apart from the damage at the post junction in the west end has incurred little visible damage to the underside. There appears to be an upper transverse bearer, which has sustained some fire damage, on the west end along the top and some area in the first floor of the doorway at the east end.

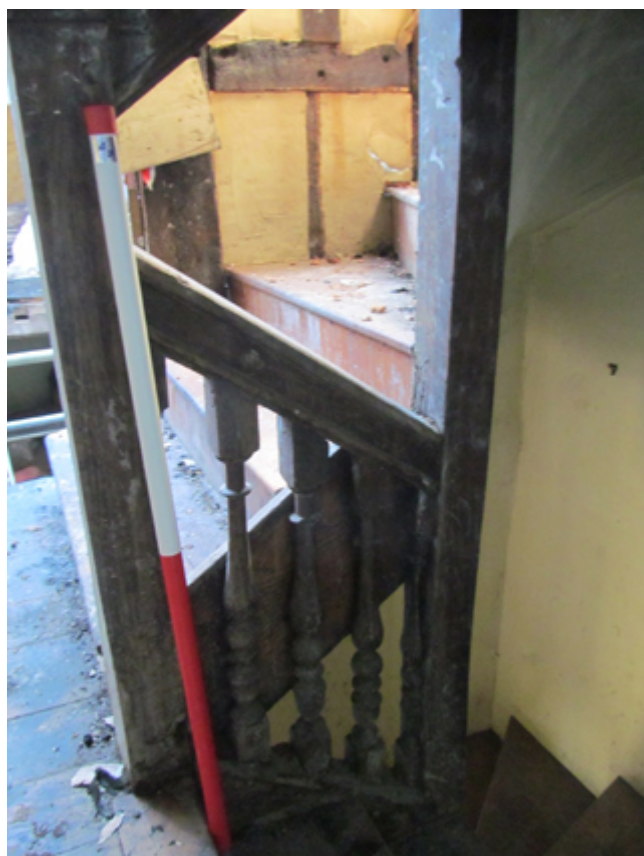
Plate 28: Newel post and turned balusters

The decorated newel post, turned balusters and carriage of the staircase are original; at the ground floor there is some trace of rot and aging as with the second floor junction on the newel base and balusters (Plates 27-28). The carriage of the steps rising up to the first floor landing appears to be an old piece of timber that has suffered some decay. The stairs are mentioned in the Historic England building listing, and as such it should be assumed that the referred to sections are original. When viewing the underside of the stairs from inside the cellar, there are machine cut timbers used to make the runners and risers at ground floor-first floor level, as well as a view from the first floor landing where the stair

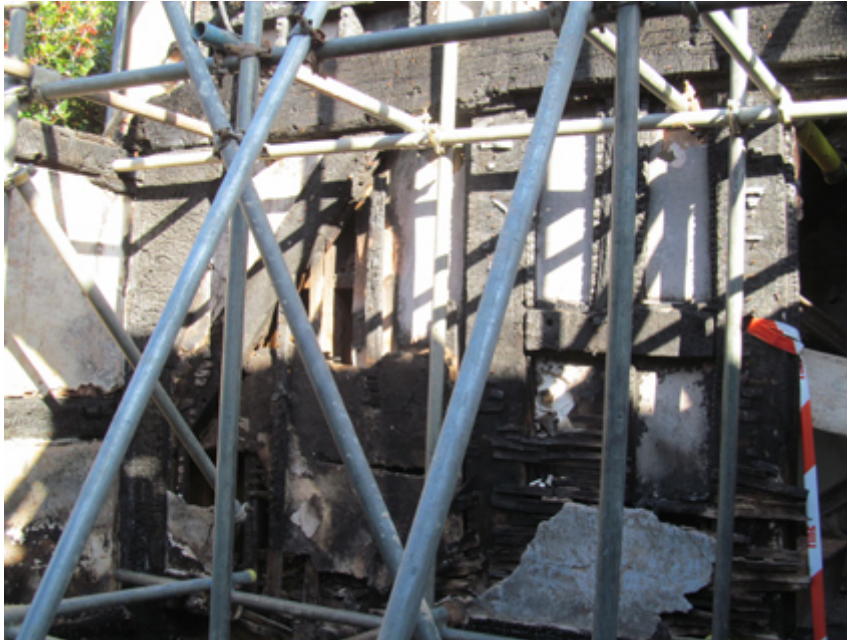
Plate 34: North wall of F3

Room F3 has very little of it surviving with the floor and roof burned out during the fire. The timber frame at this level has been severely burned (DSA 2015). In the north wall some evidence of the surviving box frame remains (Fig. 16, Plate 34). The jowled post and brace as well as struts and tiebeam are all badly charred, the outer layer of plaster and lath is almost completely burned away apart from the bottom half of the mid-section, the damage extends through to the other side of the stairs and wall. There is a dropped tiebeam, with curved braces and with a historic cut through the width of the tiebeam, this is part of the early timber framed building. It is unclear whether this is a recent alteration or historic. This section is also severely fire damaged. In part of this wall there may be the former location of a window, positioned low down in the wall. The east wall (Fig. 14.E6, 17) also contains evidence of timber framing. There is a door in this wall into room F5.

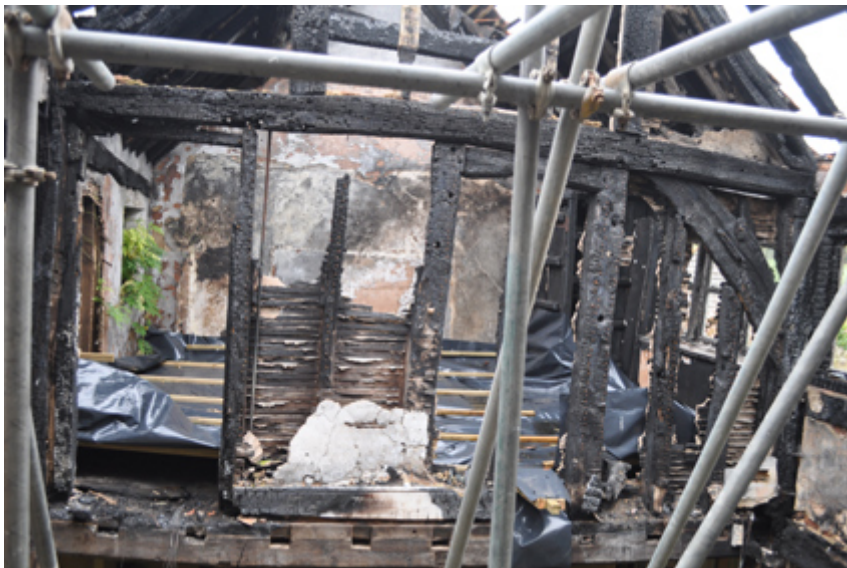
Plate 35: South wall of F3

The south wall contained a door at its east end with a series of studs and an arched brace at its west end (Fig. 17, plate 35). There are two thick studs and six slimmer studs within the wall. On closer inspection it can be observed that the two studs are in fact chamfered door jambs, with a simple chamfered and curved overhead door arch, this is sandwiched between the two jambs. The door arch is of a particular Tudor style and can be dated to a similar arch type seen in Flintshire dated 1577 (Alcock and Hall 1994, 20). The doorway has been closed off and a minor stud placed floor to ceiling in the centre of the doorway. Above the tie beam there is a collar and queen strut truss.

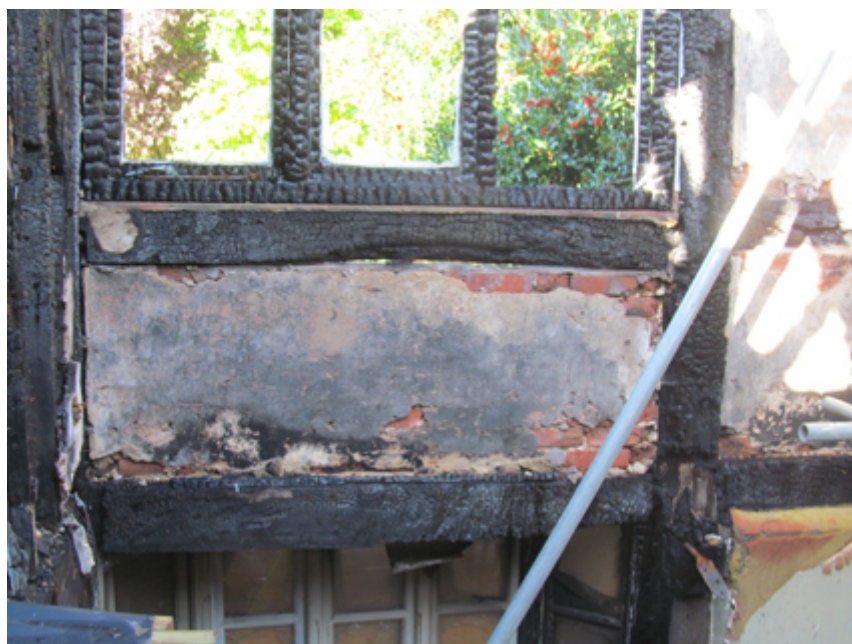
Plate 36: Infilled panel

The west wall was constructed of a large box frame and contains a mullioned window (Fig. 14.E5, 16). The windows are completely burned, only the charcoaled frame remains. They were probably replaced as part of the modernisation that occurred in 1993. There is a slim mortar line which is present around the bottom edge and one side of the window. And a single course of brickwork along the top of the window between the wall plate and rafters.

The bricks are a recent addition, they are wide; the edges are clean and straight. It is possible they were placed there because there was a hole between the rafters and wall plate and the bricks were laid to fill the hole. Beneath the window is a midrail between the studs and a brick infilled panel (Plate 36). To the right are two other brick infilled panels, where the plaster has fallen away the old brickwork can be seen and appears to be spalled. All the timbers in this section are badly burned.

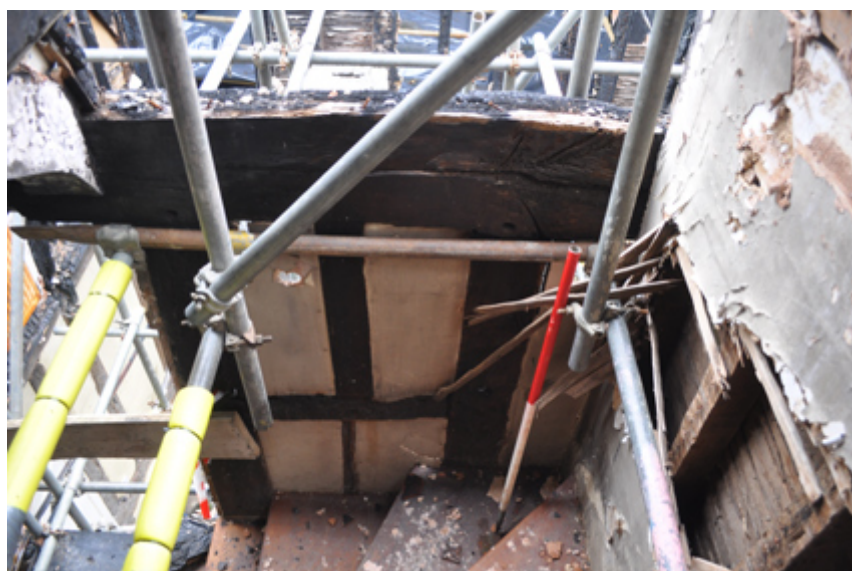
Plate 37: Timbers within the stairwell

The dogleg stairs continue up into the attic space and abuts the timber framed wall between the two sections of the Front Range (Figs. 14.E5-E6, 15.E8-E9). There are three sections of timber frame and panel within the stair column as it rises from the first floor level (Plate 37). This contains a sill piece running through the centre and two small stud pieces surrounded by two double height common studs. The face of the timbers in this location appear to have darkened due to smoke damage but apart from that, they do not look damaged. The timbers are probably original, they all have varying degrees of wear, and are of a dark brown colour. The timbers are unevenly finished suggested that that they were hewn rather than machine cut, the sill piece show signs of possible historic beetle attacks. Further to this there are historic circular holes within the sill piece that go through to the other side, and the adjacent stud. The timbers could have been reused at an earlier date or the screw holes may have been created possibly for strengthening of the frame. The back of panels can be viewed from the ground floor, and the lath has been mostly burned away and what remains is the plaster skin. There is a section in the bottom right corner that is broken.

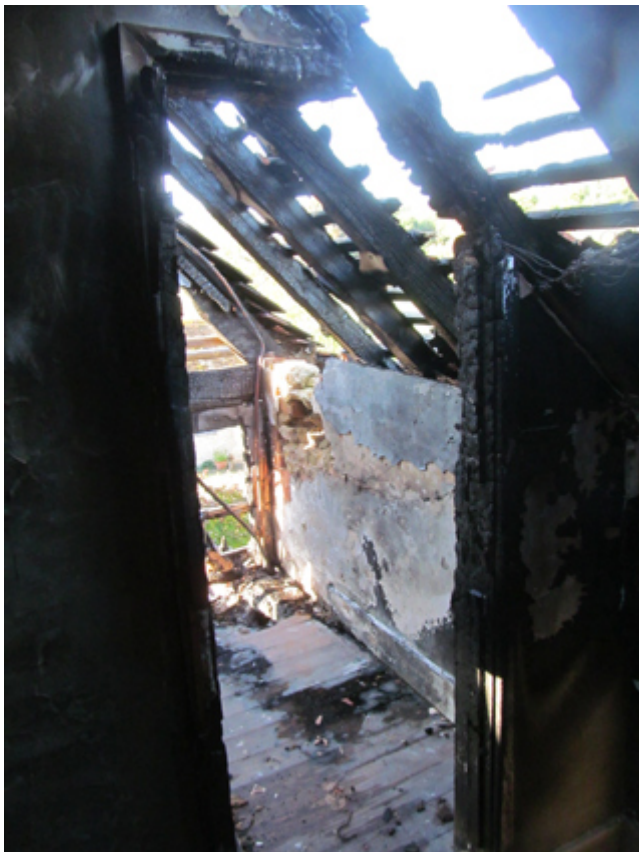
Plate 40: West wall of A2

The majority of timbers in the attic roof are intact, but very smoke damaged. Several holes exist in the roof. The tiled roof has come away in sections, either as a result of the fire or because the fire brigade removed them in order to create a vent for the smoke (DSA 2015).

The west doorway from the main room of the attic enters room A2. The east wall was of plasterboard with a modern timber frame. The south wall has little that remains apart from a severely fire damaged tiebeam and a single burned rafter. The wall on the west side has been badly damaged by fire in the left corner, plaster has fallen away to reveal the spalled bricks beneath (Plate 40). The rafters are severely damaged, and the back purlins in some instances have burned completely away, no tiles remain on this section of the roof. There is a hole in the floor in the south west corner of the room around 500 mm². There is a four panelled door lying on the floor, with an iron handle. This could be an original door.
