JOHN MOORE HERITAGE SERVICES

**ADDENDUM TO  
BUILDING RECORDING  
ON  
UPPER PARK FARM,  
BECKLEY, OXFORDSHIRE  
NGR SP 57246 11417**

**MARCH 2016**

## **ADDENDUM: UPPER PARK FARM**

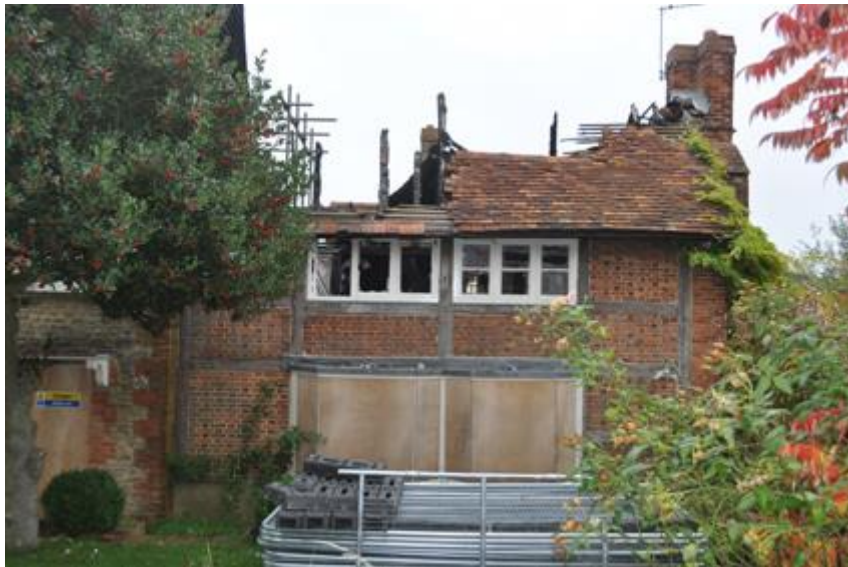
The front or west elevation contains two main component parts (plate 42). On the south part the house has what initially appears to be a large box timber frame, with a chequered Flemish bond infill. Large box framing is considered to be an indication that the structure is of an early date (Mercer 1975, 115-6). Mercer suggests that these designs were in use before 1450 and continued afterwards. However, it is apparent internally that the original large box timber framing is illusory, which also implies that the areas of brick infill are a secondary reworking of the structure. There are four timber frame bays surviving in this part of the building, of which the central two bays have 20<sup>th</sup> century windows. The size of the outer bays have different dimensions to the inner bays. The bay windows are vertically aligned with first floor windows, two sets of three two paned modern wood casement windows, with a length of lead coping underneath.

Plate 42: South part of west elevation

A plain clay tiled roof has been severely fire damaged. The topmost section of roof adjacent to the right end chimney stack has burnt away, with no rafters remaining. Above the second floor window on the right there is a triangular section of roof that remains with the tiles still in place.

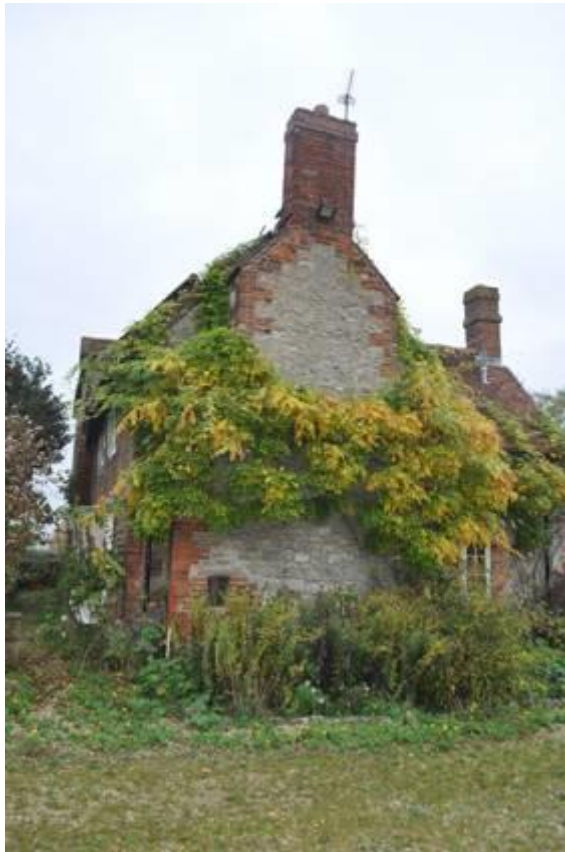
Plate 43: South gable end

The south façade contains three visible components. On the left hand side of the structure there is a two storey gable end with projecting chimney stack (plate 43). The wall is constructed in limestone rubble and red brick quoins. The chimney has two shoulders with tiled areas of runoff and a water tablet. The brick chimney stack was probably remodelled in the early to mid-17<sup>th</sup> century, the brickwork is old, in places deteriorated with small patches of concrete infill and the mortar lines are thin. Placed in the chimney stack to the left at ground floor level there is a small modern glimpse window, with a wooden lintel. The south elevation is largely obscured by wisteria.

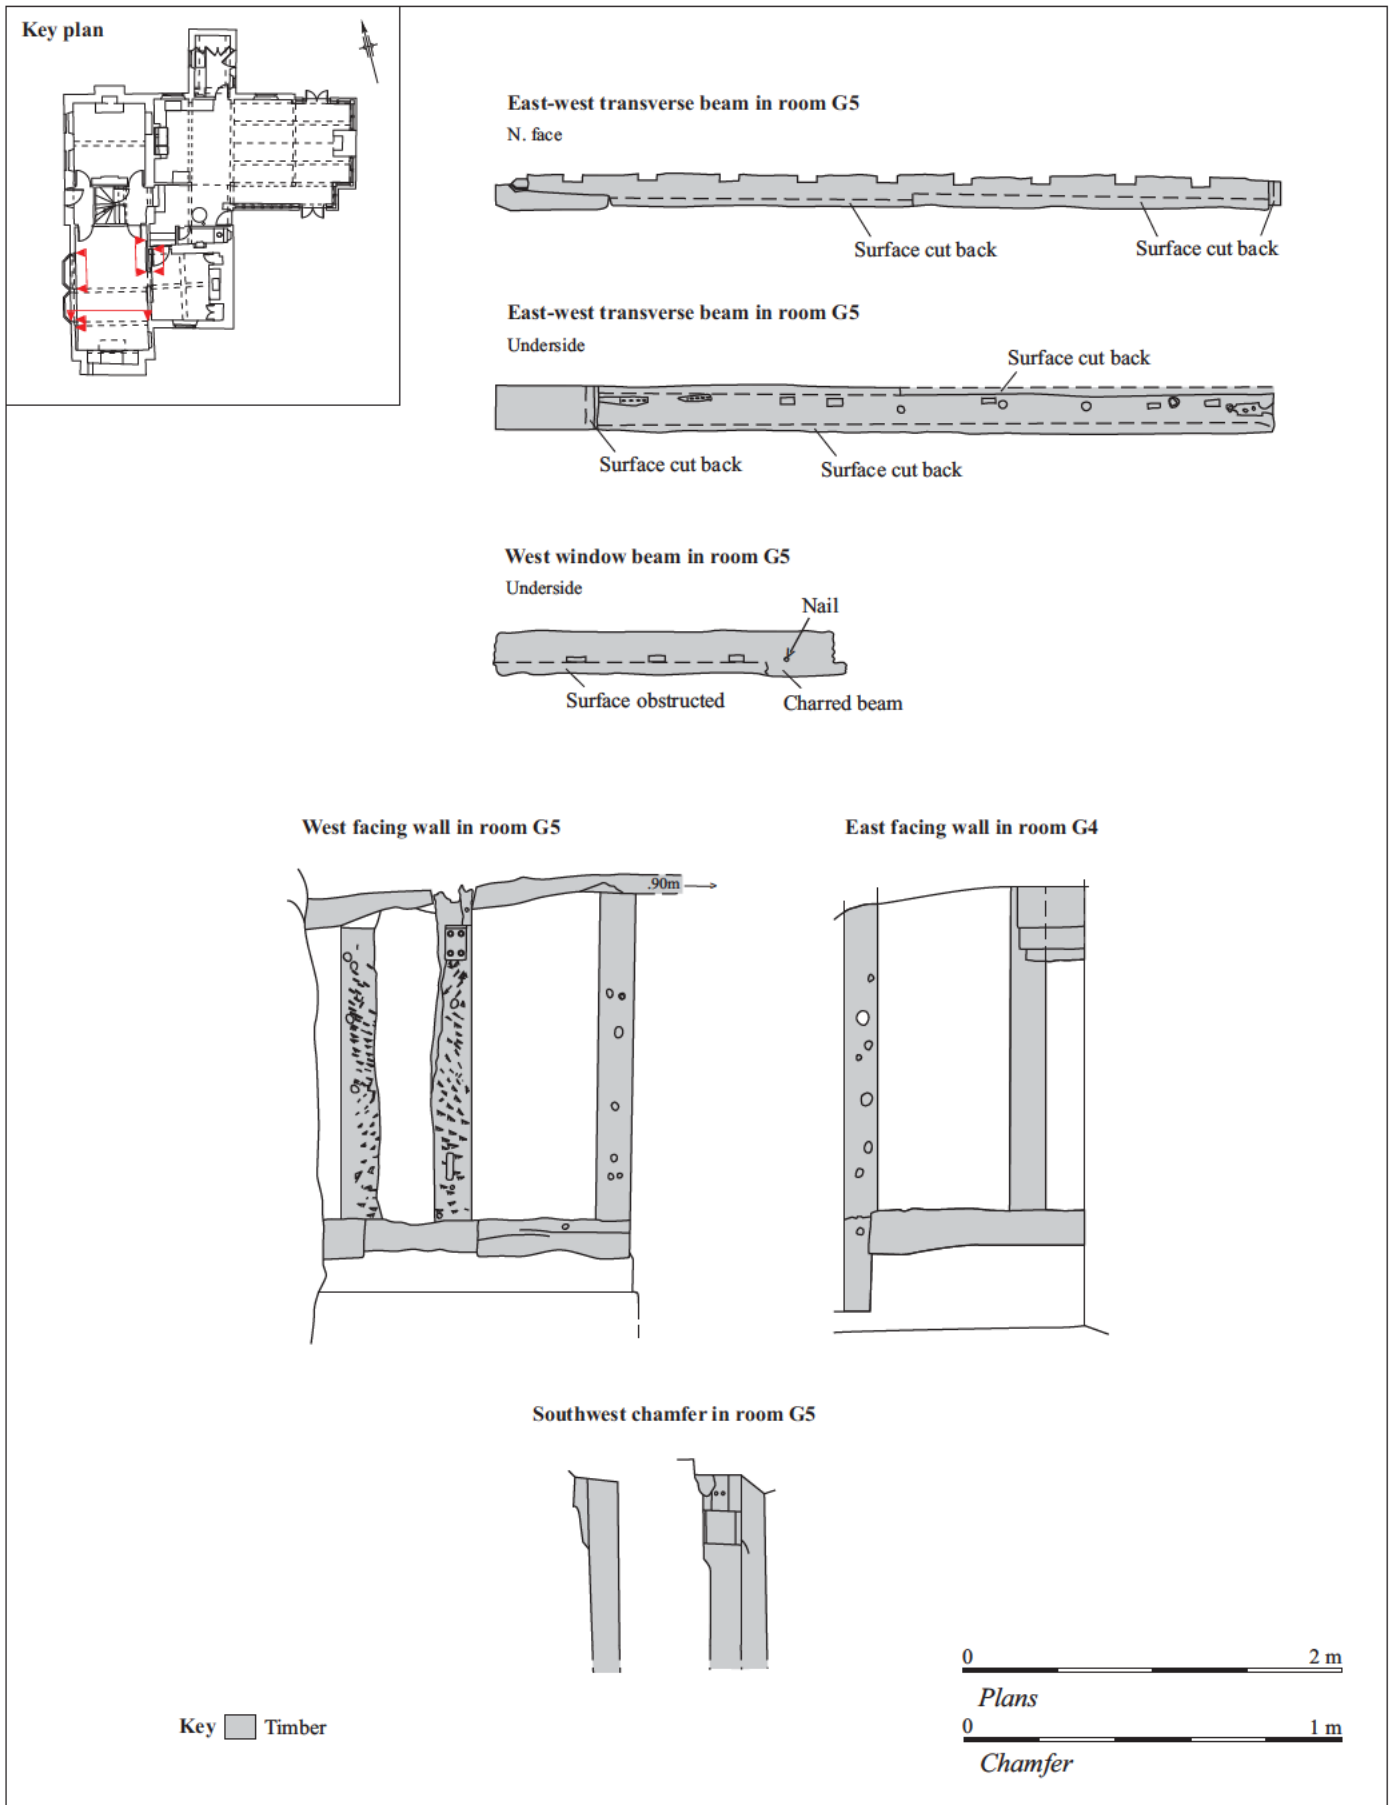
Figure 22: Timber details from rooms G4 and G5

Internally the ground floor room that requires to be re-discussed is room G5. The east wall of room G5 (internal) contains several exposed timbers consisting of four common studs, and a sill beam (Figure 22, plates 44-45). The sill beam has an area cut out towards its northern end as though it was designed to fit around an earlier feature. Two of the stud posts align on the inside of this niche. The south stud here has a mortise joint indicative of

The south window has suffered the least fire damage. The arcade post on the south side has a vertical cut on the top of the north edge measuring approximately 1m in length (figure 22, plates 46-47). This is the remains of a splay for part of a window, for which further evidence is exposed in the horizontal beam above the window.

The southern transverse beam is chamfered with one stop on the south side. The western post has a corbel, supporting the transverse beam (figure 22, plate 51). There is a historic wrought iron L-tie (no date), three iron pins are inserted to the underside of the transverse beam connecting into the corbel, probably to stop the beam failing and provide extra support. There are a number of mortise cuts into the beam that appear to indicate an earlier wall or screen inserted under this beam. At the eastern end of the transverse beam there are historic repairs to the beam using two scarf joints, a newer section extends from the wall providing support where the beam has rotted. A stone wall supports the east end.

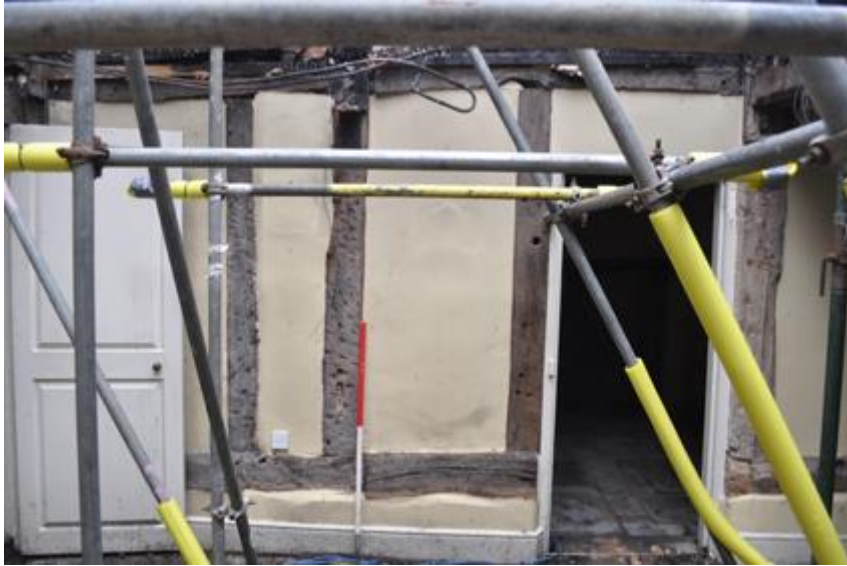
Plate 44: Timbers in east wall of G5

timbers extending into the room at this point. It is presumed that this feature is designed to fit around the end of a stone wall, probably one that may have originally contained a chimneybreast. Also in the east wall is the connecting doorway between rooms G4 and G5, which is located within the centre of the wall. Plaster was removed from the panel between the doorway and the cut in the sill beam. The lower sill beam appears to have a fixture for a stud post. There is a small length of sill beam remaining on the south side of the doorway leading to the dining room (G4) in the south section of the lounge. At the south end of the east wall there is a recessed fixed two light window with transoms. Though much of the ground floor appears to have survived the timber of the upper part of this wall are structurally compromised (DSA 2015).

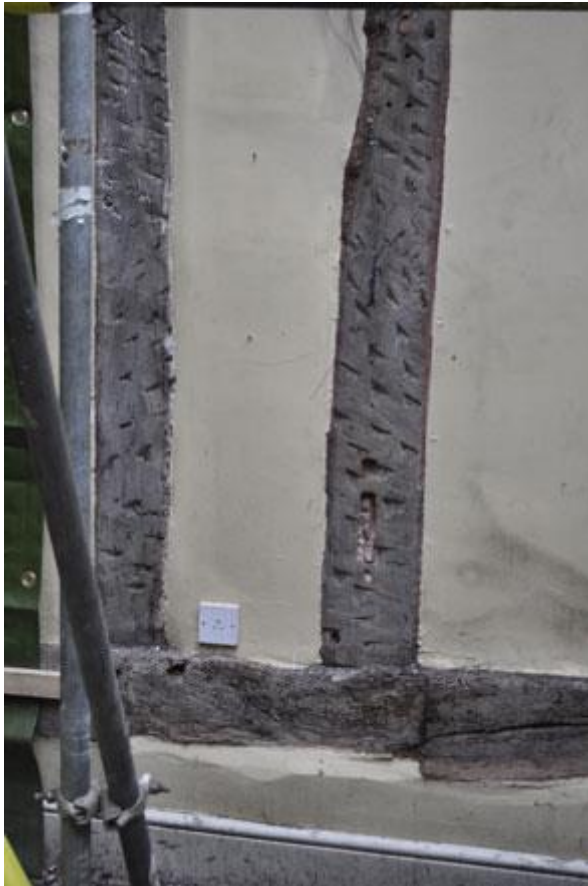
Plate 45: Mortise joint in post

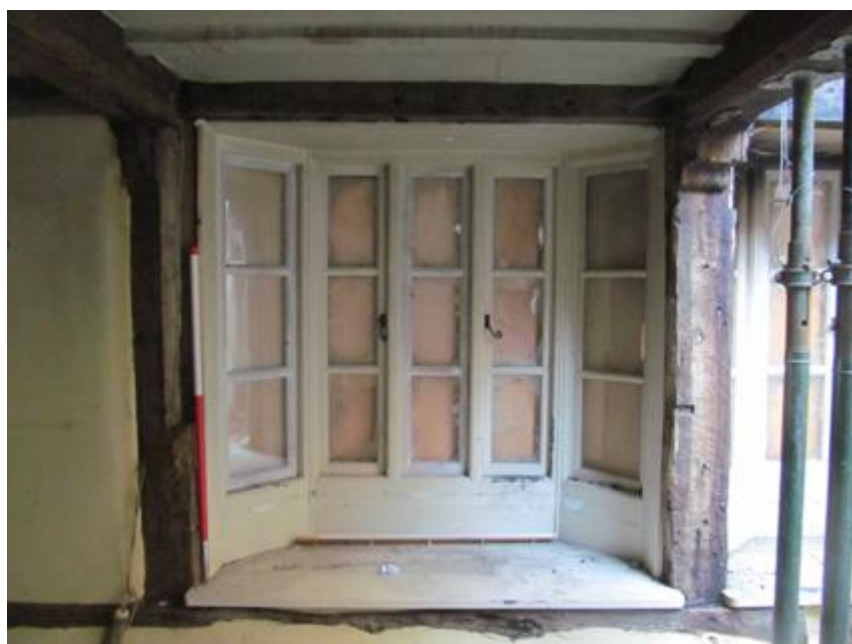
Plate 46: South bay window with cut

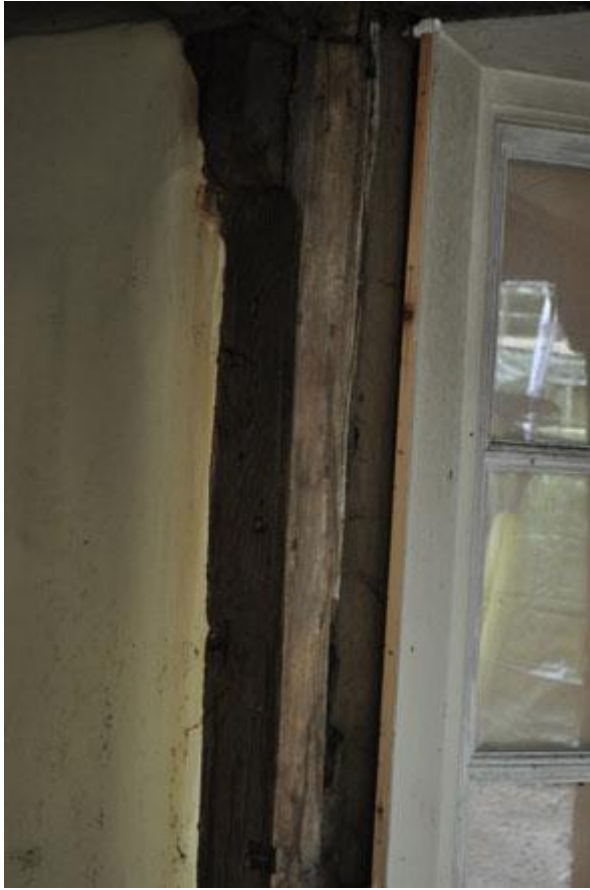
Plate 47: Chamfered post on side of original window

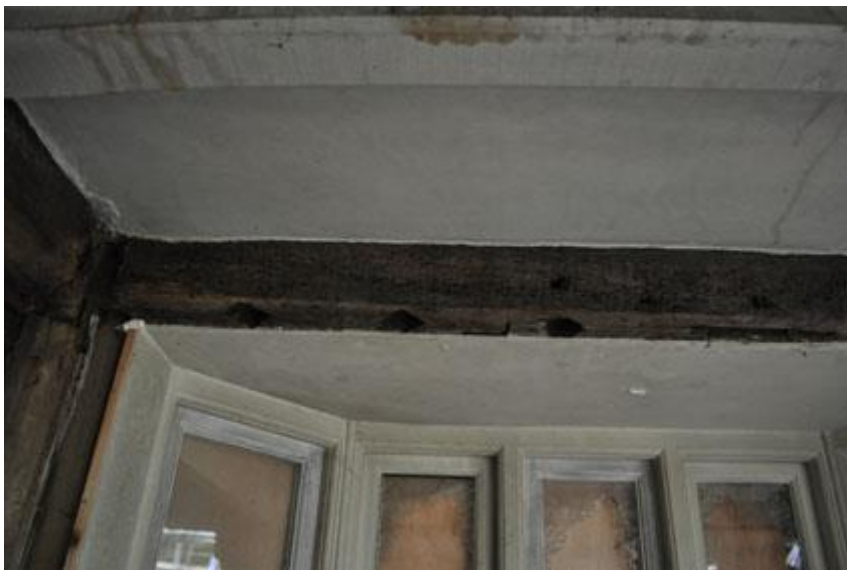
The horizontal beam has mortise joints cuts into the underside (plate 48-49). Three of these are the location for diamond shaped mullions, which are a primitive feature of Tudor architecture. One of these has evidence of a dowel hole. There is a brief period of time

from 1539 to 1567 when these features were used and the windows were essentially unglazed (McCann 2010). Examples have been recognised at Vale Farmhouse, Frostenden and Rose Brook Cottage, Little Warley. On the north side of these there is evidence of a previous larger stud post, and two smaller stud fittings in the form of mortise joints.

Plate 48: Diamond mullion and mortise joint for stud beam

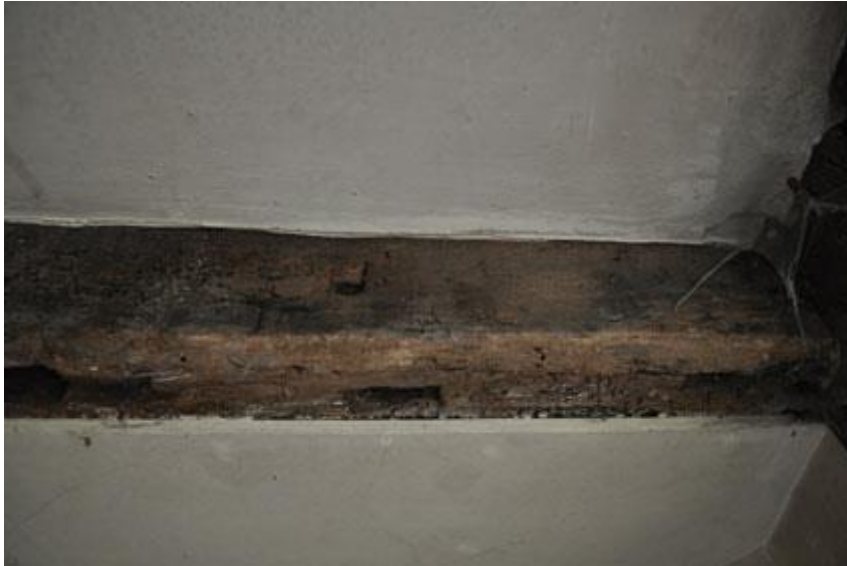
Plate 49: Mortise joints for stud posts

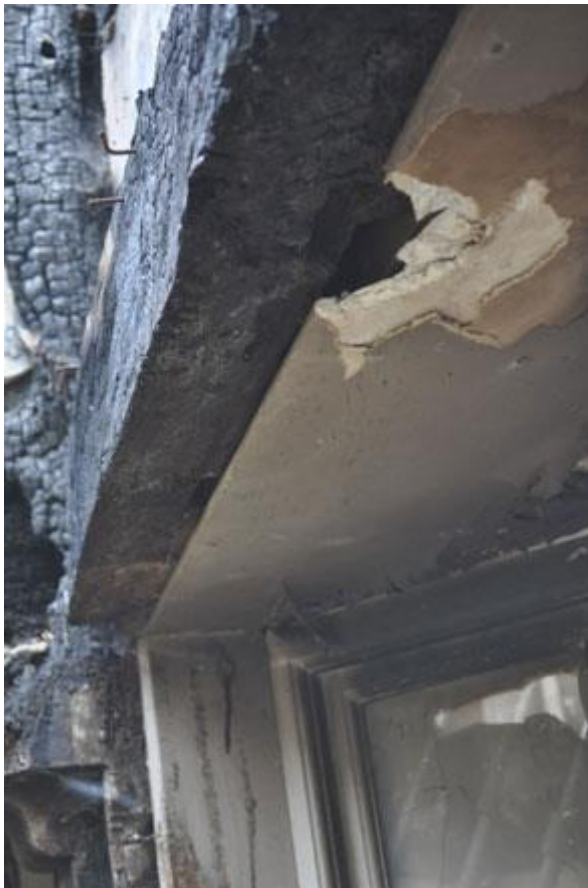
Plate 50: Mortise joints in underside of horizontal beam above north bay window

The north bay window frame and sill has areas of severe burning. The horizontal joist above the window shows signs of mortise joints for stud posts. That mortise joints occur

above both bay windows, would imply that the brick infill is not original and that the large box frame originally had smaller stud posts filling the internal wall space.

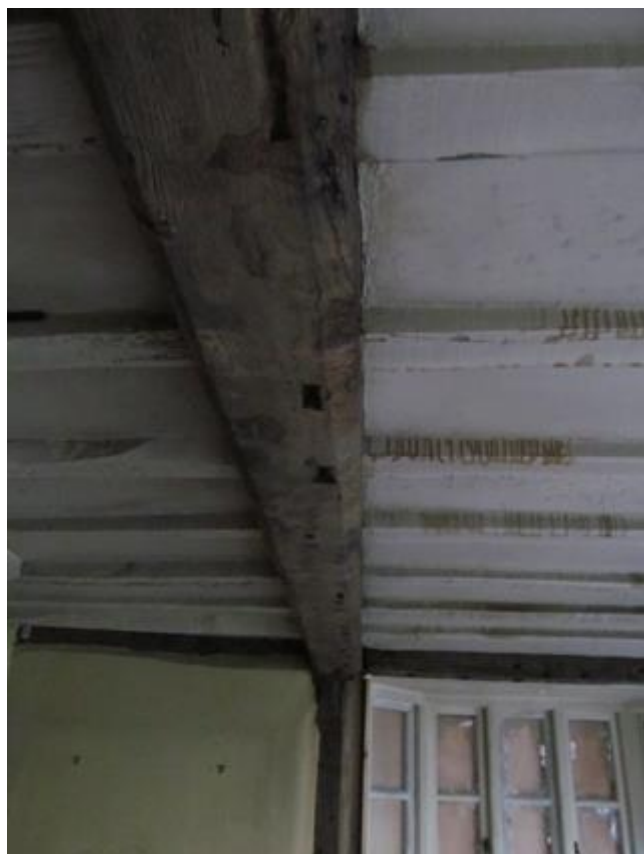
Plate 51: South transverse beam in G5

The ceiling would have contained three transverse beams that would be attached to the arcade posts. Between the south transverse beam and the south wall there are two joists near to the hearth that are probably original. The remaining joists appear to be newer, because they are slimmer, and have traces of machine saw cuts (plate 51).

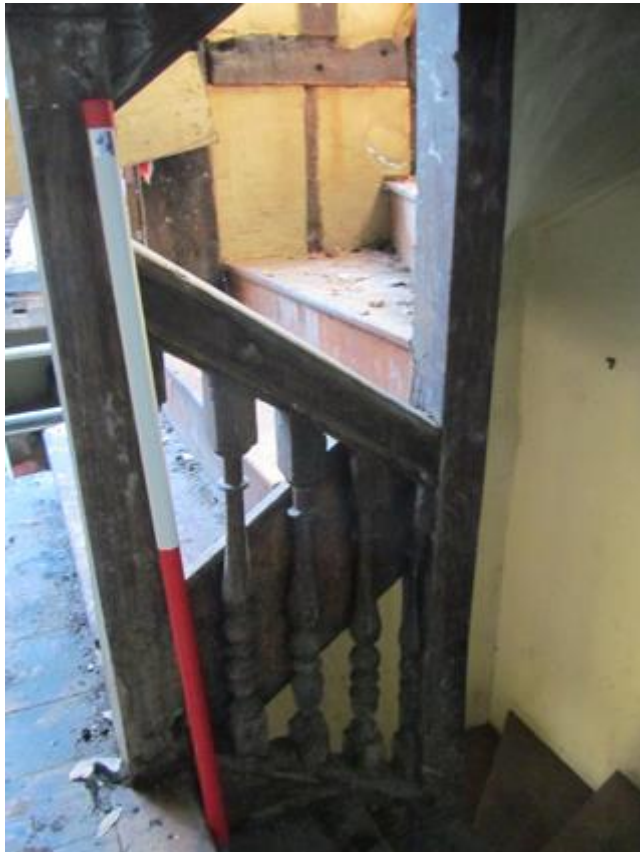
Plate 52: Newel post and turned balusters, with timber frame window behind

The hall at the base of the stairwell (G7) has a door in the south wall leading into the lounge (G5). On the west side there is the main stairwell that contains a dogleg staircase rising two floors and ending in the attic space (plate 52). Timber framing is evident in the wall on the south side of the stairs, and the remains of a window staggered out of line with the floors is evident.

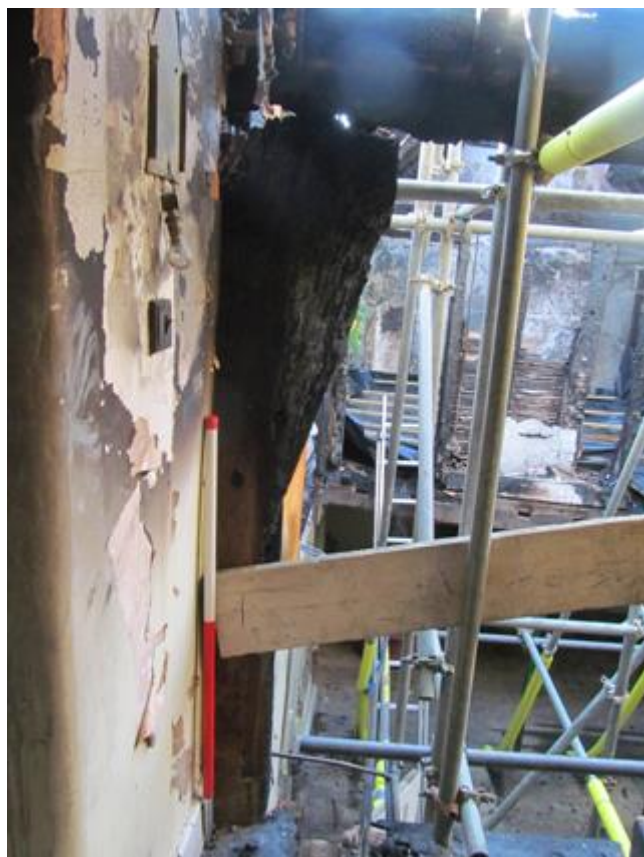
The landing (F3a) on the first floor is a roughly rectangular space. Parts of the south wall are burned out; some of the timber frame sections still remain, but are heavily scorched and burned on revealed faces abutting (plate 53). Part of a jowl arcade post is evident on the east side.

Plate 53: East side of south wall of landing

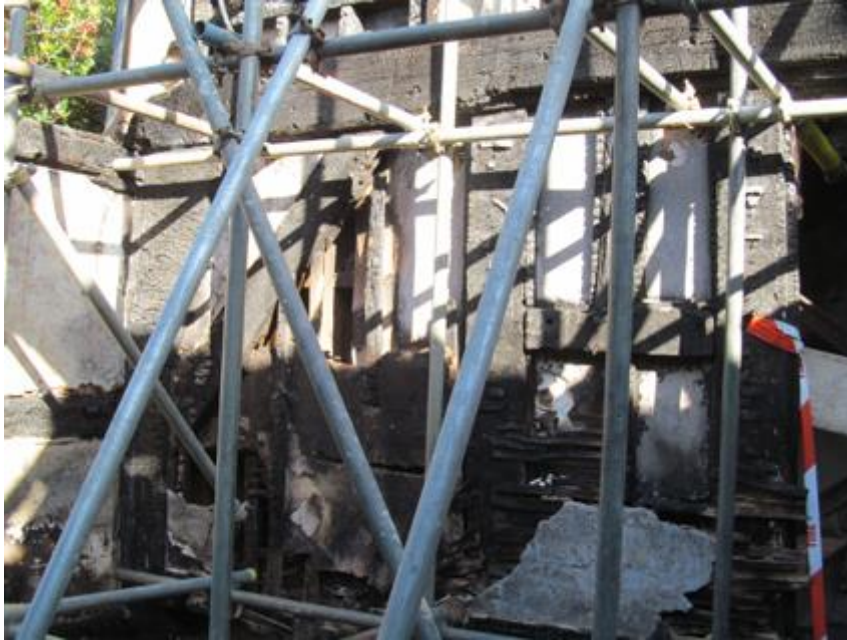
Of room F3 very little survives with the floor and roof burned out. The timber frame at this level has been severely burned (DSA 2015). In the north wall some evidence of the surviving box frame remains (plate 54). The jowled post and brace as well as struts and tiebeam are all badly charred, the outer layer of plaster and lath is almost completely burned away apart from the bottom half of the mid-section. There is a dropped tiebeam, with curved braces and with a cut through the width of the tiebeam; this is part of the early timber framed building. In this wall there is probably the former location of a window, positioned out of alignment with the floor levels.

Plate 54: North wall of room F3

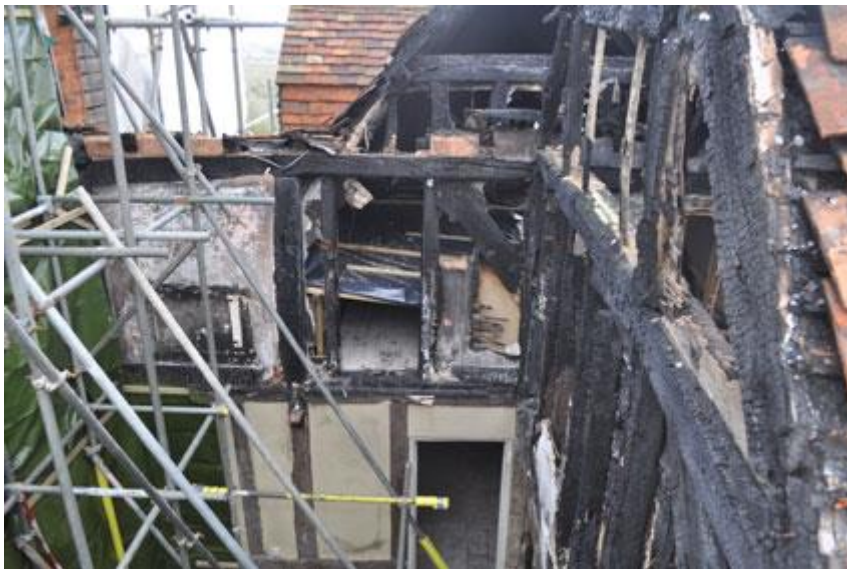
The east wall contains evidence of timber framing. There is a door in this wall into room F5. The arcade post of the division of the bays also has a mortise joint in it to indicate that there was an internal wall division in the northeast corner, presumably associated with a chimney.

Plate 55: East wall of room F3

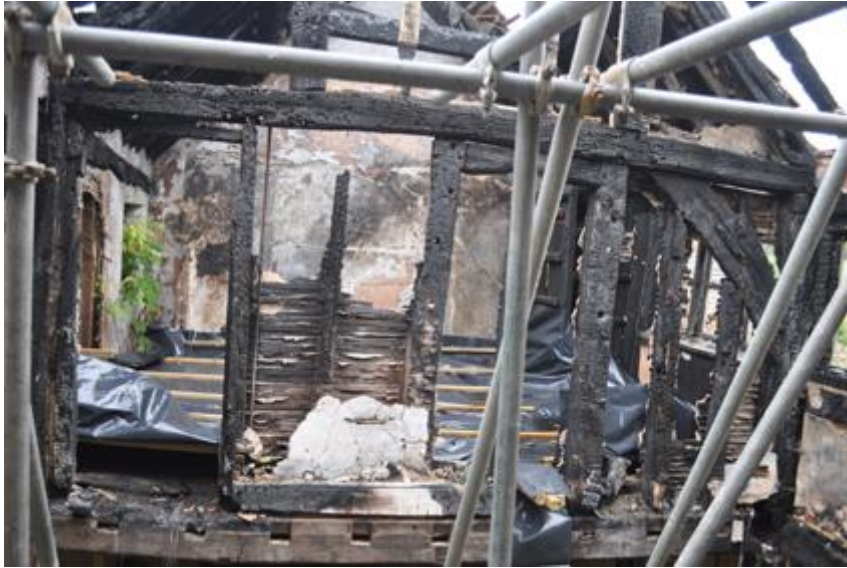
The south wall contained a door at its east end with a series of studs and an arched brace at its west end (plate 56). There are two thick studs and six slimmer studs within the wall. On closer inspection it can be observed that the two studs are in fact chamfered door jambs, with a simple chamfered and curved overhead door arch sandwiched between. The door arch is of a Tudor style and can be compared to a similar arch seen in Flintshire dated 1577 (Alcock and Hall 1994, 20). The doorway has been closed off and a minor stud placed floor to ceiling in the doorway. Above the tie beam there is a collar and queen strut truss.

Plate 56: South wall of F3

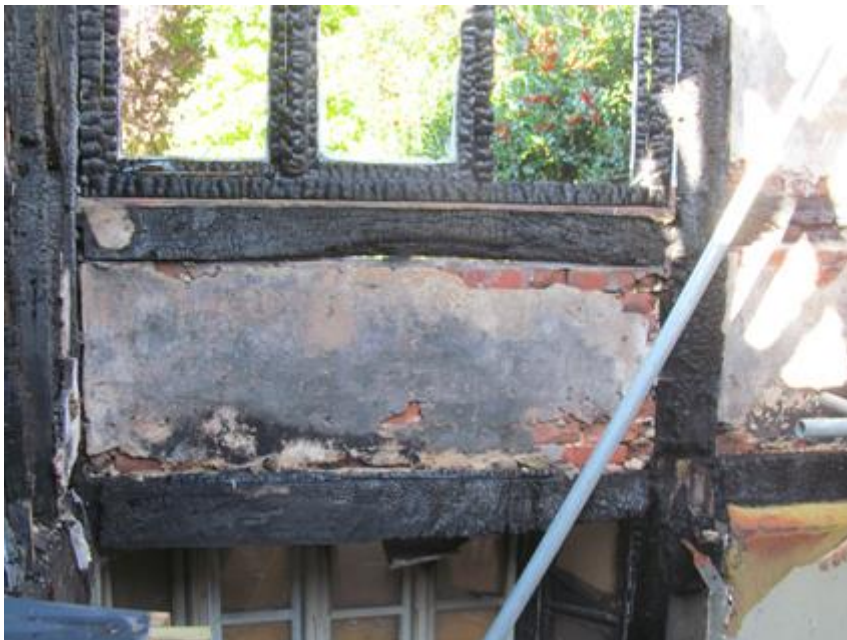
The west wall was constructed of a large box frame and contains a mullioned window. The windows are completely burned, only the charcoaled frame remains. They were probably replaced as part of the modernisation that occurred in 1993. There is a slim mortar line which is present around the bottom edge and one side of the window, and a single course of brickwork along the top of the window between the wall plate and rafters. Beneath the window is a mid-rail between the studs and a brick infilled panel (plate 57). To the right are two other brick infilled panels.

Plate 57: F3 west wall

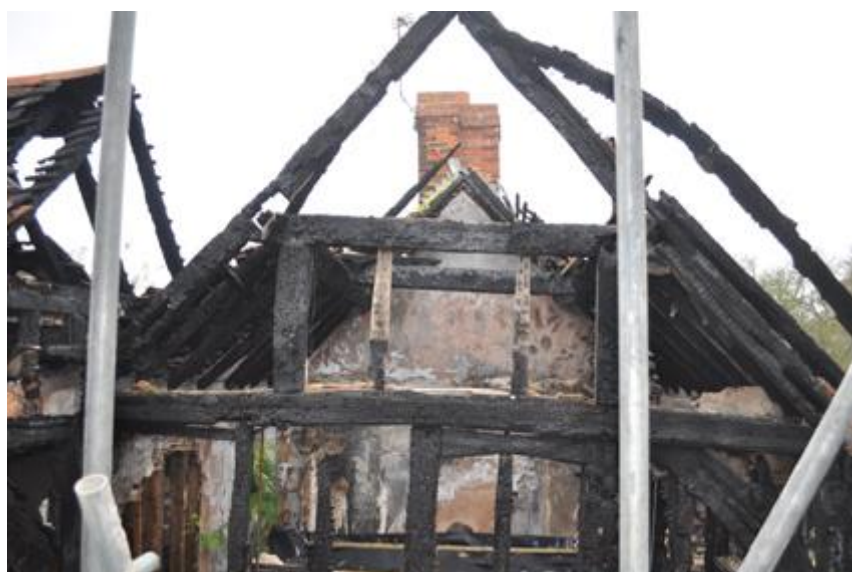
The attic area of the room above room G5 had a stone south wall, and timber framing in the north wall. The central truss looks like a queen post truss with collar beam and tie-beam (plate 58). There are two smaller struts internally to the queen posts. In the south part of the structure there is a truss simply with a collar beam and tie-beam. There are no indications that survive of there being an earlier hipped roof.

Plate 58: Central truss
