JOHN MOORE HERITAGE SERVICES

HISTORIC BUILDING RECORD

BLOCK 6, LAMBOURN BUSINESS PARK,

NOVEMBER 2020

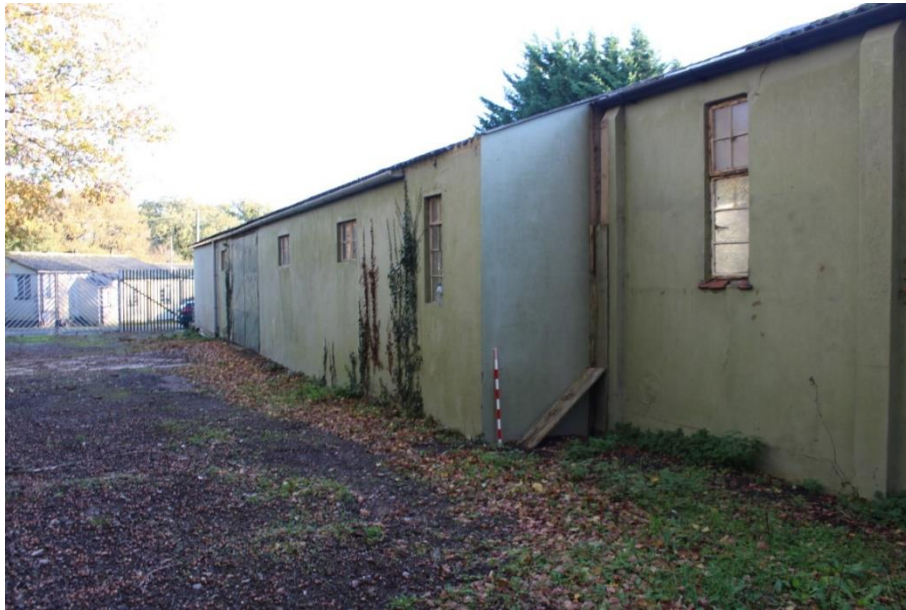
Building C makes up the eastern end of the north east elevation (Plate 1). A metal framed window is set into the elevation to the west of a metal double door that extends

the full height of the wall. To the east are a further three metal windows. A slight gap is present between buildings C and B. The north eastern elevation of building B is divided into five panels by five brick buttresses (Plate 1, Plate 2). Located centrally in the first, second and fifth panels are metal windows; the third panel contains a metal door, positioned off centre, while the fourth panel contains a metal roller door. The north eastern elevation of building A is of similar construction (Plate 3); the elevation is divided into nine panels by ten brick buttresses. Between each panel, except the most westerly, is a metal window positioned just below the eaves.

Plate 1: North east elevation, buildings B and C. Looking south.

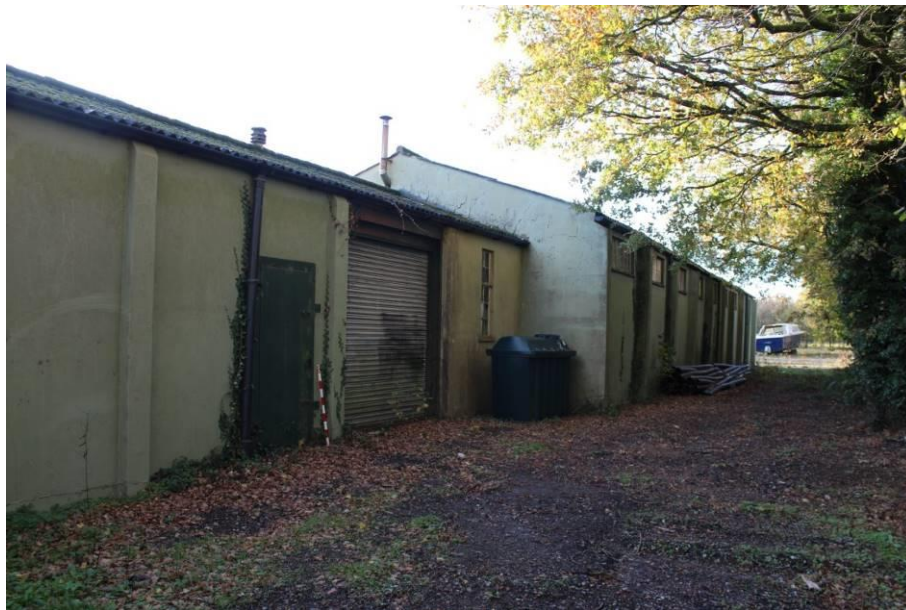
Plate 2: North east elevation, buildings A and B. Looking west.

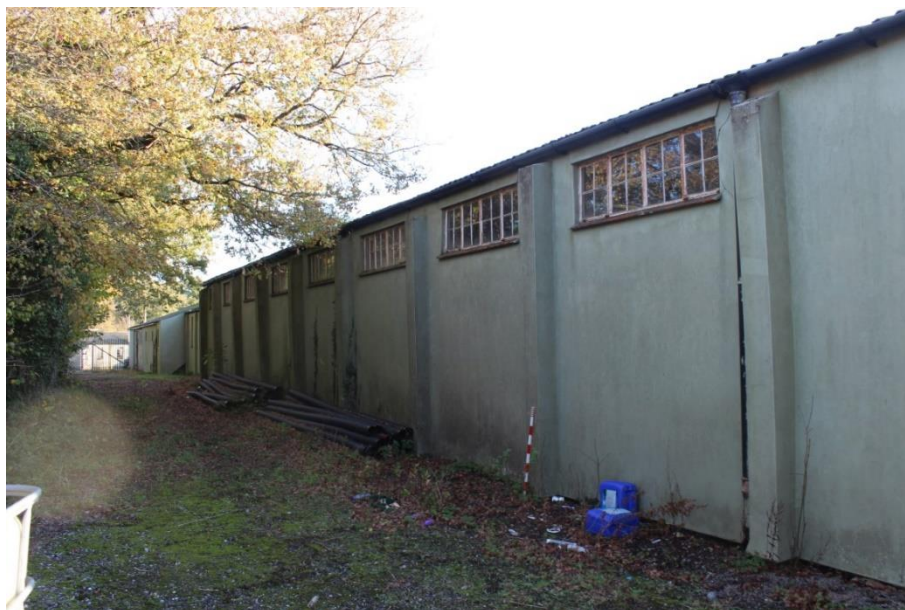
Plate 3: North east elevation, building A. Looking south east.

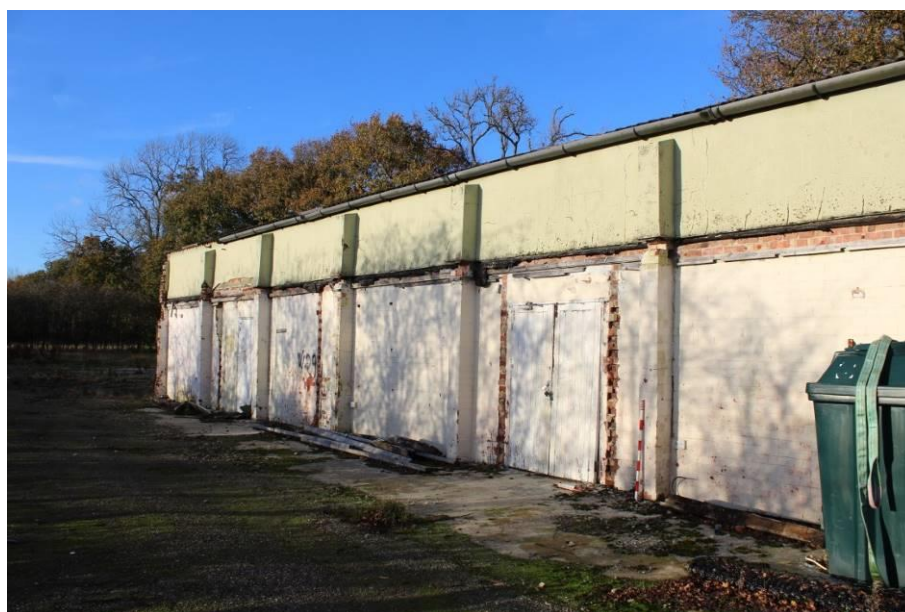
Building A forms the northern end of the south west elevation (Plate 4). The elevation is similarly divided into nine panels by ten brick buttresses. A doorway is present in the second panel, located slightly off centre; a double doorway is located in the fifth panel, while a modern window has been inserted into the eighth panel. There is evidence that a lean-to structure was formerly located against the elevation: wall scars are present in five places along the elevation; each buttress is notched at the same height, consistent with the removal of a roof structure; above this point the wall is rendered in concrete while below it is painted brick.

Plate 4: South west elevation, building A. Looking north

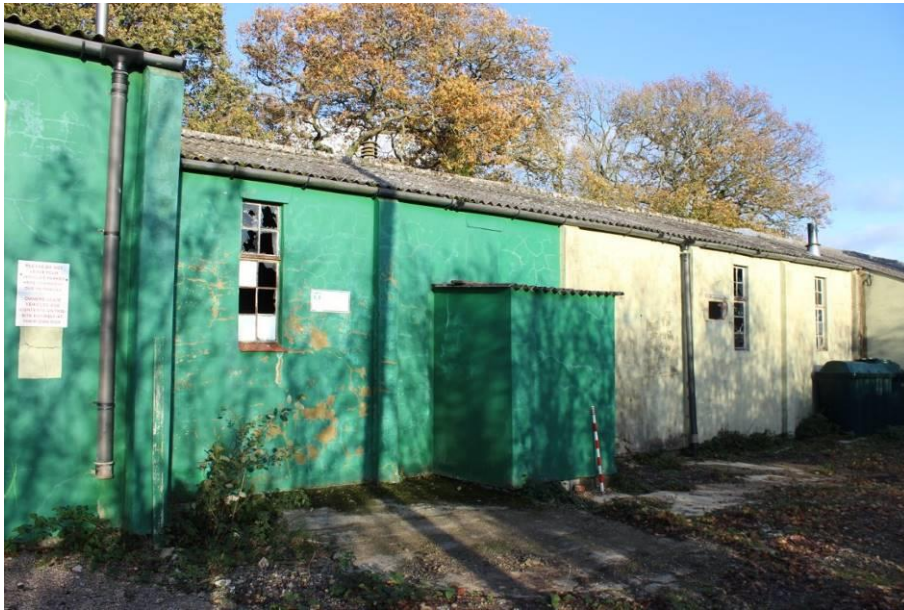
Building B is also divided into five panels by five brick buttresses (Plate 5). Metal windows are located centrally within the first, fourth and fifth panels; a small brick built

Plate 5: South west elevation, building B. Looking east.

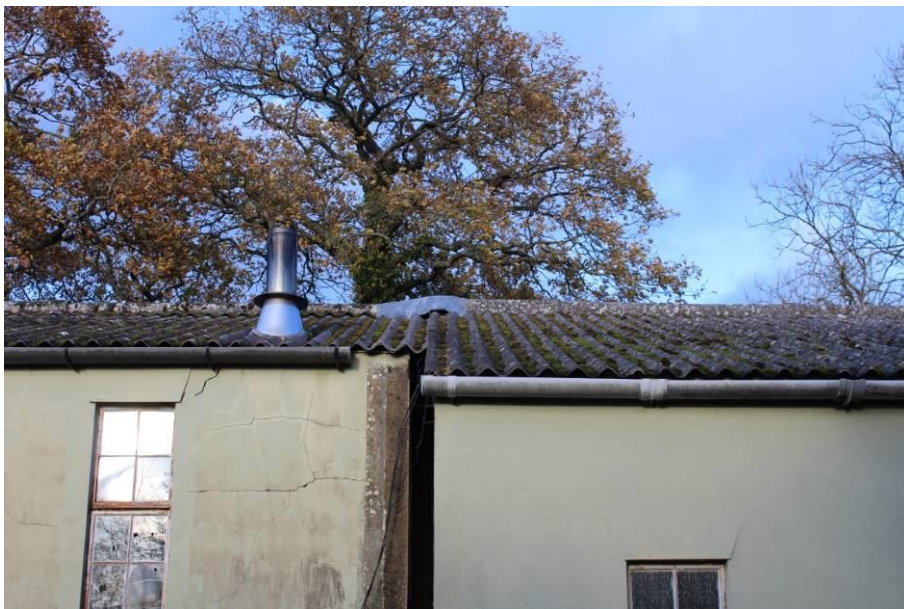
porch with a corrugated asbestos sheet roof extends from the second panel. A small gap is present between buildings B and C (Plate 6); the south western elevation of building C contains four metal windows (Plate 7); three are arranged at a regular height and interval while the northern most is situated at a lower height. A modern window is present at the southern end of the elevation and three doorways, each containing a metal door, are located at semi-regular intervals along the elevation. Wall scars are also evident here, indicating that a lean-to structure formerly encompassed the central door and window.

Plate 6: South west elevation, showing gap between buildings B and C. Looking north east

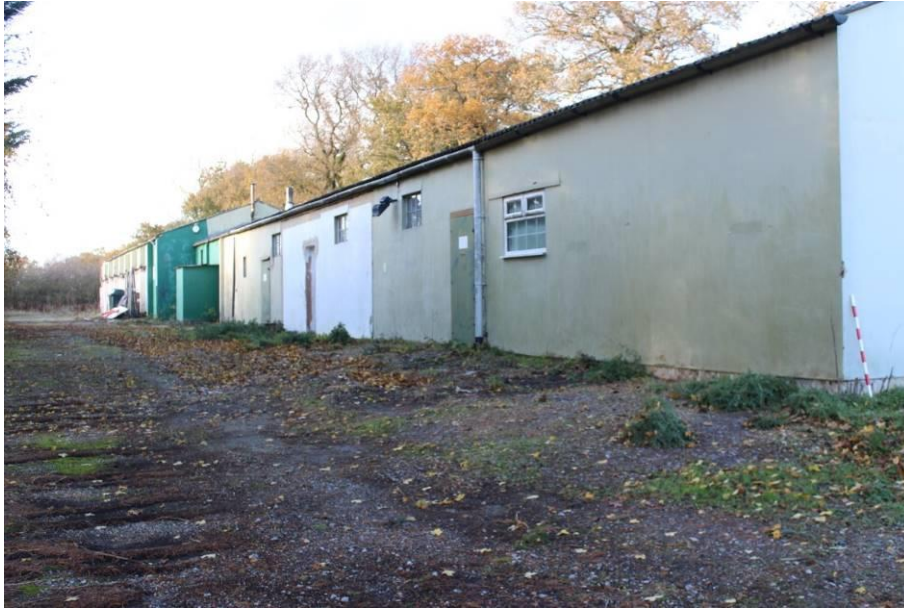
Plate 7: South west elevation, building C. Looking north.

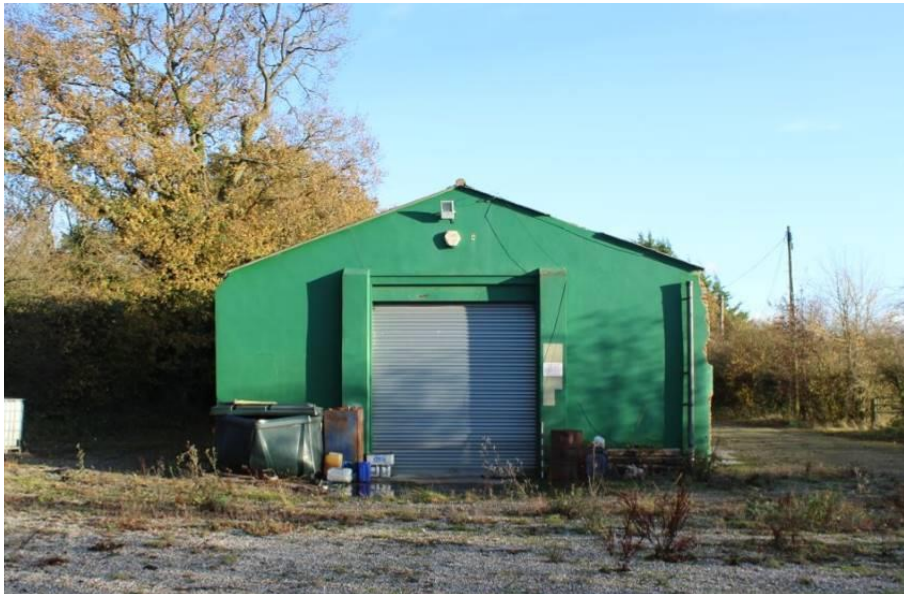
The north west elevation is the northern gable end of building A (Plate 8). The elevation comprises a metal roller door flanked by two buttresses that extends to the level of the eaves.

Plate 8: North west elevation, building A. Looking south east

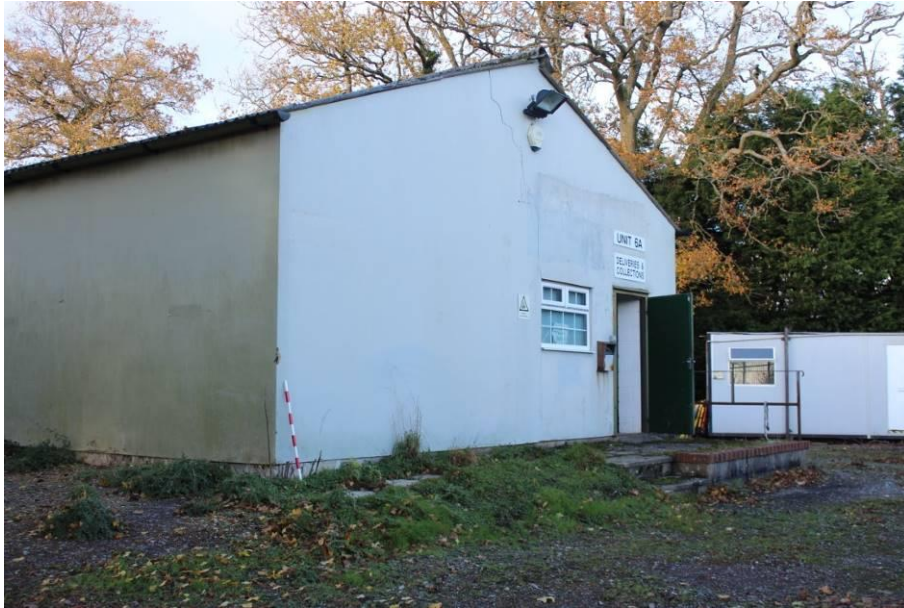
The south east elevation is the southern gable end of building C (Plate 9), and contains the main entrance. The elevation is accessed by way of a set of modern concrete and brick steps and contains a metal doorway and modern PVC window, positioned to the right of centre.

Plate 9: South east elevation, building C. Looking north.

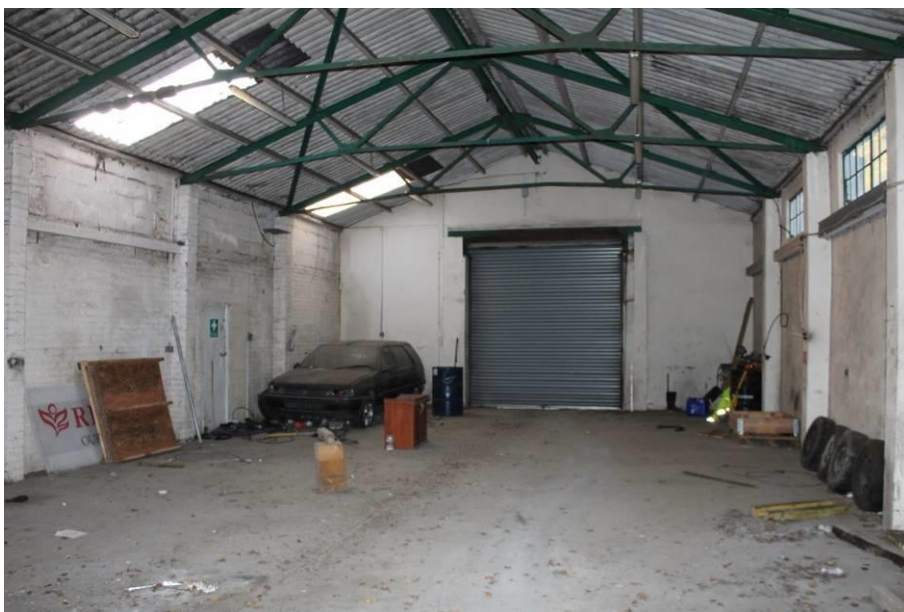
Room A1 is accessed from the north-west through a modern metal roller door (Plate 10). The room is open to the roof and eight roof trusses are visible; the corrugated asbestos roof is supported on wooden purlins and a RSJ runs the length of the room just below the apex of the roof. Each truss rests upon a brick buttress and a series of tube lights are suspended from the purlins. The floor is concrete and contains two modern automotive inspection pits. With the exception of the most northerly panel, each panel of the north eastern wall contains an original metal window, located centrally just below the roof; these comprise two top hung casements of two panes over two positioned either side of two fixed light windows, also of two panes over two.

Plate 10: Building A, northern end. Looking north west.

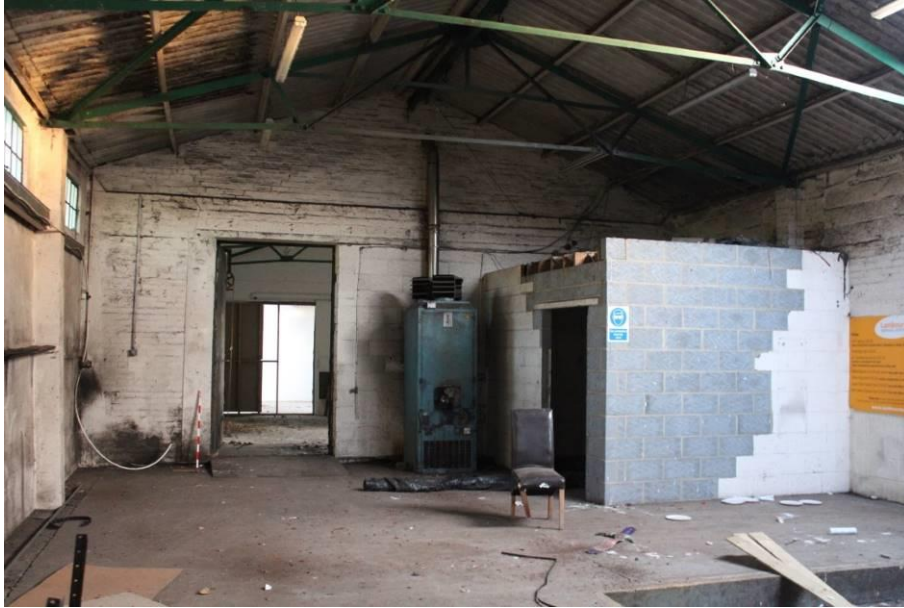
Plate 11: Building A, southern end. Looking south east

The south western wall is brick (Plate 11); an entrance on the northern side leads to building B. This entrance has been partially blocked with concrete blocks. The south western wall contains eight blocked windows, mirroring the position of those on the north eastern wall (Plate 12). A blocked doorway is also present in the most southerly panel but one. Two doorways, each containing a modern wooden door, are present in the second and fifth wall panels consecutively. A modern concrete block partition is located in the south east corner of the room.

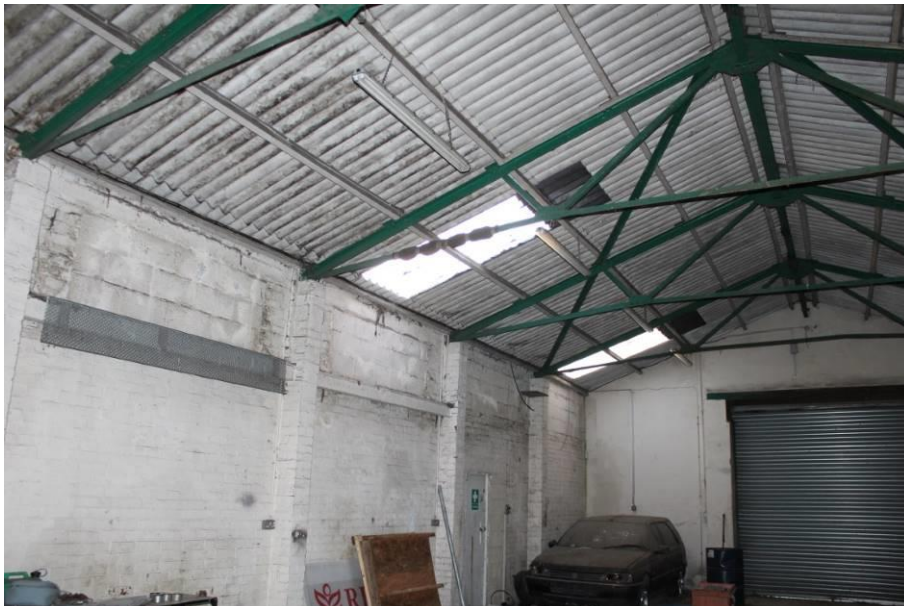
Plate 12: Building A, showing blocked windows and RSJ in roof structure. Looking west

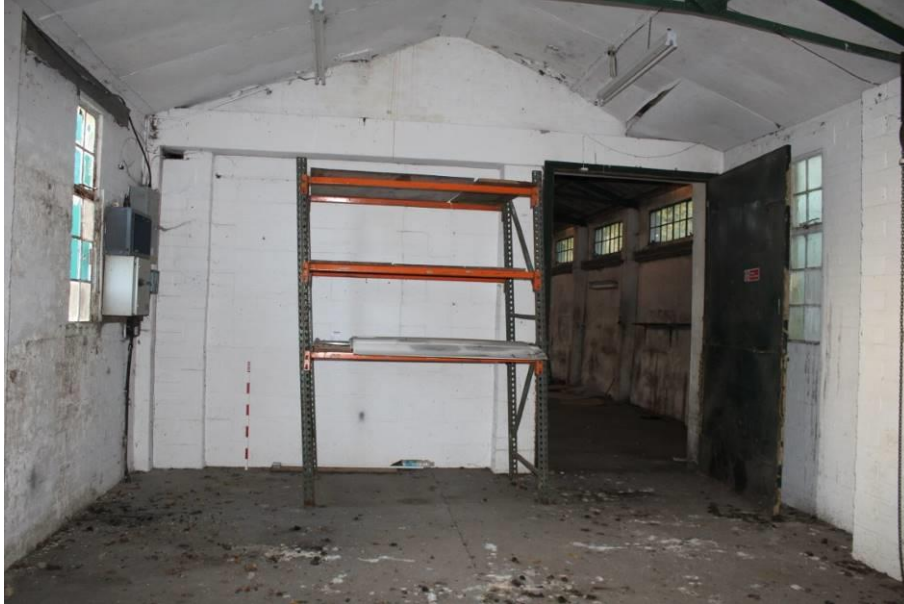
Room B1 of Building B is accessed from the north-west through an open doorway, formed from concrete blocks that have been used to narrow an earlier entrance (Plate 13). The room is open to the roof and two steel trusses are visible; the roof is clad in plasterboard or asbestos sheeting, from which tube lighting is suspended. The floor is concrete. The concrete block partition forms the north western wall.

Plate 13: Room B1, north western wall. Looking north west.

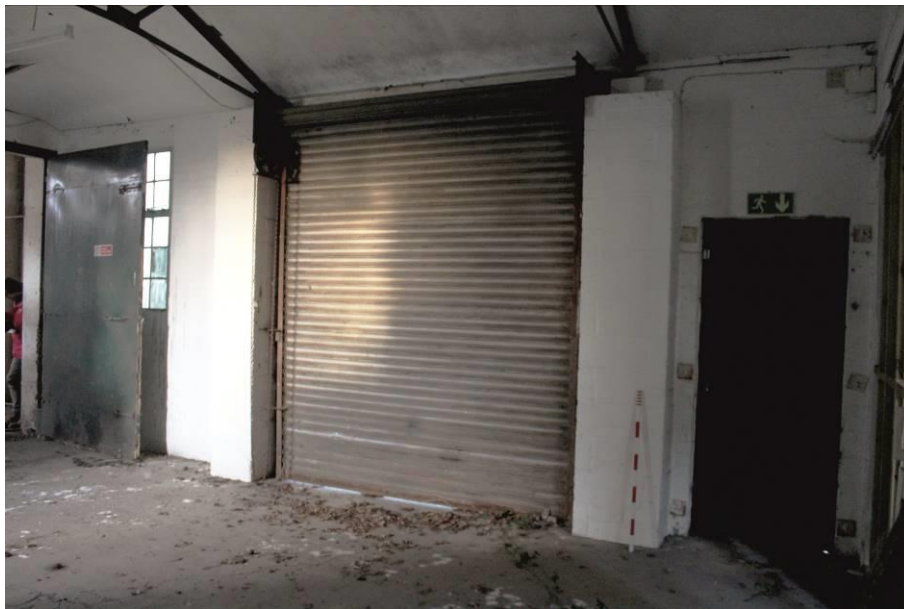
Plate 14: Room B1, north eastern wall. Looking north.

The north eastern wall comprises two and a half panels, formed by two brick buttresses. A historic metal window is situated centrally in the northern panel (Plate 14). This comprises a top hung casement of two panes over two, situated over a fixed light of two panes over three. The central panel is occupied by a hand operated roller door, flanked by two concrete block buttresses. The southern half panel contains a modern metal door.

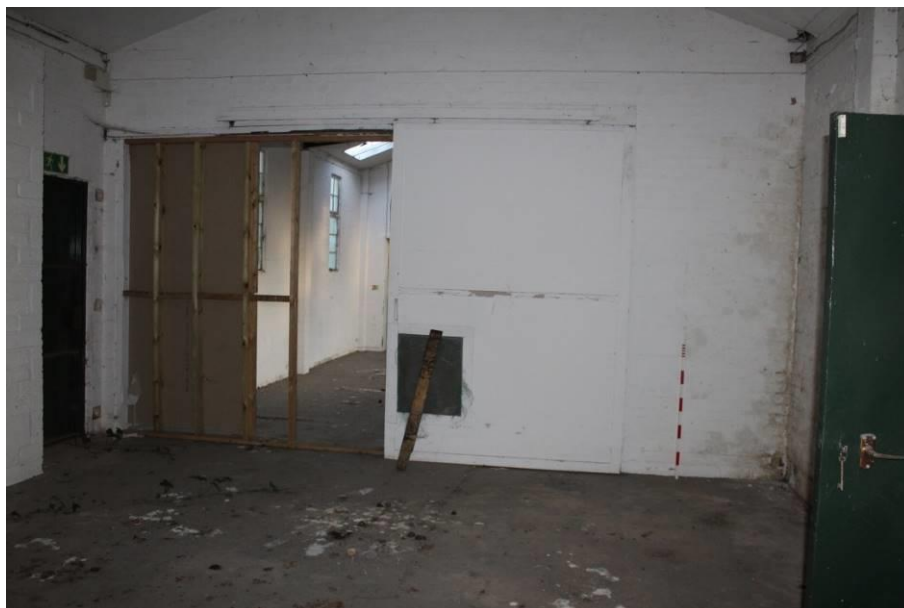
Plate 15: Room B1, south eastern wall. Looking south east.

The south eastern wall is an original brick partition between rooms B1 and room B2 (Plate 15). A later entrance, wooden partition and sliding door has been inserted into this wall. A blocked doorway is present on the southern side of the wall. The northern panel of the south west wall contains a historic metal framed window, mirroring that on the north eastern wall (Plate 16). The central panel contains a modern metal door that leads into a small former porch area, the exterior door of which is blocked with concrete blocks; a blocked window is located above the door to the porch.

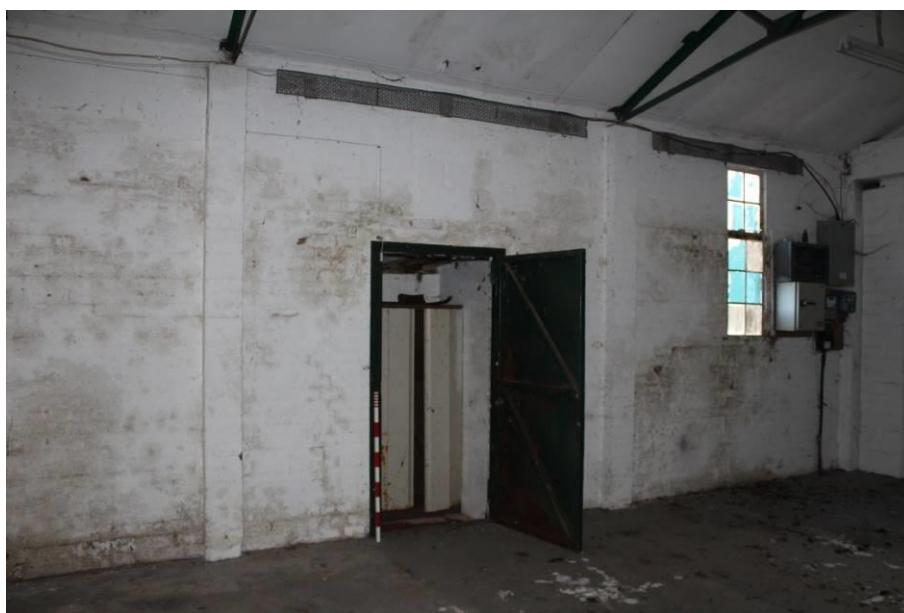
Plate 16: Room B1, south western wall showing porch and blocked window. Looking west.

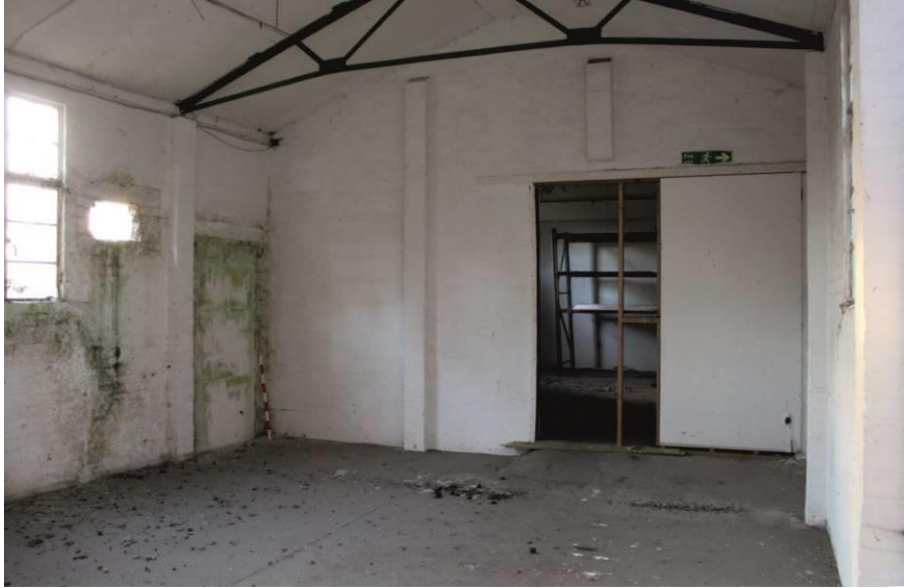
resulted in the truncation of a brick buttress, one of two positioned either side of the ridgeline (Plate 17).

Plate 17: Room B2, north western wall showing truncated buttress. Looking west.

A blocked doorway is present to the south of the extant buttress (Plate 17). The north eastern wall comprises two and a half panels, formed by two brick buttresses. Historic metal windows are located centrally within the southern two panels; both comprise two lights: a top hung casement of two panes over two, over a side hung casement of two panes over three (Plate 18). This is mirrored on the south eastern wall, though a blocked doorway is also located in the northern panel. The south eastern wall contains an entrance to room C1 of Building C, located off-centre on the northern side of the wall. A blocked window is located centrally, just below the eave height.

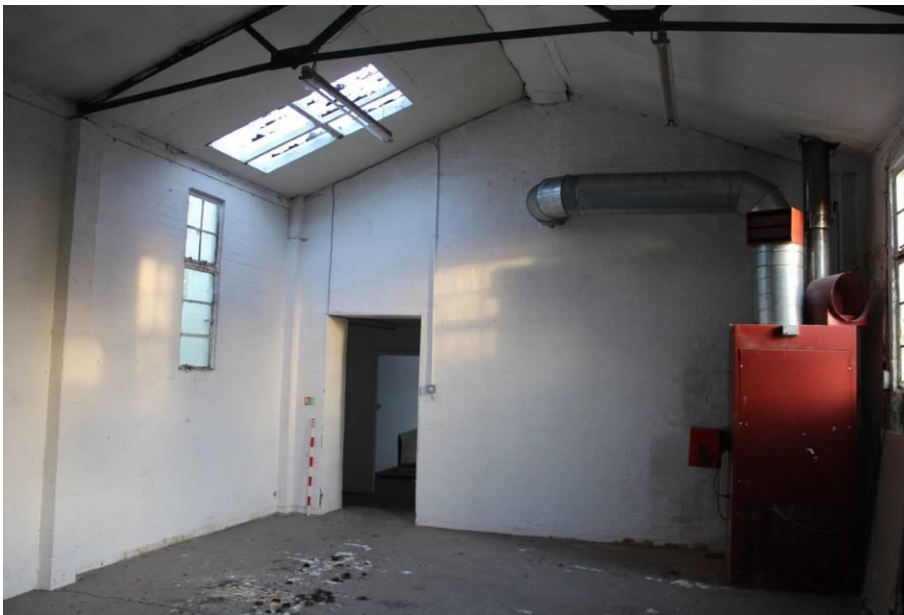
Plate 18: Room B2, north eastern and south western wall. Looking east.

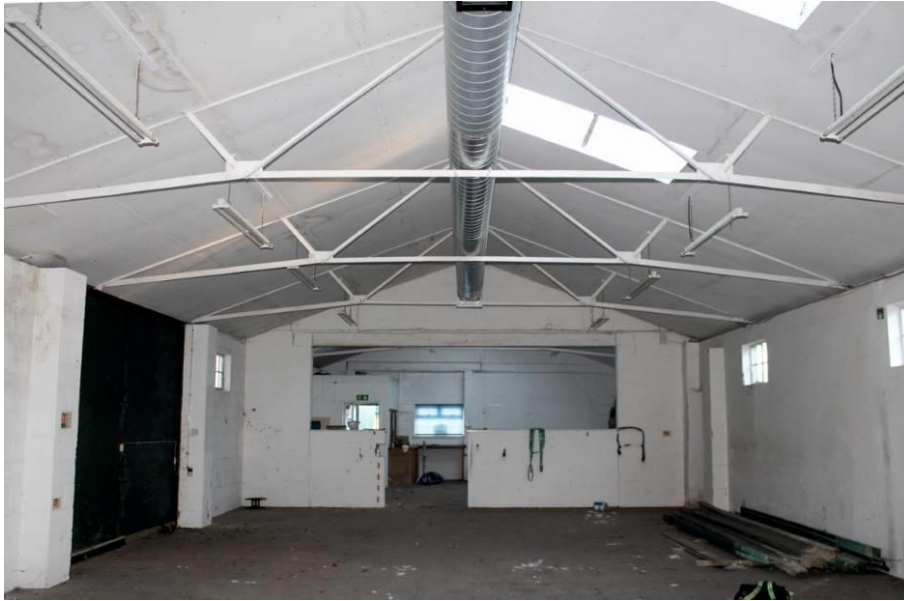
Room C1 is accessed from the north west through a half-height opening in Room B2. Access is down a modern concrete ramp into a small ante-room created by an internal partition that also contains rooms C2 to C4. Room C1 is open to the roof and six steel trusses are visible; the roof is clad in asbestos or plasterboard sheeting and three skylights are present on the south western side (Plate 19). A series of tube lights are suspended from the ceiling.

Plate 19: Building C, room C1 showing roof structure and partition. Looking south east.

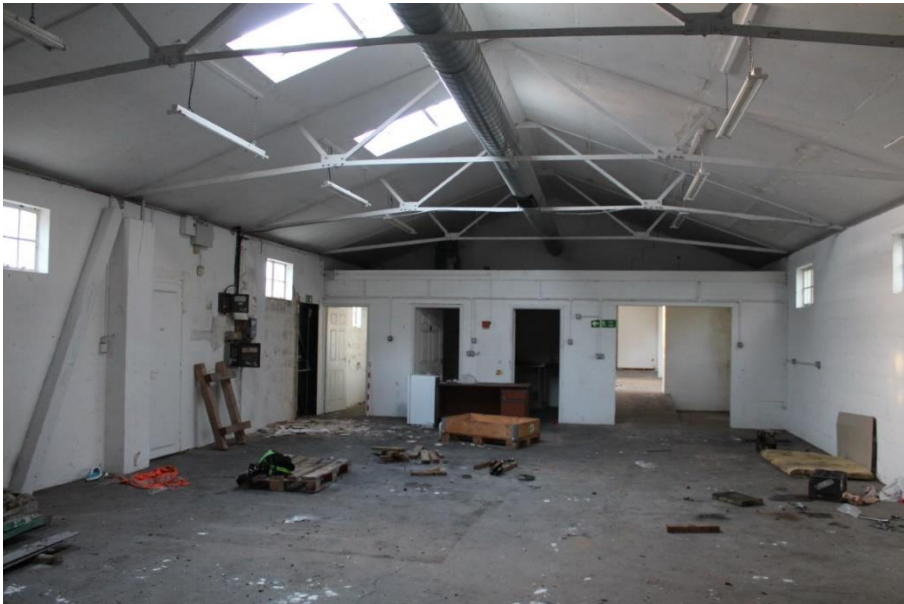
Plate 20: Building C, room C1 showing partitions C2 to C4. Looking north west.

which are rooms C2, C3 and C4; these are two toilets and a kitchen respectively (Plate 20).

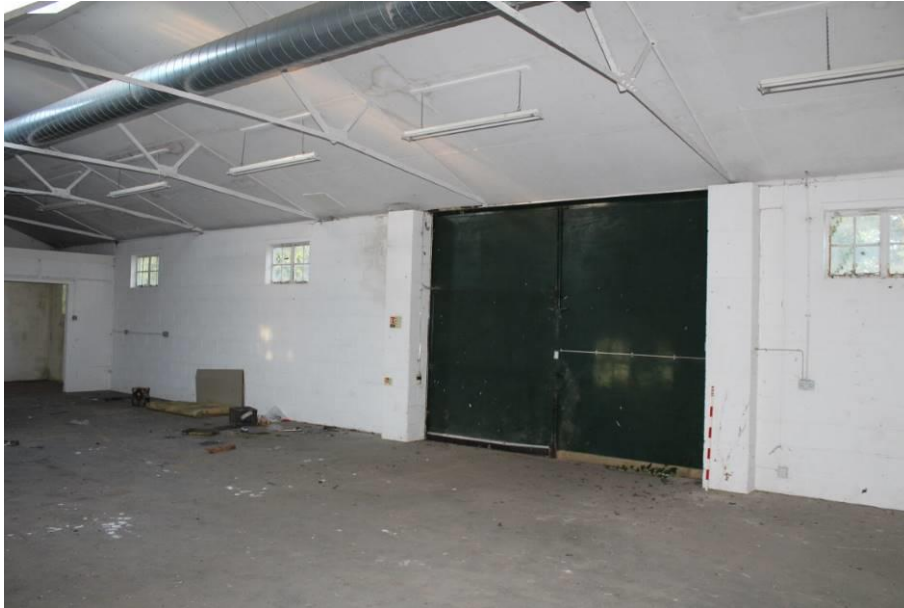
Three metal windows are situated on the north eastern wall (Plate 21): the northern most is a fixed single light window of two panes over four; to the south east are two double light windows, both a side hung casement of two panes over two. A further double casement is located to the south east of a metal double door that is flanked by two concrete block buttresses. A partition that forms room C5 is located at the southern end of the wall.

Plate 21: Building C, north eastern wall. Looking north.

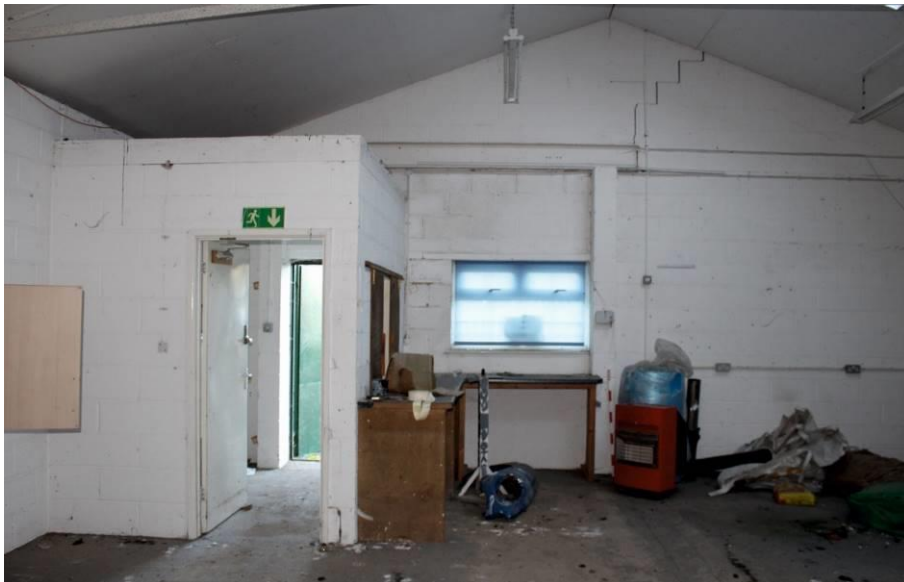
Plate 22: Building C, room C1 showing partition C5 and blocked entrance. Looking south east.

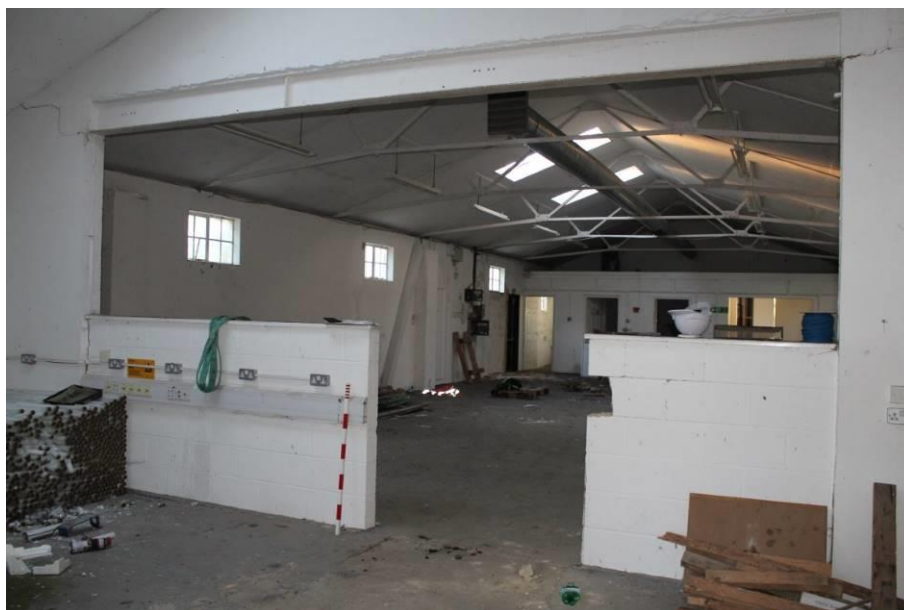
Plate 23: Building C, room C1 showing south western wall and internal partition.
Looking west.

Three metal doors are located at regular intervals along the south western wall of the room (Plate 23); interspersed between these are four windows, three of which are historic metal casements in the same configuration as those on the north eastern wall. The most southerly window is a modern PVC unit. The northern end of the south eastern wall, the gable end of the building, is the partition that forms room C5; to the south of this is a modern PVC window. A RSJ is located above the partition and window, supported by a concrete block buttress. This suggests that the window and partition are situated within a larger blocked entrance.
