HISTORIC BUILDING RECORD

BLOCK 8, LAMBOURN BUSINESS PARK,

LAMBOURN WOODLANDS, HUNGERFORD RG17 7RU

NOVEMBER 2020

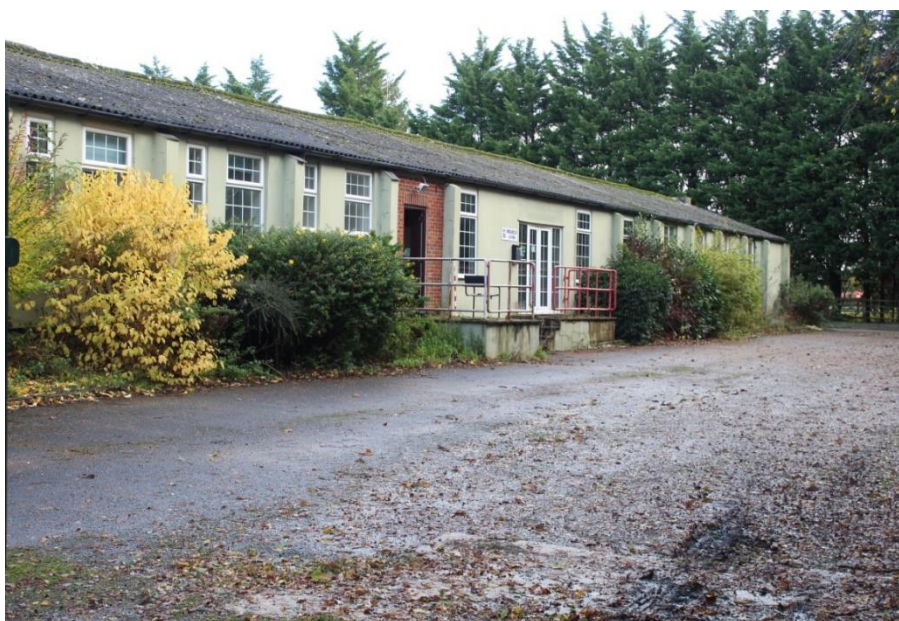
Elevation AA comprises the southern elevation of the southern building (Plate 1). The southern elevation contains 16 modern PVC windows, set centrally within the panels between the buttresses which are located at regular intervals along the elevation. Two entrances into the building are located centrally within the elevation, both accessed through a set of modern stairs constructed from concrete blocks and enclosed by metal railings. The western entrance, leading to room A1, is a PVC door set into a modern brick panel that spans the gap between two buttresses, while the eastern entrance, leading to room B2, is a set of PVC French doors.

Plate 1: Elevation AA, looking north east

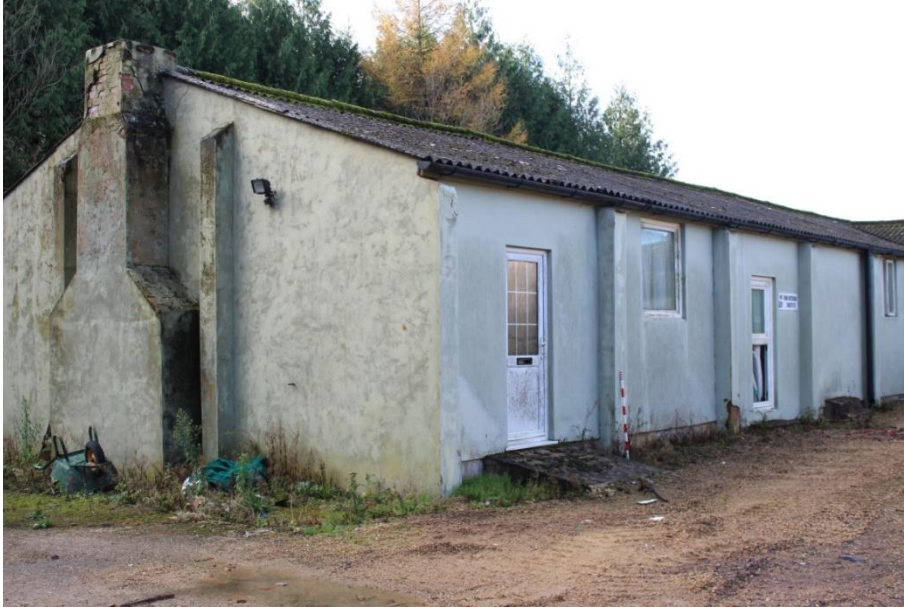
Plate 2: Eastern end of elevation BB and southern end of elevation EE, looking south east.

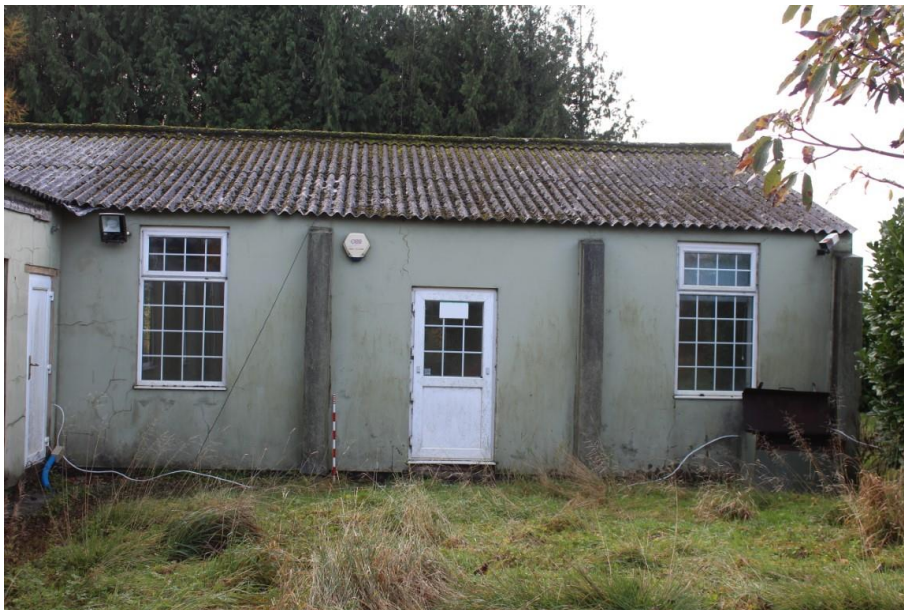
Plate 3: Western end of elevation BB, looking south.

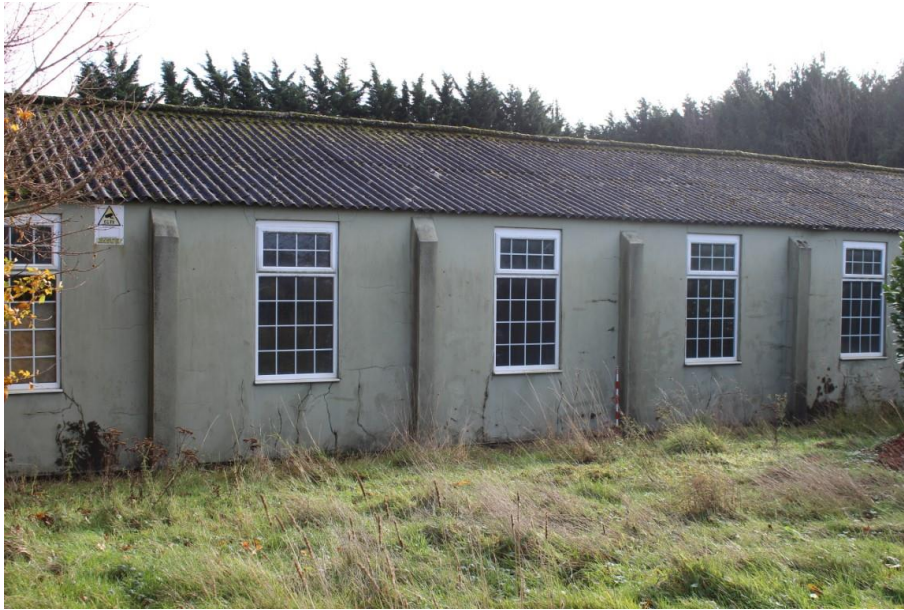
Elevation CC comprises the western elevation of the western building and the western gable end of the southern building (Plate 4). The most northerly panel is blank, while panels two to nine each contain a PVC window; the tenth panel contains two PVC doors, leading to room H1. The western gable end of the southern building contains two PVC windows and two buttresses.

Plate 4: Elevation CC, looking south east.

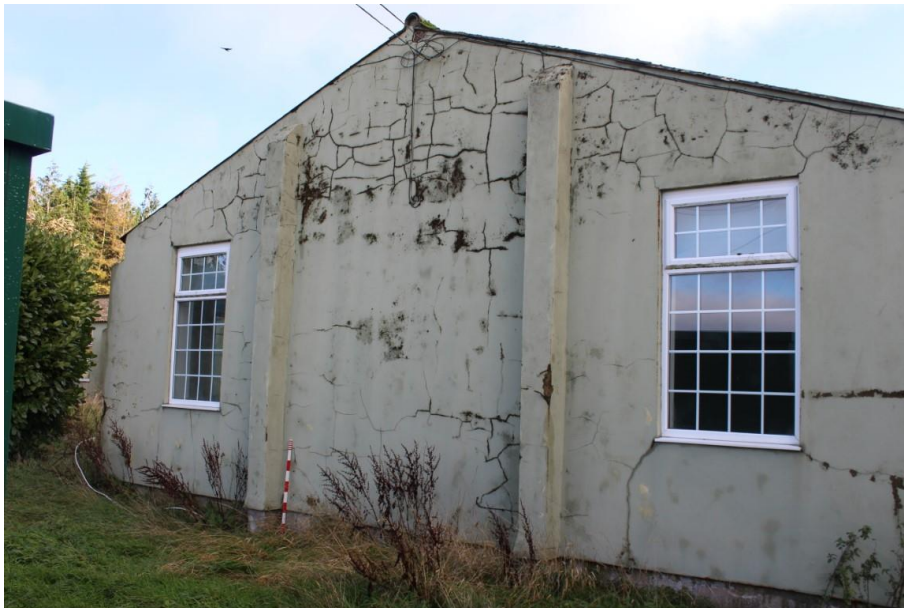
Plate 5: Southern gable end, elevation EE. Looking north east.

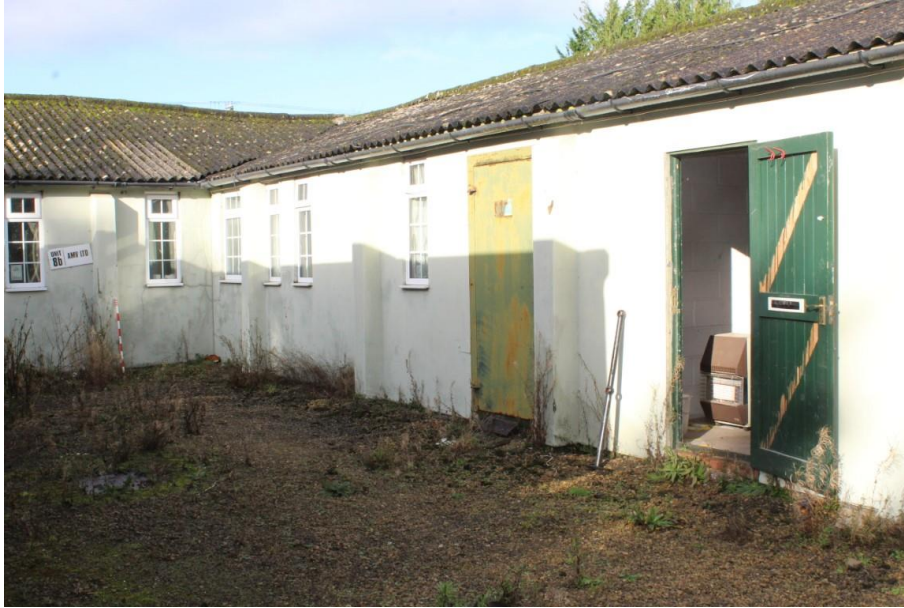
Plate 6: Western end of elevation DD, looking north west.

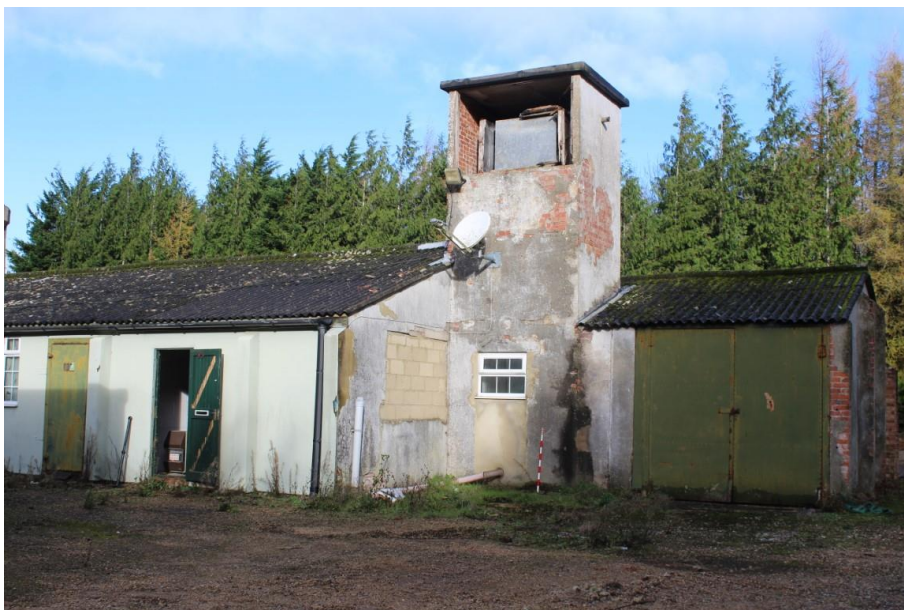
Plate 7: Eastern end of elevation DD, looking north-north west.

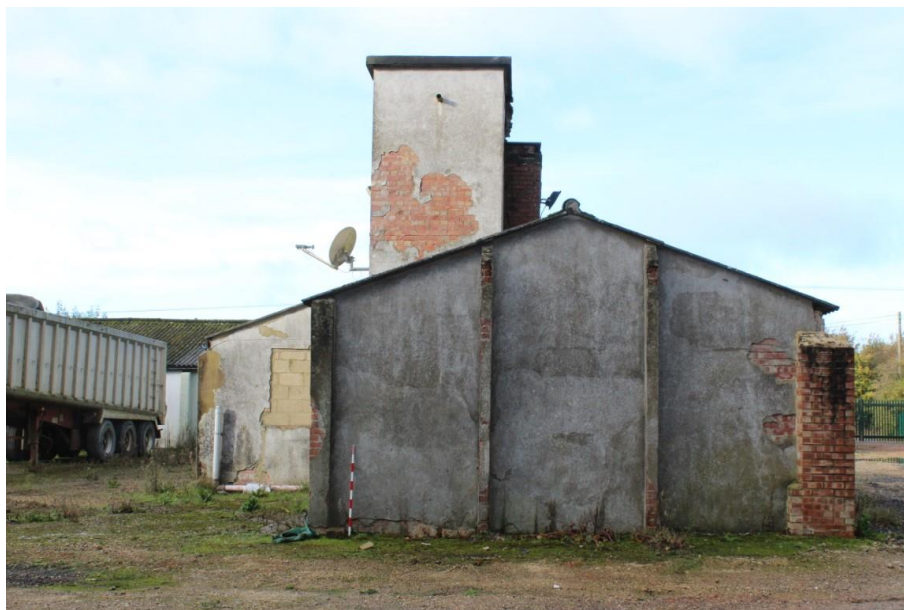
Plate 8: Northern side of elevation EE, looking west.

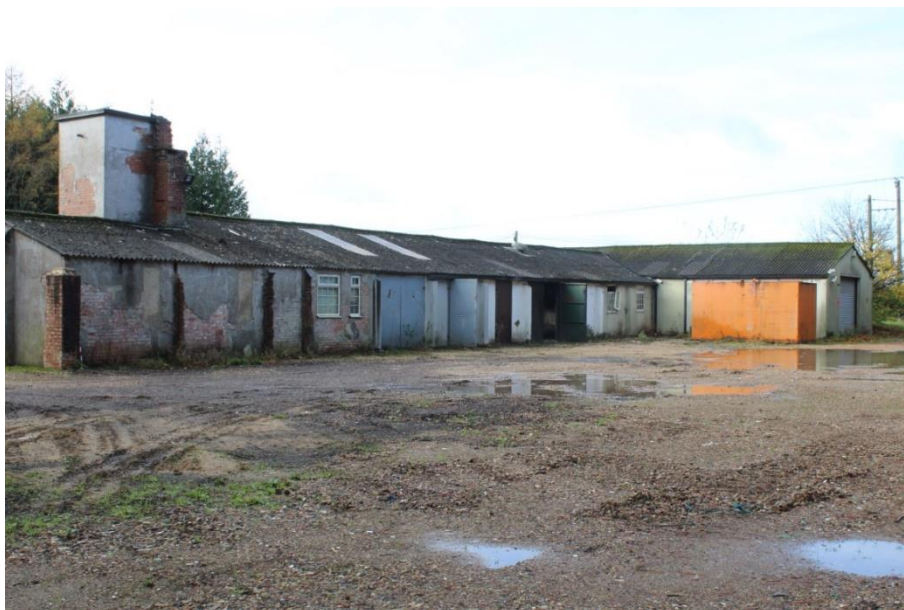
Plate 9: North elevation FF and east elevation EE, looking south west.

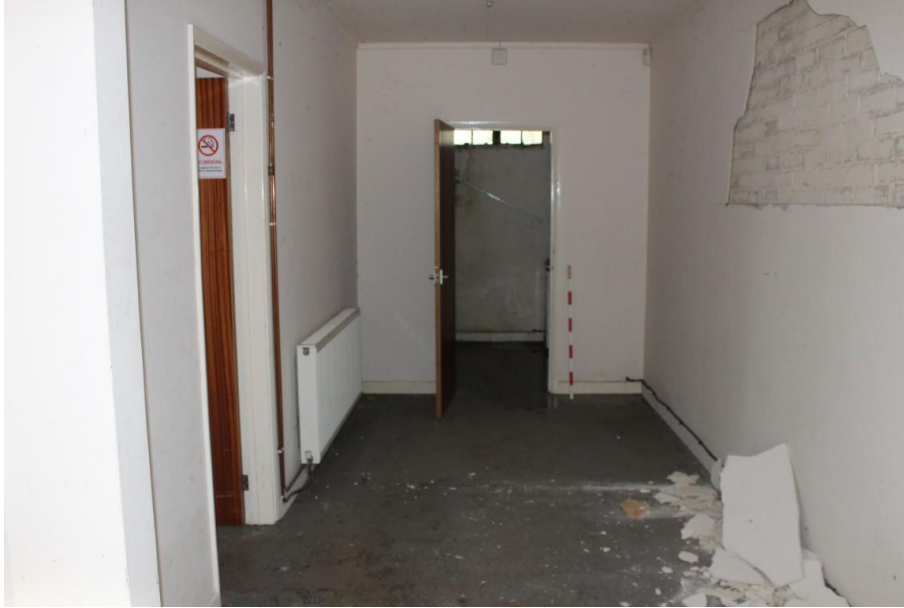
Plate 10: Room A1; showing partitions. Looking north.

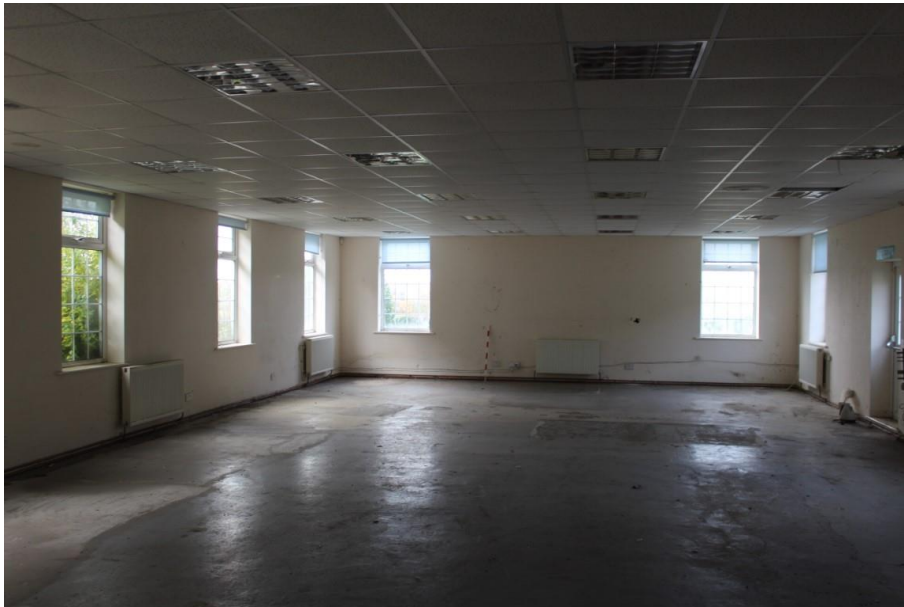
Plate 11: Room A7, looking west.

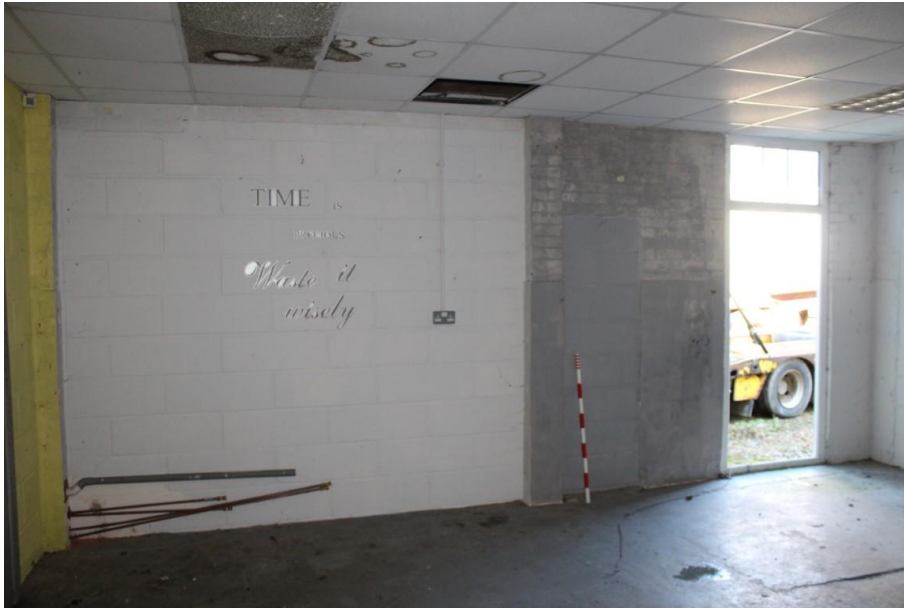
Plate 12: Room B1, northern wall; showing blocked entrances. Looking north

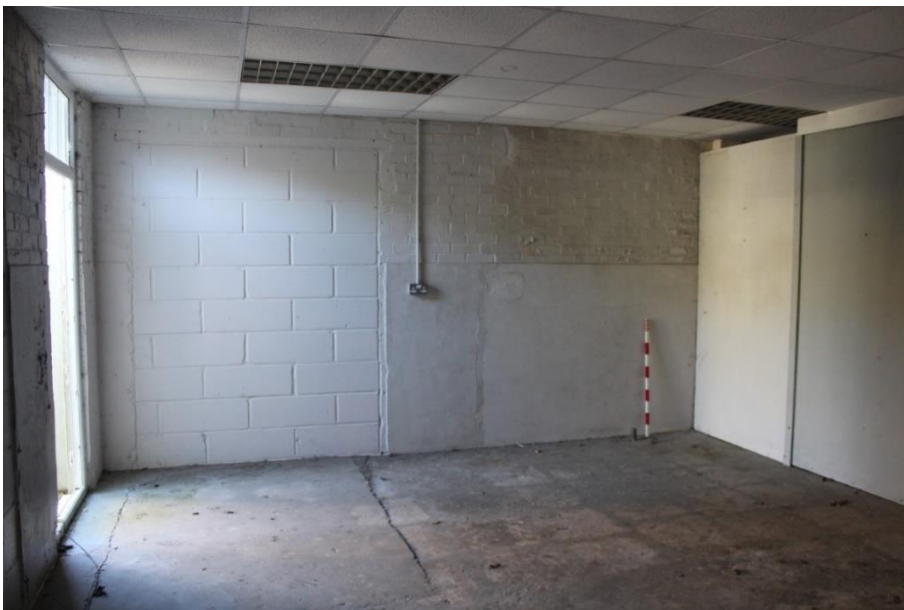
Plate 13: Room B1, eastern wall showing blocked internal doorway. Looking east.

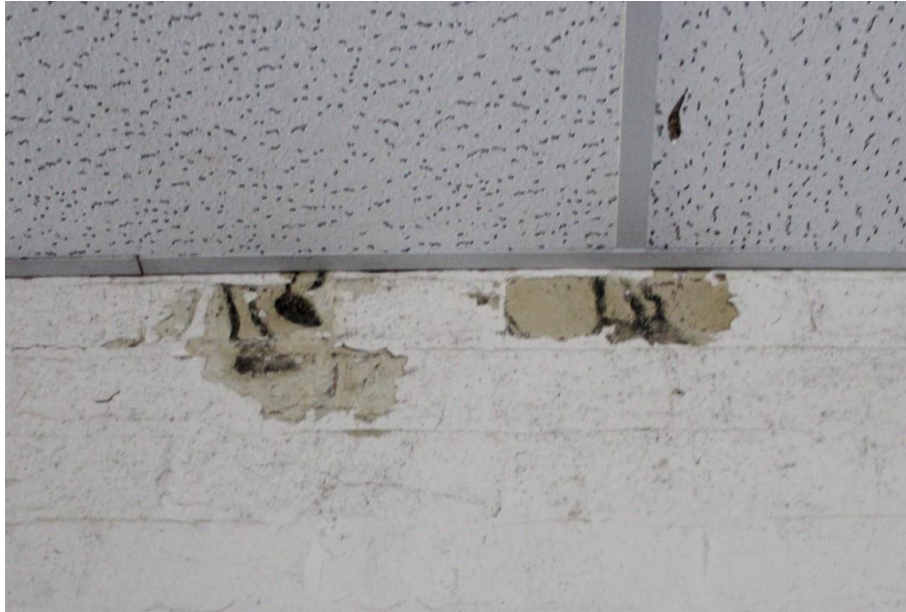
Plate 14: Room B1, eastern wall; showing small patch of surviving graffiti. Looking east.

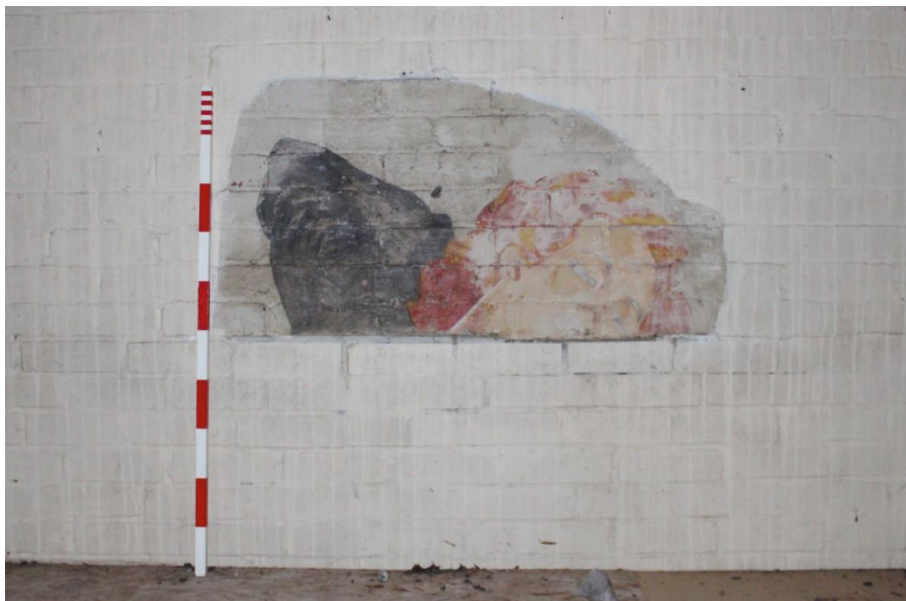
Plate 15: Room C1, eastern wall; showing mural. Looking east

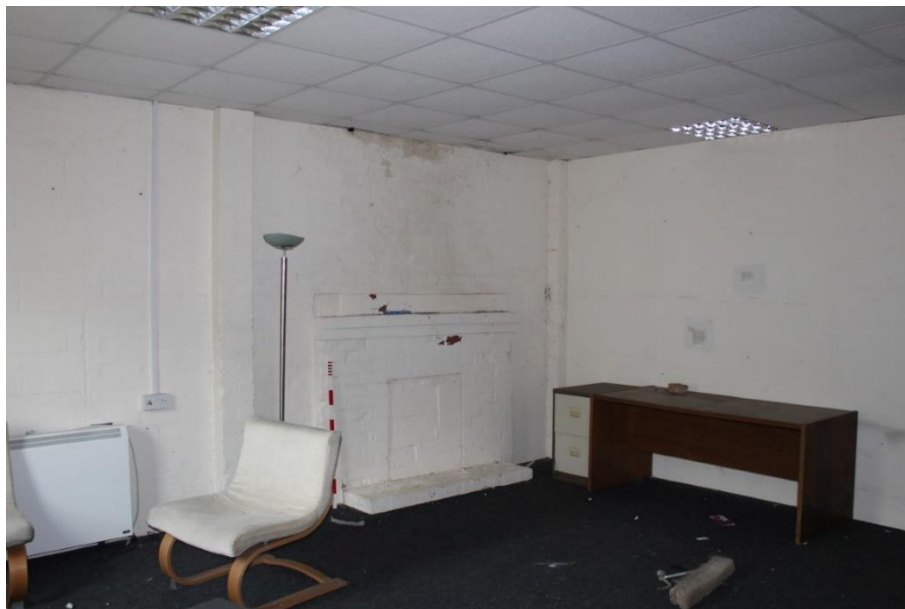
Plate 16: Room C2, eastern wall; showing fireplace. Looking east.

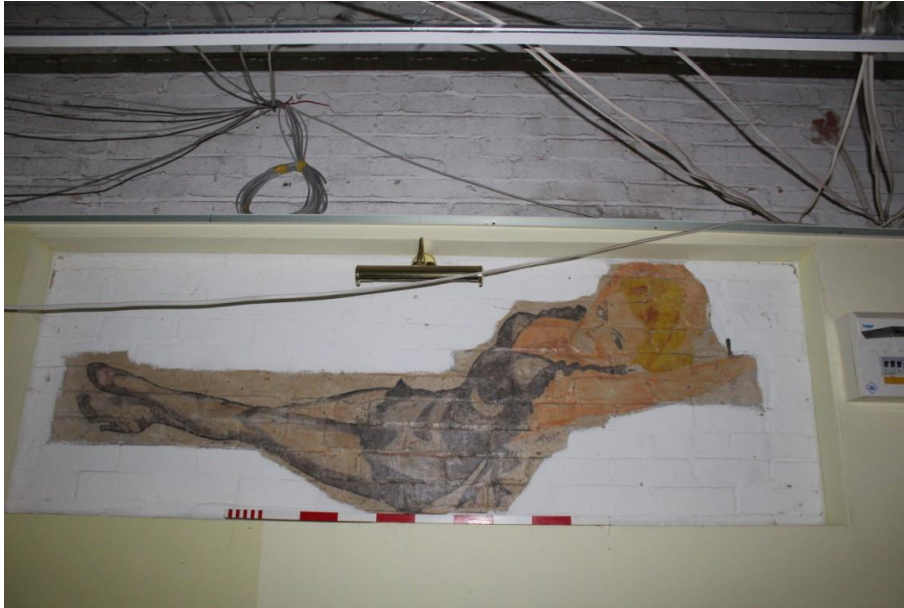
Plate 17: Room C6, western wall; showing extant mural. Looking west.

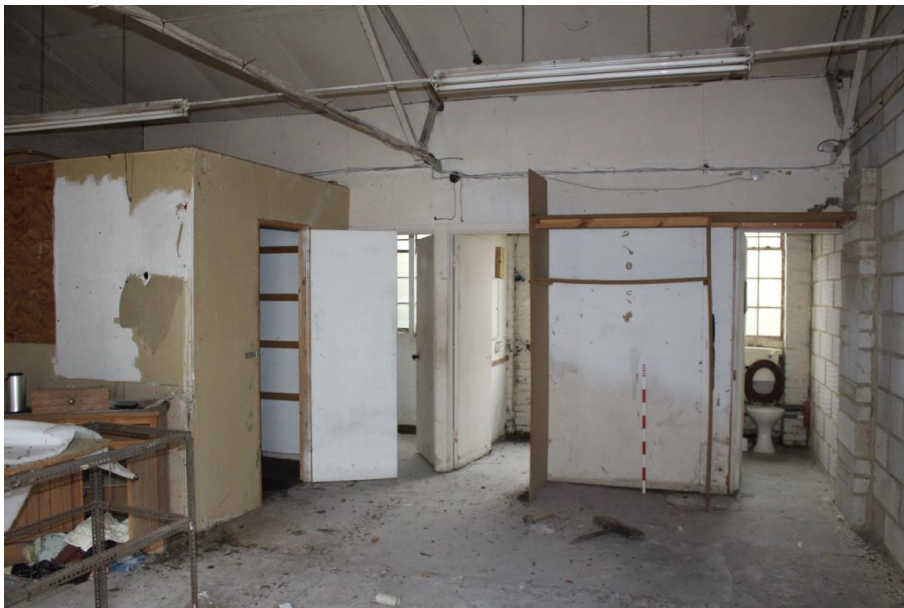
Plate 18: Room D1, partitions D2 to D4. Looking west.

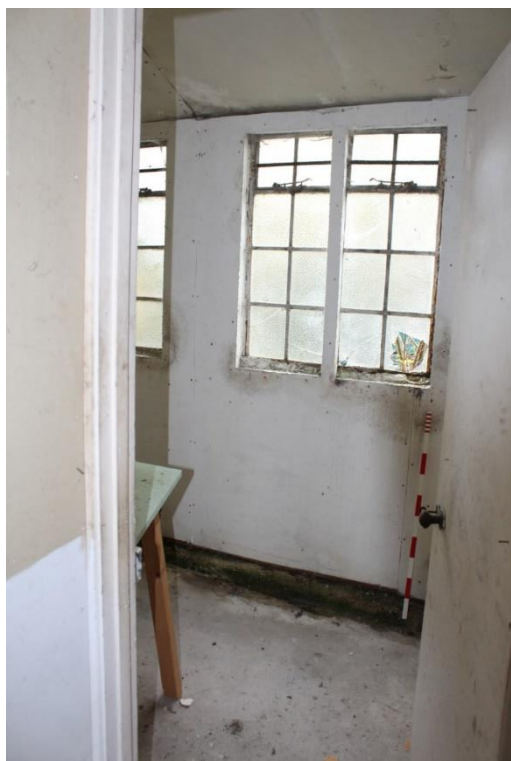
Plate 19: Historic window in room D4; Looking west.

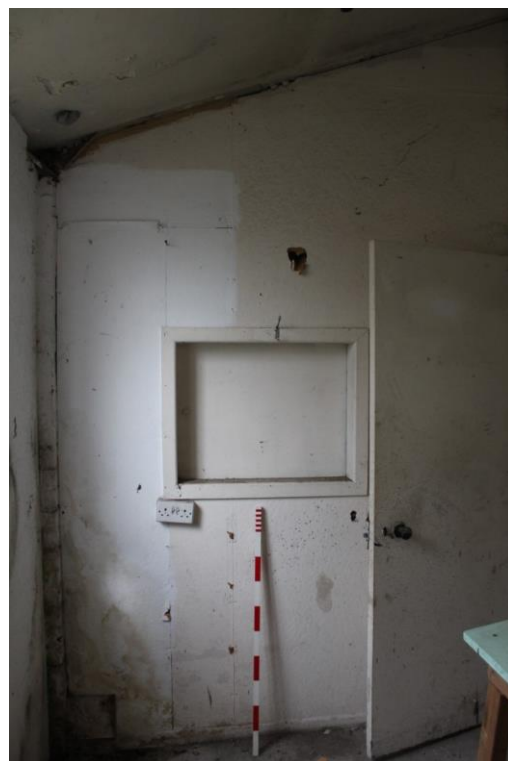
Plate 20: Hatch in room D4; looking north.

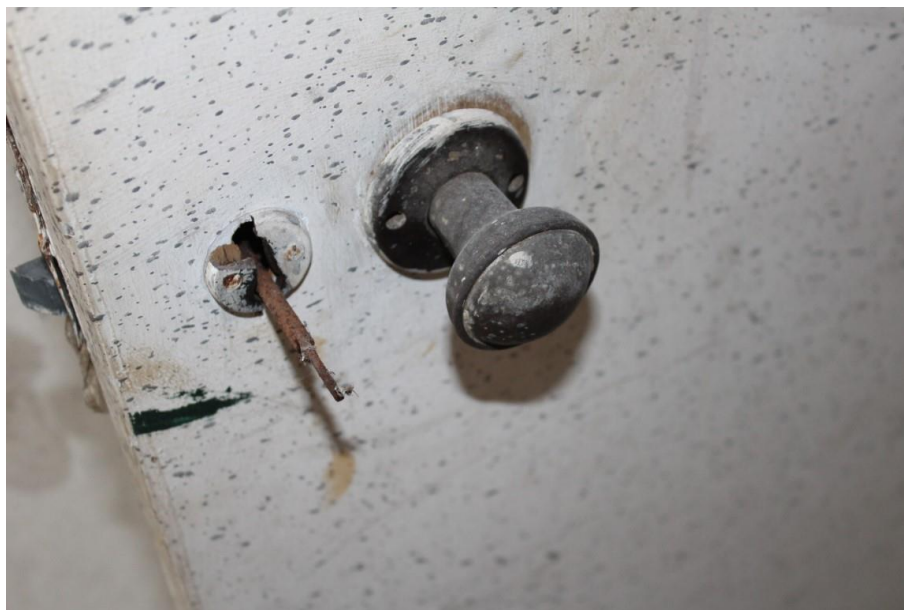
Plate 21: Bakelite handle and lock escutcheon in door to room D4

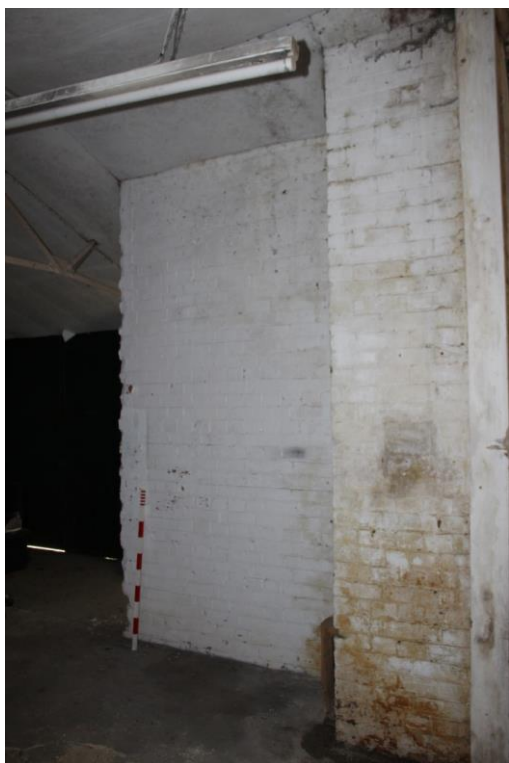
Plate 22: Room E; water tower structure.
Looking south east.

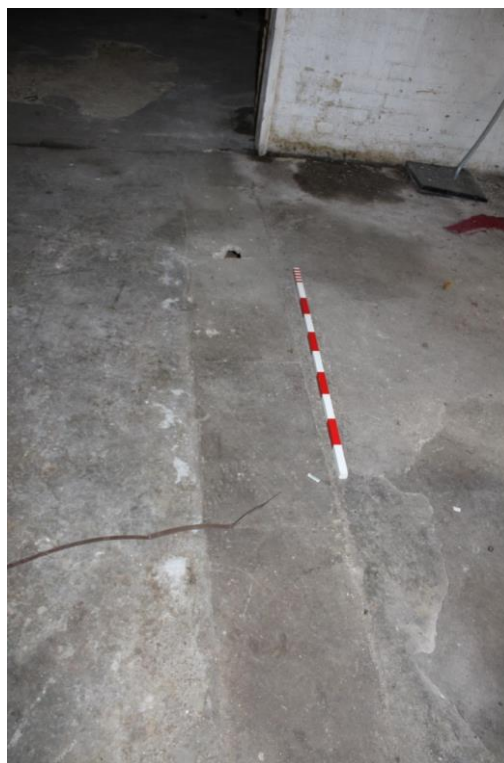
Plate 23: Room E; water pipe trench.
Looking east.

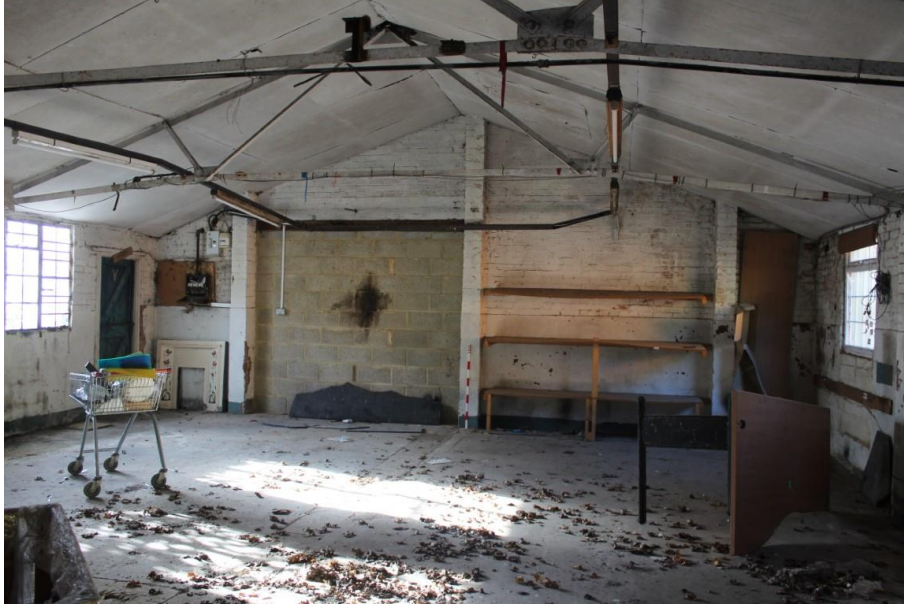
Plate 24: Room G1; west wall and roof structure. Looking west

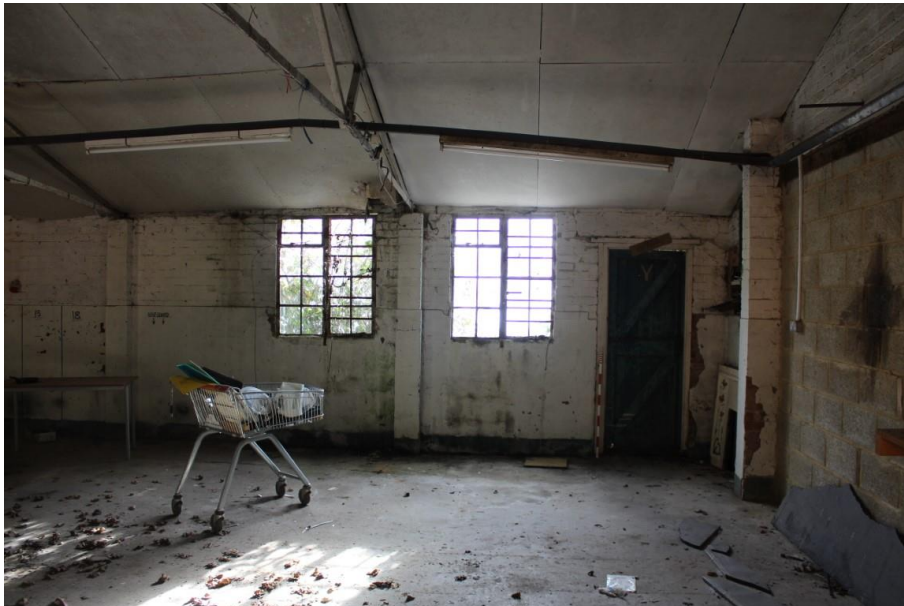
Plate 25: Room G1; southern wall with historic door and windows. Looking south

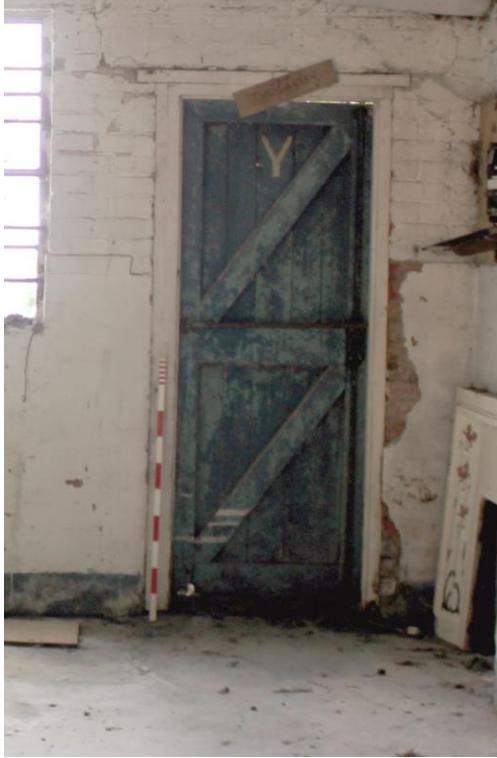
Plate 26: Room G1; northern wall with historic door. Looking north

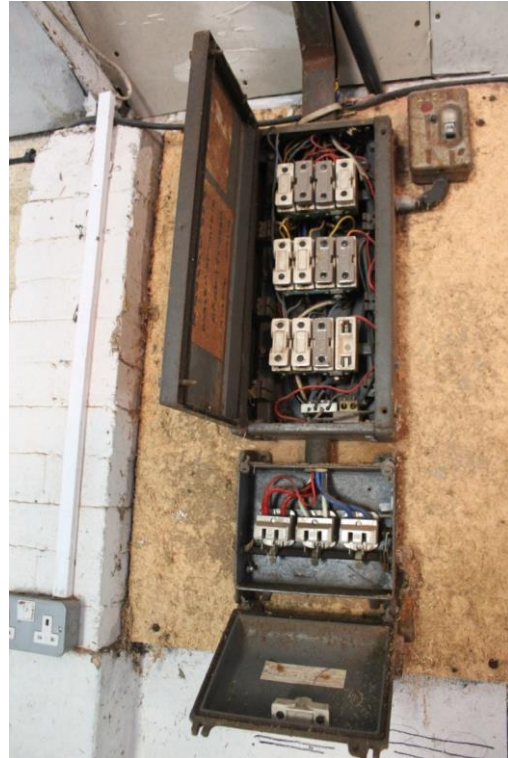
Plate 27: Room G1; northern wall with historic fuse box and switches. Looking north

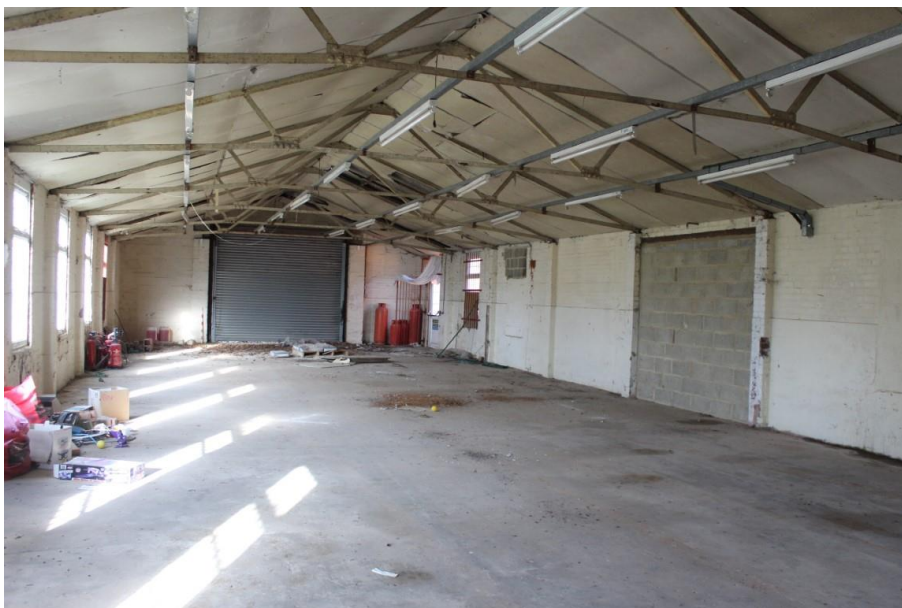
Plate 28: Room H2; showing roof structure and blocked doorway. Looking north.

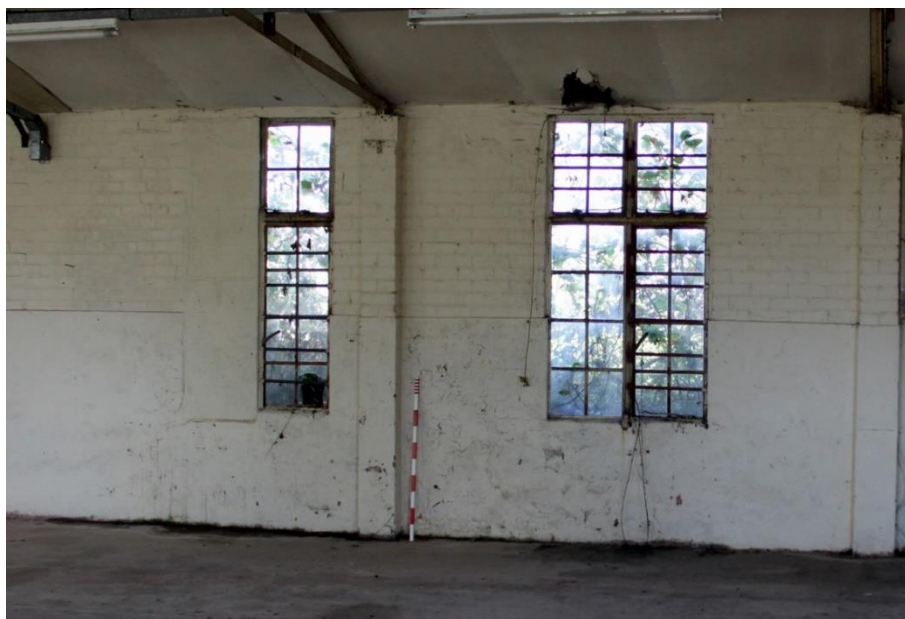
Plate 29: Room H2; eastern wall with historic windows. Looking east
