**HISTORIC BUILDING RECORDING AND WATCHING
BRIEF**

SCHEDULED MONUMENT NO: SM OX 182, HE 1006329

THE BULLCROFT, HIGH STREET,

WALLINGFORD, OXFORDSHIRE

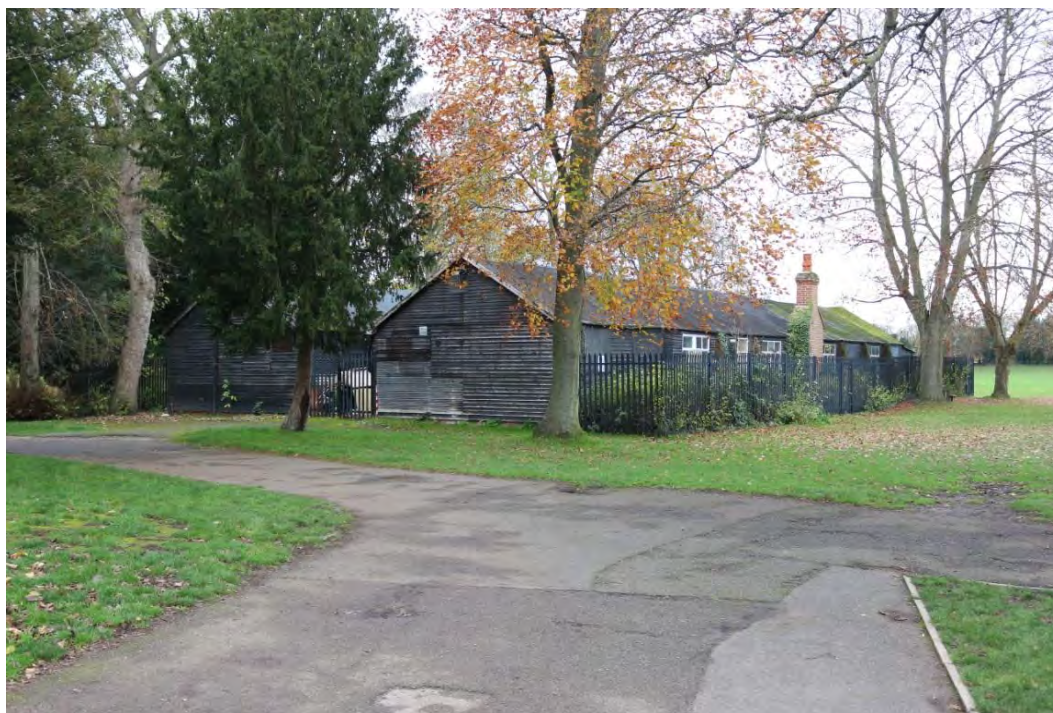
Plate 1: The recreation rooms as viewed from the entrance to The Bullcroft. Looking north east

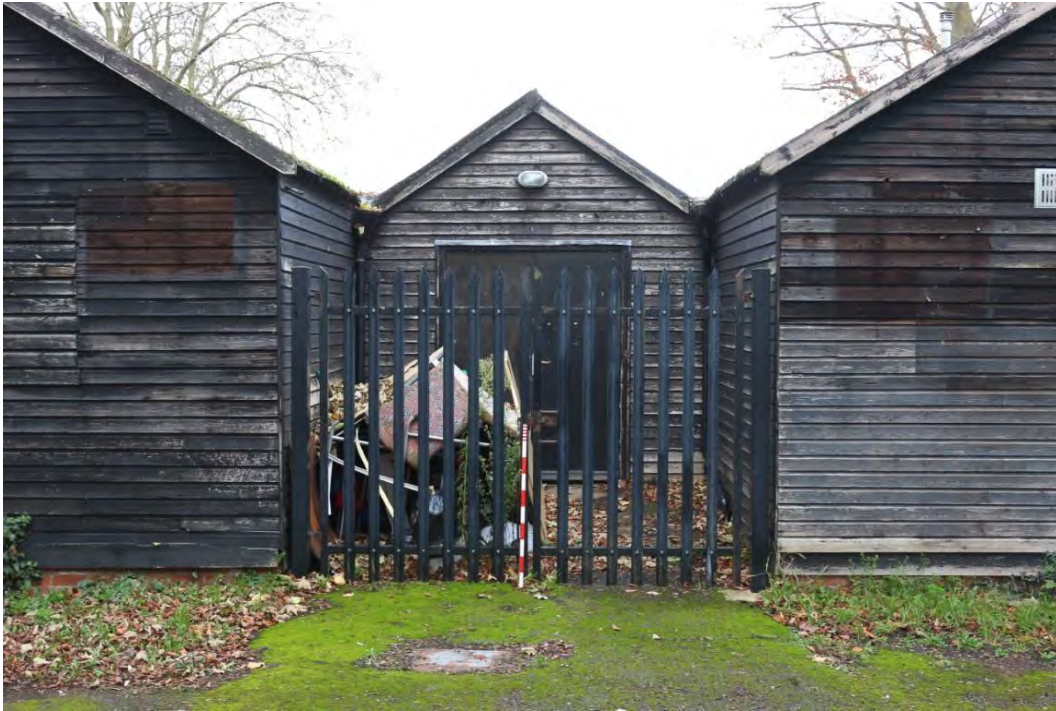
Plate 2: The central entrance into the building. Looking north

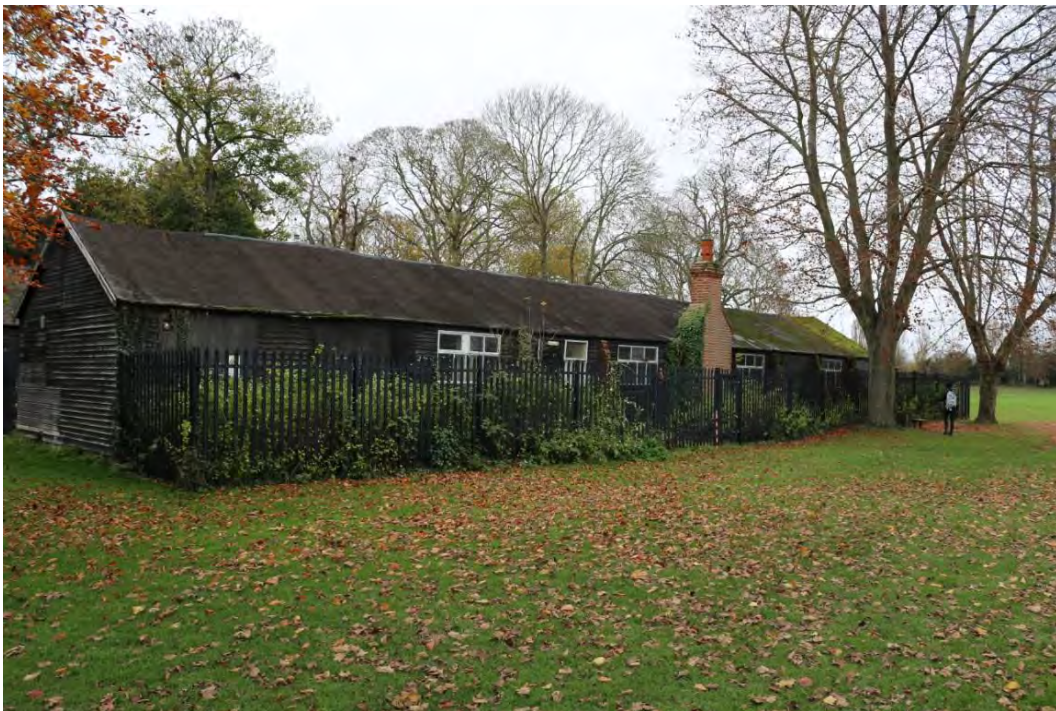
Plate 3: The eastern elevation of the east block. Looking north west

The clear outward lean of the eastern wall of the east block and western wall of the west block perhaps indicate that the external brick buttresses present around the structure are a later addition, constructed to counter this.

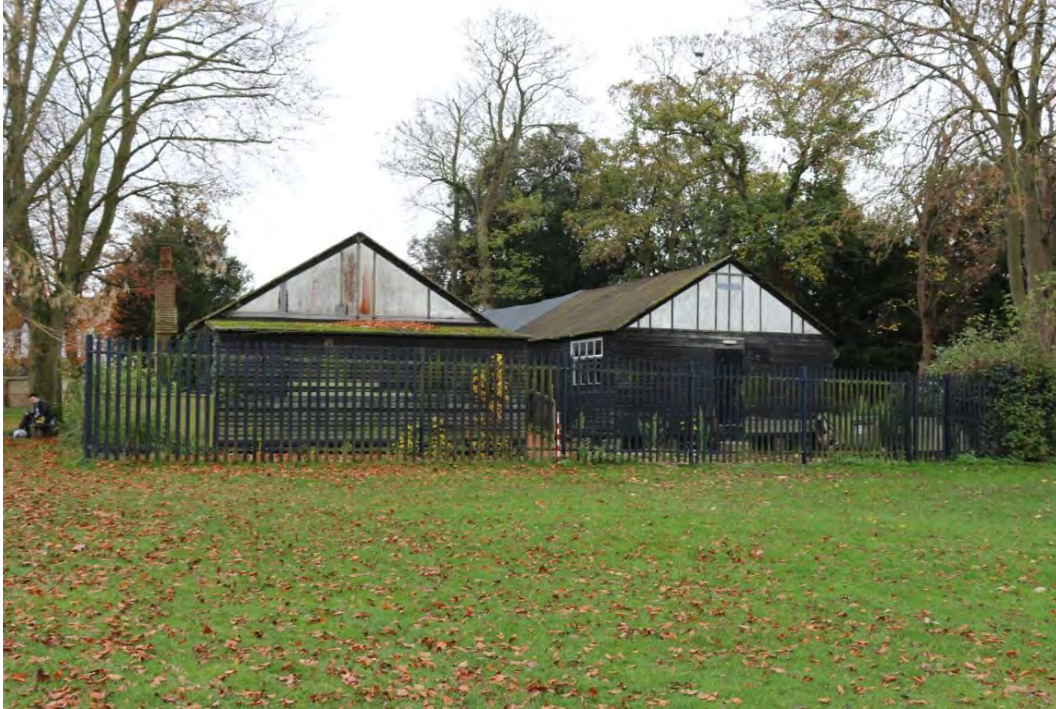
Plate 4: The northern elevation. Looking south-south west

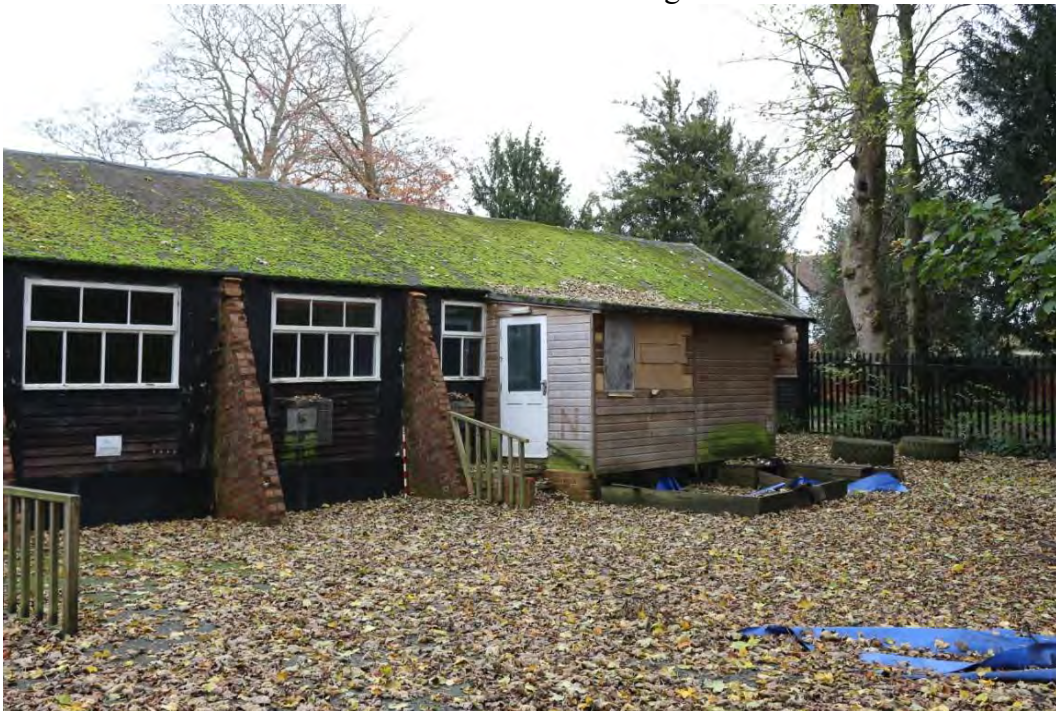
Plate 5: The southern end of the western block, showing later extension. Looking south east.

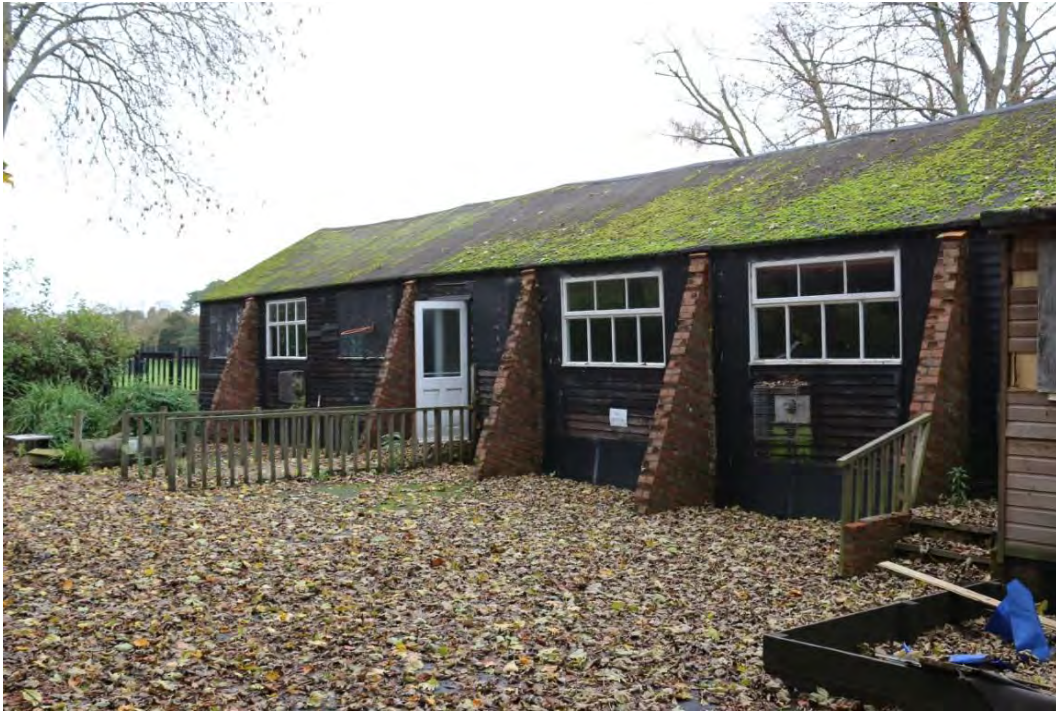
Plate 6: The northern end of the western block, showing buttresses. Looking north east.

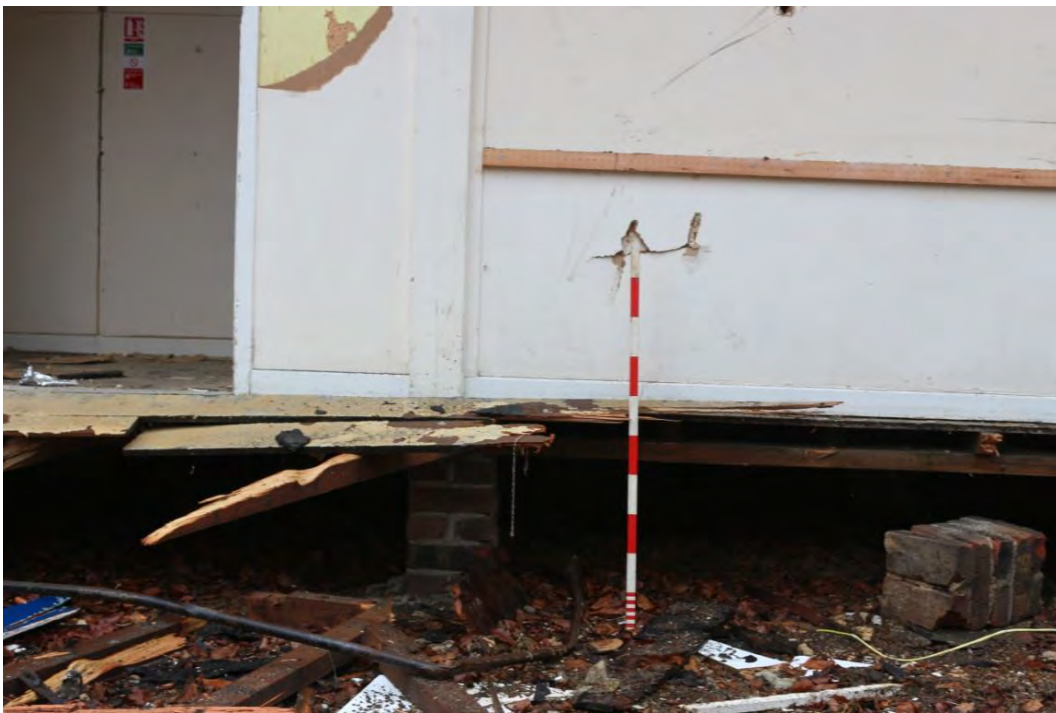
The superstructure of the building rests on a brick plinth, while internally the floor structure rests on a series of brick pads, spaced at *c.* 1.5m intervals throughout (Plate 7). These are cut into the underlying topsoil to a depth of 0.1m. During demolition it was noted that the original (pre-1941) ground surface had been preserved under the building (Plate 8).

Plate 7: Mid-demolition, showing brick pad and supporting beam under eastern block. Looking east.

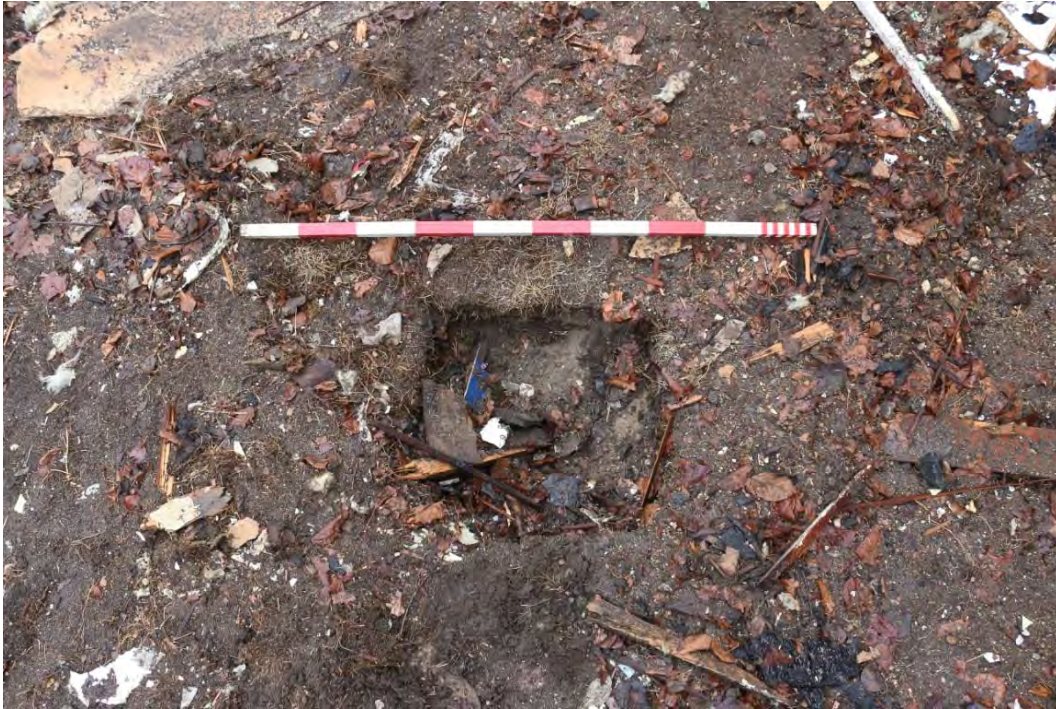
Plate 8: Post-demolition, showing cut for brick foundation and extant turf.

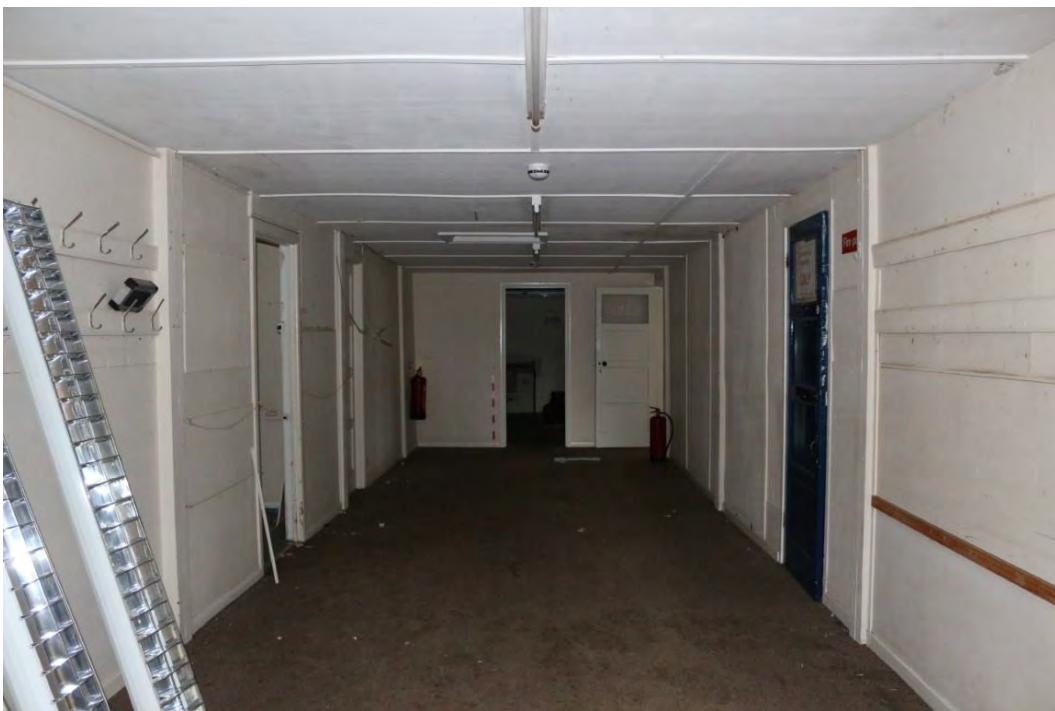
Internally the three blocks are divided into a series of separate rooms. The central block, which contains the main entrance to the building at its southern end, forms a central corridor from which the eastern and western blocks are accessed (Plate 9). The corridor, Room 1, provides access to Rooms 2, 5 and 10 in the eastern block and Rooms 13 and 18 in the western block. The ceiling in the central block (Room 1) is a later suspended plasterboard ceiling while the walls are plasterboard.

Plate 9: Room 1, central corridor. Looking north.

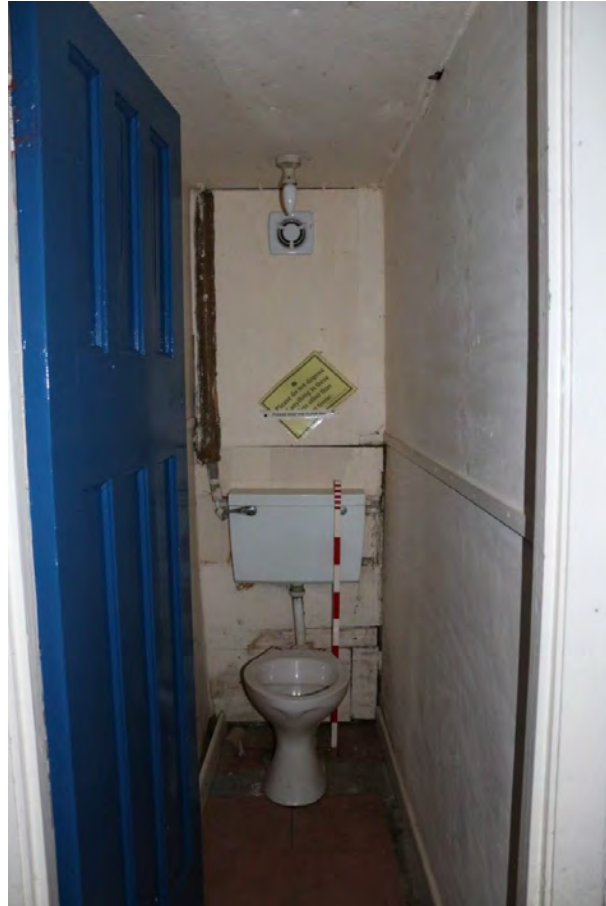
Plate 10: Toilet cubicle within Room 3. Looking south.

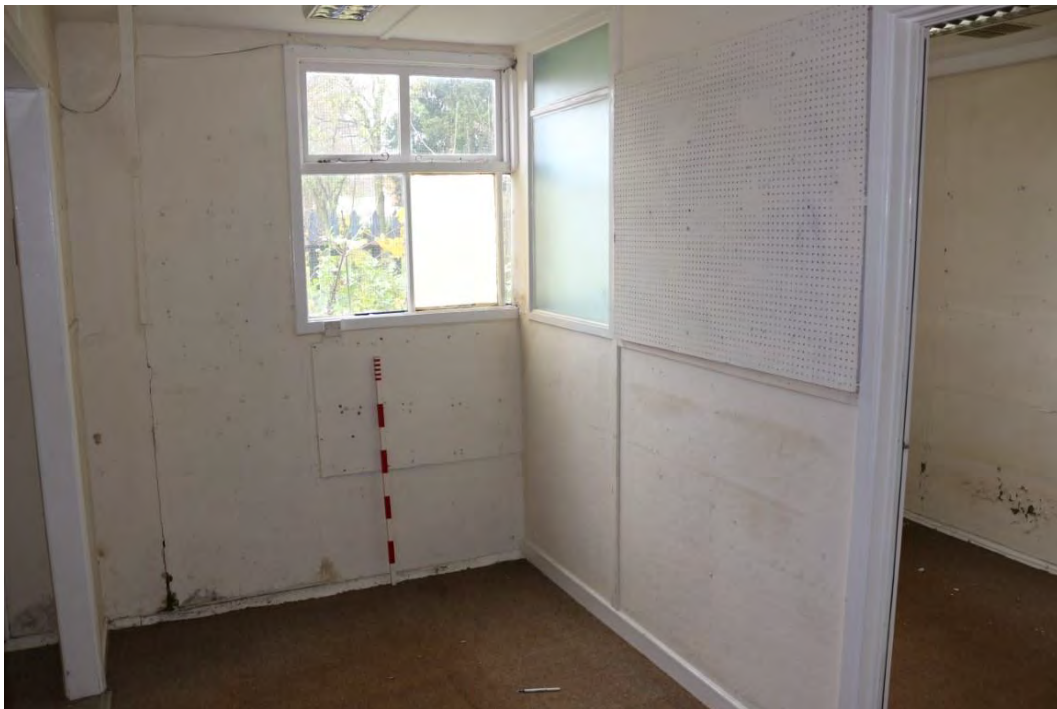
Room 5, accessed from corridor 1 through a four panel door, is a small ante-chamber or reception room that leads into Room 6, a corridor that in turn provides access to Rooms 7 and 8 (Plate 11). Rooms 5 to 8 have a later suspended plasterboard ceiling while the northern wall of Rooms 7 and 8 is a later partition, as evidenced by the bisection of an external window in Room 8. This window comprises two lights; a top hung casement of three panes over a fixed window of four panes. The glazing bars are wooden. This is the dominant window form throughout the building. An external doorway is present on the eastern wall of Room 6, containing a modern plank door; this appears to have originated as a window, the left side of which is still extant.

Plate 11: Rooms 6 and 8, showing partition of external window. Looking east.

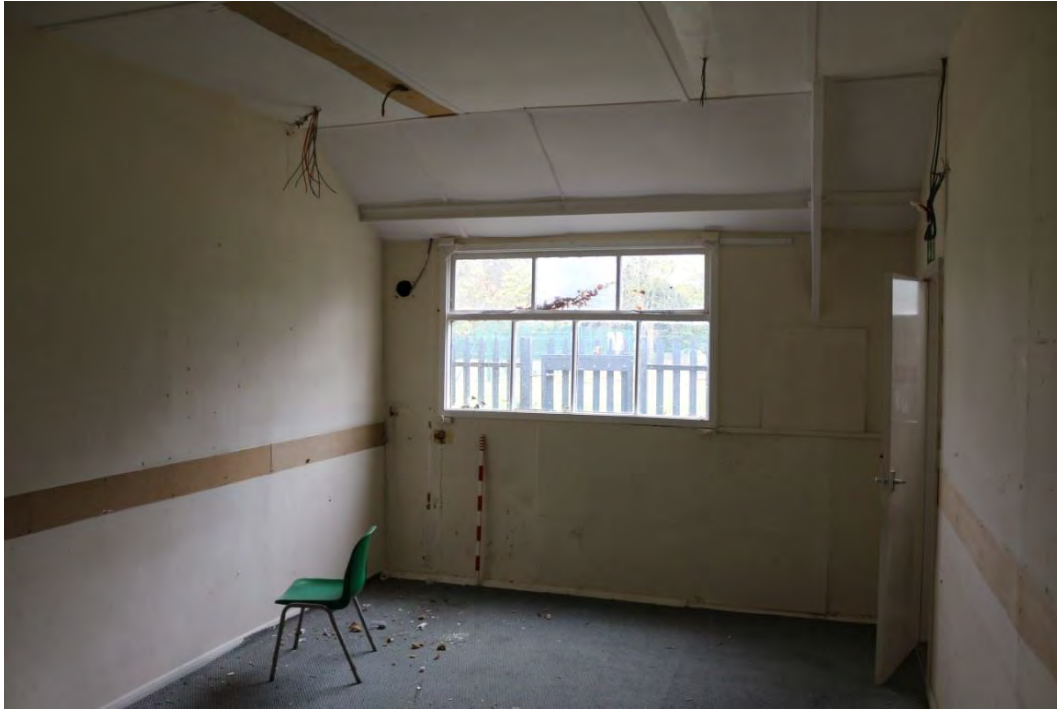
Room 9, accessed from 6 through a modern single panel door, has a higher ceiling, though this is still a later addition (Plate 12). A blocked doorway is present in the northern wall of the room while a window is present on the eastern wall. It appears evident that Rooms 5-9 have been created through the partitioning of a larger room, bounded by Rooms 2 and 4 to the south and Room 14 to the north.

Plate 12: Room 9, showing window. Looking east.

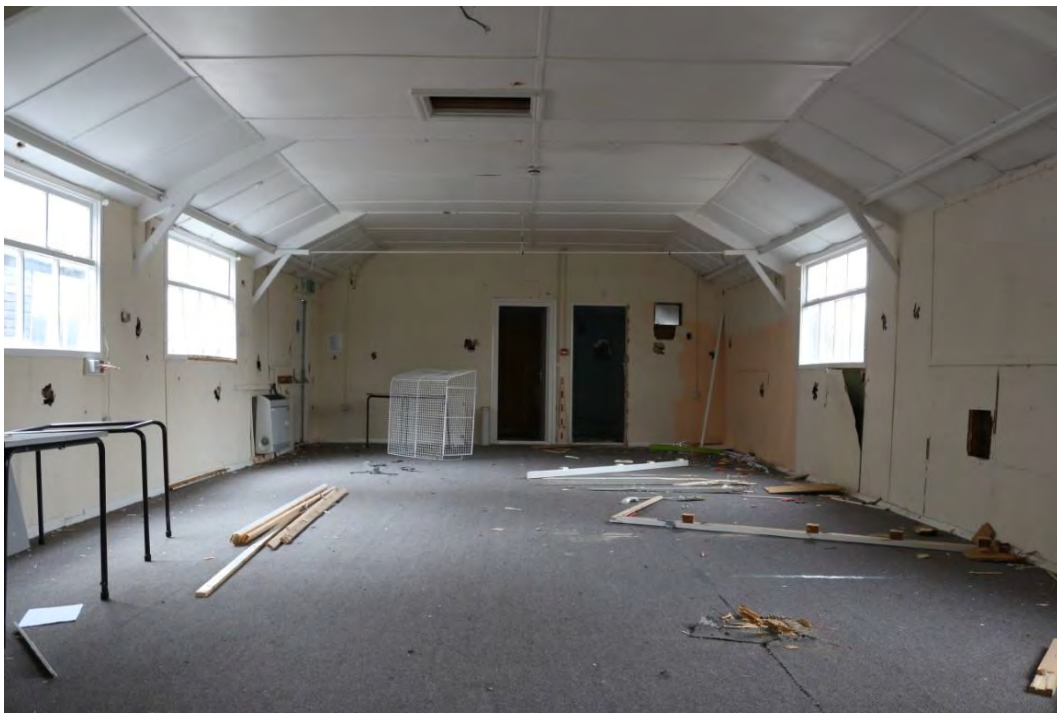
Room 10, accessed through a six panel door from corridor 1, occupies the northern half of the eastern wing. The room contains a suspended ceiling clad in plasterboard and four roof trusses are partly visible; each having a raked support brace (Plate 13). Angle iron purlins are present, secured to each truss with a metal fixing, while the most northerly truss also has a steel tie beam. This may be a later addition to counter the spreading of the roof structure, which is particularly evident in this room. In addition to the doorway the western wall contains an exterior door at its northern end, situated in the location of a former window, and two further extant windows. Two extant and two blocked windows are present along the eastern external wall, in addition to a brick built fireplace. The fireplace contains a central segmented arch, brick hearth and a tile mantle (Plate 14). Two doors on the northern wall lead to a modern extension containing cloakroom 11 and toilets 12.

Plate 13: Room 10, showing blocked windows and roof structure. Looking north.

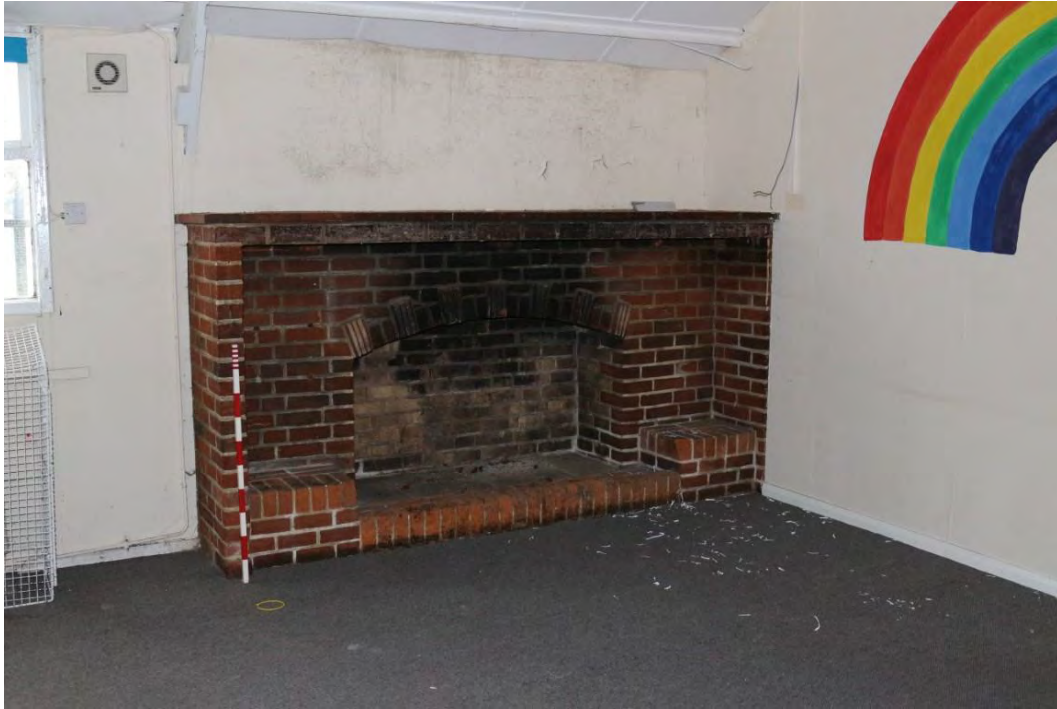
Plate 14: Fireplace in room 10. Looking south east.

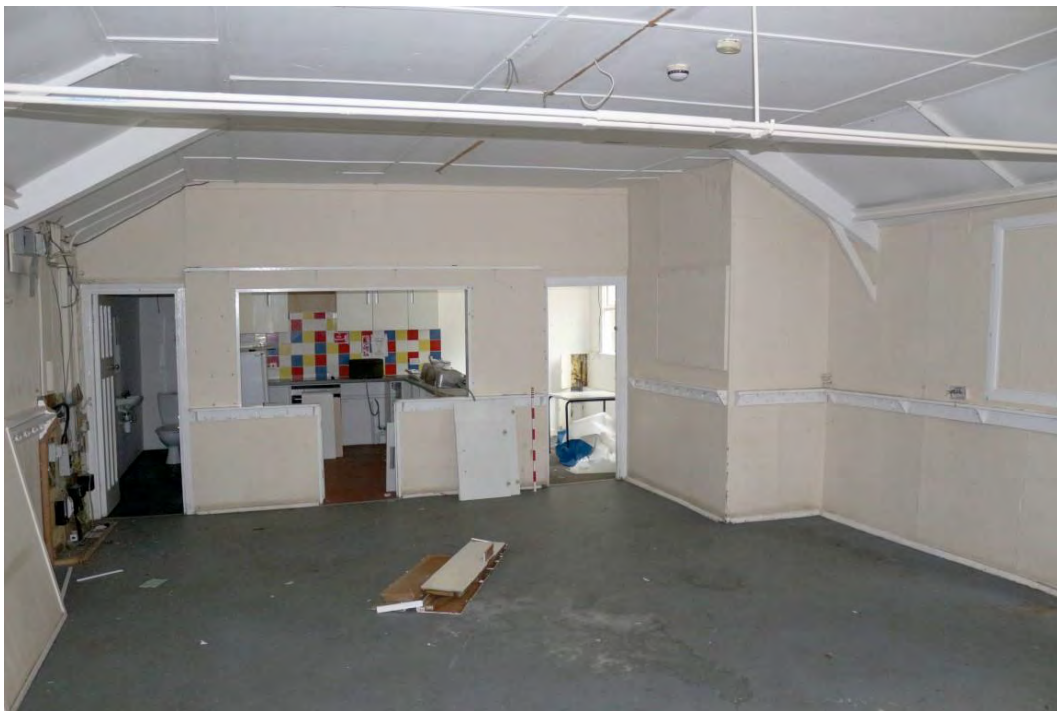
The most southerly room of the western wing, 13, is accessed through a three panel door from corridor 1; this room occupies the southern third of the western wing (Plate 15). The room has a plasterboard ceiling and the floor is vinyl. Located at the southern end of the room is a toilet room, 14 and a partitioned kitchen area, 15. The western wall contains a door leading to modern extension 16, a toilet block, while the northern wall contains a door leading to Room 17.

Plate 15: Room 13, showing Toilet 14 and Kitchen 15. Looking south.

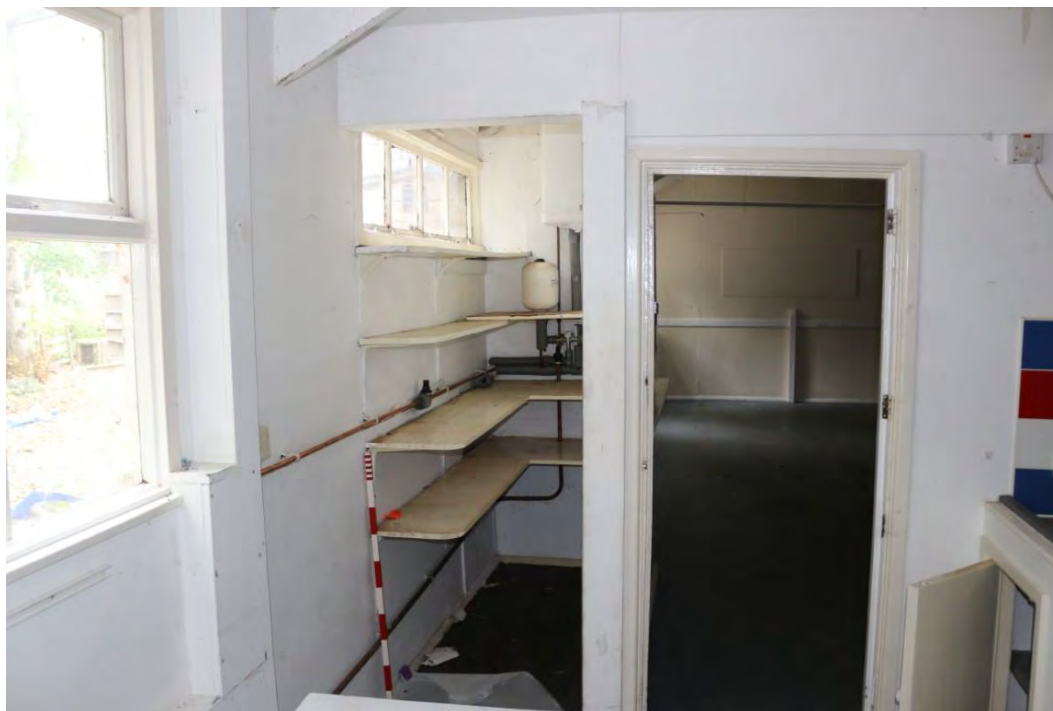
Plate 16: Storage larder within Room 15. Looking North.

A series of coat hooks are present along the walls, associated with the building's former use as a nursery school. Toilet 14 is accessed through an original six panel door, though the sanitary ware is a later addition. Kitchen 15 contains a range of modern fittings; however, the partition from Room 13 and a small larder located against the western wall are likely to be extant original features (Plate 16).

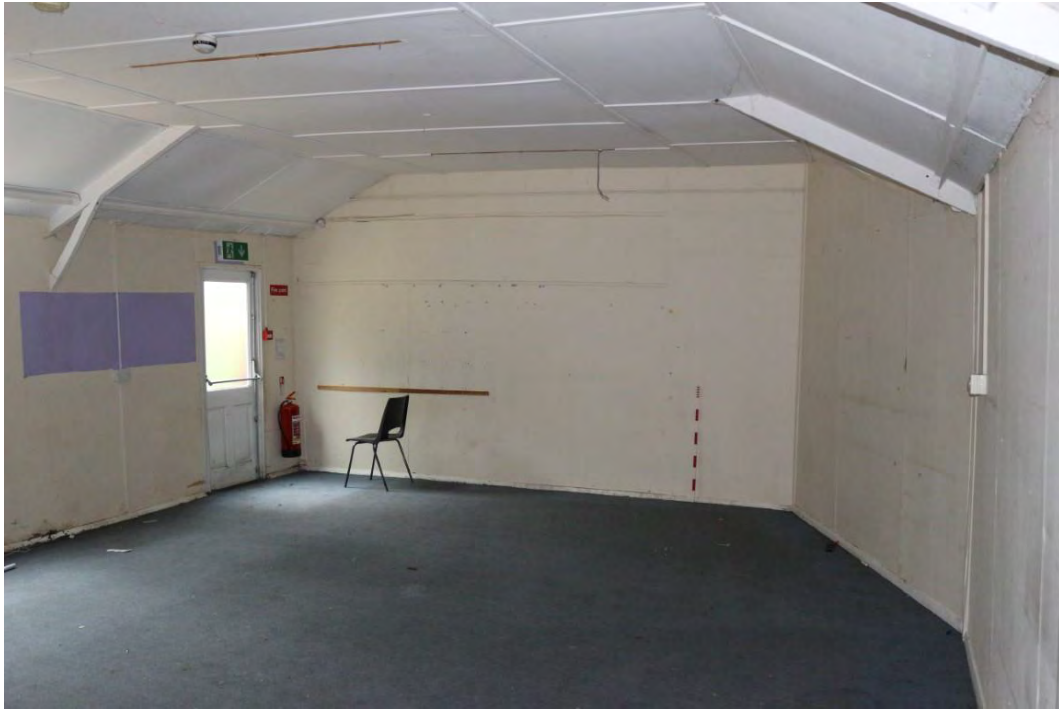
Room 17 is accessed from 13 through a six panelled door. The room has a plasterboard ceiling and the floor is vinyl, laid over the original floorboards. Two blocked doorways are present on the eastern and northern walls of the room and the north eastern corner of the room has been modified in order to create a passage into Room 18 from corridor 1 (Plate 17); the western wall contains two windows and a doorway containing a modern plank door, again inserted into the former location of a window (Plate 18).

Plate 17: Room 17, showing altered eastern wall. Looking north-north west.

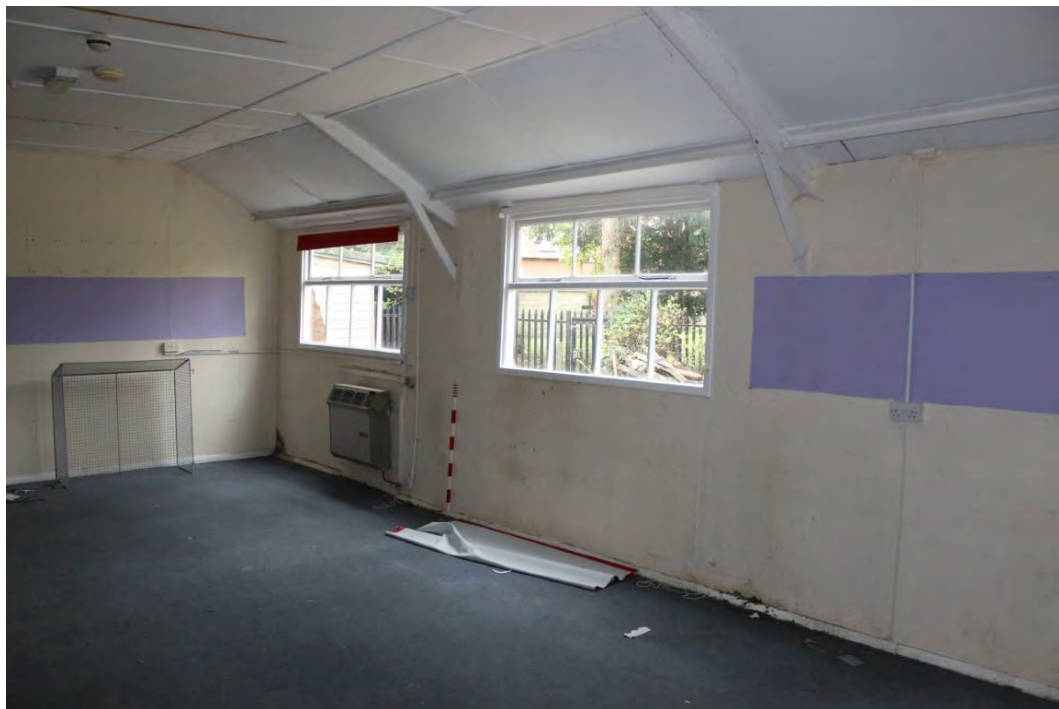
Plate 18: Room 17, showing windows and leaning wall. Looking south west.

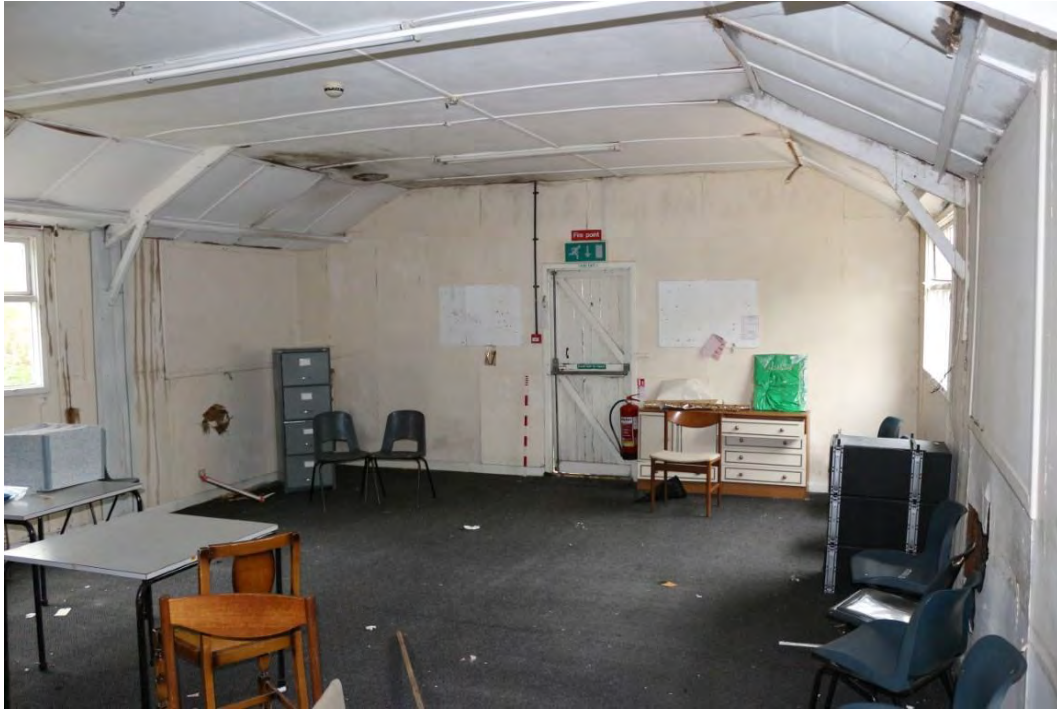
Room 18 is accessed from corridor 1 through a six panelled door. The room has a plasterboard ceiling; two trusses are partially visible and the most southerly has a metal tie beam (Plate 19, 21). The southern wall contains two doorways; one providing access to the room and the other blocked, though still containing an original six panel door (Plate 20). The eastern wall contains one extant window at its northern end and two blocked windows; the northern wall, the gable end of the block, contains a centrally located doorway, within which is a plank door. The western wall contains an extant window, situated between two blocked windows.

Plate 19: Room 18, showing door and blocked windows. Looking north.

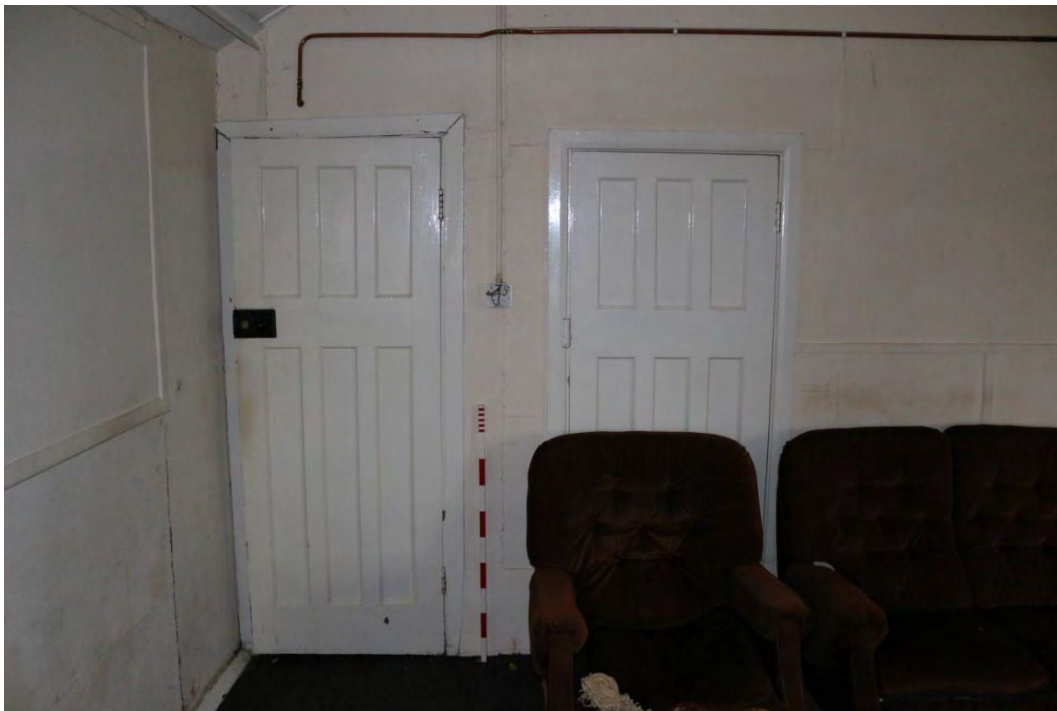
Plate 20: Room 18, showing access door and blocked doorway. Looking south.

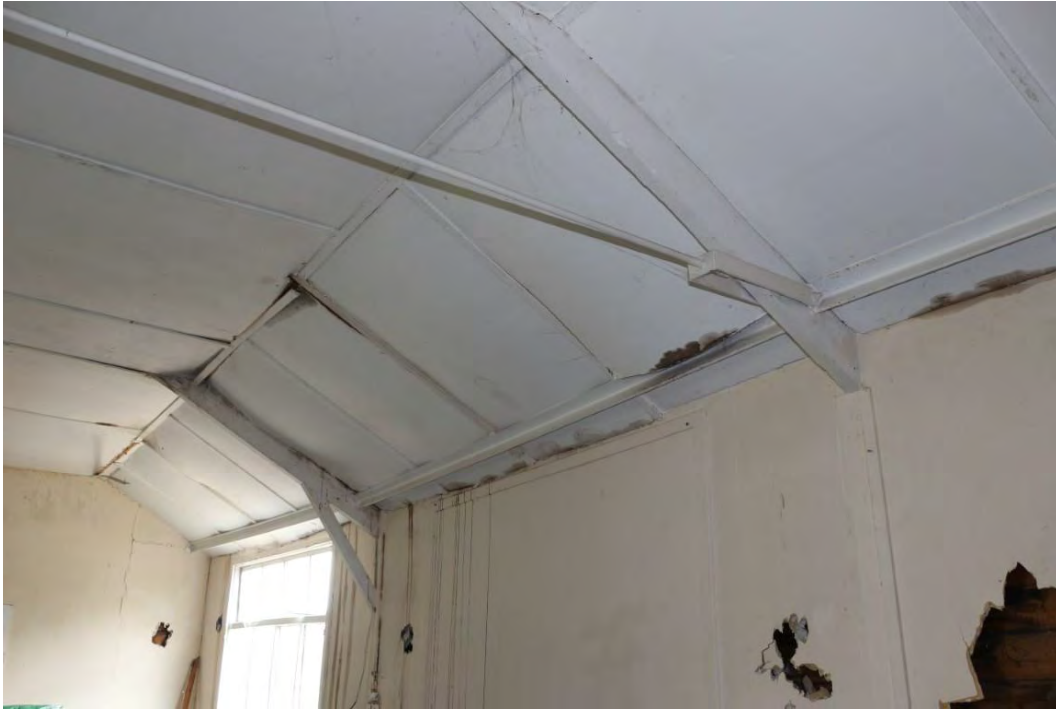
Plate 21: Room 18, showing roof structure and metal tie beam. Looking north east.

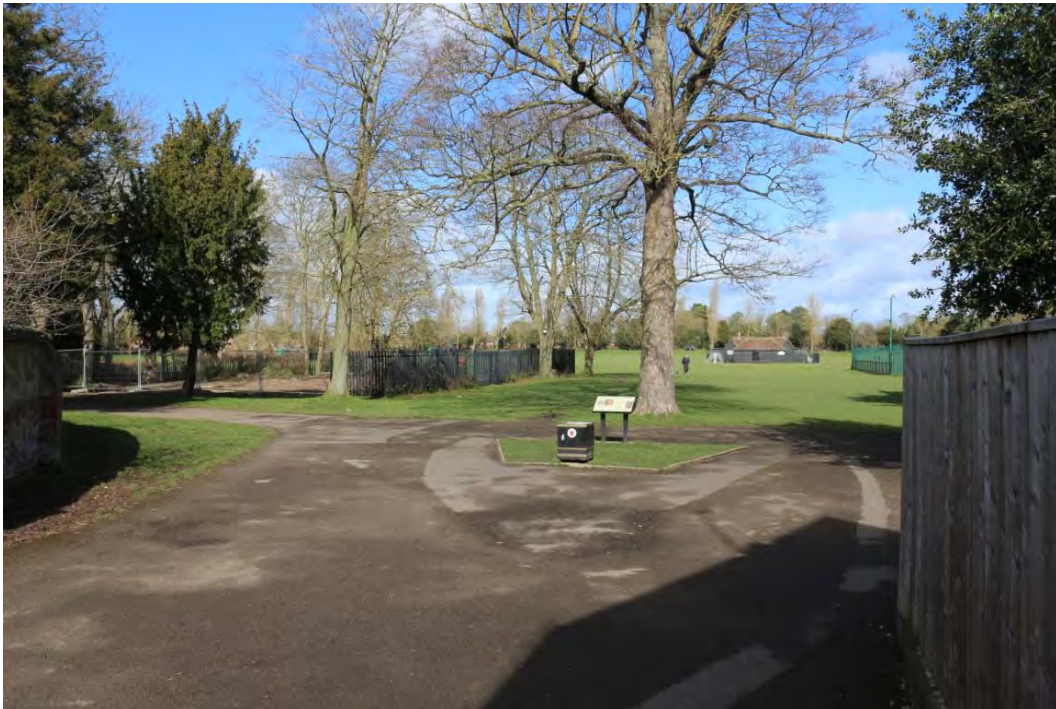
Plate 22: The site as seen from the entrance to The Bullcroft, post-demolition.
Looking north.

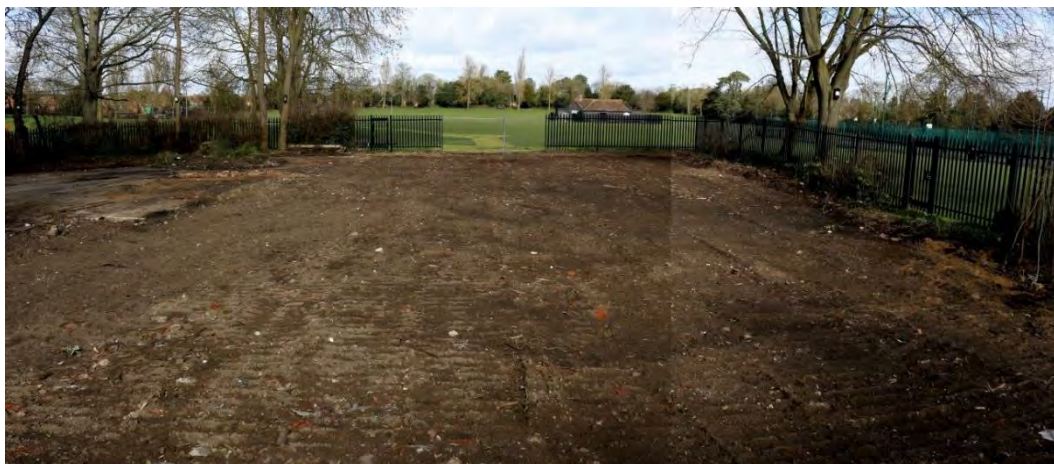
Plate 23: The site, post-demolition. Looking north.
