**HISTORIC BUILDINGS ASSESSMENT**

**THE OUTBUILDING TO THE REAR OF  
76 HIGH STREET, LONG CRENDON,  
BUCKINGHAMSHIRE**

**February 2008**

**JMHS Project No:** 1896

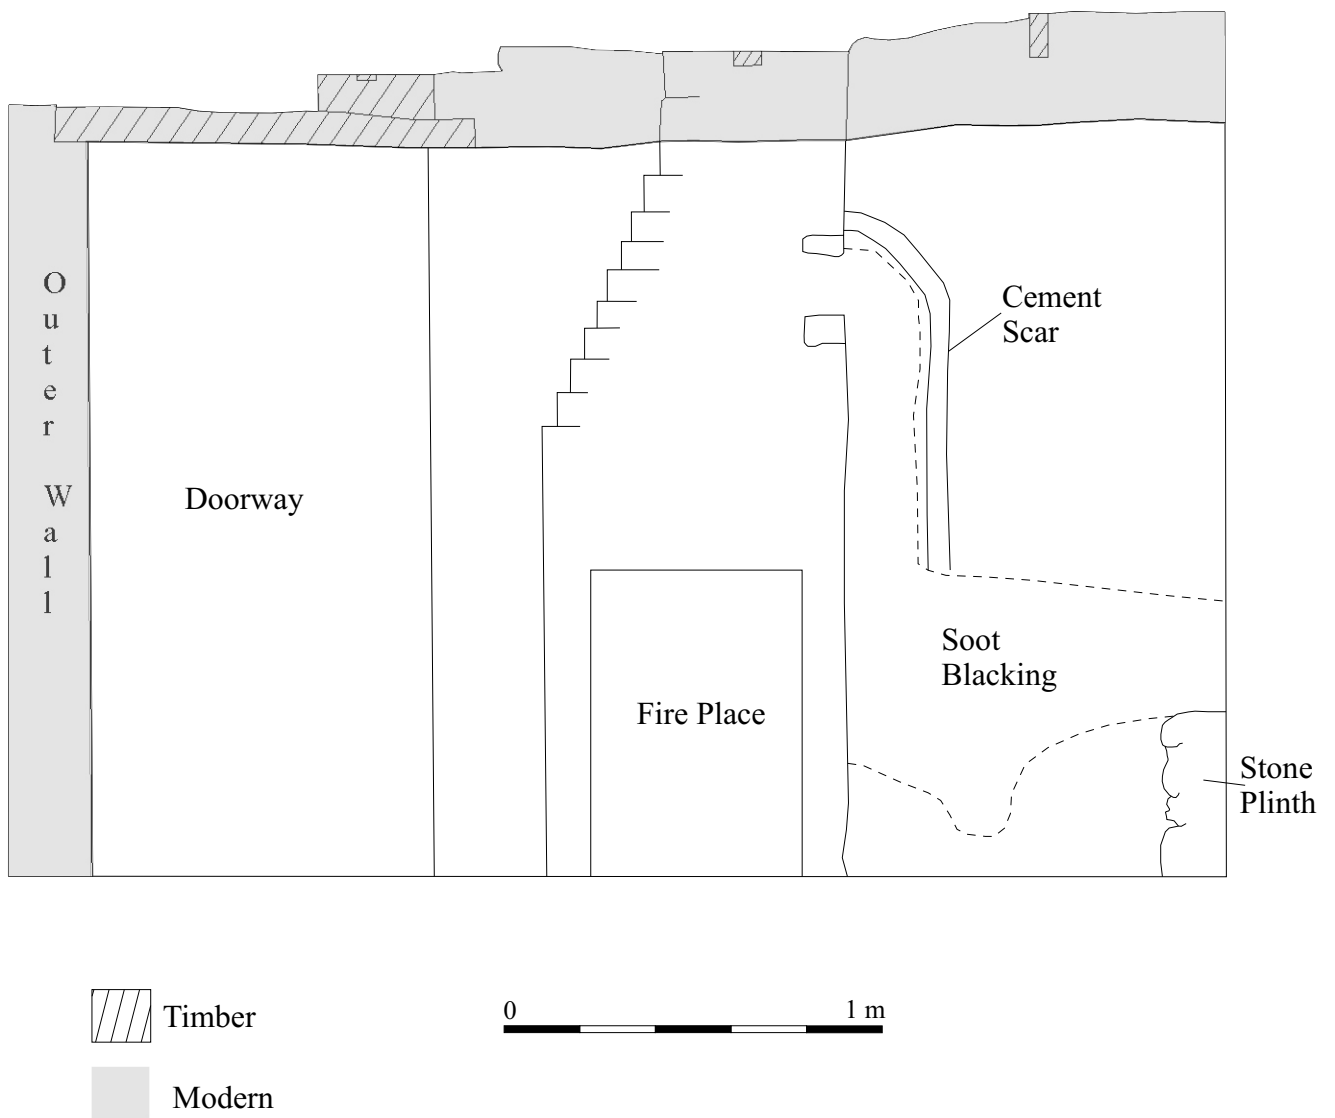
Figure 3. Elevation of the fireplace within the second room

The main feature of the second room is the fireplace (plate 4), built in brick and contemporary with the interior wall. To the north of the fireplace the wall shows a distinct scar of plaster where a covering or structure has been attached to it (plate 5). Below this scar is considerable discolouration of the wall surface by soot or burning. An opening on the side of the chimney stack at a level just below the top of the scar would indicate that a second flue had been accommodated (figure 3).

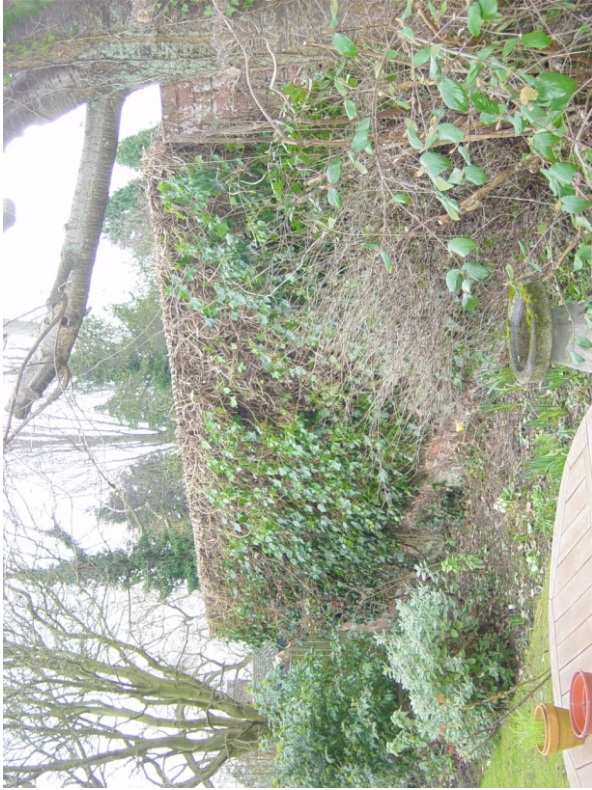
The property is single storey and rectangular in plan (plate 1). It is built of red brick and has two large windows in the southern wall. It is roofed with sheets of corrugated asbestos. The building has two doorways at either end of the building, east and west. It is in a state of disrepair and the rear, northern, wall is overgrown with ivy (plate 2).

Plate 2. Rear of building (north side)

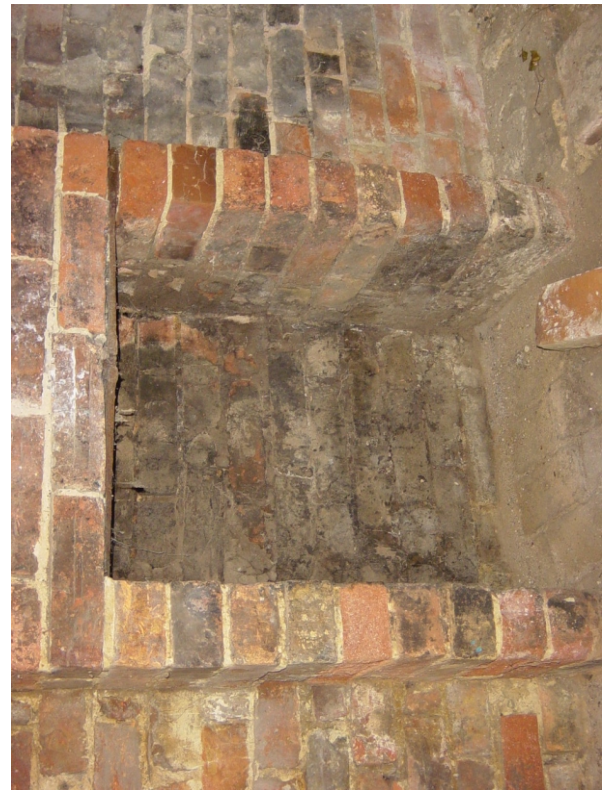
Plate 4. Fireplace

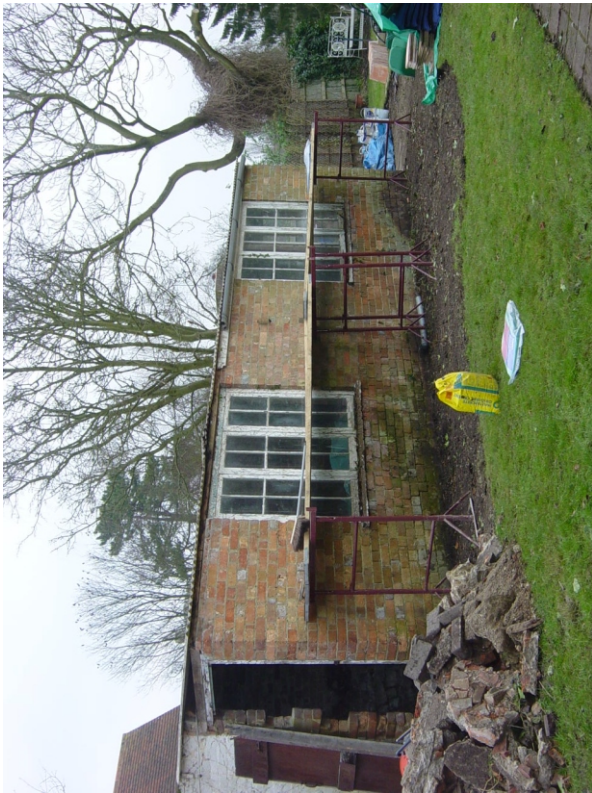
Plate 1. Front of building

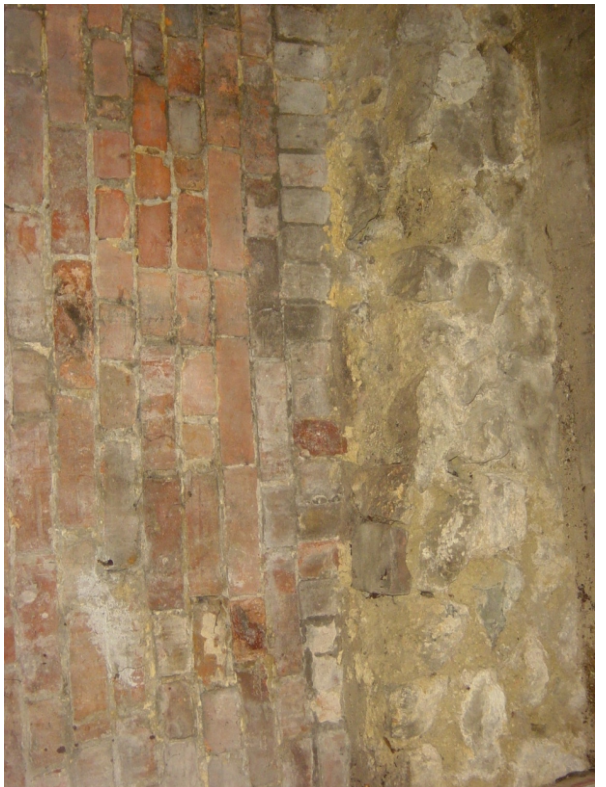
Within the first room a stone built footing for the northern wall can clearly be seen. It is approximately equivalent to 6 courses of bricks high (plate 3). The stone footing of the north wall continues into the second and third rooms. Built from this is the main fabric of the northern wall. It is all of red brick, with no discernible pattern to the bonding with a mixture of stretchers and headers. The majority of the western wall appears to be abutted to the northern wall and is not in the same phase of construction, it also displays some signs of later repair. Towards the north-western corner the lower three courses of the wall are original and bonded into the northern wall.

Plate 3. Stone footings

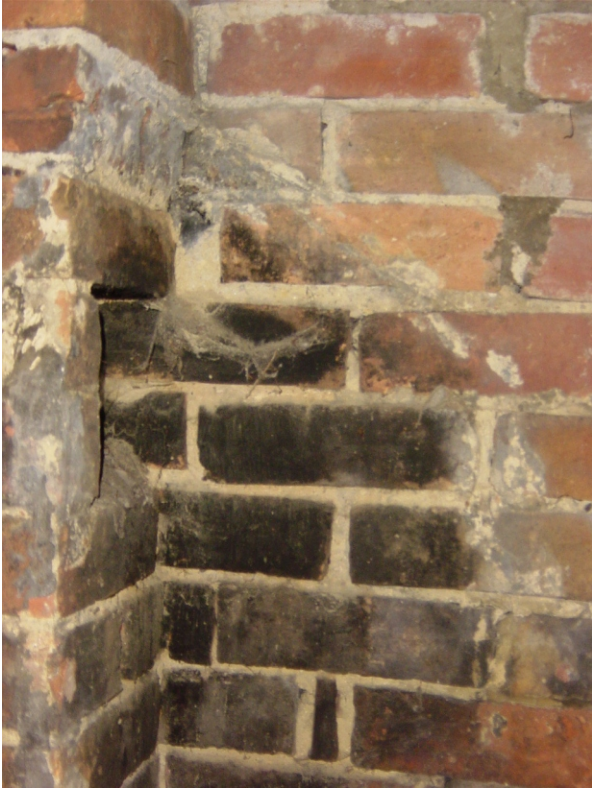
Plate 5. Plaster scar and soot blackening

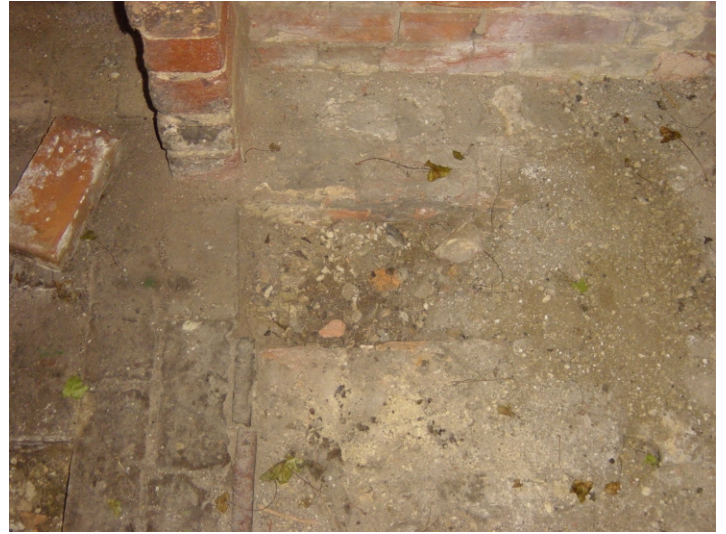
Apparently associated with the area of scorching on the wall is an area of the floor devoid of brick flooring. This area appears to have what could be footing for a structure just below floor level (plate 6).

Plate 6. Footings in floor of second room

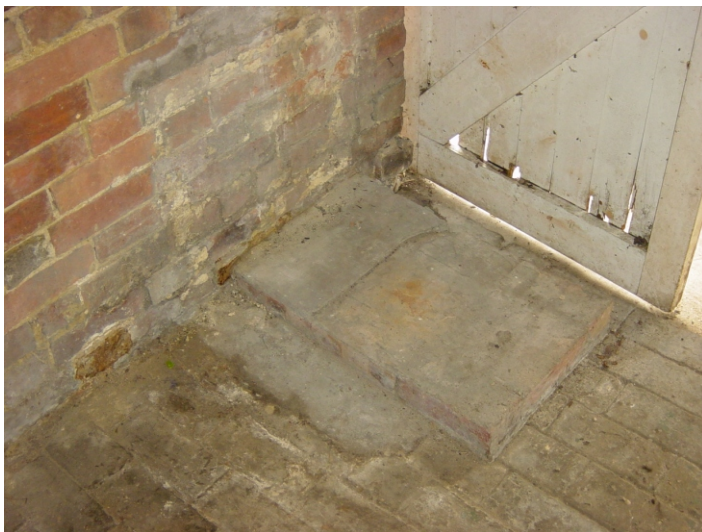
Within the third room is a continuation of the brick flooring seen in the second room. This appeared to have been repaired in several places. Built into this is a one brick high plinth measuring 0.44m by 0.69m, it is situated next to the doorway (plate 7). Approximately 1m above this plinth is a 0.11m diameter metal pipe in the eastern wall (plate 8).

Plate 7. Brick plinth

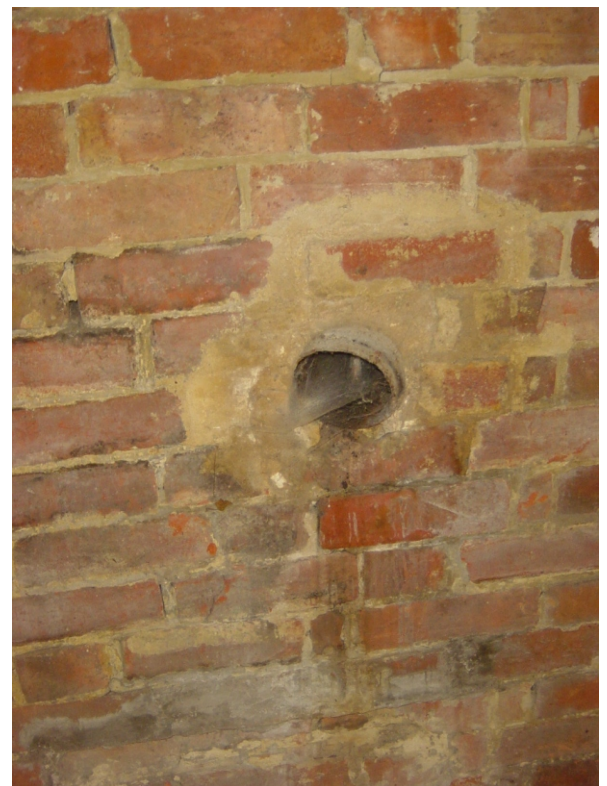
Plate 8. Chimney pipe

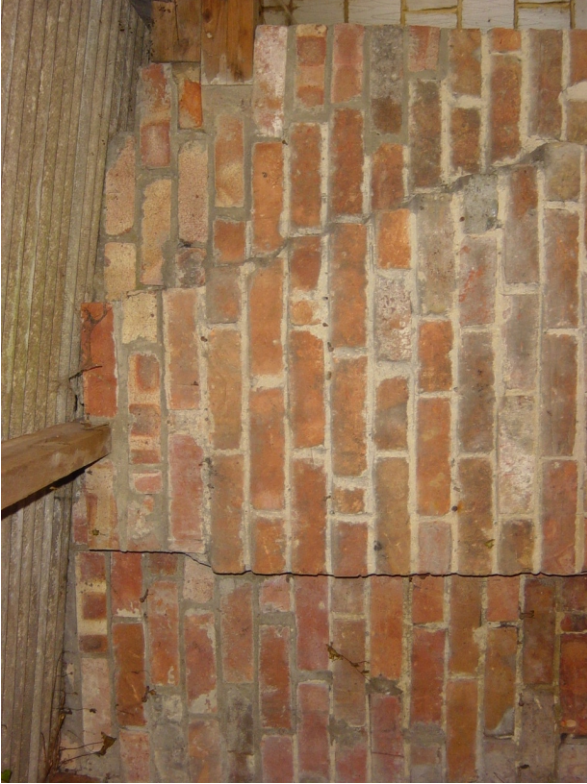
Plate 9. Rear of fireplace in the first room

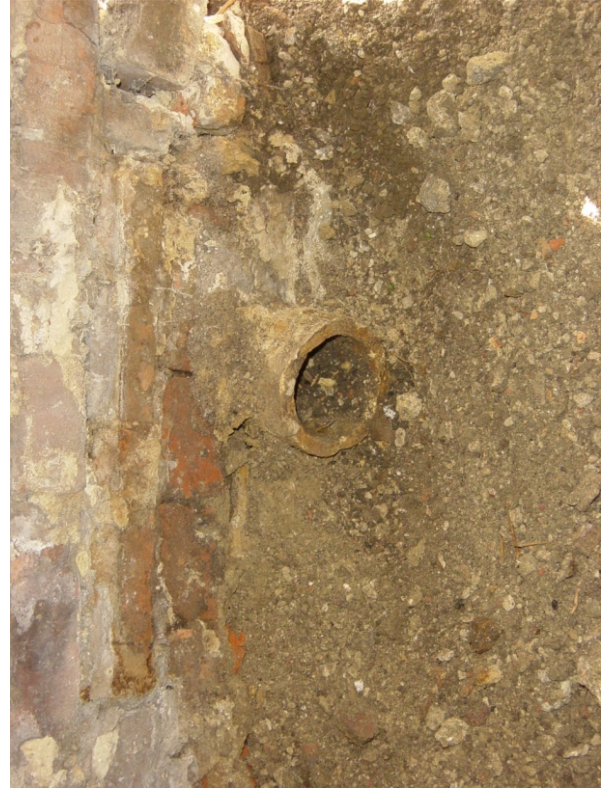
When the floor in this room was removed a ceramic pipe was seen to exit through the stone footings of the eastern wall (plate 12). The pipe was directly under the brick plinth. A second ceramic pipe was seen under the southern wall, which also had stone footings in places. It seems likely that the stone footings of the southern wall are original and the new build of the wall was taken off of these foundations already in place.

Plate 12. Pipe under flooring in third room

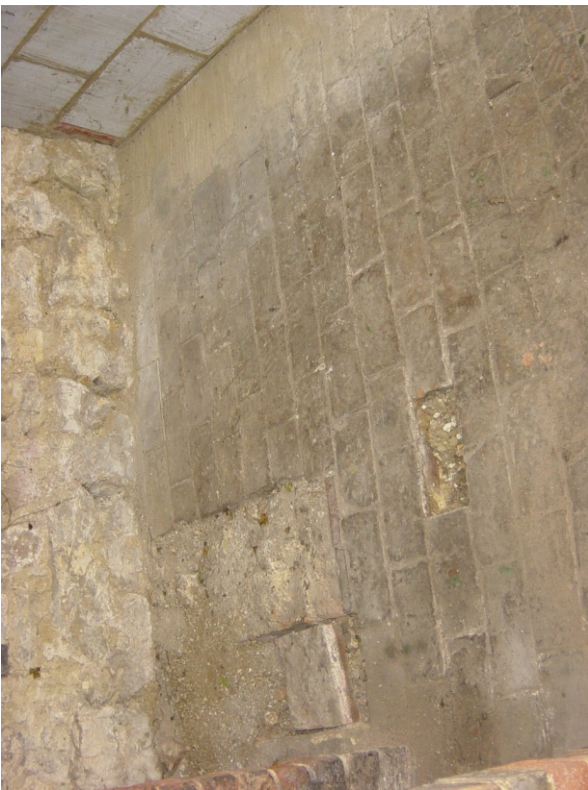
Part of the original flooring is evident in this room. A brick floor laid onto a loose bedding of soil and building debris. This floor also forms the base of the hearth of the fireplace. The bricks have been removed from the southern portion of the room and replaced by early 20<sup>th</sup> century square tiles.

Plate 10. Brick floor of the second room

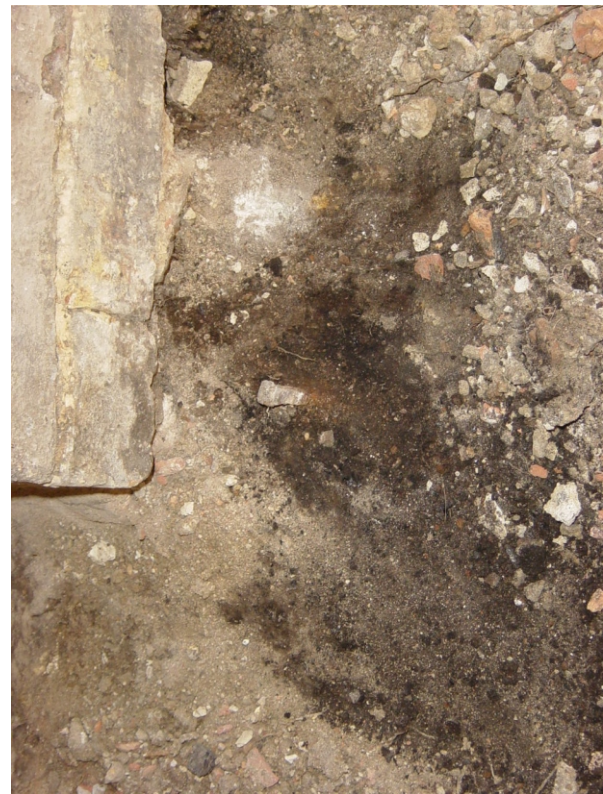
The floor was modern concrete. When it was removed it was seen to be resting on a make up layer that included red ceramic roof tiles. These tiles displayed peg holes and were presumably from the original roof of the building. Under this layer was a beaten earth floor that had a deposit of coal dust, ash and charcoal over and trampled into it. Fixed into the beaten earth floor were four iron fixings (plate 11), presumably footing for machinery.

Plate 11. Fixing in the floor of first room
