**AN ARCHAEOLOGICAL WATCHING BRIEF**

**HANWELL CASTLE, HANWELL,**

**OXFORDSHIRE**

**JULY 2008**

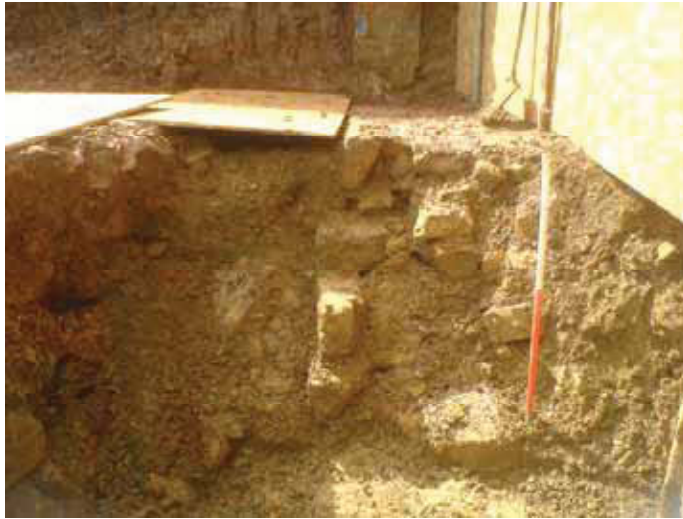
The natural geological deposit in the area was a yellowish grey marlstone rock bed (18). Cut into this were the foundations for the main north-south garden wall (05), which was of ashlar blocks. These foundations also provided the foundations for the upstanding wall (01) at the south-western corner of the garden. The distinction was made between the walls because of the rebuilt nature of wall (01). Wall (05) survived at varying heights from wall (01) in the south to the upstanding gatepier in the north. Wall (05) survived to a height of approximately 1m in places, with blocks up to 0.5m x 0.7m x 0.2m in size. The level of the base was approximately equal to the level of the garden area.

Plate 1. Wall (05) with Wall (01) in the background

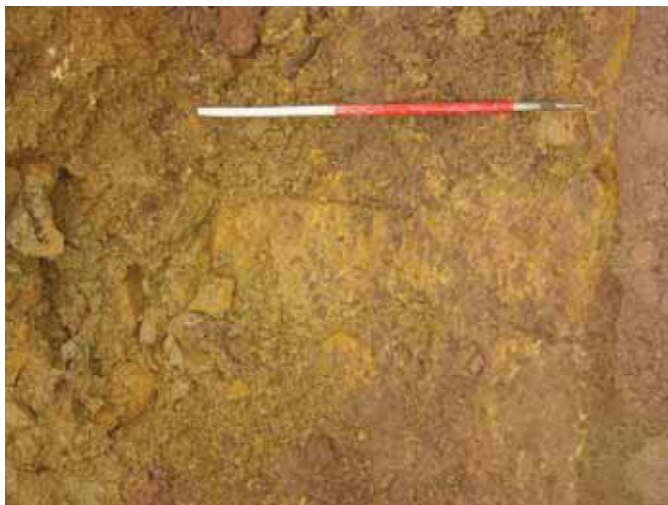
Bonded into the lowest layers of wall (05) were a series of five east-west aligned walls on the exterior of the present garden. The southern-most wall (10) was built to retain the natural that was cut [09] back in this area. It was stone built and 0.5m wide, surviving to a height of at least 2m. To the north of this wall at a distance of 1.15m was a second wall (12), this was 0.3m wide and also stone built.

Plate 2. Wall (12) bonded to Wall (05)

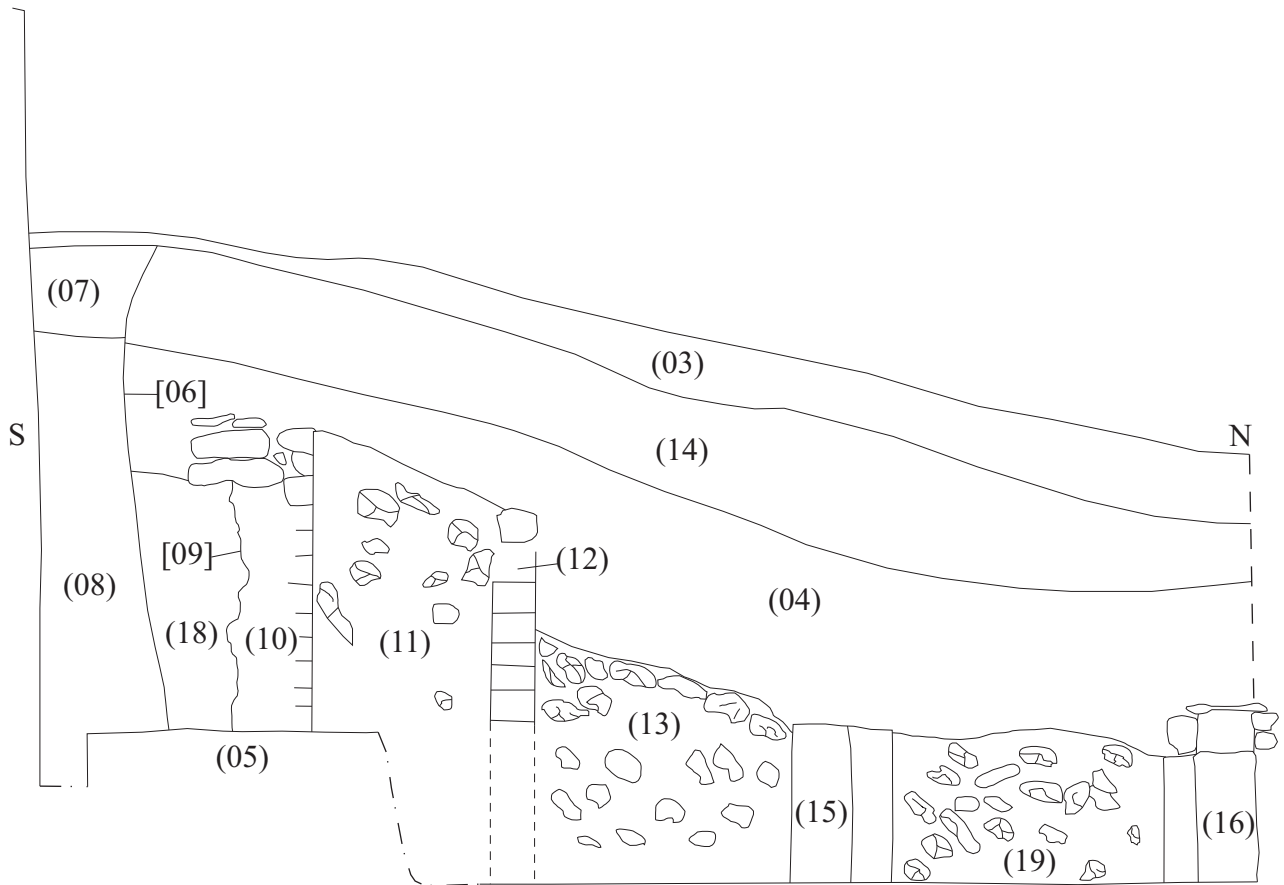
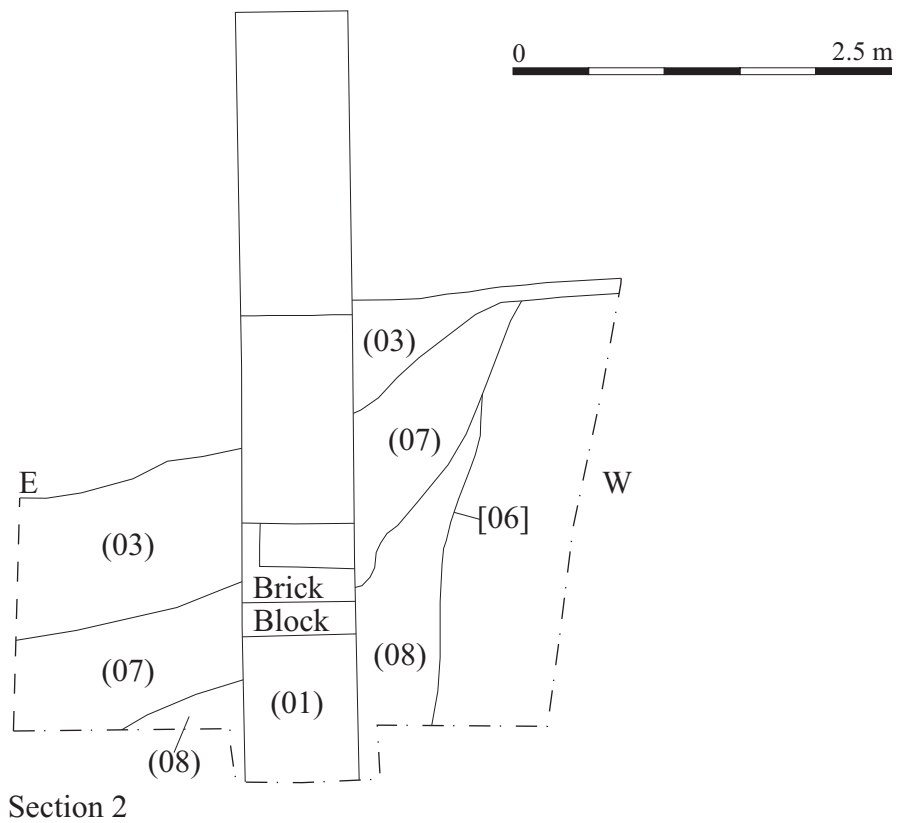
Figure 2. Sections

Section 1

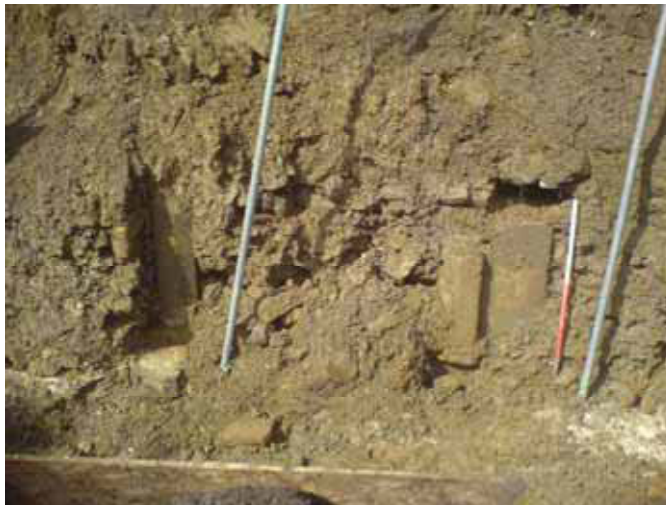
To the north of wall (12) at a distance of 1.7m was a third wall (15). This was 0.7m wide of ashlar sandstone blocks and survived to a height of at least 1m. It formed an entrance 1.8m wide with a fourth wall (16). This wall was also 0.7m wide and 0.8m in height. Both were chamfered inwards on the interior of the gateway (Plate 3).

Plate 3. Walls (15) and (16)

The two walls (15) and (16) clearly form a gateway. This would have originally been set back to the west from the line of the wall. The curve of the drain indicates that the more northerly wall (16) bends towards the church. It would seem logical that the other would follow a similar route, probably forming a pathway between the two.

Because the gate way is recessed compared to the wall it is possible that it may have formed an entrance to a *pentice* or covered way leading to the church. The bonded foundations with the main wall would indicate that it would have been an original feature presumably dating to the late 15<sup>th</sup> century.
