Archaeological Building Recording
at
OLD MOAT FARM HOUSE
STOKE MANDEVILLE

Buckinghamshire

K A Rodwell
for
JOHN MOORE HERITAGE SERVICES

September 2008

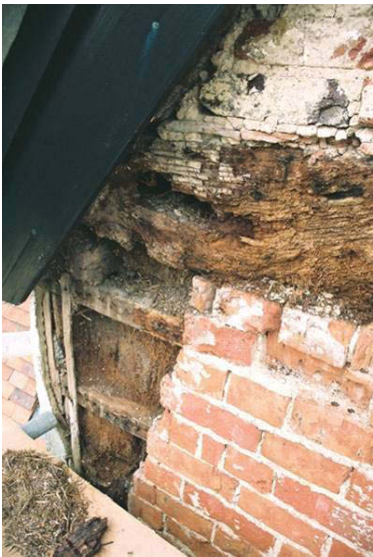
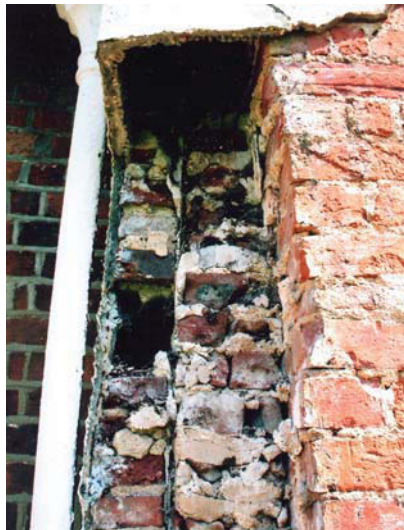
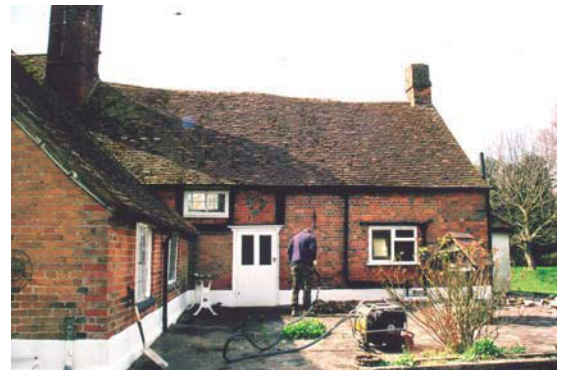
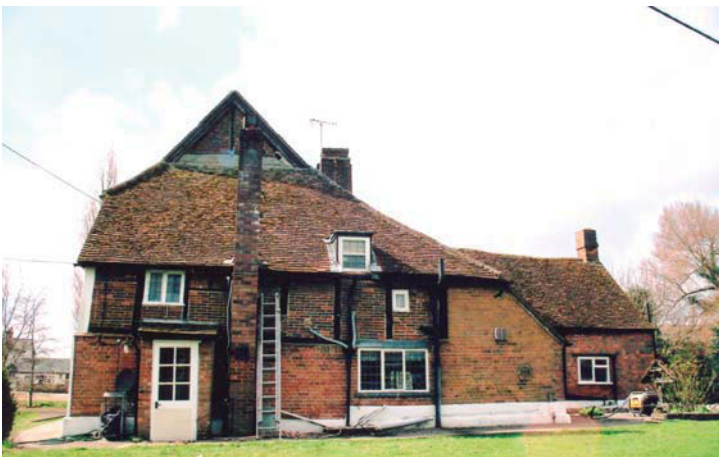
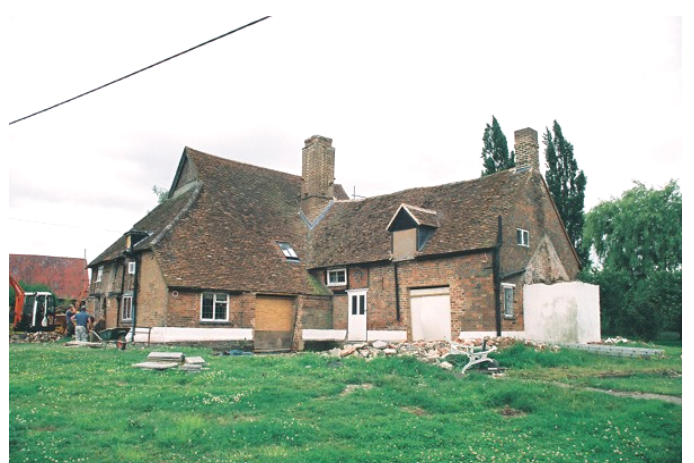
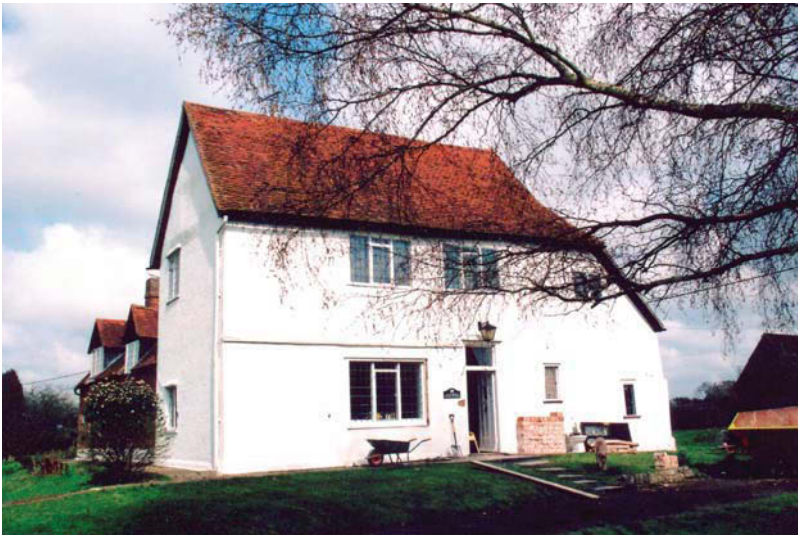
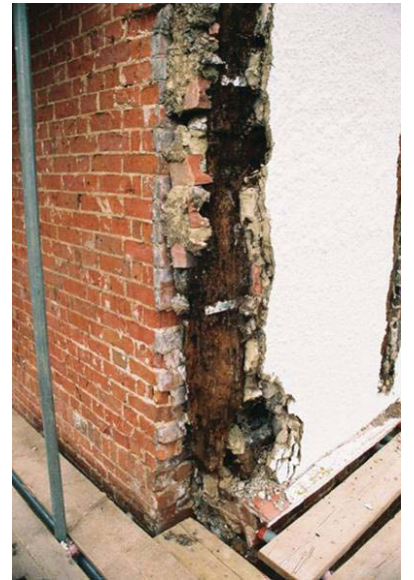
Fig 5 Exteriors
(clockwise from above)

- South-west elevation with rendering partially stripped from wing
- North-east elevation
- View from the north
- North-east elevation to wing
- South-west elevation, wing detail; jowled NW corner post & tie beam
- South-west elevation, wing detail; NW corner post void
- South-west elevation with rendering stripped from wing

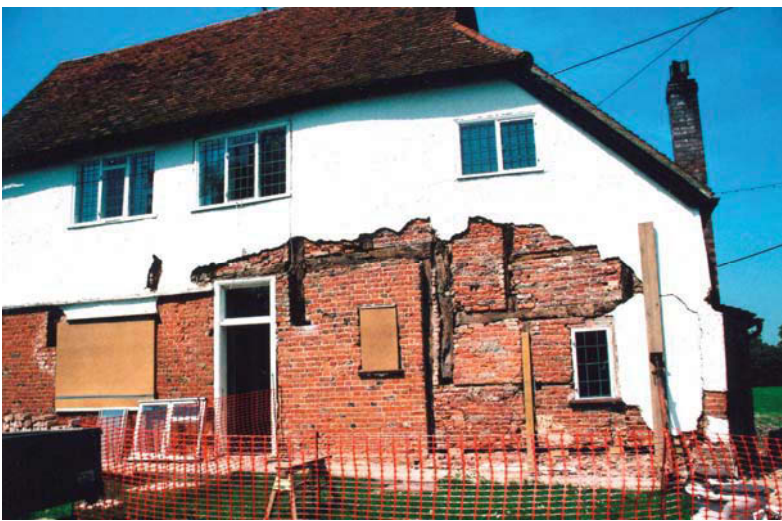
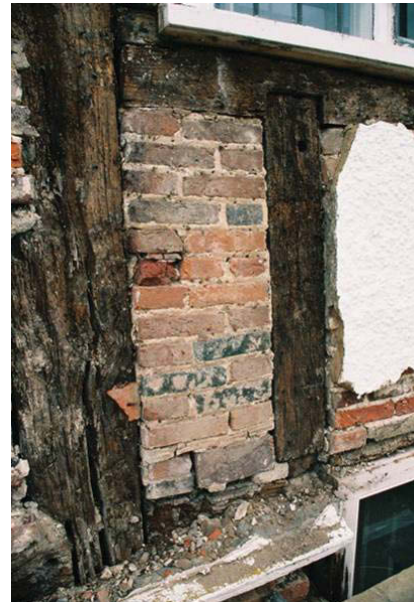
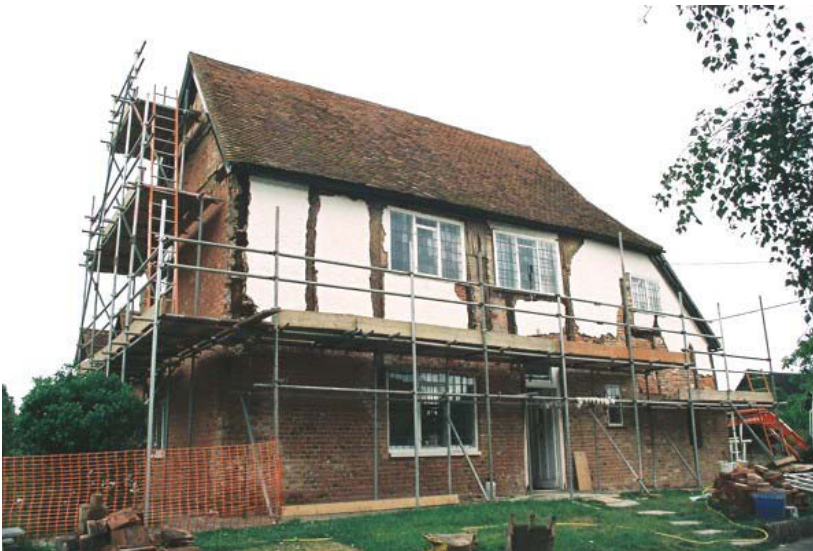
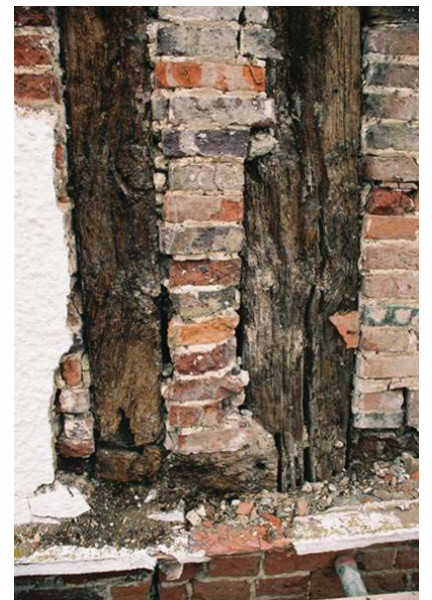
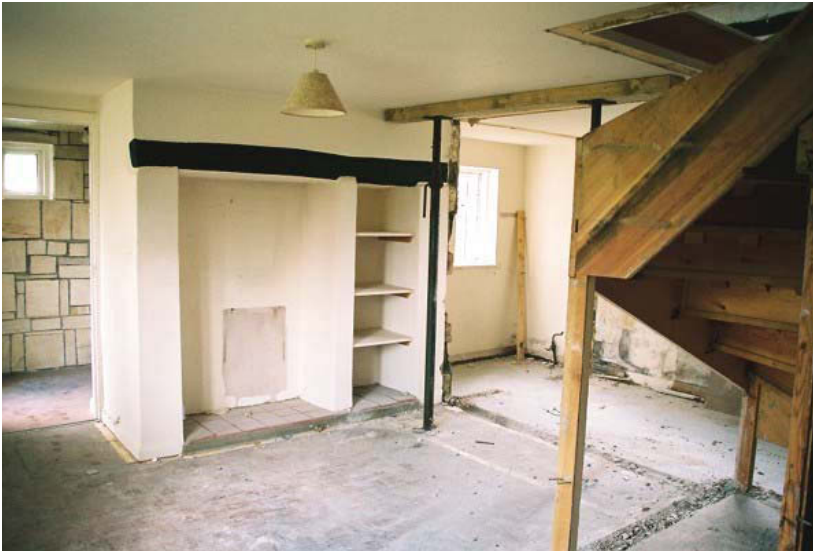
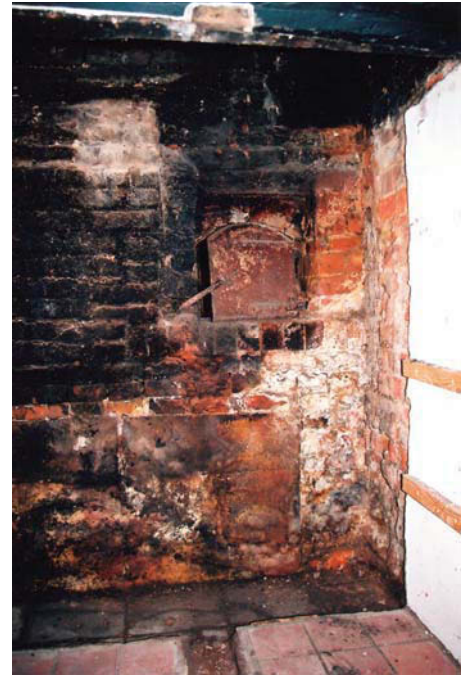
Fig 6 South-east Elevation

cill, the other has mortices for a missing rail and a separate stud forming the northern jamb which suggests that this is a historic window position. The timbers were generally in poor decayed condition, particularly the south-west corner post which was heavily eroded. The north-east corner post survives to nearly its full height and has the slighter secondary framing to the outshot butted against it. This was probably brick-nogged from the outset as the bricks are thin, often vitrified and mainly laid as stretchers.

- Before removal of rendering
- Decayed SW corner post
- Framing detail over door
- Framing detail between first floor windows
- Framing on first floor exposed
- Framing at north-east end

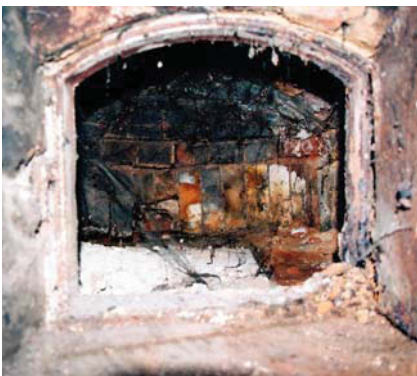
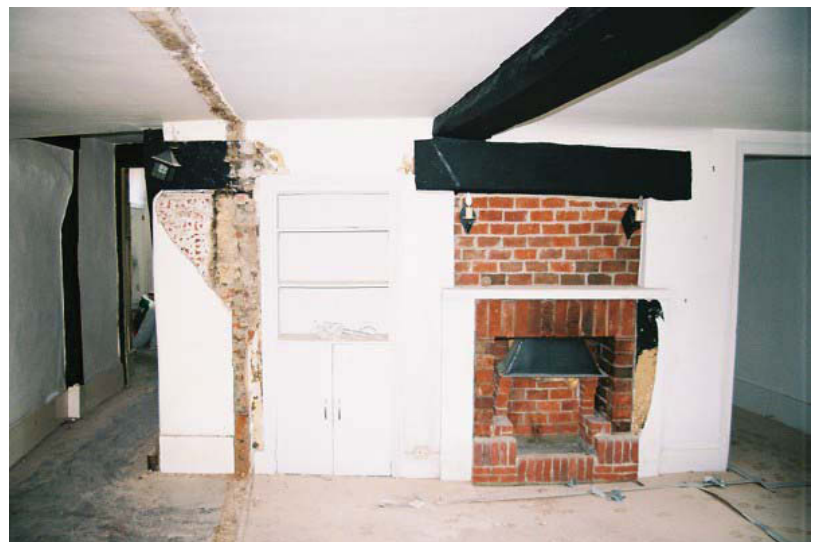
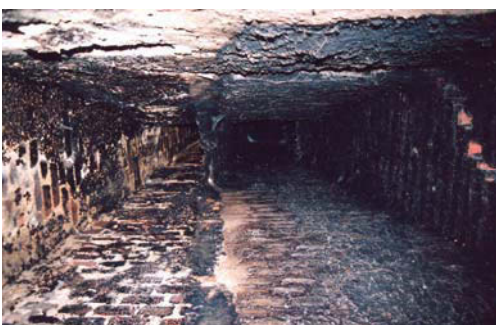
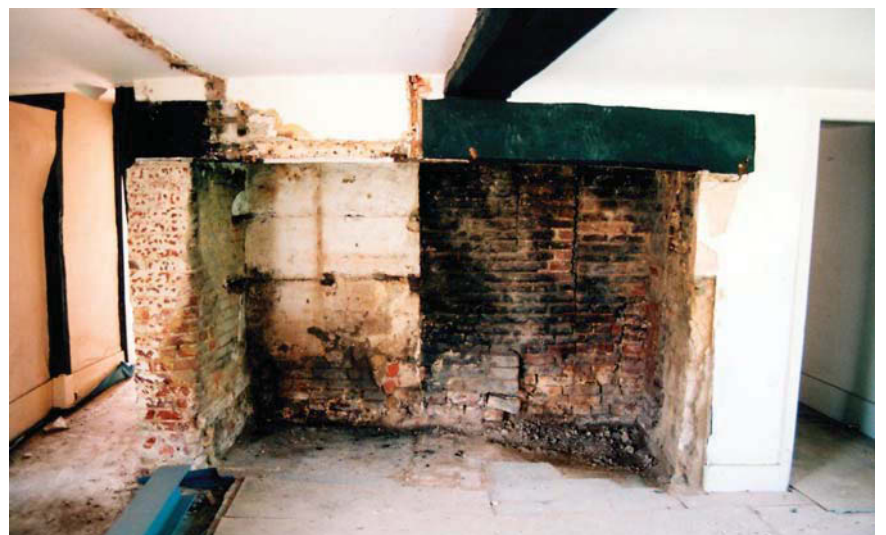
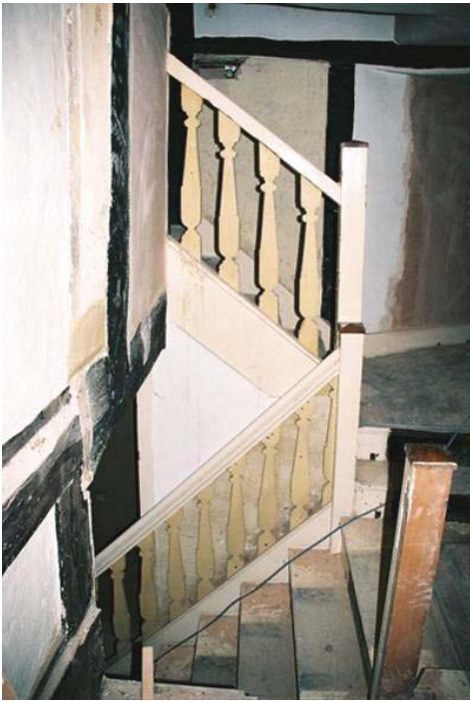
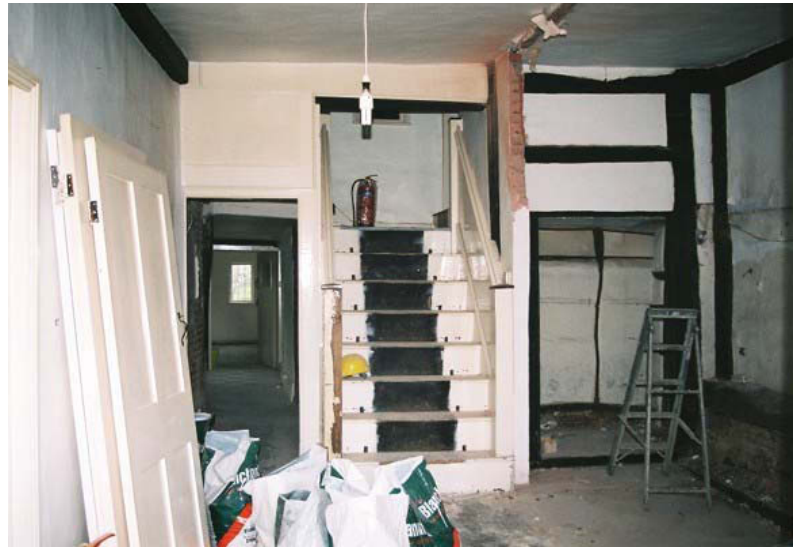
Fig 7 Ground floor
(clockwise from top left)

- Fireplace in study before opening up
- Back wall of study fireplace with door to oven
- Fireplace in dining room before opening up
- Fireplace in dining room after opening up
- Flue to dining room fireplace
- Oven detail, study fireplace

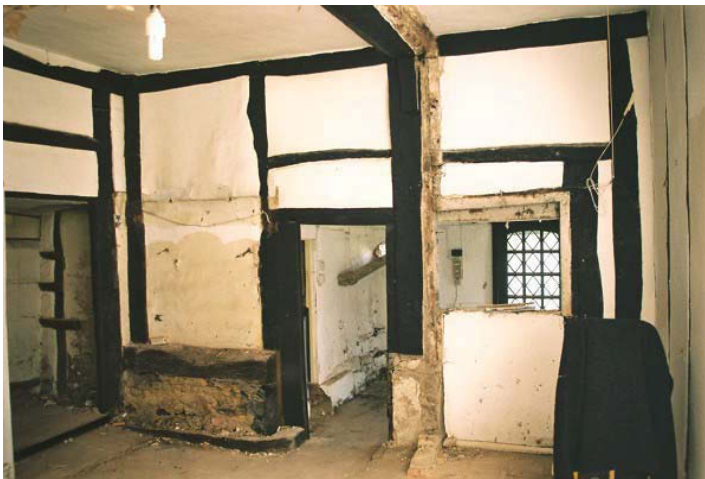
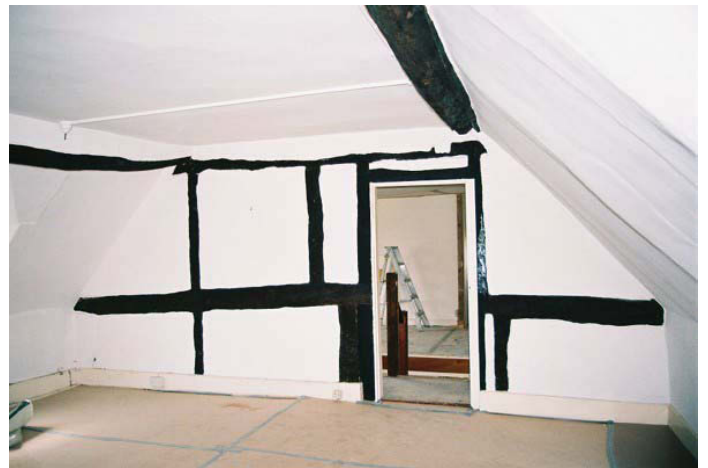
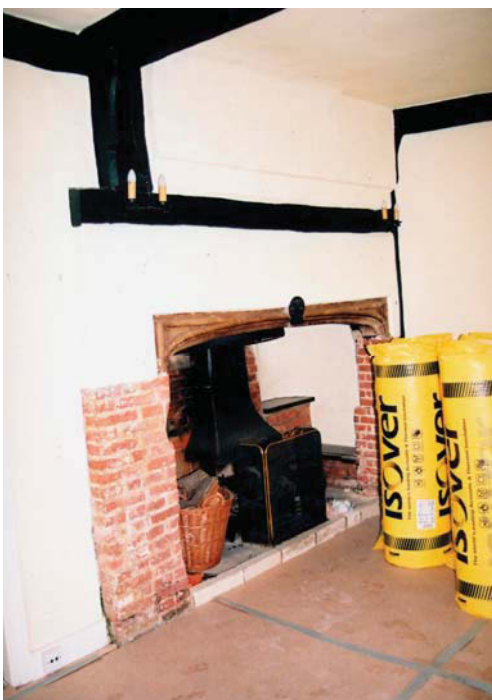
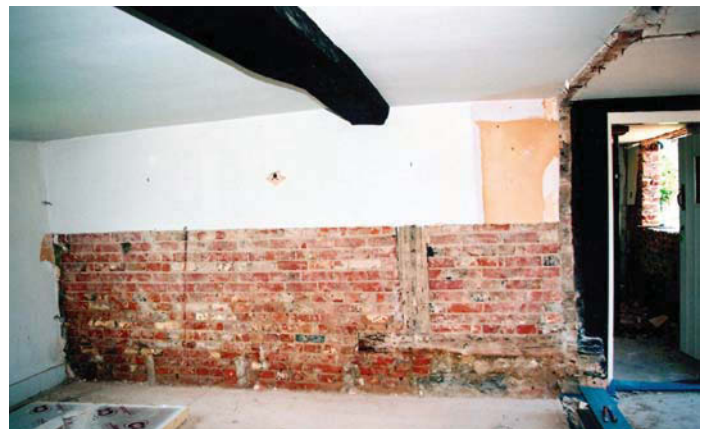
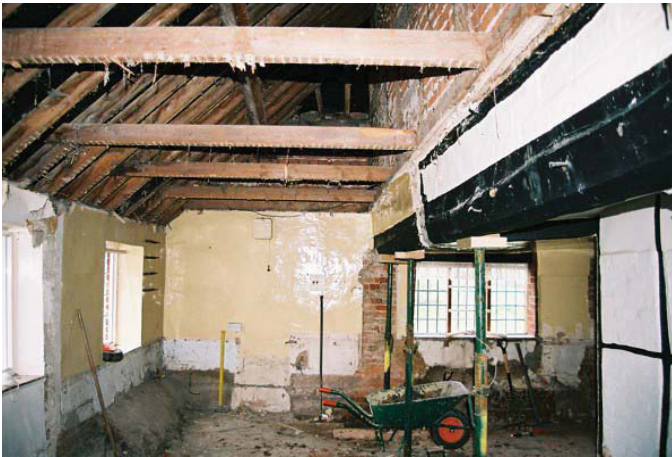
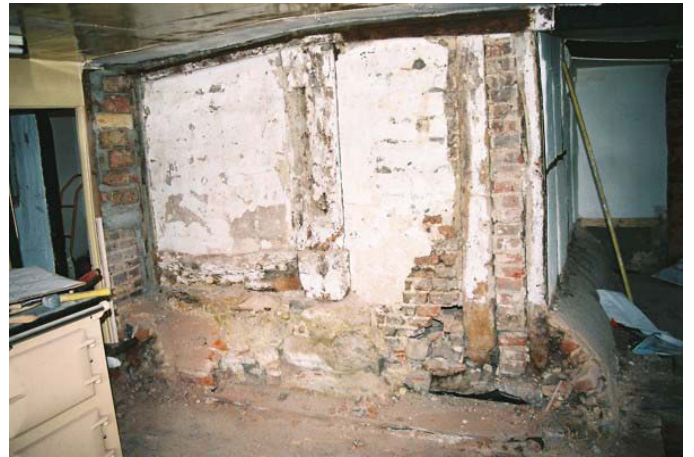
Fig 8 Ground floor
(clockwise from above)

- Hall looking north-west
- Dining room/study partition; first floor
- Dining room/study partition; ground floor, fragmentary cill beam & post
- Drawing room fireplace; lintel of c.1500
- Hall, north-east wall of wing, formerly external with cill beam on rubble plinth
- Staircase with exposed splat balusters, cut through original external wall of wing

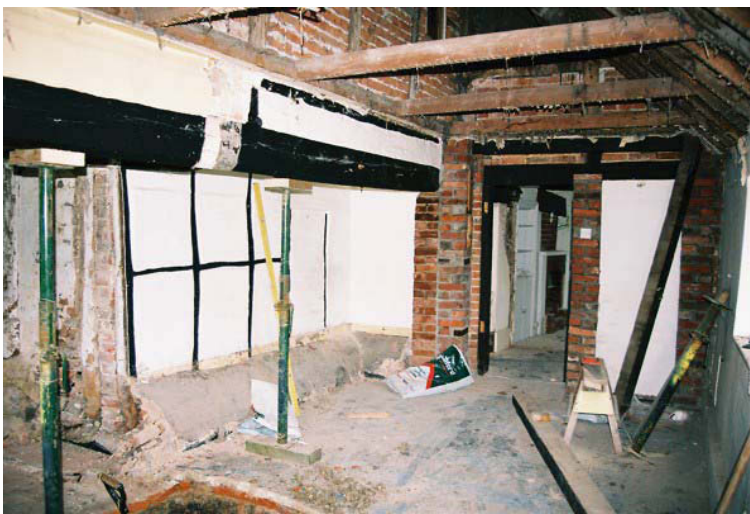
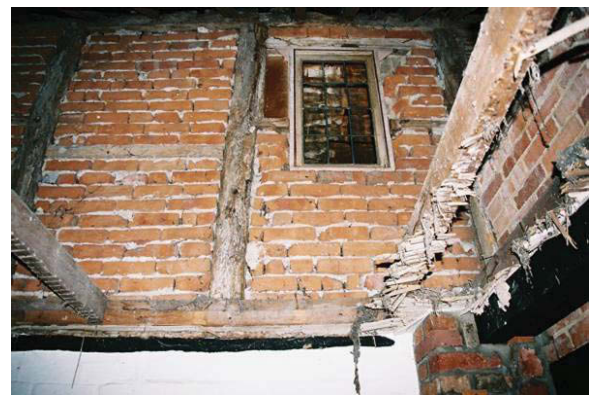
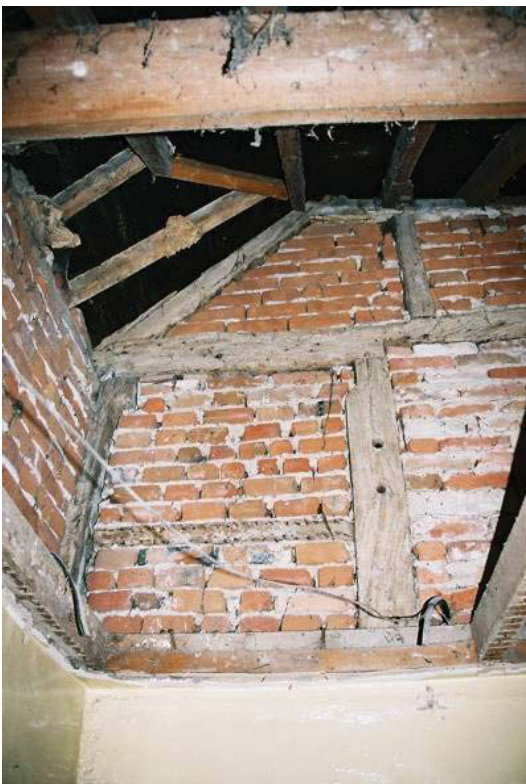
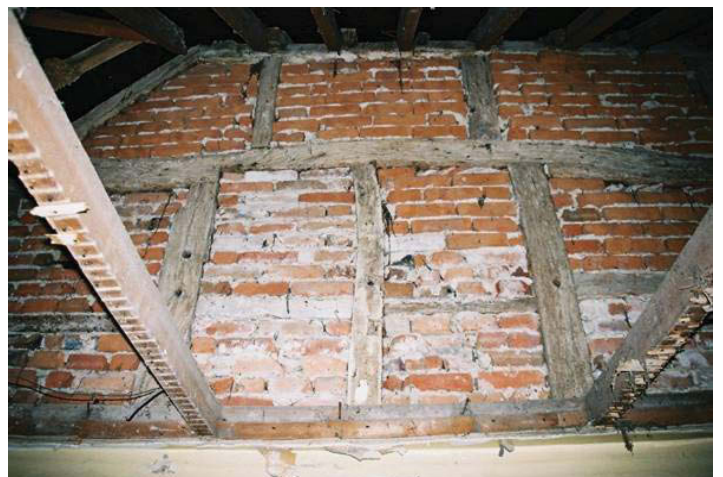
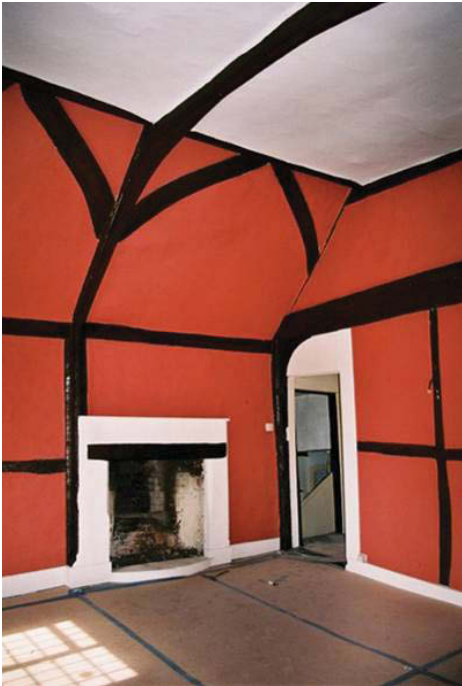
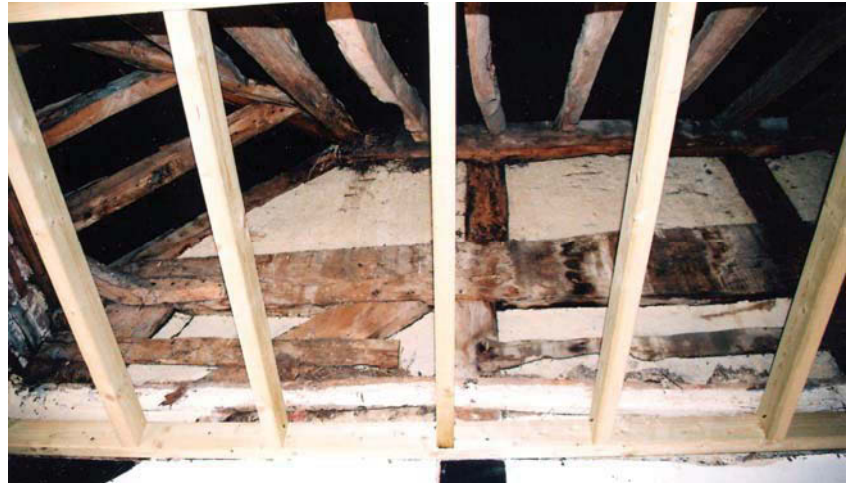
Fig 9 **Ground floor**
(clockwise from top right)

- North-west corner of wing; corner post & cill beam on plinth
- Kitchen ceiling removed to expose formerly external NW wall, timber-framed and nogged with brick
- Framing detail NW wall
- Framing detail corner of NW wall
- Kitchen looking SW; framing supported on beam
- Kitchen looking NE

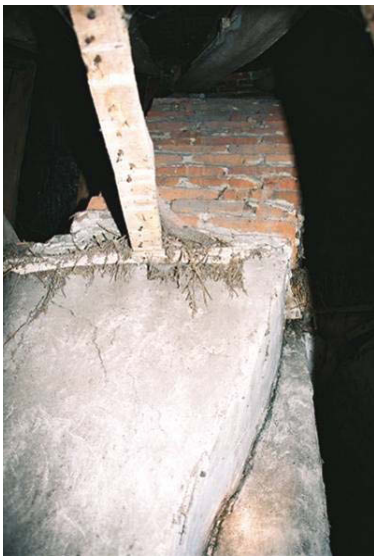
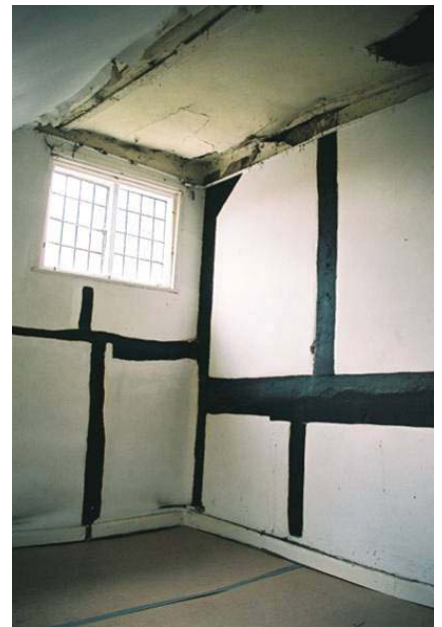
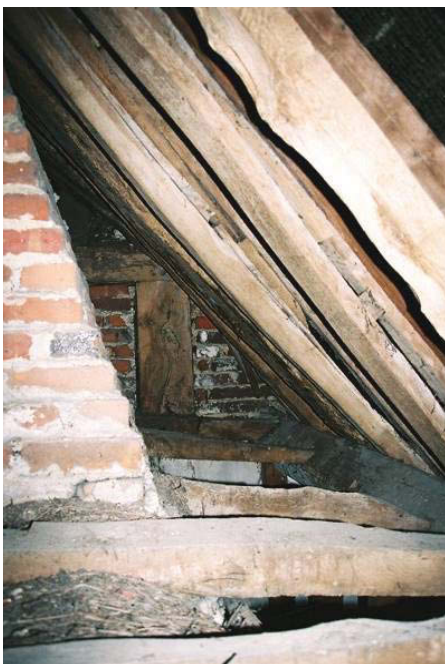
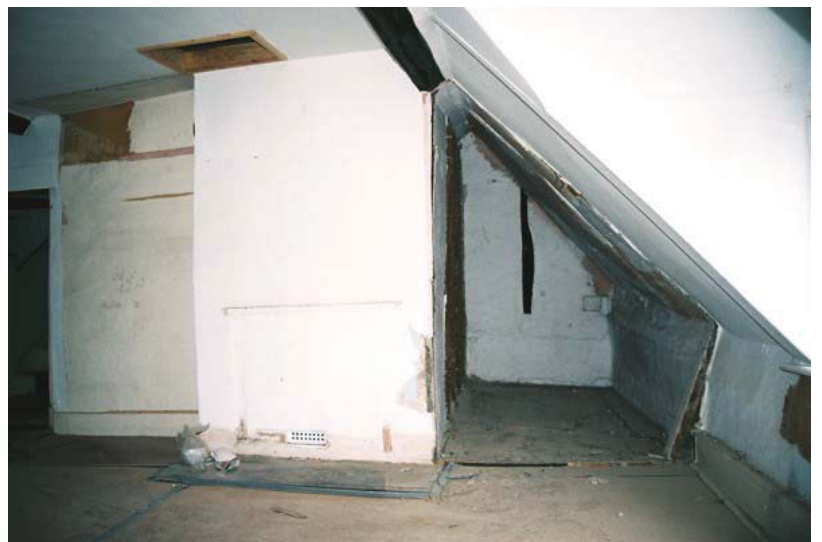
Fig 10 First floor
(clockwise from top left)

- Chamber over drawing room
- Room over utility; ceiling removed to expose external NE gable of wing
- Room over utility before removal of ceiling
- Room over dining room; upper part of chimney stack with blocked 19th century fireplace
- Looking along side of dining room stack to former external wall of wing
- 19th century flue added to dining room stack
