A Historic Building Survey  
of Farm Buildings  
at  
HOME FARM, ISLIP ROAD,  
BLETCHINGDON  
OXFORDSHIRE

K A Rodwell  
for  
JOHN MOORE HERITAGE SERVICES

July 2009

**A HISTORIC BUILDING SURVEY OF FARM BUILDINGS**  
**AT**  
**HOME FARM, ISLIP ROAD, BLETCHINGDON, OXFORDSHIRE**

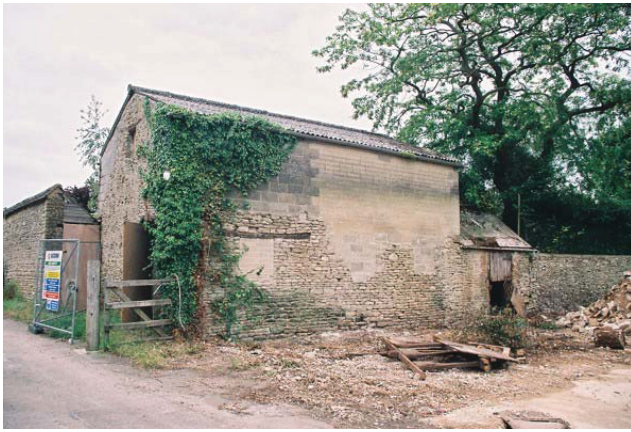
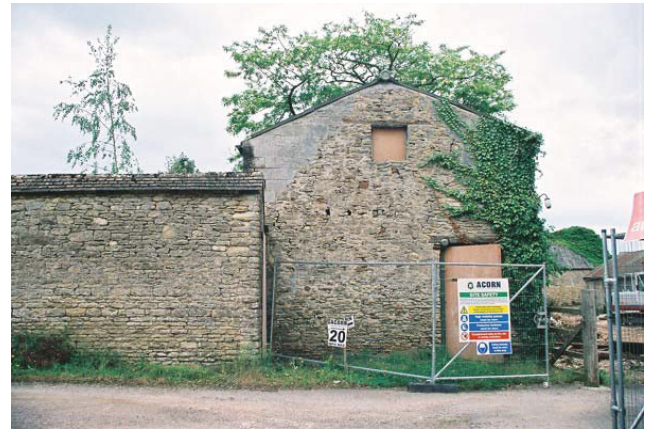
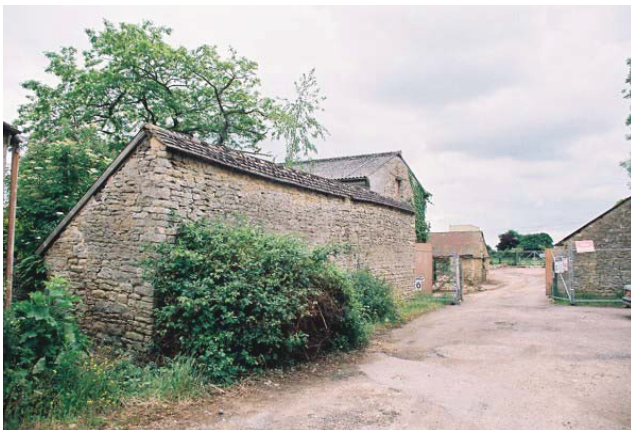
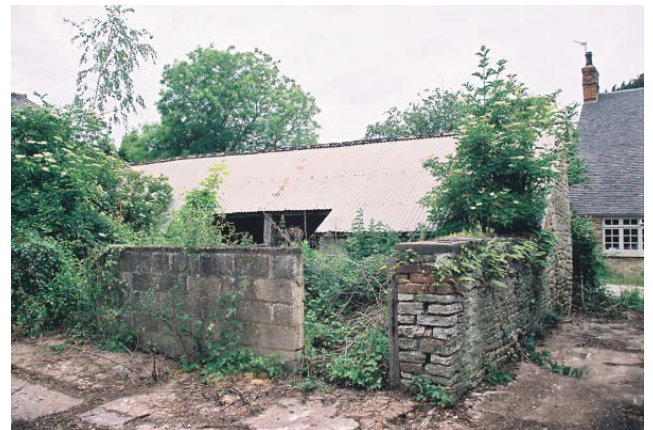
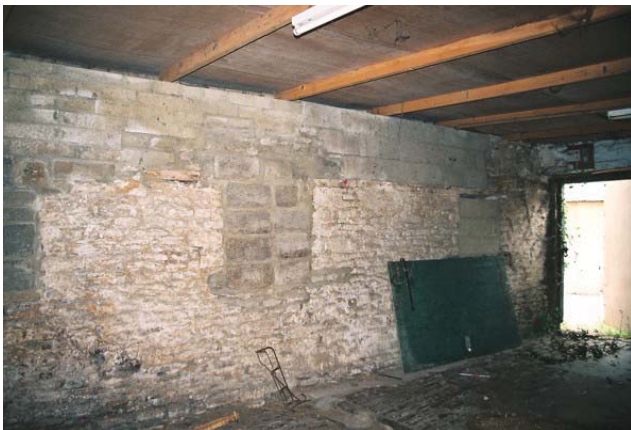
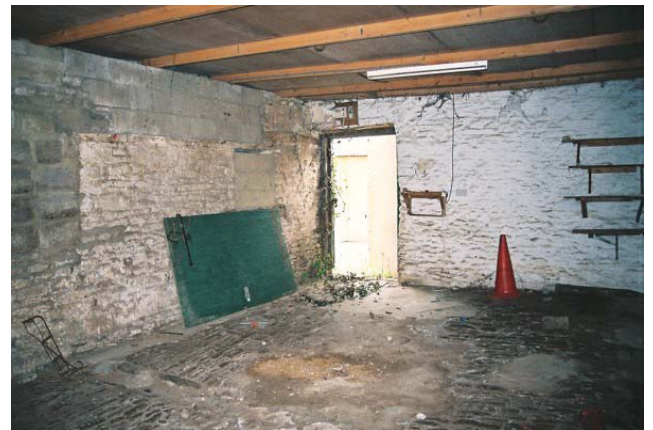
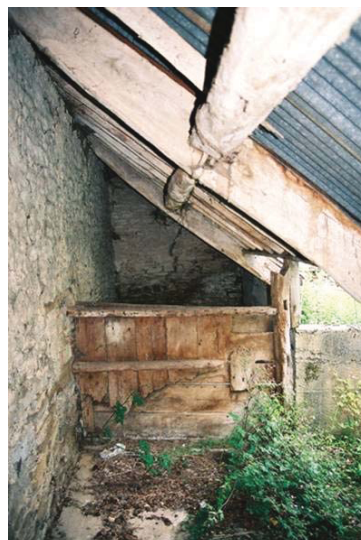
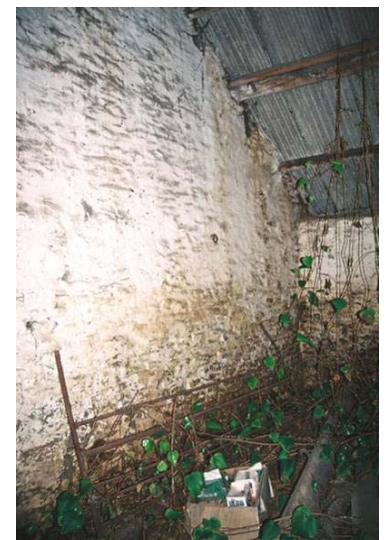
**Fig 6 Building 2**  
(clockwise from top left)

**Building 2** (Figs 2-3, 6). This is set on the north side of the yard with the west gable wall adjoining the entrance. It is built of random rubble and originally had a steeply pitched roof with low eaves which have been raised in blockwork; PH 1951 is

inscribed in cement mortar at the apex. There is an original door with a pegged frame and a gable light under a long wooden lintel. Above the door is a line of joist sockets probably for a lean-to roof. The south elevation originally had three windows, all infilled with blockwork when the wall was heightened; one retains its lintel. The interior of the main building repeats the structural sequence visible externally and has a pitched limestone floor with a drain. The inserted upper floor and the roof are modern.

A single-storey rubble-built outbuilding is butted against the east end; this has a boarded stable-type door. There is a gable light and a lower window in the east wall; both are blocked. It has a corrugated roof on old purlins without a truss.

Adjoining the north-west corner of the main building at right angles with an intervening doorway is a narrow range with a high rubble west wall facing the entrance drive. This forms the rear wall of a pig sty fronting onto a subsidiary yard to the east. It has a steeply pitched rubble end wall which continues as one side of a pig pen; other subdivisions are blockwork. The three-bay roof has elm principals and purlins covered in corrugated steel and there is one old internal boarded partition. A further three pens built of brick or blockwork (all overgrown) are butted against the north wall of the main building.

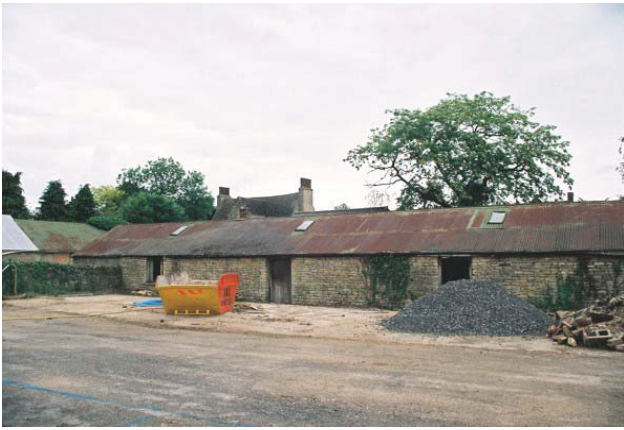
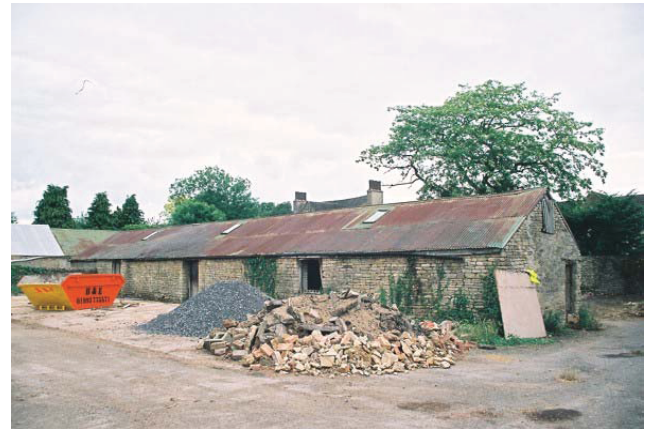
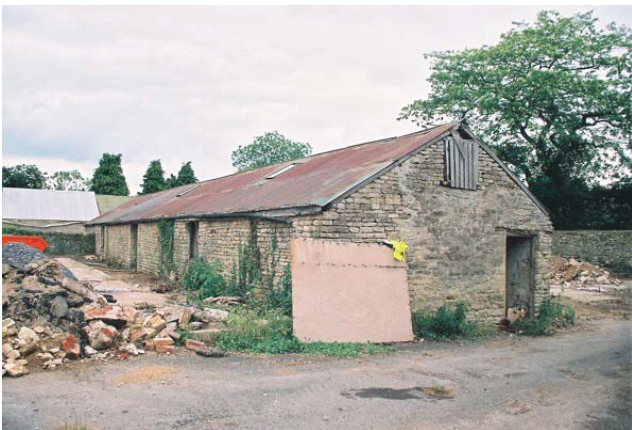
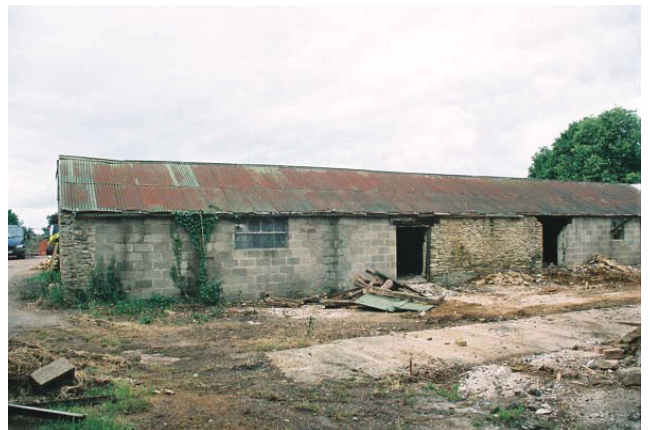
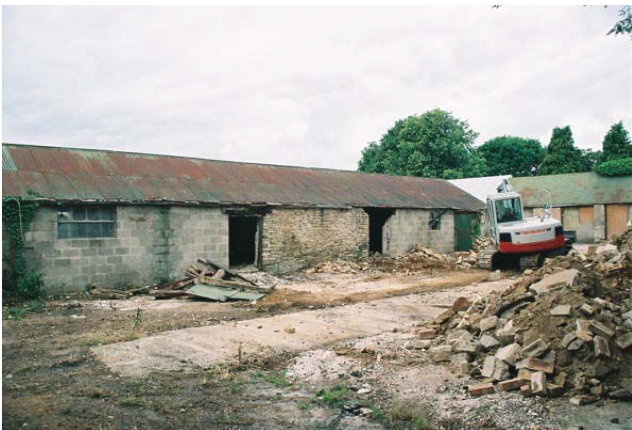
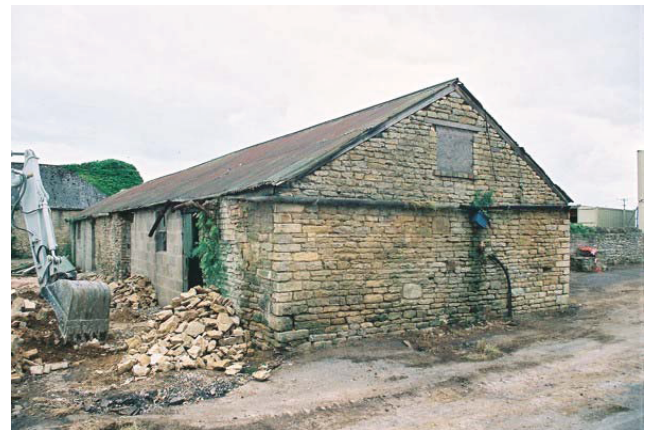
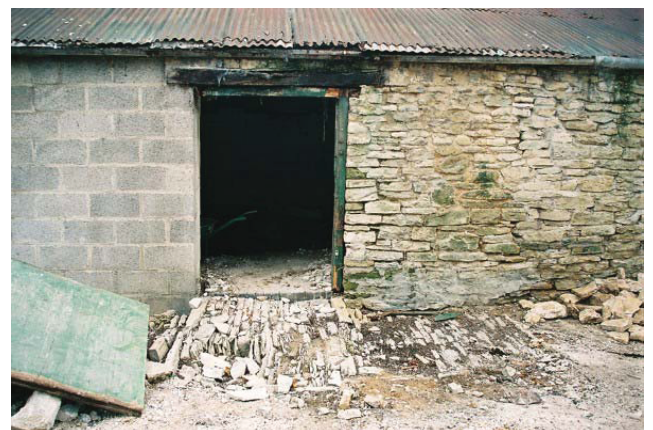
**Fig 7 Building 3**  
(clockwise from top left)

**Building 3** (Figs 2, 4, 7-8). This single-storeyed building is set across the southern side of the yard and is free-standing with open space to the south. It is constructed of coursed and roughly squared limestone rubble set in soft brown mortar and has a corrugated iron roof. The south wall is of uniform construction with a central door and two evenly spaced windows; these have pegged pine frames and secondary yellow brick cills; the door is boarded. The east gable wall has two builds; the south end and apex are like the south wall but the remainder is random rubble with a door at the north end. The quoin of the north wall is also random rubble but the majority of this elevation is concrete blockwork. In the centre there is a length of random rubble walling between two doorways and the west end beyond a third door is also rubble. The split boarded doors have pegged pine frames of 19th century type and pitched

limestone paving externally. The west wall is coursed rubble throughout with a gable light.

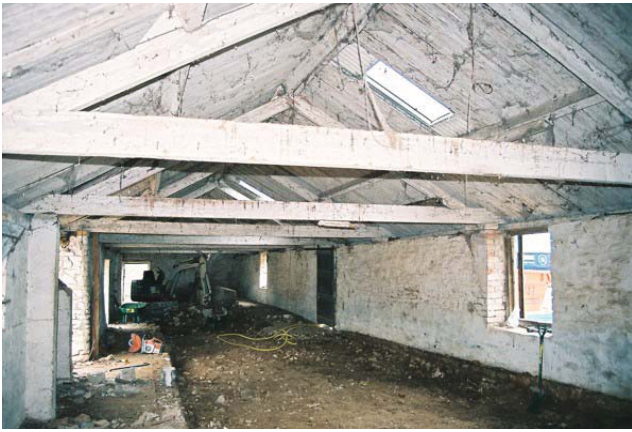
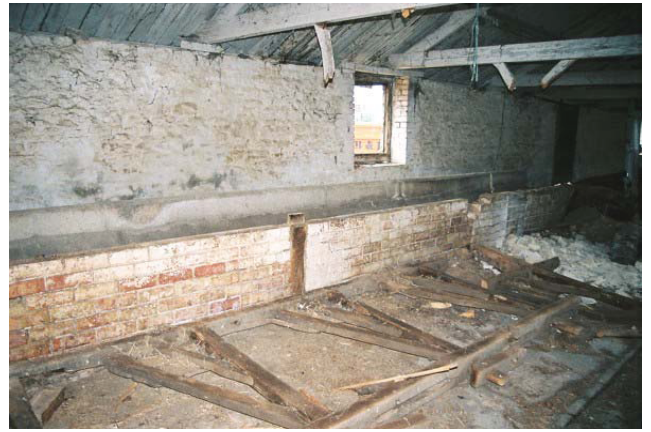
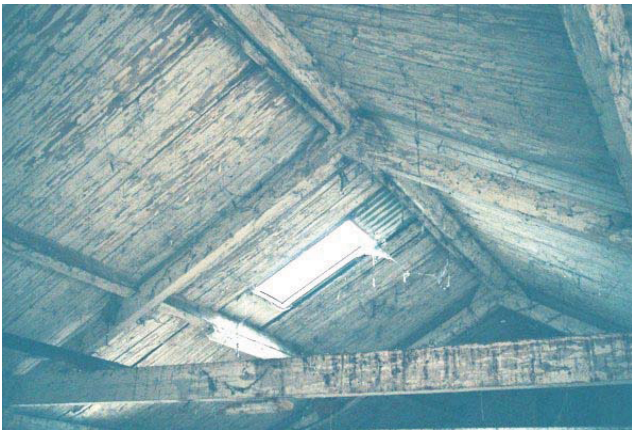
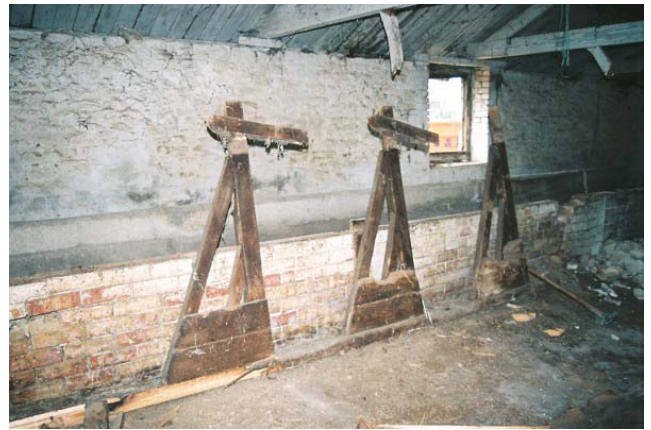
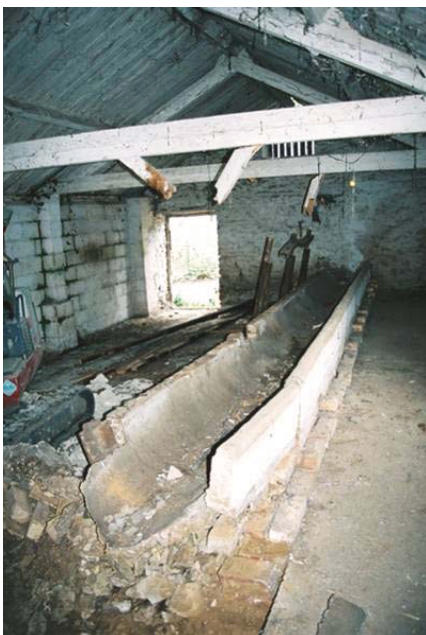
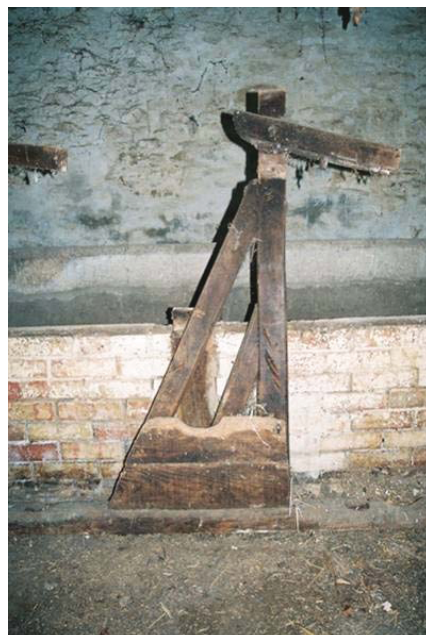
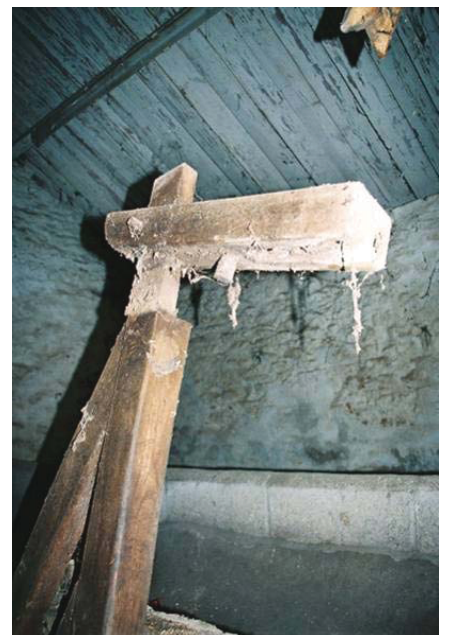
**Fig 8 Building 3, interior**

Internally the walls are whitewashed, the windows in the south wall have brick jambs and the rubble sections of the north wall lean outwards. The building is eight bays long and has a concrete-floored walkway along the north side fronting stalls with a free-standing manger to the rear and a second walkway at the back along the south wall. The manger is constructed in brick with a concrete-lined trough and incorporates a wooden stall framework with a cill beam set on the northern lip of the trough; posts are built in at intervals (dismantled at time of survey). The posts were 1.08m apart and 1.4m high with paired diagonal braces, boarded at the foot on the east side. There was a continuous top rail; fixed directly over this each post had a pivoted top member c.0.5m long with an open mortice in the underside at the free end (Fig 8). These were held clear of the top rail by short projecting pegs. There are seven triangular roof trusses of machine-sawn pine set on a plate on the north wall and bearers on the south side. A single tier of edge-set purlins is lodged on the back of the trusses and there are paired ridge-pieces. The roof slope is boarded.

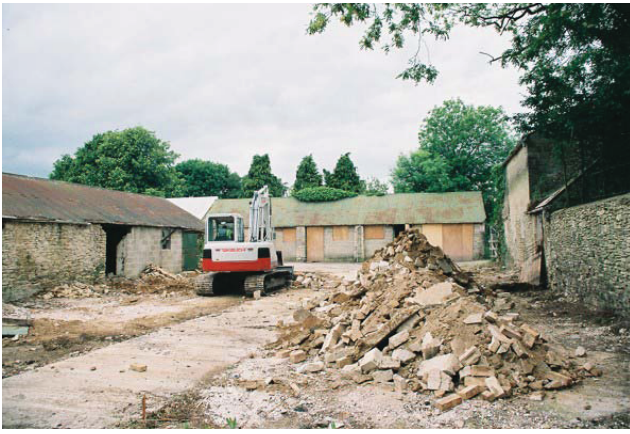
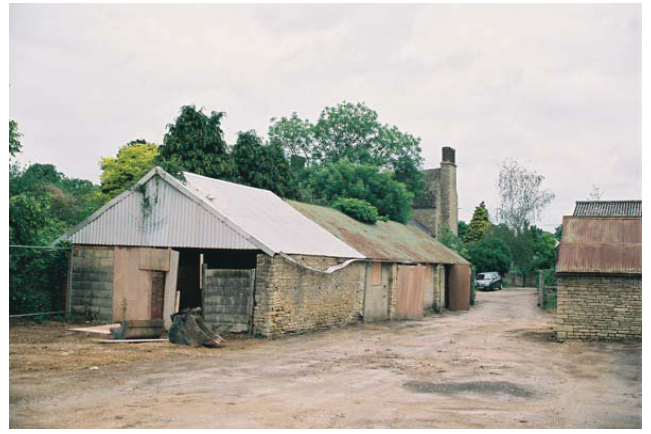
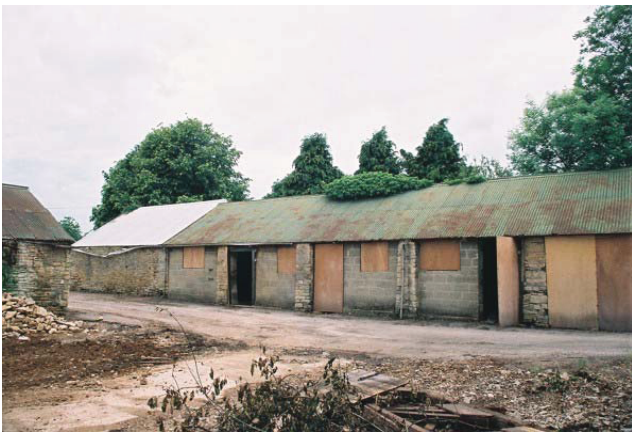
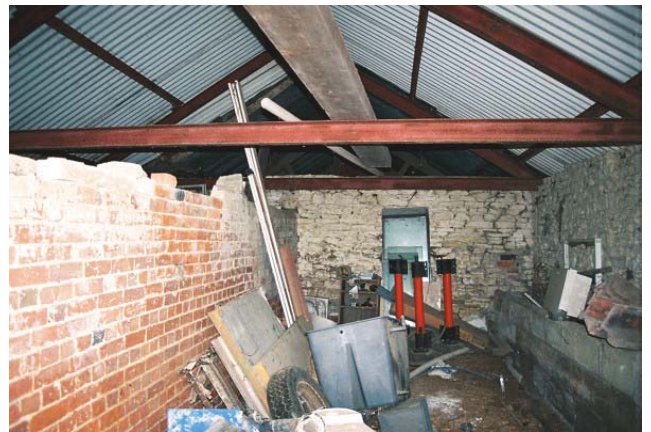
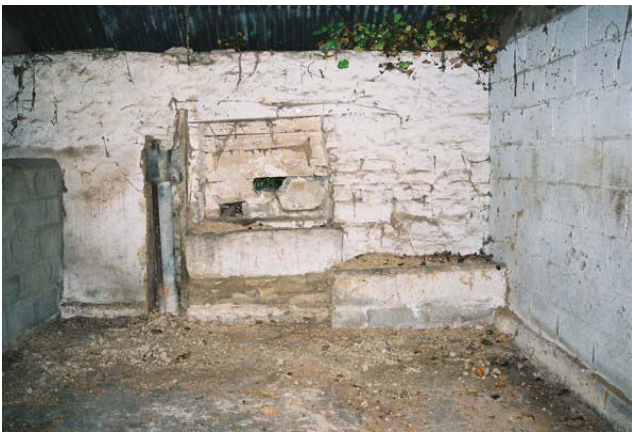
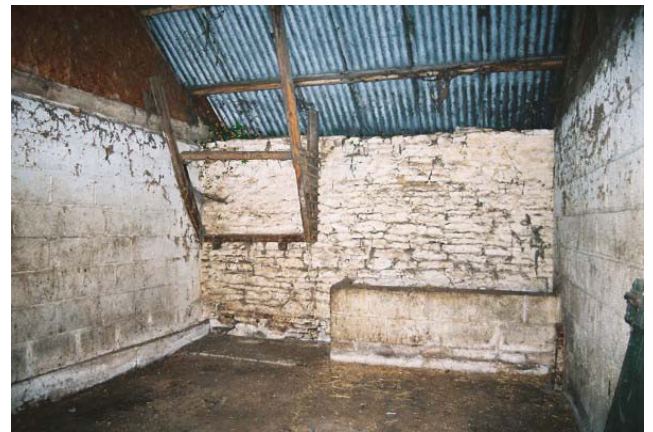
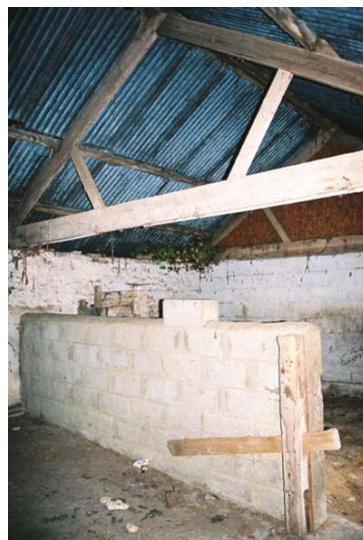
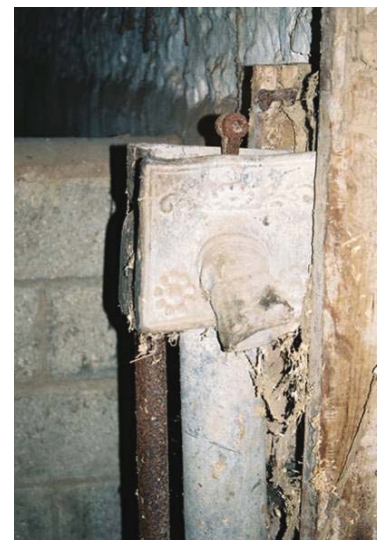
**Fig 9 Building 4**  
(clockwise from top left)

**Building 4** (Figs 2, 5, 9). This is set on the western boundary of the site and is single-storied. The main part is five bays long and was originally open fronted with square rubble piers, now infilled with concrete blockwork. The west wall is plain rubble and there is a corrugated iron roof. The north wall is rubble but is infilled between the back wall and a pier, indicating that the building was originally longer. Internally it is divided on the bay lines by concrete block partitions and has roof trusses of machine-sawn pine with nailed diagonal struts and edge-set purlins. One of the compartments has a blocked opening in the west wall which has had a stone trough inset. This was fed by a square-headed lead pump with a spout and foliate ornament in low relief. Other units have blockwork mangers built against the west wall.

The south end is later and consists of two deeper bays originally open to the south with a coursed rubble east wall and a west wall partly rebuilt in brick. The interior is

divided longitudinally by a brick wall in English bond; this is not full height. There is a modern corrugated steel roof and trusses.

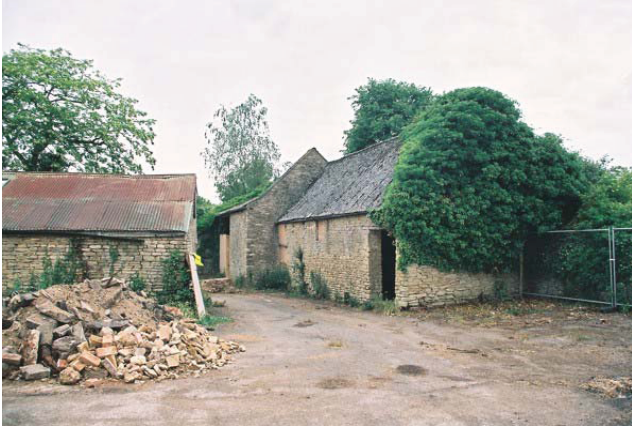
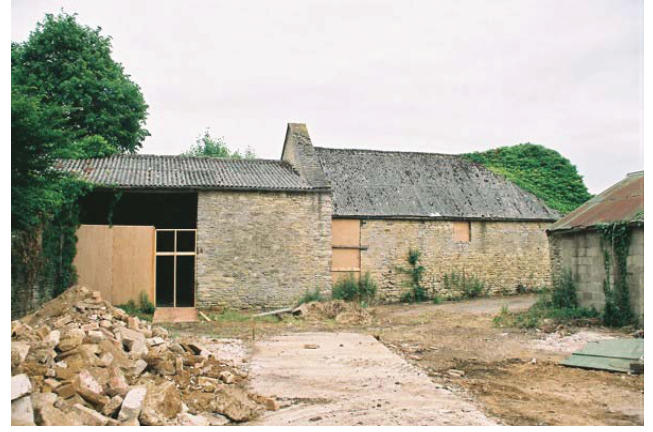
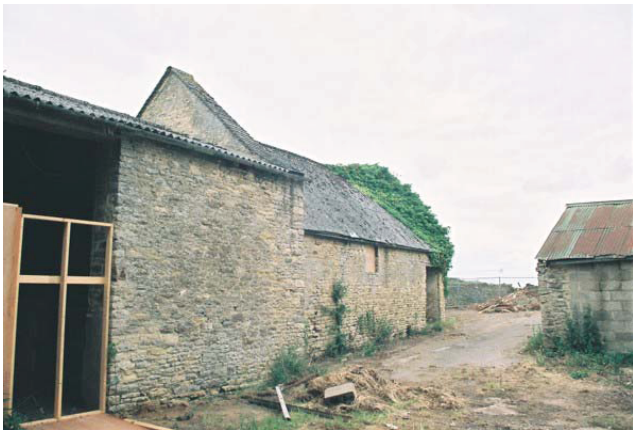
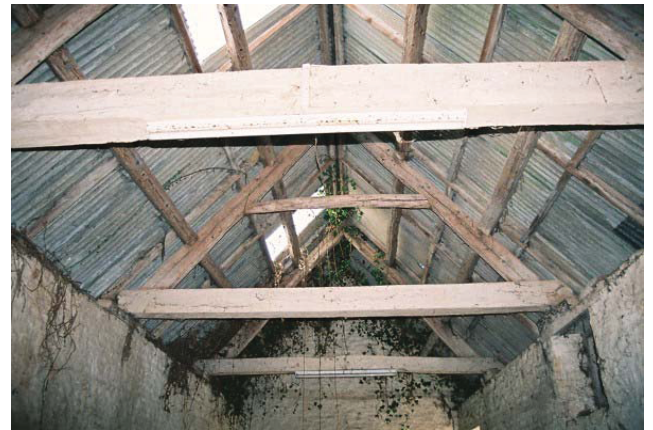
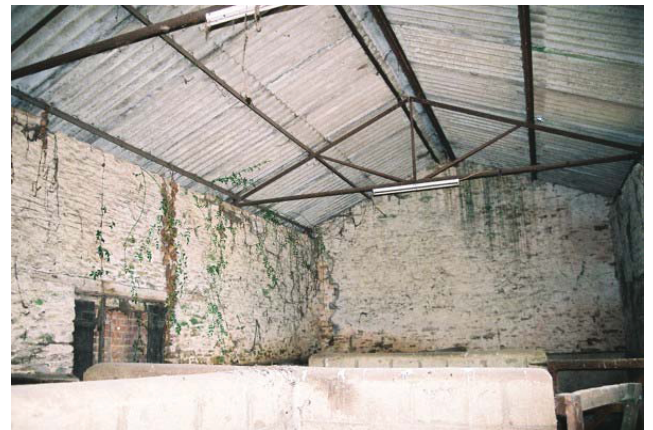
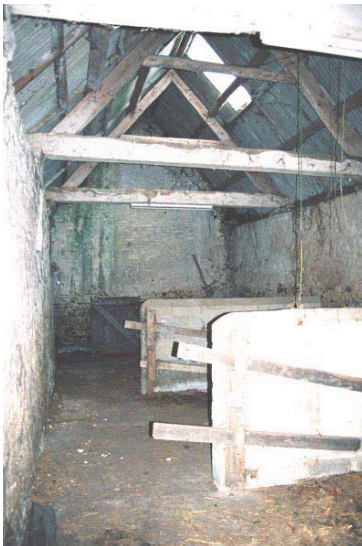
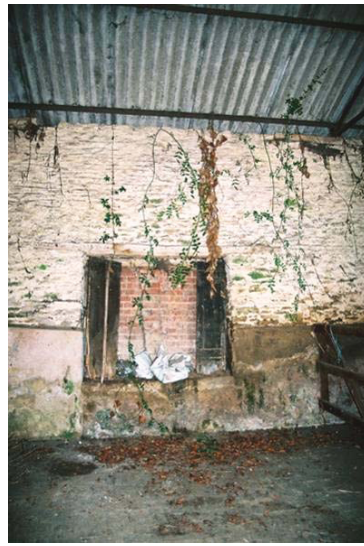
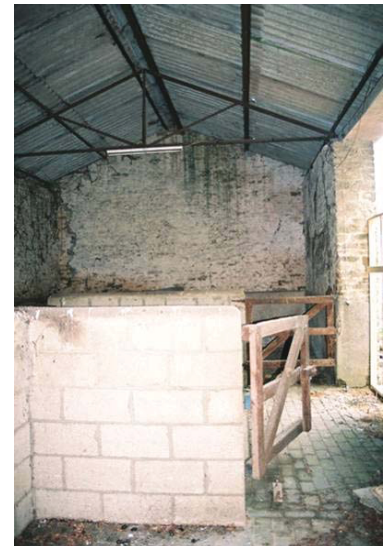
**Fig 10 Building 5**

**Building 5** (Figs 2-3, 10). This is set on the eastern boundary of the yard and is in two sections. The southern unit is the later and is built of more regularly coursed rubble with a full-height doorway at the north end, a smaller door at the south end and a high-level window. There are no openings in the south and east walls. Internally it has three original roof trusses, probably elm, of pegged construction with substantial tie beams and slighter waney collars, two tiers of purlins halved over the principals and a sequence of chisel-cut carpenters' marks. The rafters are contemporary with the corrugated asbestos roof. The floor is concrete and there are two concrete block stall partitions.

The northern unit is constructed of thinner greyer rubble and is three bays long with a wide central cart door in the west wall; this has a concrete lintel. In the opposite wall there is a smaller doorway with a wooden lintel; this has been blocked in brick and concrete and has a pair wooden shutters. The roof is corrugated asbestos on 20th century angled steel trusses at a lower pitch than the original; the south gable wall survives to its original height. There is a brick floor and paired pens of concrete blockwork in the end bays.
