K A Rodwell for JOHN MOORE HERITAGE SERVICES June 2009

# A REPORT ON A FIREPLACE AT ARDWICK HOUSE, CHURCH ROAD, WHEATLEY, SOUTH OXFORDSHIRE

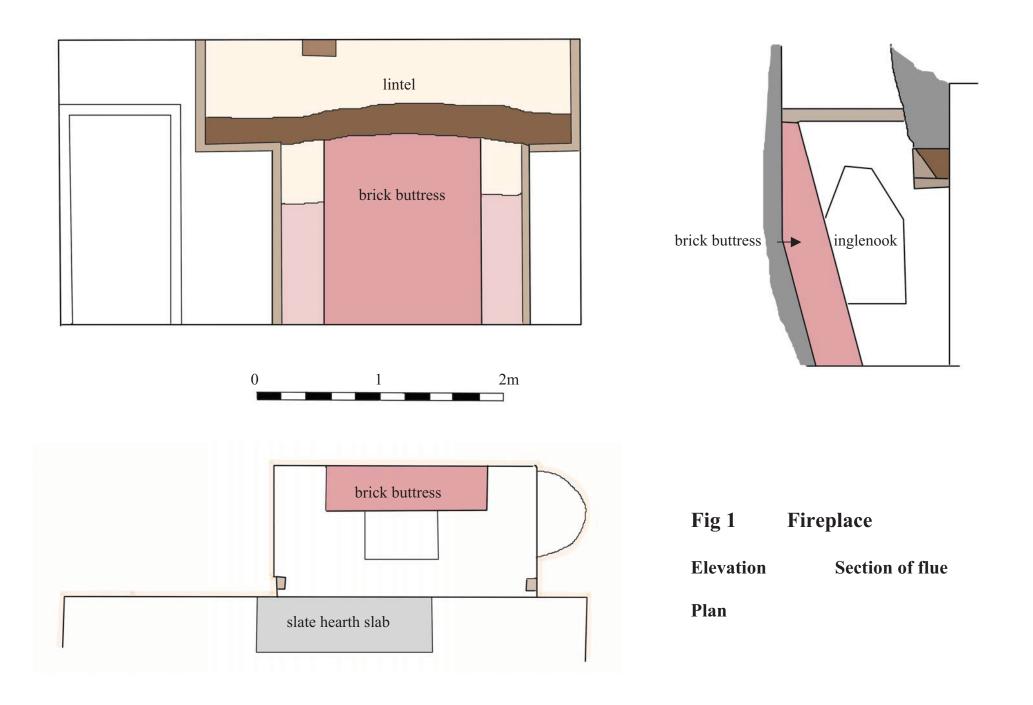
Fig 1 Fireplace: plan, elevation and section through flue

The fireplace has an exposed cambered oak lintel with ends c.0.3m square; the jambs below are plastered and proud of the face of the timber which is pecked for plaster; the wall above is painted random rubble. The junction between the two finishes is edged with oak battens and there are oak 'jambs' inset below the lintel. The hearth is c.1m deep at floor level and has an inglenook on the north-east side; the recess is formed in rubble and repaired in brick and has a 20th century wooden seat. The western reveal is also brick and there appears to be a filled opening, either a second inglenook or an oven door.

Butted against the back wall is a brick 'buttress' 1.28m wide, 2m high and c.0.4m deep. It has a sloped face and discontinuities in the coursing at the base indicate the

position of a previous grate. The wall to the rear is also faced with bricks of different dimensions to a height of c.1m. This forms part of a separate build, partly contiguous with the inglenook which runs behind the 'buttress'. The upper back wall and the whole of the flue above lintel level are rubble-built and heavily sooted. There are high level timber ties at intervals which have double-ended hooks on their undersides; these are probably intended for hanging foodstuffs to smoke. The top of the flue is divided and currently open. The floor of the hearth is mainly flat-laid bricks which appear to respect the 'buttress', painted white except for a patch where a gas fire formerly stood. Outside the hearth and offset to the south-west there is a slate hearth slab which appears to have been associated with a reduced 19th century fireplace opening set flush with the face of the wall.

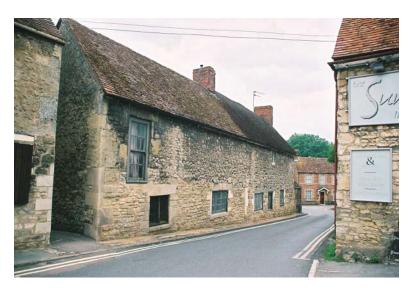
- 2) The back wall of the hearth and the inglenook were repaired in brick, probably due to wear through continuous use later in the 18th century.
- 3) The large open hearth was infilled and replaced by a smaller fireplace offset to the south-west side. This is now only represented by a slate hearth slab. The reduction probably took place in the early-mid 19th century; other features in the room indicate that the interior was modernised at this time.

- **Fig 2 A** Exterior of stack, north-west gable
  - **B** North-east elevation to Church Road, stack to right
  - **C** Hearth detail showing offset slate slab for 19th century fireplace
  - **D** Interior of flue open at top showing timbers with suspension hooks
  - **E** General view of fireplace with brick 'buttress' built in centre
  - **F** Eastern side of hearth showing inglenook; 'buttress' to left

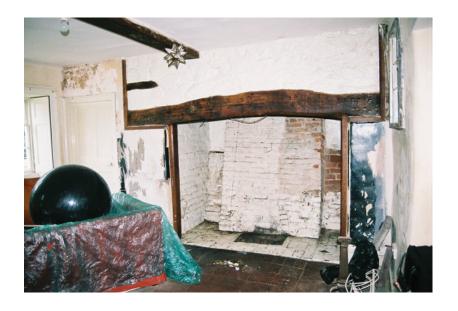
The brick 'buttress' is a secondary feature butted against the back of the hearth at a time when it had already been refaced in brick. The structural sequence suggests that the whole opening was reduced in size in the 19th century and that the 'buttress' was

introduced earlier in the 20th century when the fireplace was reopened to make a feature in the room.
