A Historic Building Survey
of Farm Buildings
at
HALLCOURT FARM, MIDGHAM,
READING,
BERKSHIRE

K A Rodwell
for
JOHN MOORE HERITAGE SERVICES

July 2009

A HISTORIC BUILDING SURVEY OF FARM BUILDINGS
AT
HALLCOURT FARM, MIDGHAM, READING, BERKSHIRE

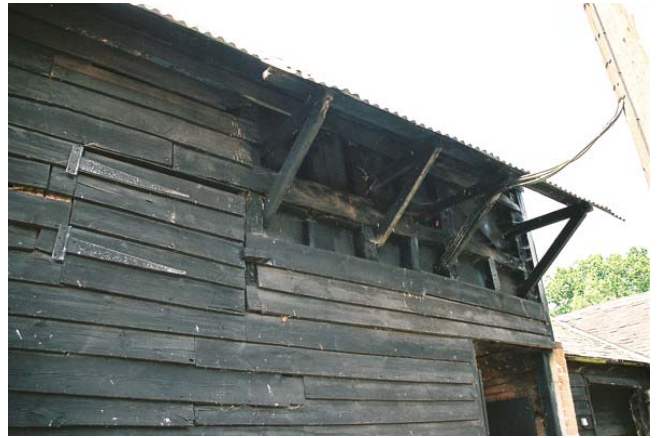
Roof detail; north end of east elevation

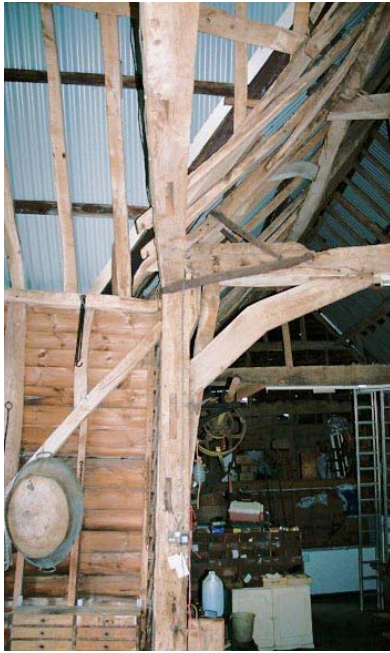
Post on north side of porch with mortices for missing brace and mid-rail

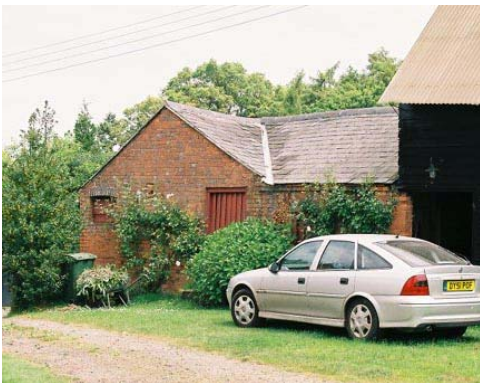
East elevation of stable M with blocked door & windows
