NUNHIDE FARMHOUSE SULHAM BERKSHIRE

An Architectural Investigation

IMOGEN GRUNDON

September 2011

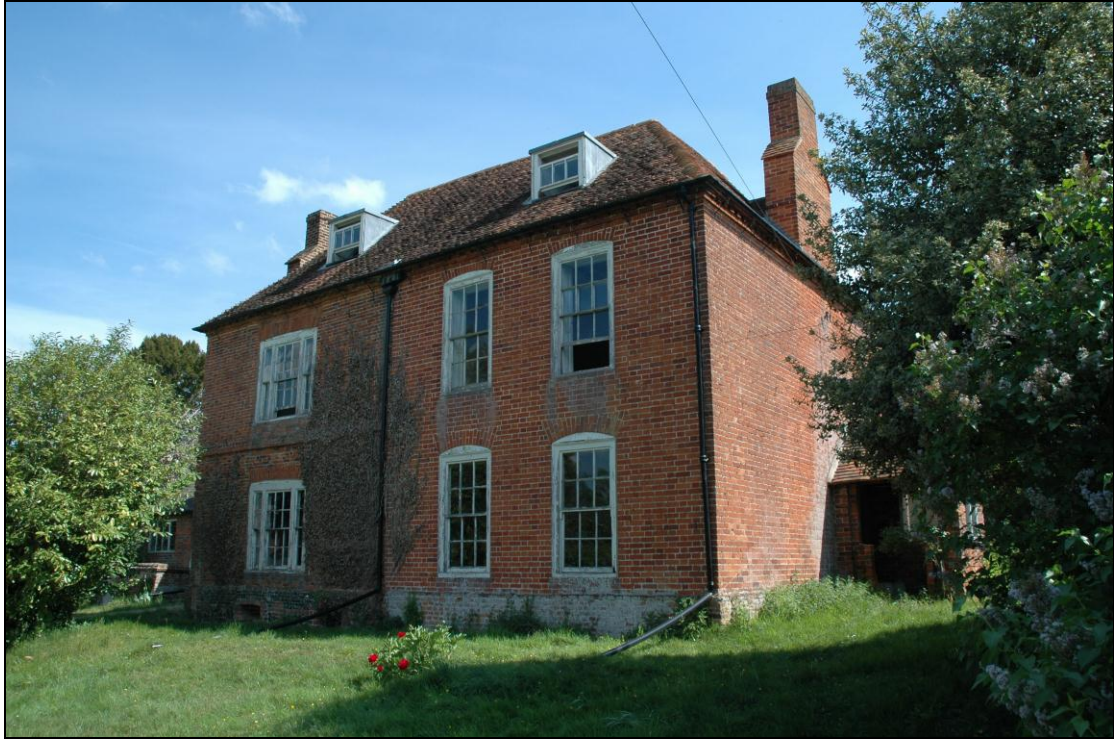
Fig 1. The Principal (West) Elevation

This shows that there are in fact two separate builds apparent on the exterior and there has been no attempt to disguise the fact. The brick bond used on both halves is Flemish, though there is a difference in the bricks and mortar used. Two further extensions have been added to the north end of the building and a porch on the south end.

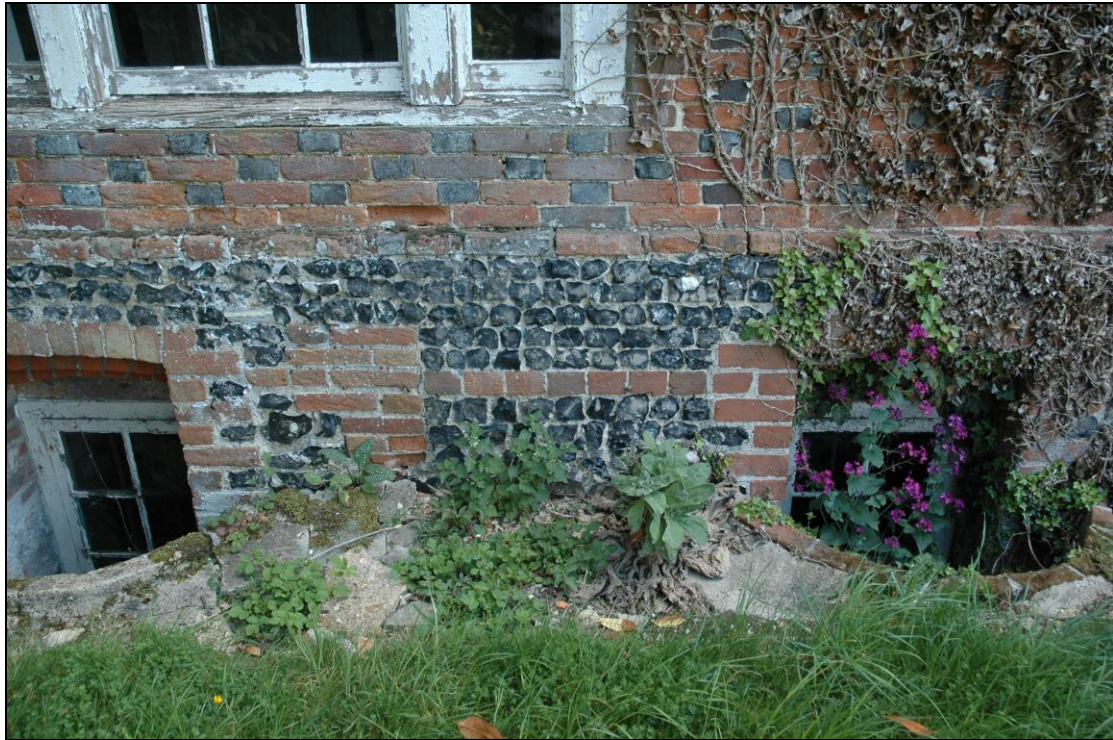
Fig 2. The brick and flint plinth of the north part of the west elevation with basement windows and light-wells

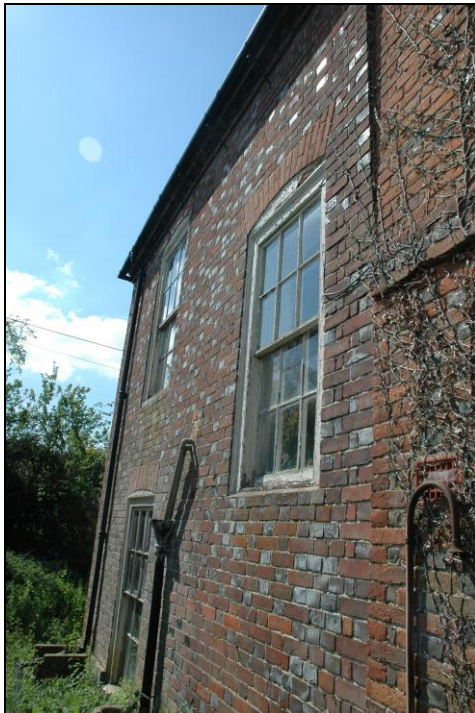
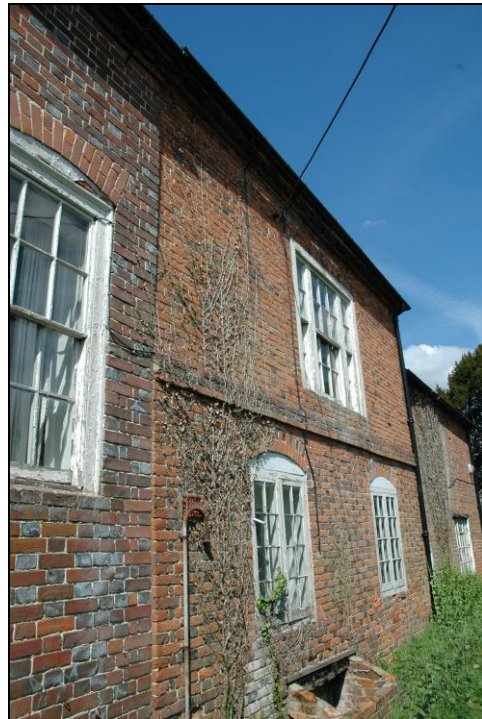
Figs 5 & 6. The East Elevation with the south end on the left and north on the right. Distortion from differential settling of the two halves is clearly visible in Fig. 3.

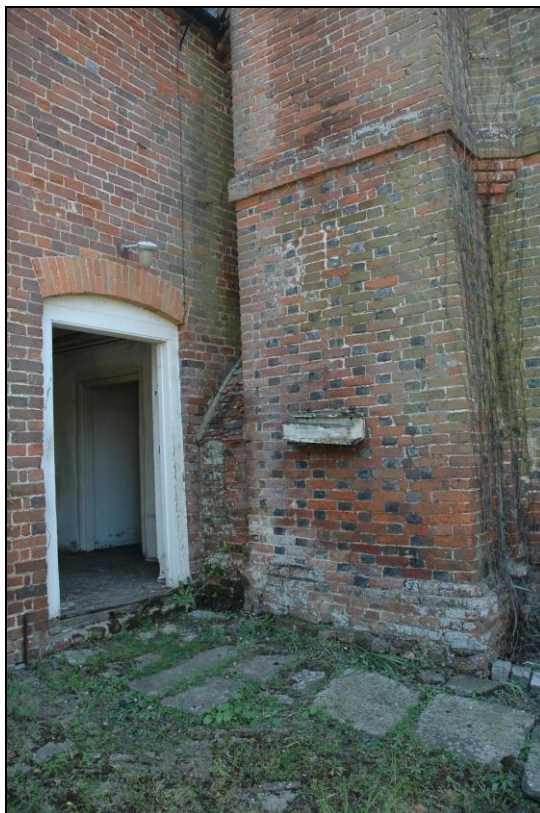
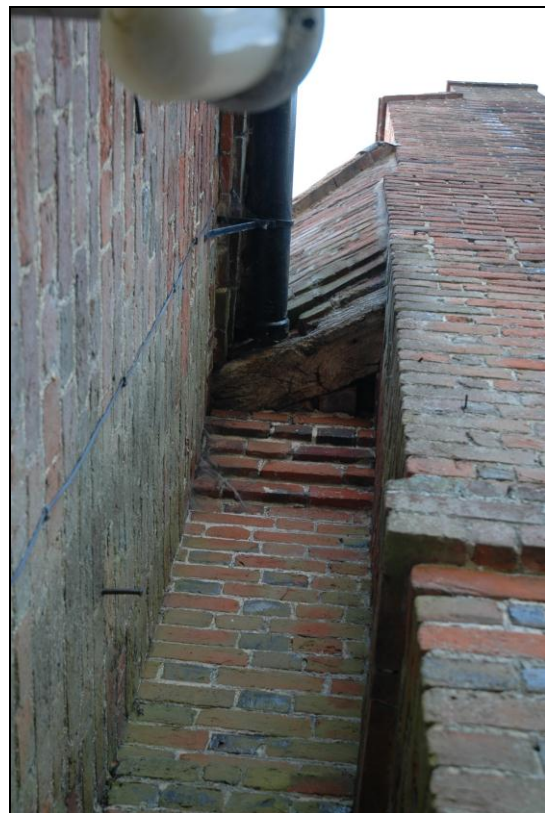
Another odd projection fills the space between the stack and the first extension at ground-floor level. This is apparently the rear of a projecting oven that formed an inglenook corner of the main fireplace in the ground floor north-west room. It has been disguised by later brickwork, as in fact has all of the earliest phase in the north part of the main house.

Figs 11 & 12. The north elevation showing the chimney stack and the anomaly on its eastern side.

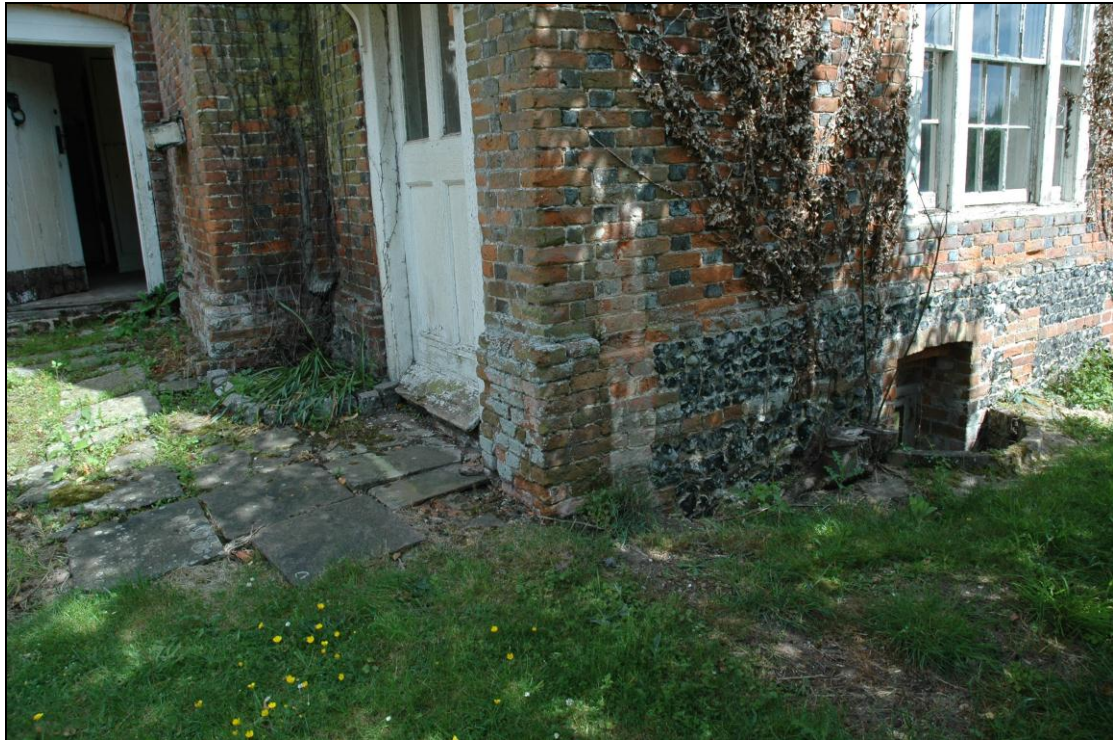
The plinth on this north side of the building is plain brick and has none of the flint so distinctive on the north end of the west elevation. It diminishes in the number of courses as it is cut into the eastern slope from 12 on the north-west corner to 5 at the junction with the first extension.

Fig 13. The north-west corner of the main house, showing the different elements of the plinth. Also seen here is the present farmhouse entrance in the first extension and some early paving slabs. The rest of this yard appears to have been paved with pebbles, which would have aided drainage and is often found in courtyards of the late 17th century. Much of this has now overgrown with grass.

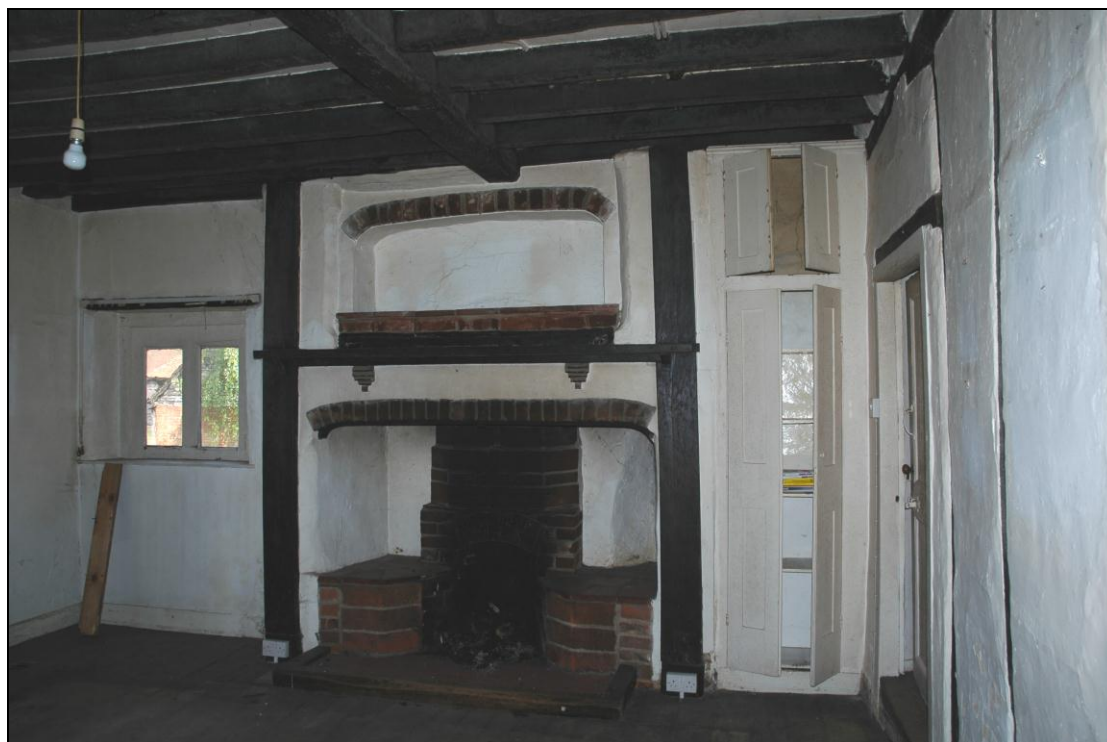
On the north wall is a door, which has been blocked, internally only, to become a window. Externally it still presents as a door. There is not enough evidence to say if there was a door here originally, but it is rather unlikely. It is more probable that the original door was on the west side and all the evidence for this has been removed. The fireplace is earlier than the 1930s surround would suggest. It has a probably late 18th-century hearth, respecting timber flooring, visible at the west end of the fireplace beneath the 1930s tile and wood hearth. This is obscured on the east side of the hearth.

Fig 20. The north wall of the Reception Room, showing the door blocked to make a window and the fireplace. The door on the right hand wall leads to the main ground-floor corridor.

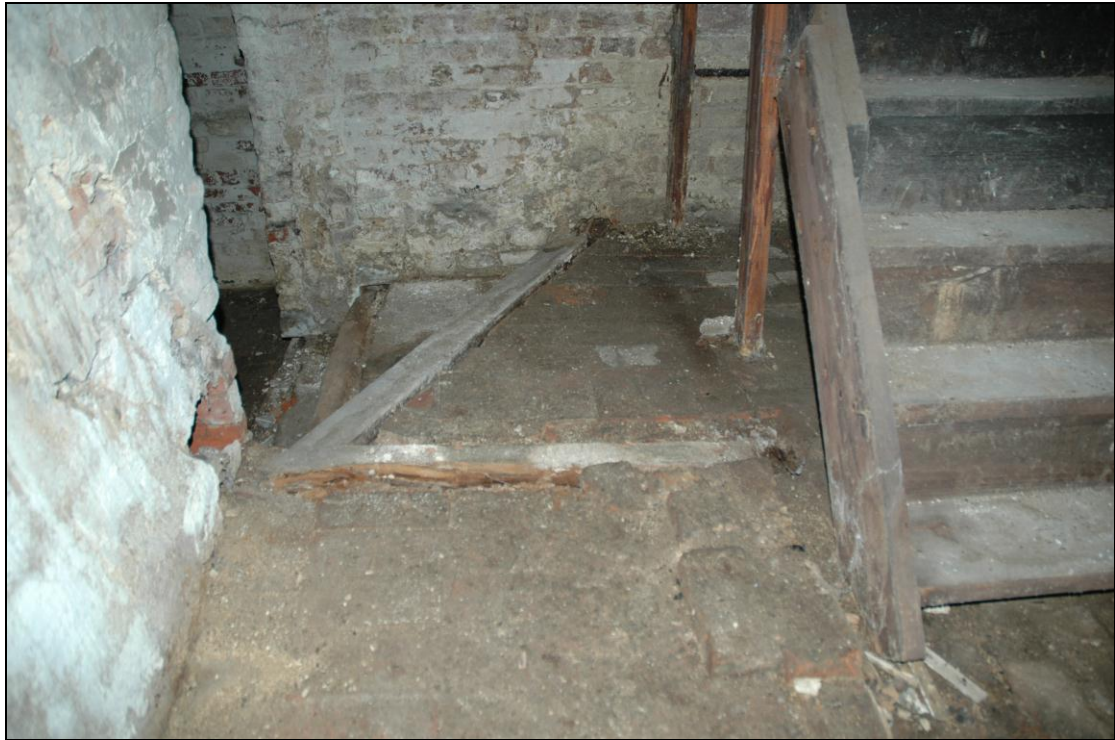
is also possible that the base of the stair may have worn or rotted away and had to be patched up (Fig 22).

Fig 22. Present position of stair to the basement (B1), with evidence on the left hand wall of its original position with the turn in the stair to the vaulted cellars (B2 & B3) at the foot.

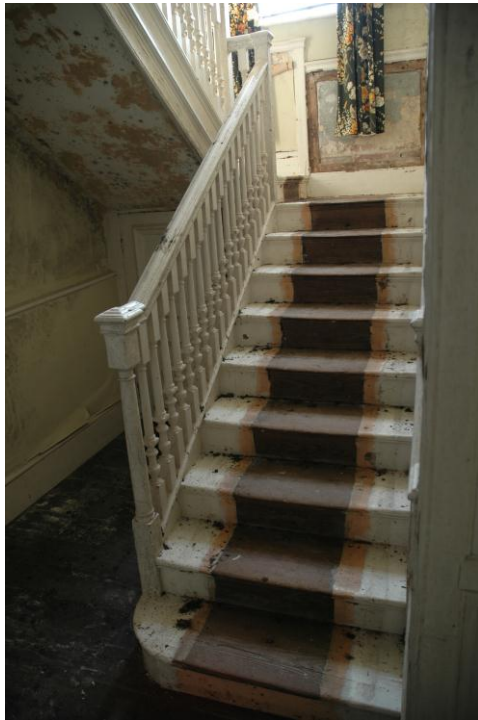
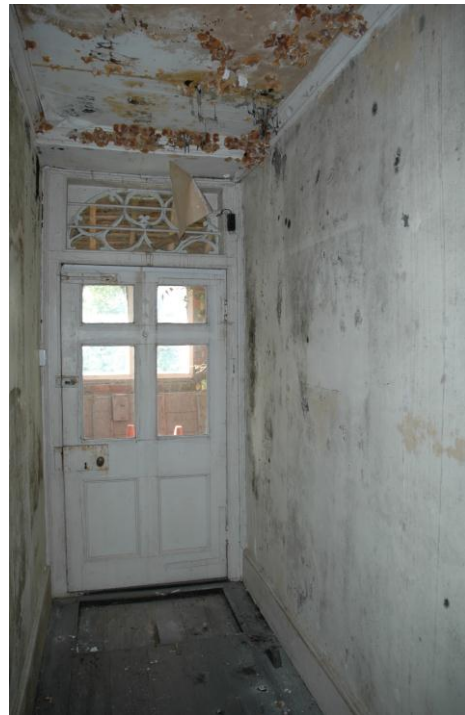
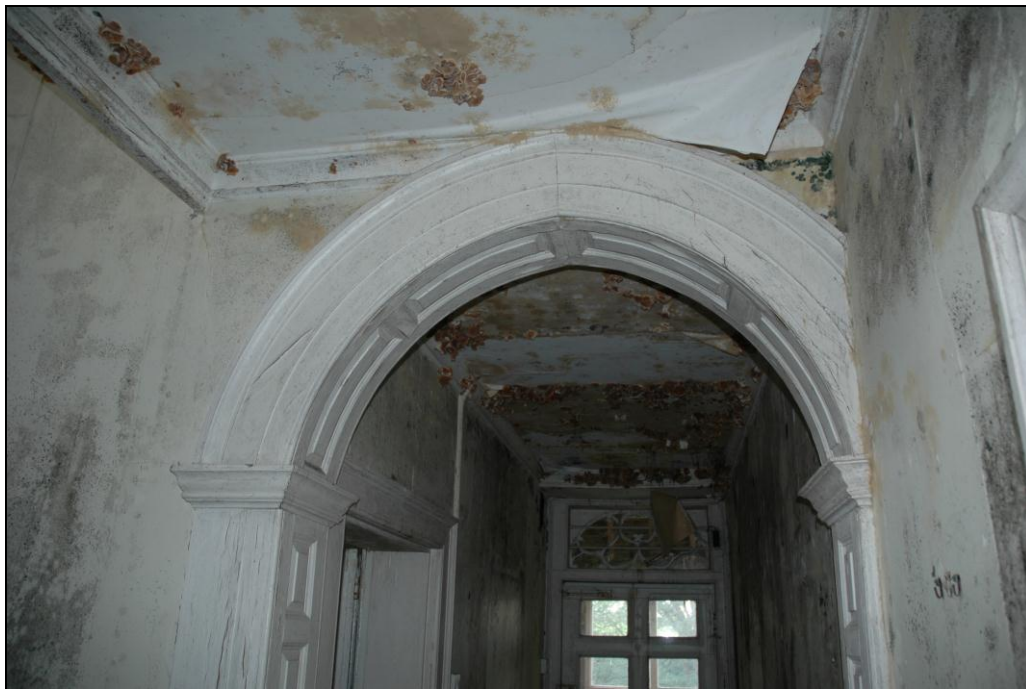
Figs 33, 34 & 35. The stair hall (G5) and entrance hall (G7) and arch dividing the two.

The entrance hall and the stair hall have very simple cornice mouldings, but these have suffered greatly from fungal rot.

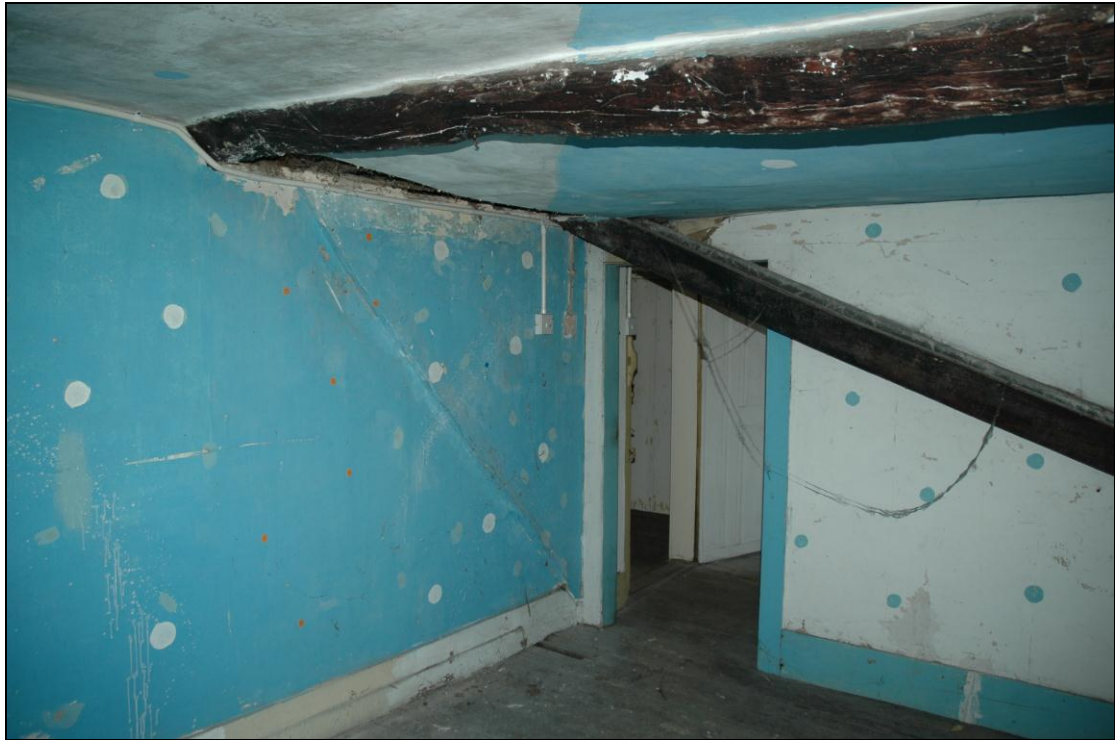
Fig 52. The south-east corner of Room S3, showing the slope of the original roof, with its purlin above and the storm water channel, which runs through the room, cutting across the door.

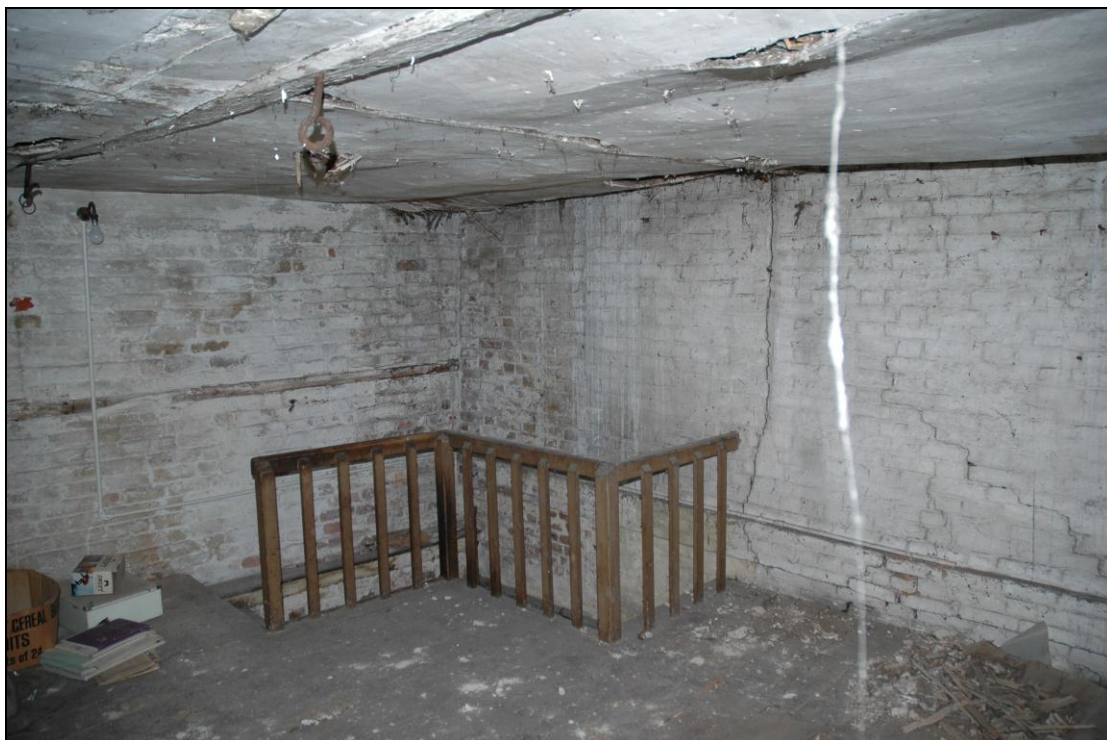
Fig 59. The south-east corner of F6, showing the head of the wooden stair. Where the rail meets the south wall is where the blocked up window of room F4 is, to the left of the crack along the straight joint. The ceiling beam in the foreground shows the hooks.
