JOHN MOORE HERITAGE SERVICES

**AN ARCHAEOLOGICAL WATCHING BRIEF AT
ST JOHN THE BAPTIST CHURCH,
LITTLE MISSENDEN,
BUCKINGHAMSHIRE**

SU 920 989

Site Code LMJBC 10
JMHS Project No: 2270

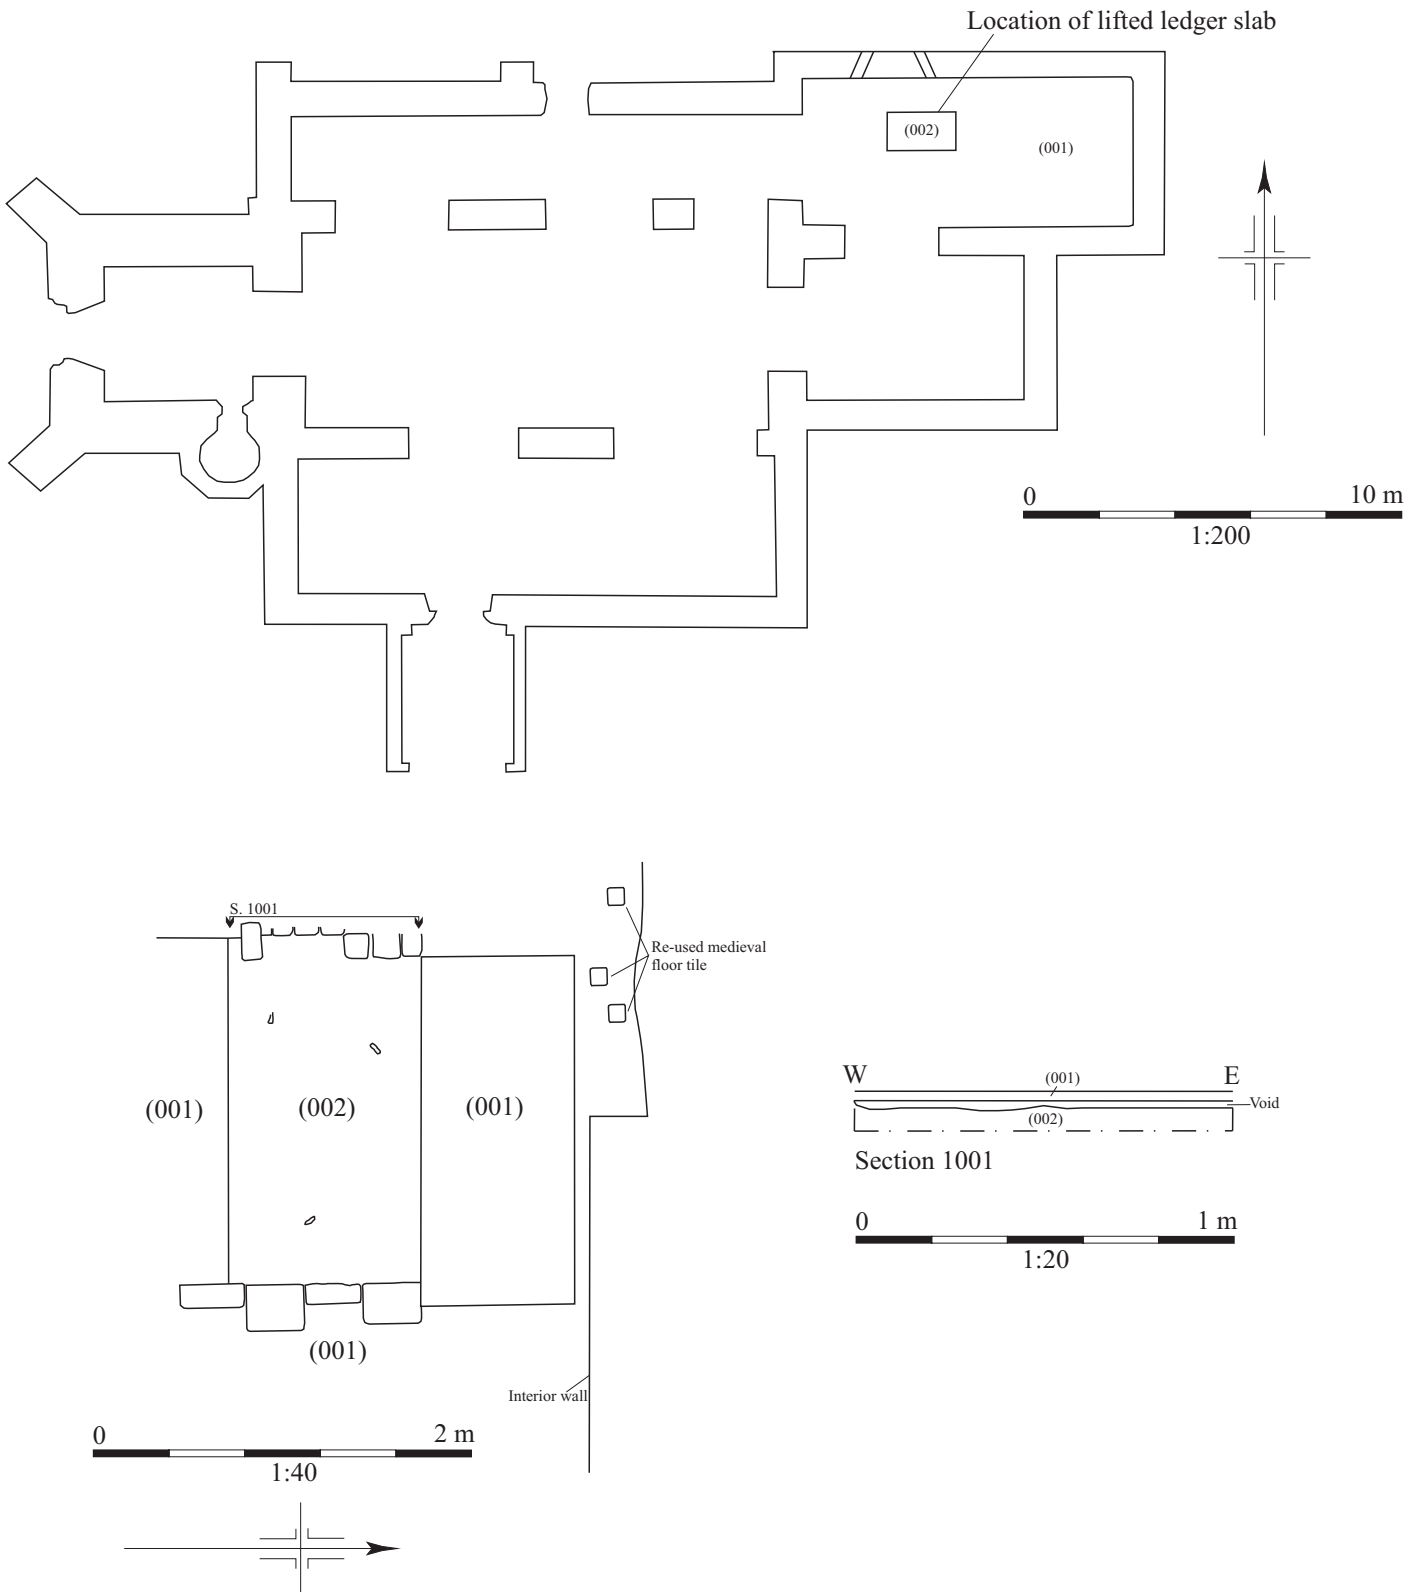
Figure 2. Plans and sections

The church floor (001) consisted of a mixture of materials dating to different periods. Replacement of the floor tiles at some point in the last 200 years meant that the western part of the church floor was raised by approximately 0.15m. The area of investigation was located in the north chapel where the lower floor level was preserved. The floor (001) to the west of the vault consisted of hand made bricks bedded on yellow sand. Some of these were removed in preparation for the lifting of the ledger slab. They were later replaced. The flooring to the east of the vaults consisted of large square orange tiles. The floor to the north of the vaults had been removed and replaced at some point in the last 100 years. This conclusion was reached after the discovery that this part of the floor had been re-laid using modern concrete, probably in association with the introduction of piping associated with the heating system (a radiator was located against the interior wall c.1.00m to the northeast of the vault). Medieval decorated tile was re-used in the flooring under the arch formed by a canopy tomb. There was also evidence of some repair of the ledger slabs using concrete and lime mortar. The removed ledger slab was constructed of a single sheet of slate, 0.07m in thickness, 1.7m in length and 1.00m in width. The surface of the ledger was heavily abraded. A partial bronze plaque on the ledger states the date of death of the interred individual as being the 10th of December, 1646. It is likely this was added at a later date, as an earlier etched inscription is also partially visible. Multiple burials and rededications often occurred in church vaults (Gilchrist and Sloane 2005: 158-9).

Fill (002) appeared to fill the vault completely, obscuring its original depth. This fill consisted of loose and friable light brown silty gravel containing numerous flint gravels. It contained numerous amounts of demolition material including CBM pieces and flecking throughout. This included handmade brick, tile (undecorated and decorated) and a single piece of peg tile. Rare pieces of coal were also present. Disturbance in the upper layers of this fill by rodent burrowing, specifically by *glis glis*, was discovered. The resultant hollows under the floor were filled in using a lime based mortar. This bioturbation would have caused minimal disturbance to the archaeology. Tile examined from fill (002) was the same as that used in flooring to the north (under the canopy tomb arch) and within the drainage system (covered by an iron grid to the west, located on the same floor level as the vaults). The level of fill (002) was reduced by 0.05m. Approximately 5 bags were removed by the stonemasons under archaeological supervision in preparation for the lime-based mortar on which the repaired ledger would be bedded. Any large or decorative pieces of tile were left within the vault fill after being photographed.

Examination of the northernmost ledge slab revealed previous repair on its southern edge using an iron 'stitch' (essentially a large staple). The stitch had subsequently corroded, forcing the natural laminate within the stone to separate and causing substantial damage to the external surface and fabric of the ledger.

The decision was made to leave the ledger *in situ* as it was not subsiding and therefore unlikely to cause future issues with the flooring. In addition, any movement would only cause unnecessary and likely irreparable damage to the ledger. The corroded iron stitch was removed and replaced with a stainless steel one and the surface damage repaired.

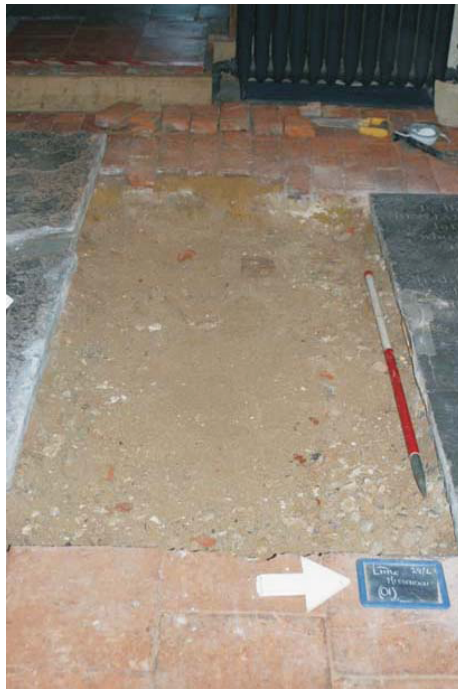
Fill (002) after removal of ledger

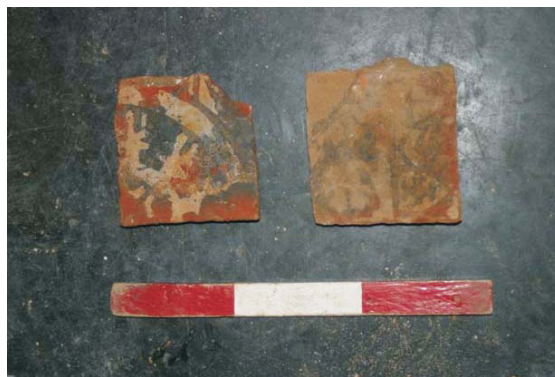
Medieval tile from fill (002)

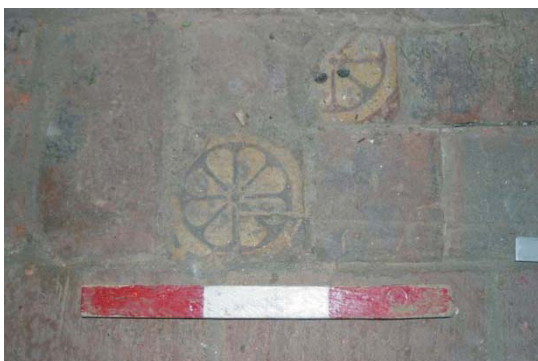
None of the tiles were observed in their original context and it is therefore difficult to make any solid conclusions. It is likely that these once covered the entire floor of the church. They appear to have been re-used at some point in the last 100 years in areas of the flooring that are largely out of view, presumably because they did not fit in with the current scheme of plain tiles.

Medieval tile re-used in flooring

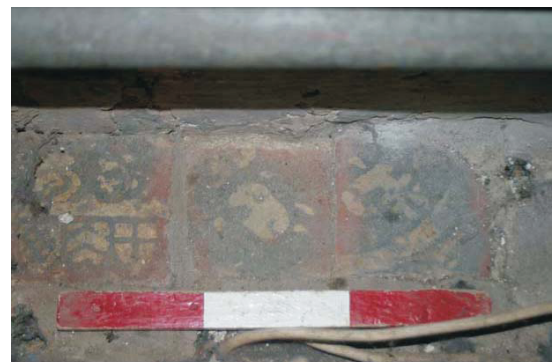
Medieval tile re-used in under-floor drainage
