HISTORICAL/ARCHAEOLOGICAL REPORT
ON THE
ANNEXE, LITTLE WITTENHAM MANOR,
OXFORDSHIRE

On behalf of
Sir Martin Wood

by
John Steane and James Ayres
for John Moore Heritage Services

MARCH 2010

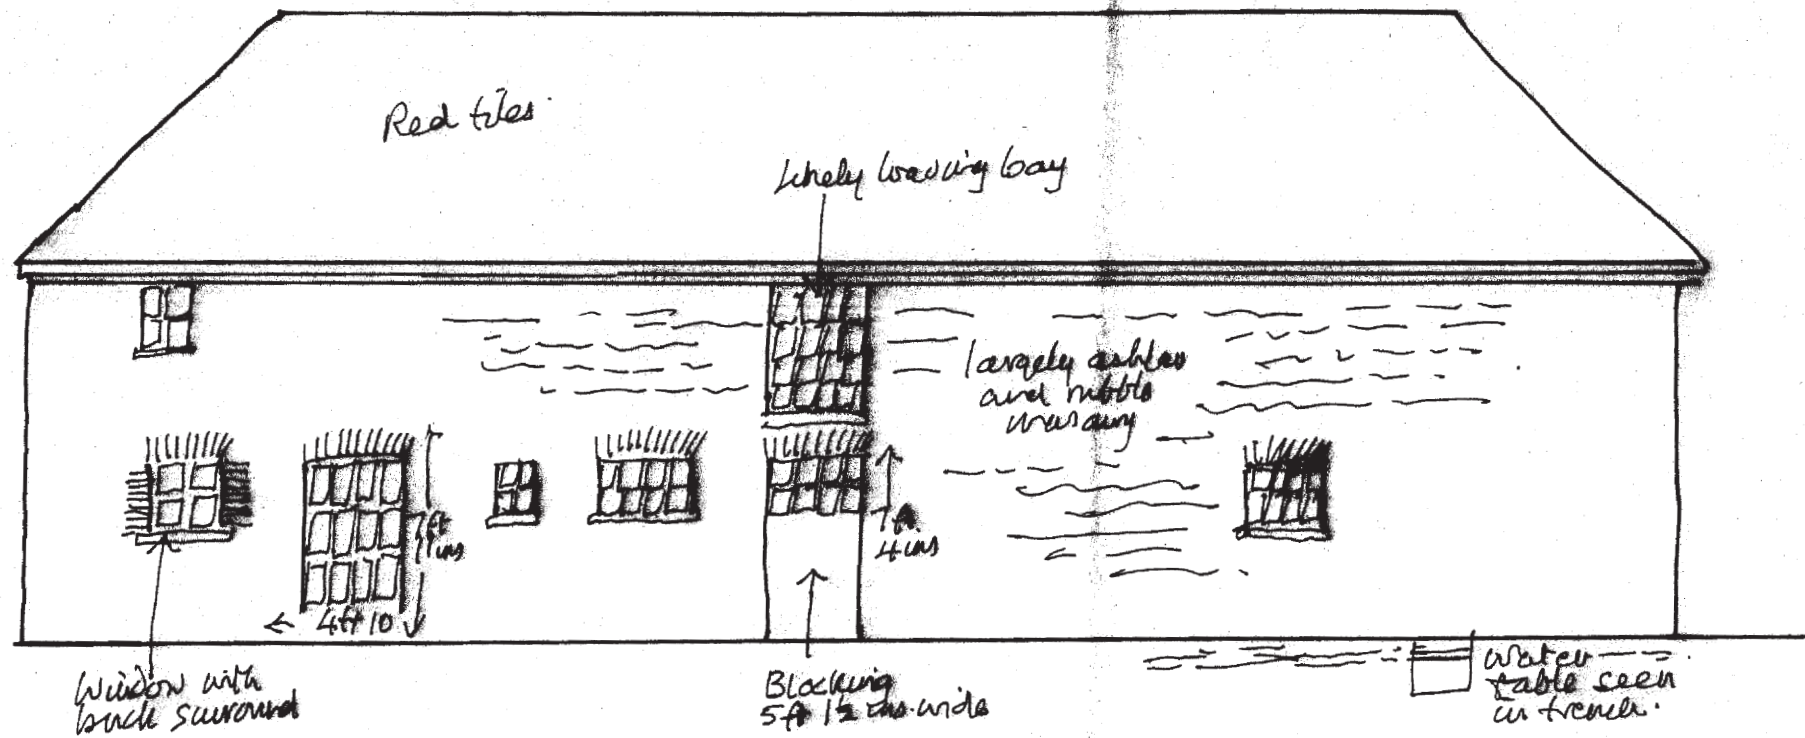
Fig 1

The exterior. The west elevation (Fig. 1) is built of limestone rubble stone with some ashlar and brick coping under the eaves. The hipped roof is clad in red clay tiles. Near the centre of the 71 ft (3008 cm) frontage is a blocked doorway (the upper zone now a window) measuring 5 ft 1 inch x 7 ft 4 ins (155 x 223.5 cm) to the stone reveals and the cambered brick head respectively. The door at the north end of this frontage is of comparable dimensions being 4 ft 10 ins x 7 ft 11 ins (147.4 x 213.5 cm).

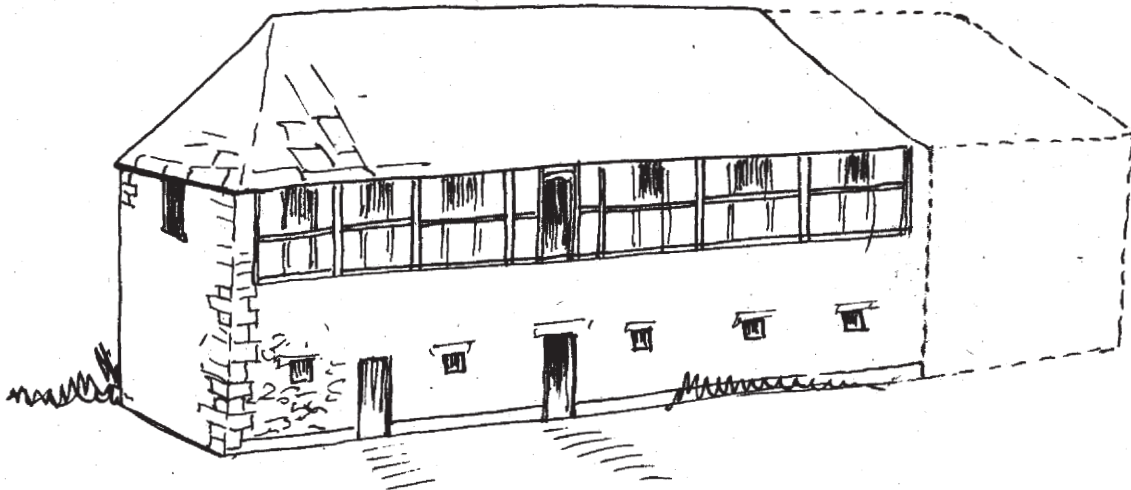
Fig 6

Finally we believe that the present historic fabric suggests that the west elevation was formally surmounted by a timber frame wall to match that on the east front, as in the stable block at Sutton Courtenay. It might be added that in this region timber framed buildings persisted into the 18th century as seen in the gables of many of the houses at Nuneham Courtenay of c. 1784.

RECONSTRUCTION of WEST ELEVATION of
THE MANOR ANNEX ~ LITTLE WITTENHAM ~ OXFORDSHIRE

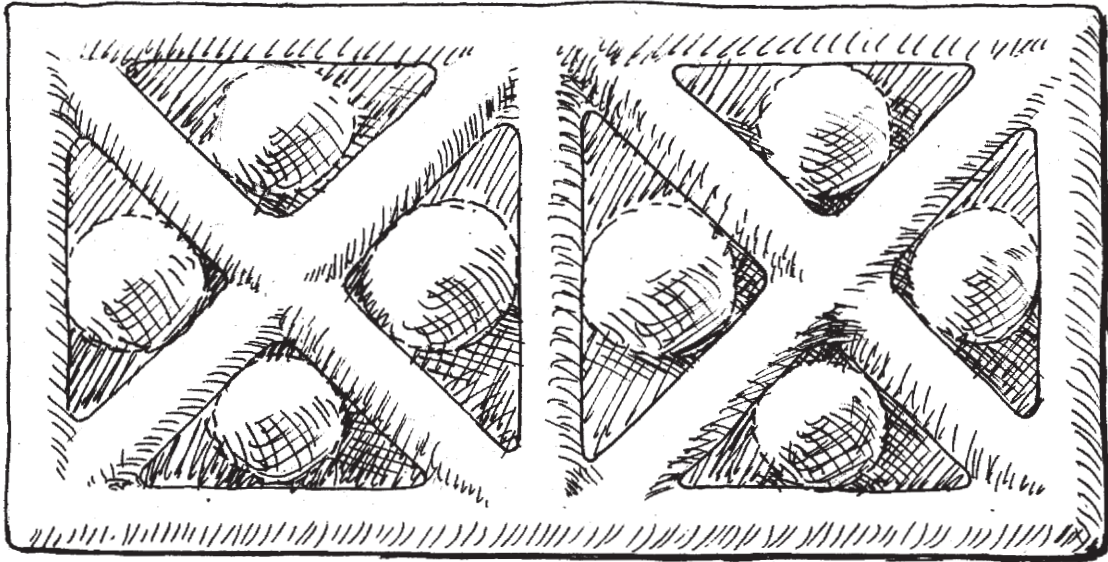
Fig 7

comparison with the fragments on show in the abbey's museum would indicate. A similar Romanesque fragment but with a diaper pattern was noted internally in a room on the first floor at the north end of the building (Fig. 7).

ROMANESQUE CARVED DETAIL ~ FRAGMENT
8 x 4 ins (20.3 x 10.2 cm) INSIDE THE MANOR ANNEX
LITTLE WITTENHAM ~ OXFORDSHIRE JA 2010

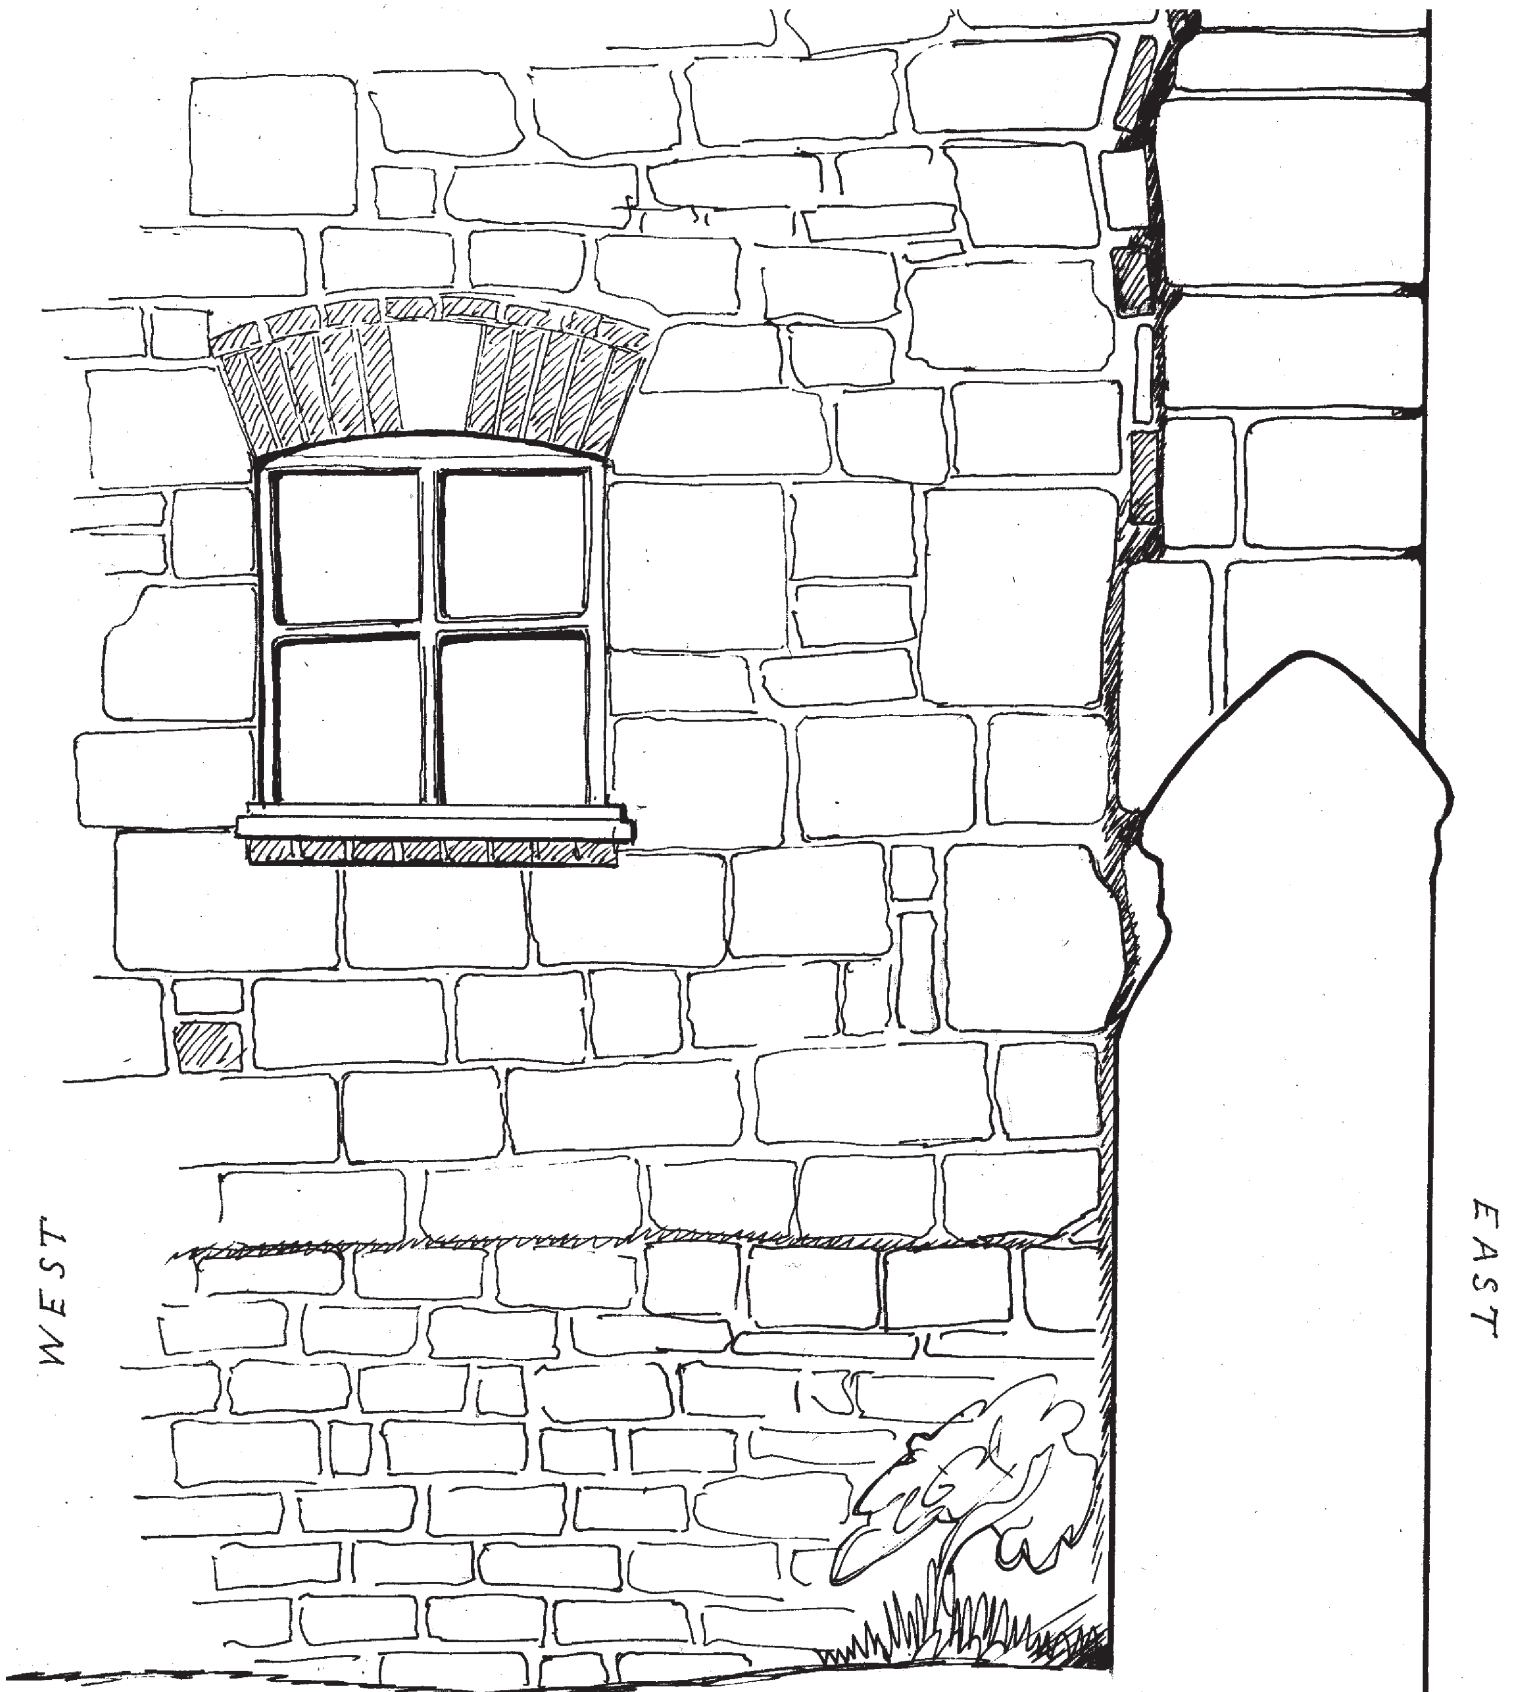
Figure 8

The narrow south wall. Here the south end of the east wall is identifiable by the straight joint in the masonry that does not bond in with the adjacent rubble walling. This segment of wall does line up with what is now a garden wall (Fig. 8); significantly this garden wall not only lines through with the east wall of this range but shares a water table offset with it (see Fig. 8 and photos 15 and 16).

END WALL TO THE SOUTH
MANOR ANNEX
LITTLE WITTENHAM ~ OXON

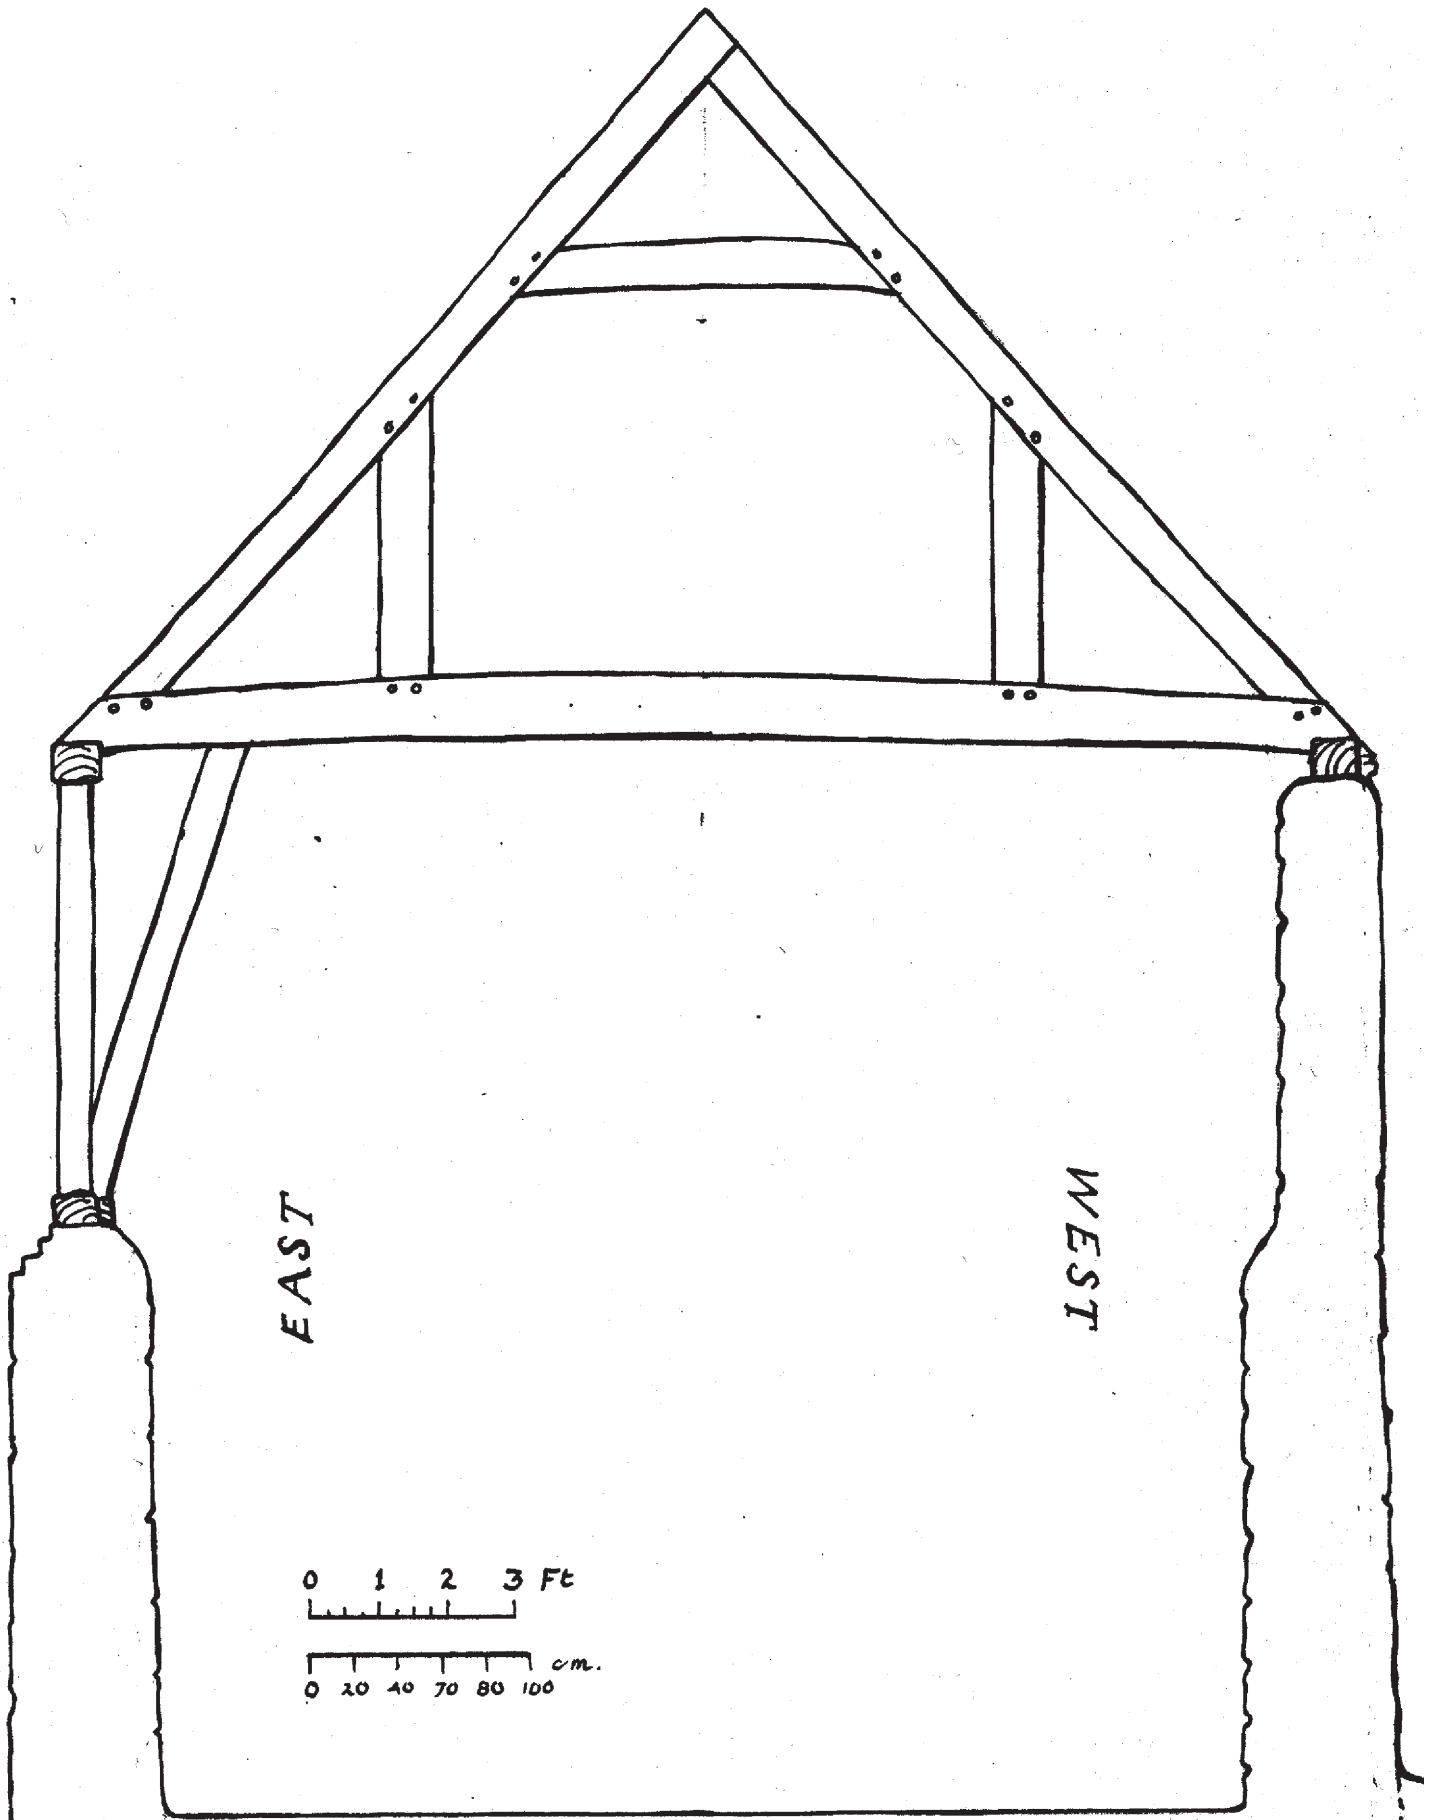
Figure 12

this reason each truss is lined up to be supported by the posts of the timber frame - although this is approximate rather than precise. As it currently exists the roof is of five bays plus the hip bays at each end – a total of seven bays in length, each bay being of approximately 10 ft (305 cm) (see Fig. 12).

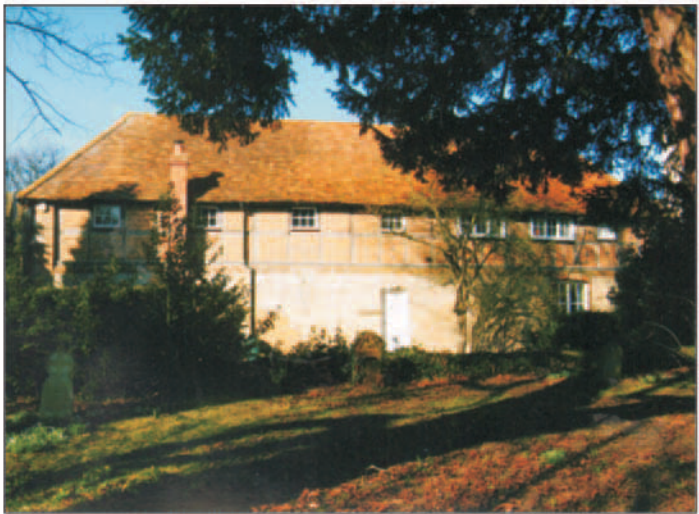
1. East Front. Note Timber framed and brick nogged upper storey. Also hipped tiled roof.

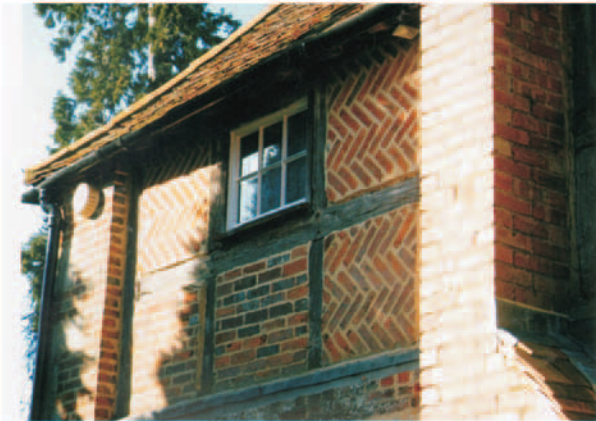
3. East wall at south end. Note herringbone panels of brick work

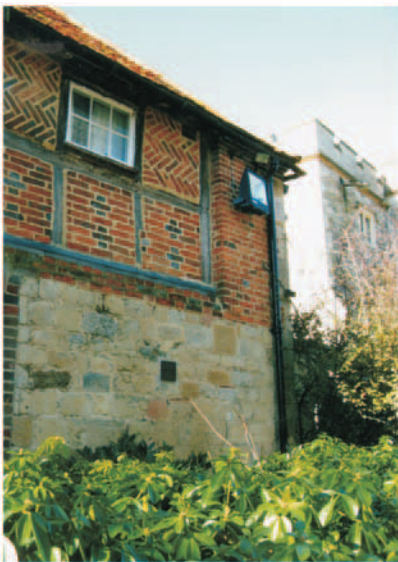
4. North end of east wall. Note fine ashlar stone blocks in lower part of wall.

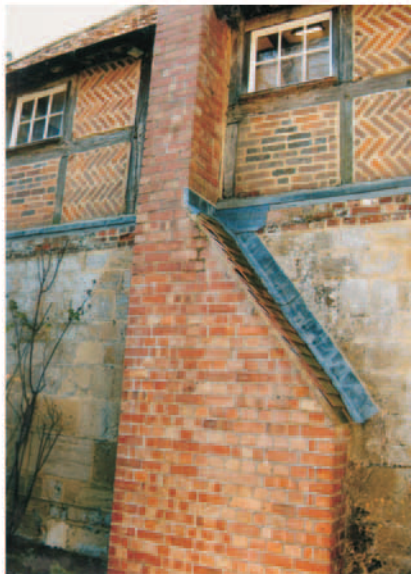
Post war (c. 1950) work on the building including the projecting Fletton brick flue at the south end of the east elevation.

5. Chimney added to east front. Note Fletton bricks. Also ashlar masonry of lower part of east wall

- If the present concrete (we presume this is under the wooden blocks) floor is lifted a record should be made of any surviving pitched and edge bedded stone cobbles, as has been done recently at Caswell Farm near Witney.
- If the Fletton brick chimney is removed the stonework should be made good, including the masoned water table.
- Timbers of the roof structure to be sampled for dendrochronology to give the felling date.

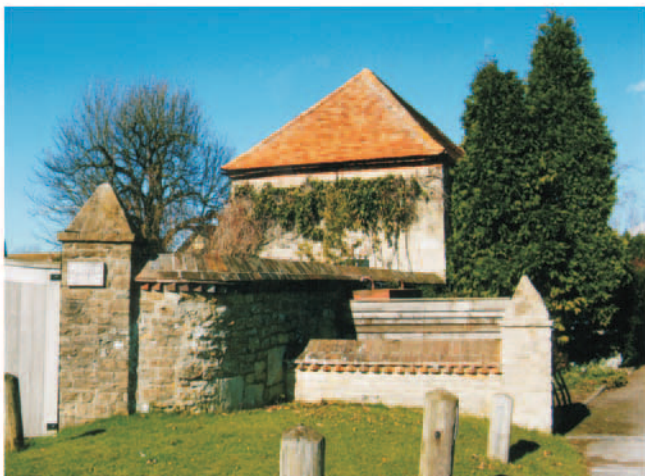
6. View of annexe from the south. Note garden wall on same line as east wall annexe.

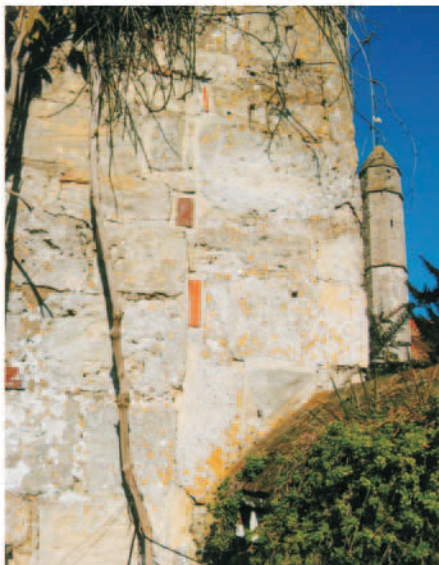
- The projecting purlin seen internally in the south east corner of the roof (photo 39).
- The straight joint already noted at the south east corner, a scar of a wall now destroyed.
- The water table that continues on from the east elevation into the garden wall.

8. End of east wall. Note straight joint indicating that building went further to south

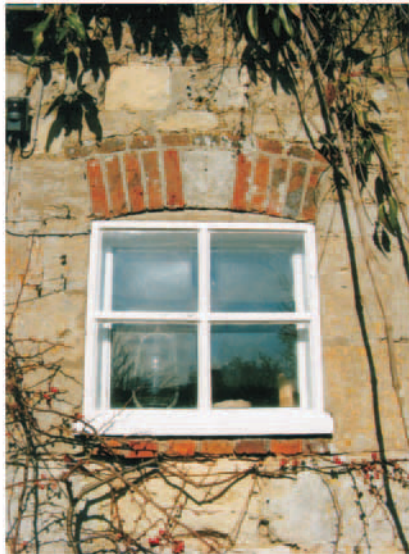
11. South window. Note stone keystone

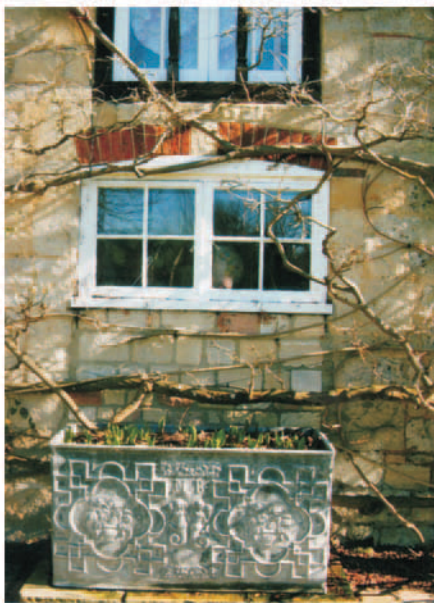
13. Blocked door with hayloft doorway above. Note two straight joints below window and blocking behind lead cistern

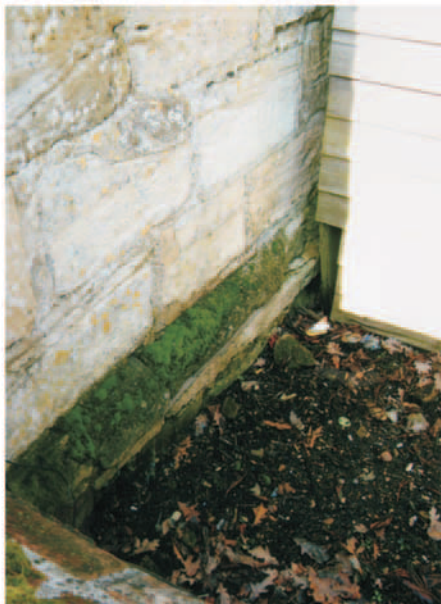
15. Water table at foot of garden wall indicating continuance of building.

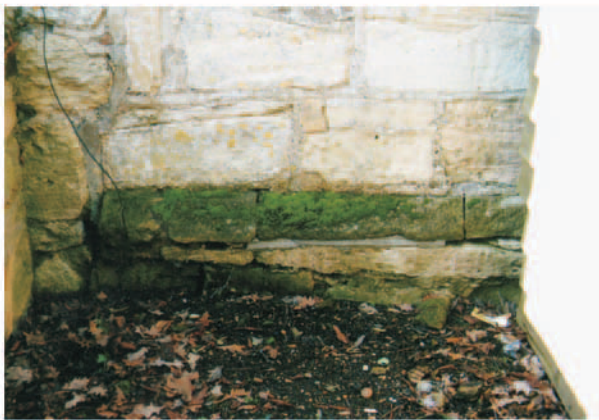
16. Water table to "garden wall" to the south east side.

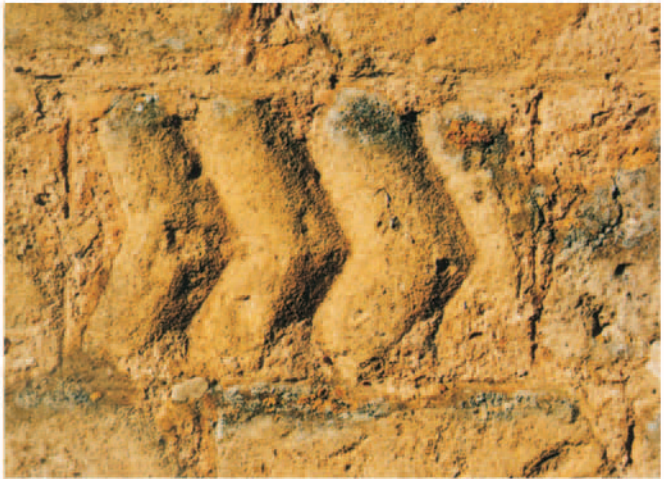
Although the stonework of the eastern frontage is of a higher quality, there is a greater proportion of ashlar masonry. The blocks appear to be of re-used masonry. The edges of the ashlar have been bruised and the mortar joints are wide. Furthermore there are two fragments of Romanesque chevron moulding placed at head height some feet either side of the doorway – possibly for talismanic purposes. These fragments and, indeed, other stonework could have come from the ruins of Dorchester Abbey as a

17. Romanesque fragment in east wall

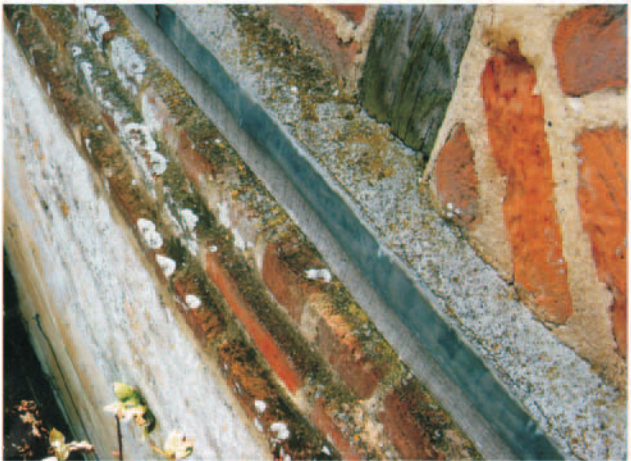
Externally the offset at Little Wittenham Manor is achieved by three courses of brick (see photo 18), the dimensions of these bricks being $8\frac{1}{2} \times 3\frac{1}{2} \times 2\frac{1}{2}$ (21.5 x 8.9 x 6.4 cm) but are of comparable date to those used in the brick noggin (e.g. 4 King's Bench Walk, London of 1677 Lloyd p98). Some of these square framed panels are infilled with bricks of somewhat larger dimensions which are laid in Flemish bond (Brunskill & Clifton Taylor 1977, 45).

18. External view showing central position of cill plate

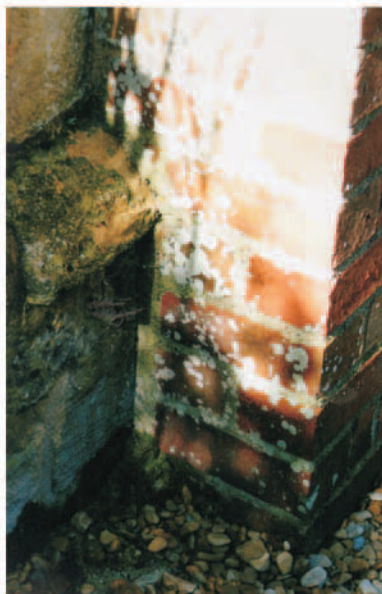
23. Detail of water table and 1950s chimney

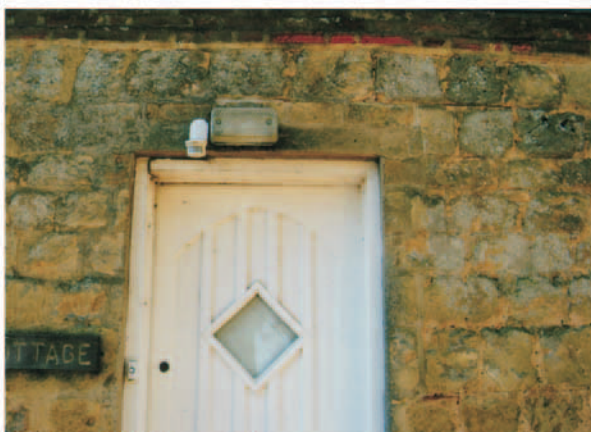
24. Concrete lintel over east door

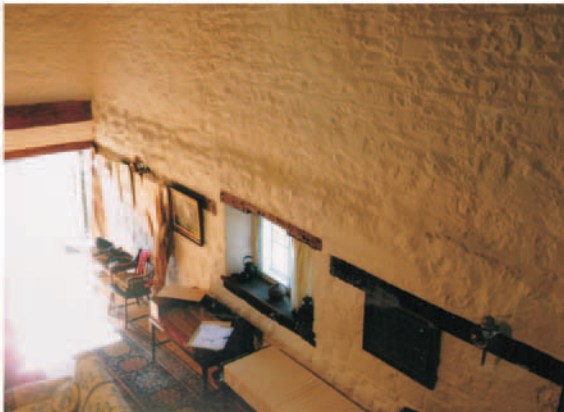
5) The horizontal timbers are bond timbers built into masonry walls. There is an article by Lawrence Hurst entitled 'The rise and fall of the use of bond timbers in brick buildings in England'. They are 'timbers worked into a wall to tie or strengthen it longitudinally'.

25. Inside of west wall showing where the wall has been raised. Note timber bonds.

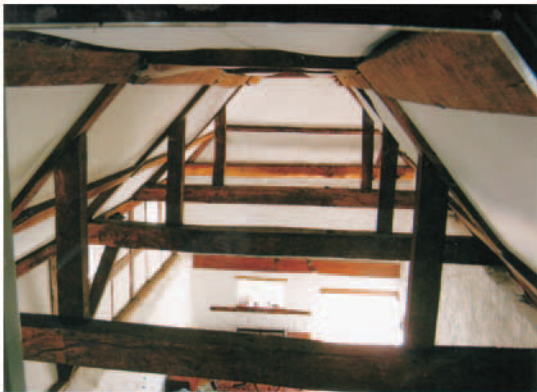
26. View of roof from balcony. Note two ranges of purlins.

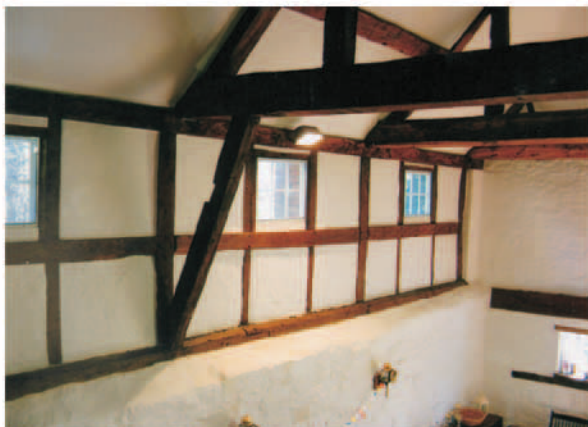
27. East wall from inside. Note thick masonry wall. Also tie beam with brace supporting it.

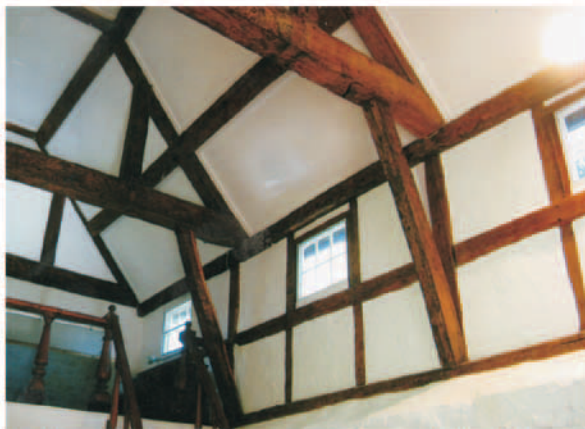
The interior face of the west wall diminishes some 7 ft 4 ins (223.5 cm) above the present floor level. This corresponds fairly well with the point at which the masonry wall to the east becomes a timber frame structure. We noted three struts of second hand timber nailed to support the tie beams on the eastern side of the building. These struts spring from the cill beam and are located between bays 2 and 3, bays 4 and 5, and bays 5 and 6 (photos 28, 33, 40).

28. East wall looking north east. Note supports nailed to tie beams

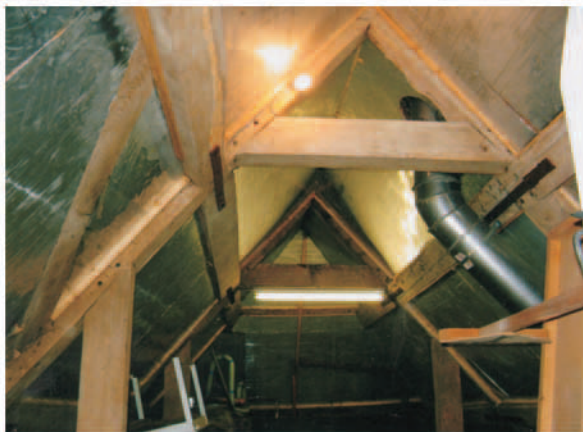
The wide positioning of the queen posts has furnished the principal rafters with sufficient strength for the collars to be placed unusually high. The heavy roof is sustained on its east side by the somewhat light weight timber frame upper wall. For

30. Apex of roof looking north. Note high position of collars

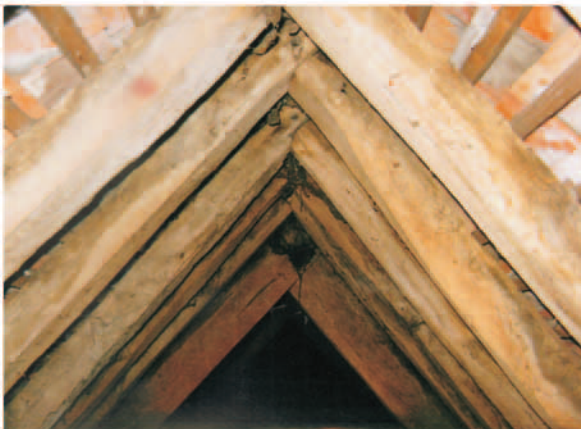
31. Common rafters at apex of roof. Note halving and pegging and absence of ridge piece.

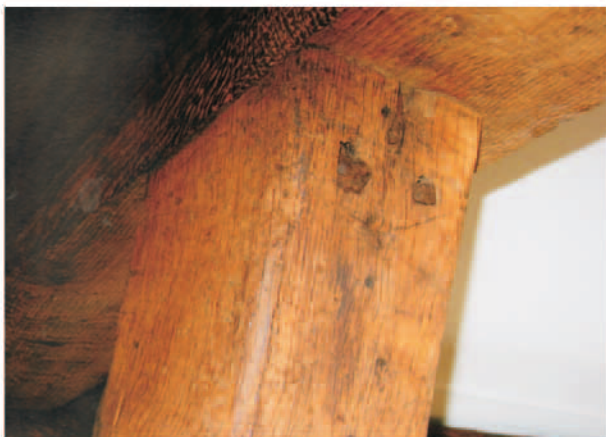
33. Strut above stairs nailed into position.

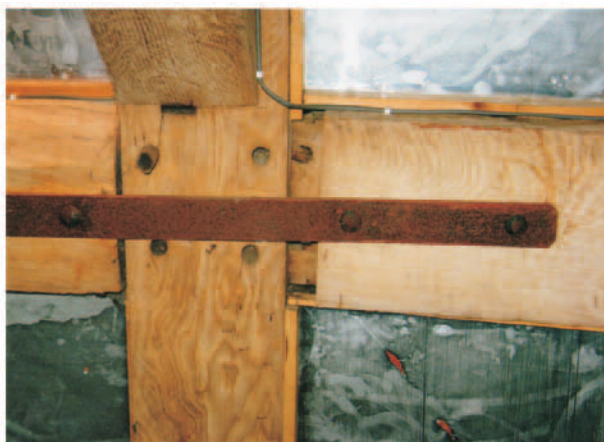
34. Iron strap nailed across principal rafter and purlins which are pulling away

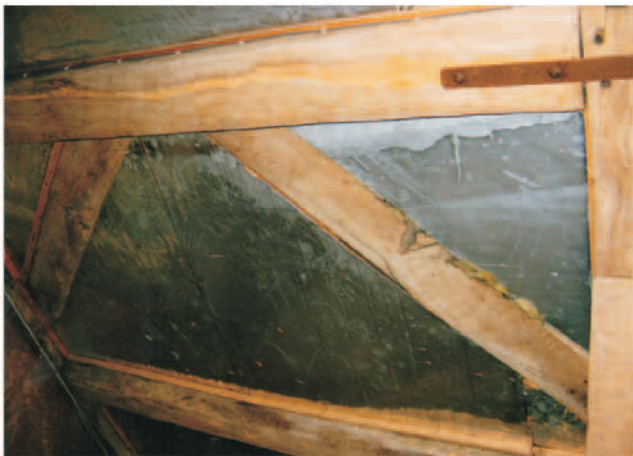
Roofs of this type required wind braces to reduce the possibility of racking. It could be that these survive under the present lining of much of the roof but we certainly found one pair of wind braces in the cock loft at the centre of the roof (photo 36). Between the principal rafters we noted in the upper cock loft a series of six common rafters most of which like much of the roof structure appeared to be primary. Generally speaking this is an extraordinarily well preserved roof (see Fig. 11).

36. Windbraces in place between upper and lower purlins. West roof

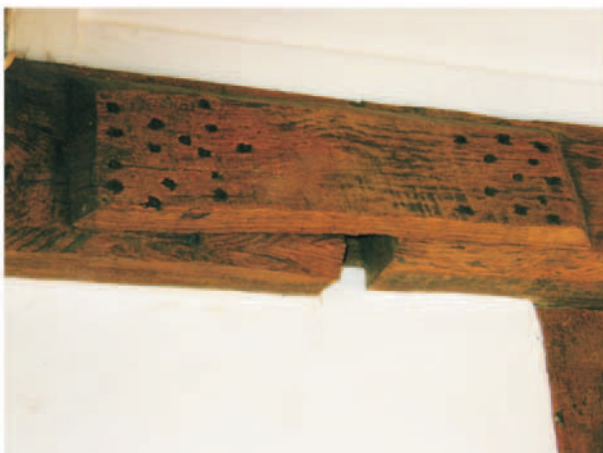
It is very likely that the weight of the roof structure and its stone cladding placed severe stress on those lightweight timber frame walls. This might well have been exacerbated by the original length of the building. Furthermore any timber frame structure leaning west or south would suffer greater extremes of temperature and humidity. This could explain why the upper part of the west wall seems to have been enveloped in masonry. The east wall survived better in a more equitable climate but even here reinforcements have been deemed necessary. We refer to the three struts and a timber plate that had been nailed onto the cill beam where a scarf is failing (see photo 38). The struts and the wood plate are fixed with wrought iron nails with 'rose' heads.

38. Oak plate nailed to pole plate east side above stairs

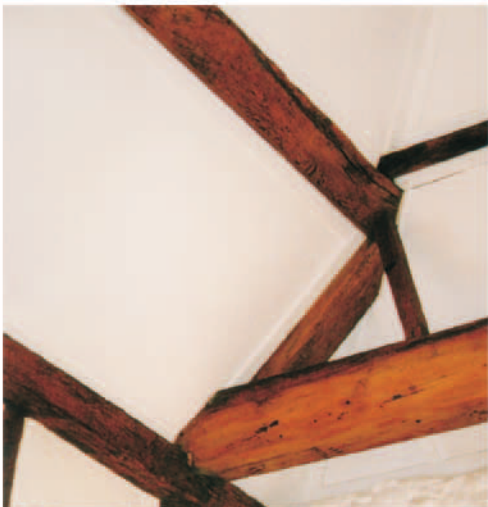
39. Pole and plate purlin. South east corner.

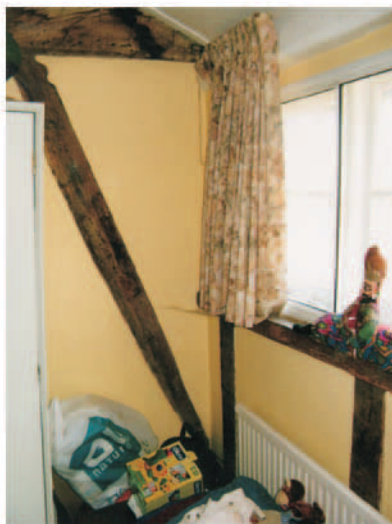
40. Strut in bay 2 from north. First floor.

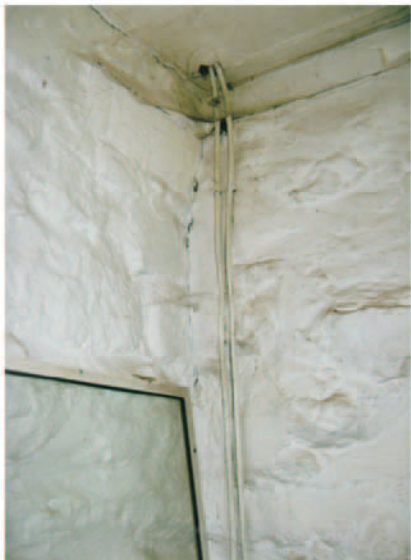
41. Detail of lateral wall (on right), east wall on left. Note crack.

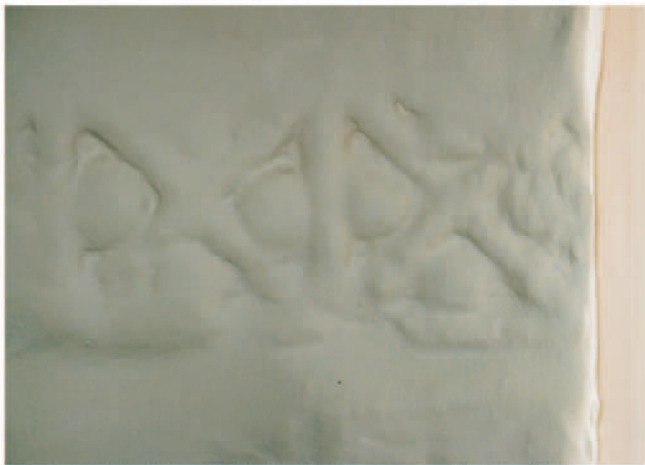
42. Romanesque fragment carved stone inside first bay, first floor, east wall.

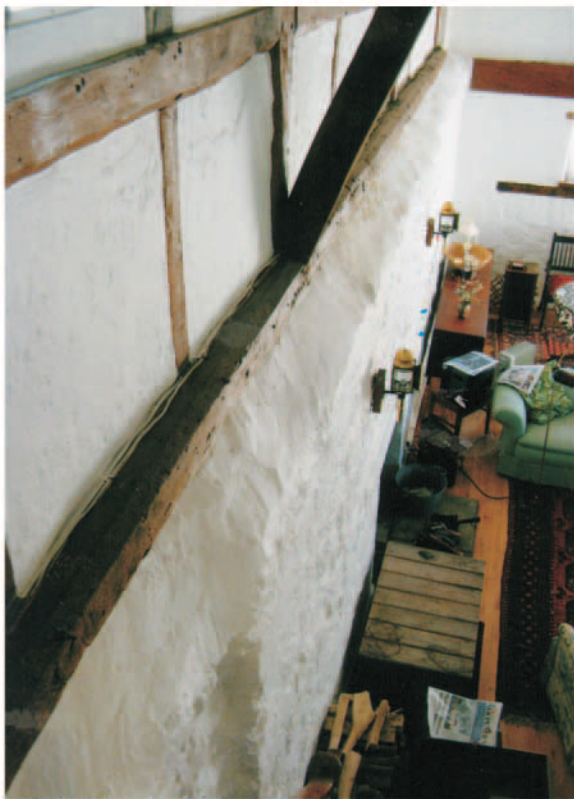
43. View showing central position of cill plate on masonry east wall.
