A Historic Building Assessment
at
32 AYLESBURY ROAD
WENDOVER
Buckinghamshire

K A Rodwell
for
JOHN MOORE HERITAGE SERVICES
July 2009

A HISTORIC BUILDING ASSESSMENT
AT
32 AYLESBURY ROAD WENDOVER, BUCKS

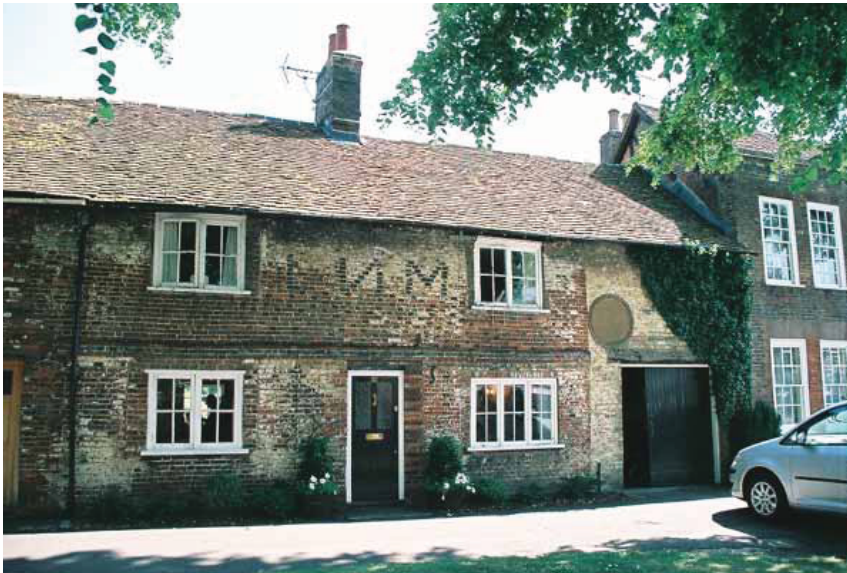
Principal (west) elevation, garage to right

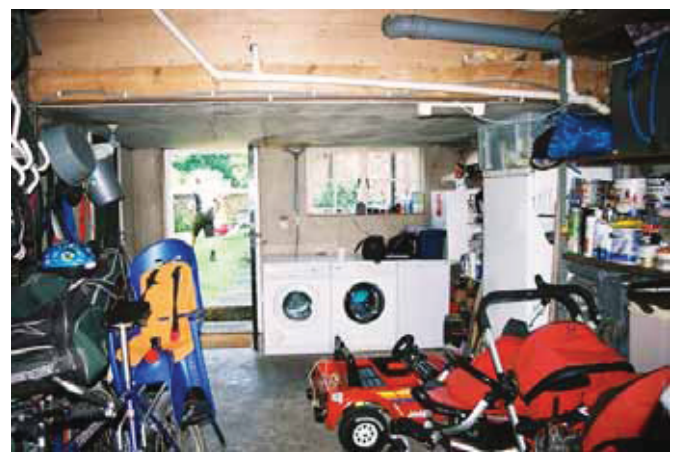
Interior looking east with inserted bathroom

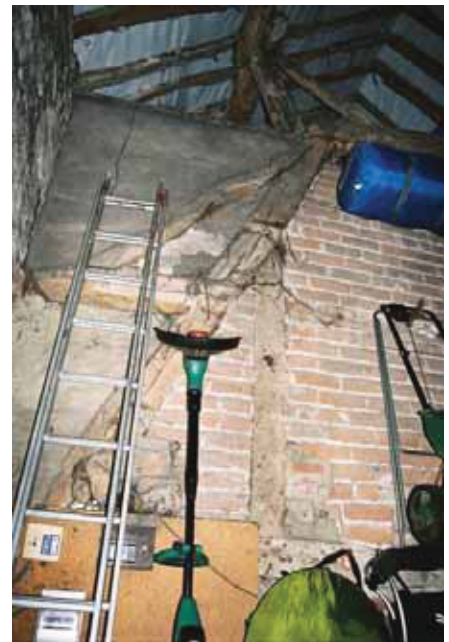
Elevation: North partition showing cruck truss

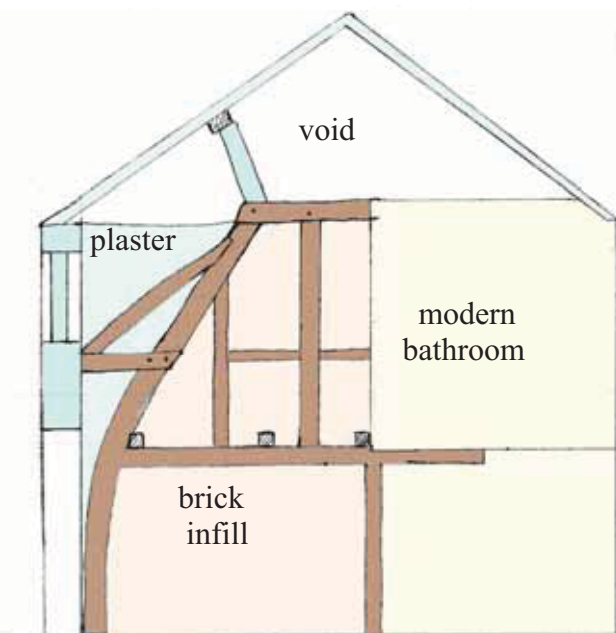
South partition wall showing former roofline (above)

North partition wall showing cruck (below)
