**HOLY TRINITY CHURCH, LENTON, NOTTINGHAM**  
**Archaeological monitoring of renewal of  
drainage, and associated works**

Project title	HOLY TRINITY CHURCH, LENTON, NOTTINGHAM					
Document title	Archaeological monitoring of renewal of drainage, and associated works					
Report no.	17005					
Project code	LEN16					
Accession no.	TBA					
Local Authority	Nottingham					
Parish	City of Nottingham					
Postcode	NG7 2FF					
NGR	455440 339320					
Distribution	Alex Ford, CEL Group; Carl Andrews: Soul Architects; Southwell and Nottingham Diocesan Advisory Committee					
Document comprises:	Doc. Control	Contents and summary	Text	Figures	Photos	Appendix
	1	2 pages	3 pages	2 (2 pages)	11 (4 pages)	1 page

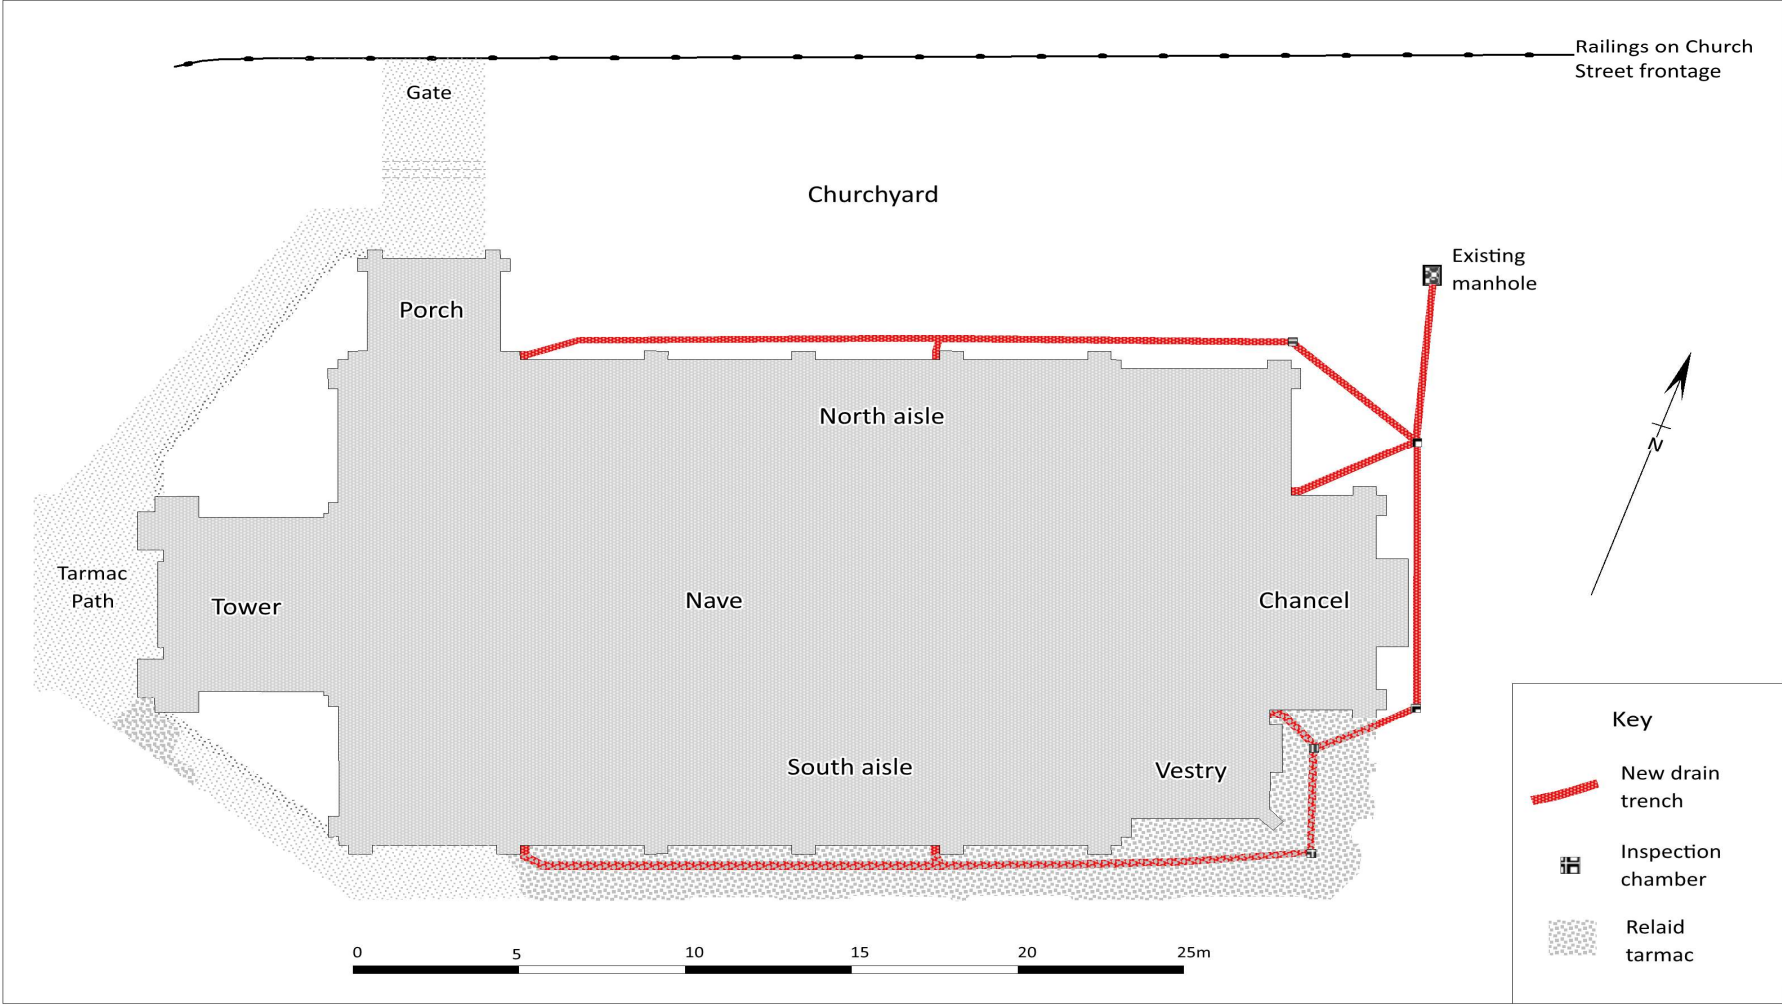
Figure 2: Outline plan of Lenton Church, showing location of excavated drainage trenches and inspection chambers, scale 1:200 (at A4)

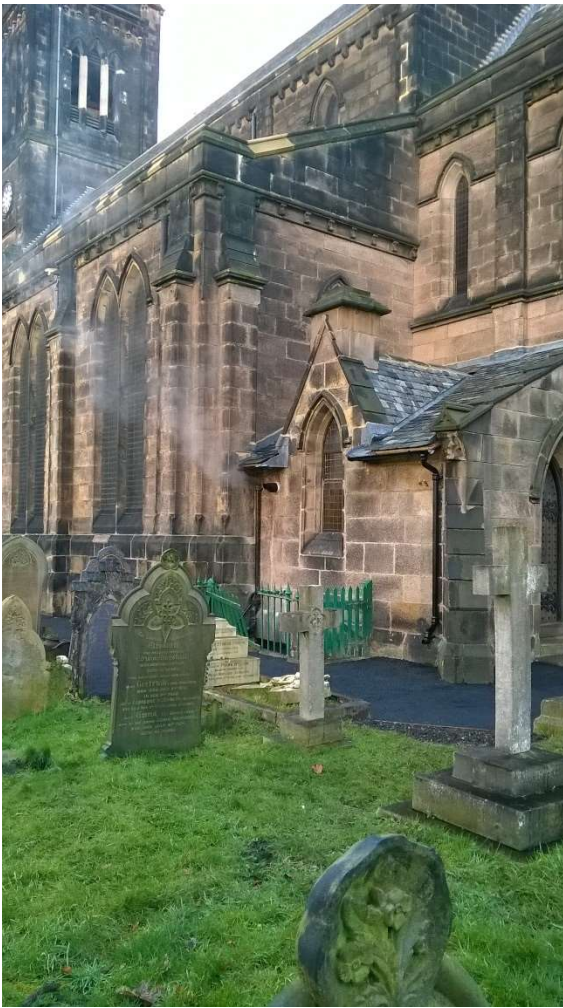
The church is in Early English style, built using a local Triassic sandstone, with the surfaces of the blocks pecked in alternating diagonal patterns. Close to, this produces a warm, honey-coloured surface, but the atmosphere of industrial Nottingham has not been kind to the building and much of the surface is heavily sooted. This, together with the solid Gothic verticality of the aisle and chancel walls, and the high-pitched roof can give the building a heavy, brooding appearance, especially when seen from the north (Photos 1, 2).

1: View of the church from the south-east, showing angle of south aisle chancel and vestry

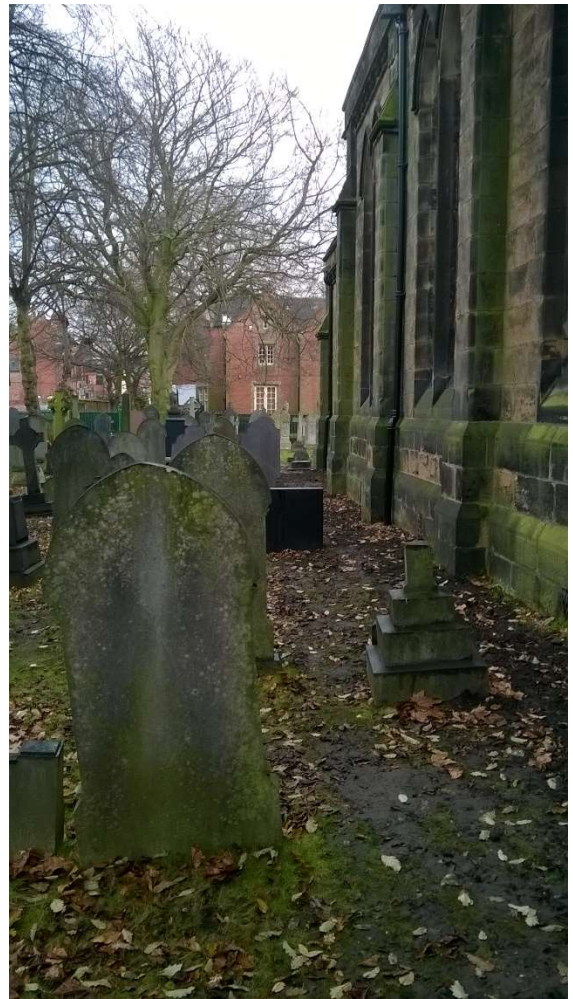
2: The north side of the church, looking eastward

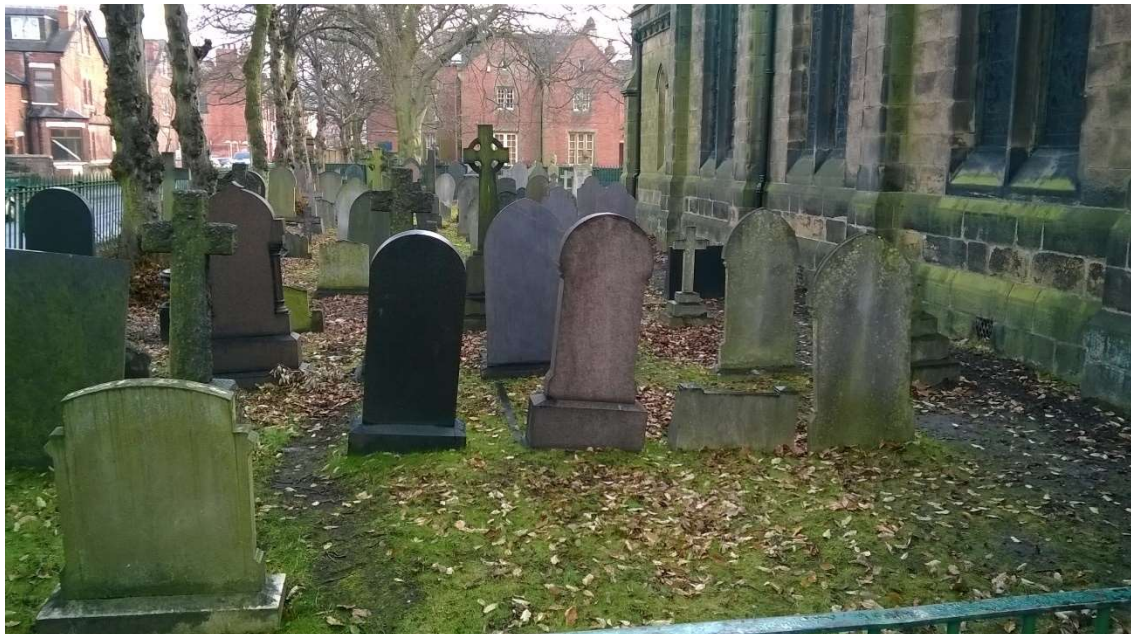
This is enhanced by the tight clustering of the nineteenth-century memorials in the churchyard, crowding in on the building (Photo 3). This is particularly marked in the area to the north of the church, where up to seven rows of graves occupy the relatively narrow strip of land between the north aisle and the iron railings along the Church Street frontage. The sombre aspect that this creates is enhanced by the heavy shade from the row of lime trees along the outer edge of this area. There are three rows of similarly clustered graves on the south side of the church, where the

3: The northern part of the churchyard, between the Church Street frontage and the building, looking eastward from the entrance through the porch, showing the tightly packed memorials in this area

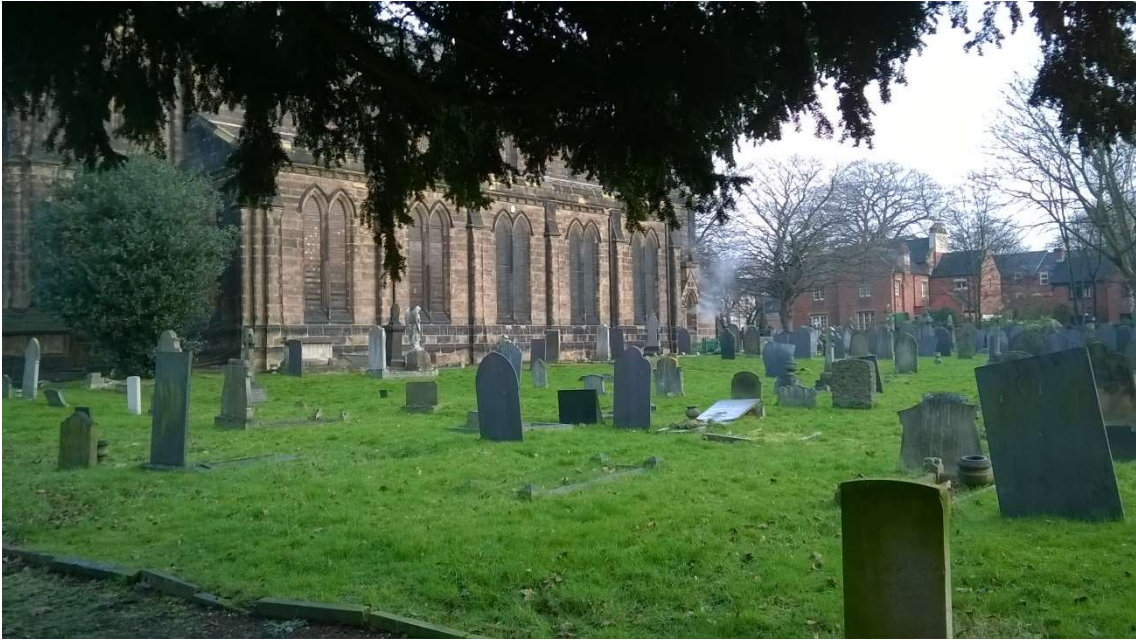
churchyard is unshaded and has a lighter, more open aspect (Photo 4). Beyond these three rows, the regular pattern of memorials continues but with gaps and whole rows missing. In some cases, it is clear that these spaces are where the grave-markers have been lost, but others may never have been used for graves.

4: The southern part of the churchyard, looking north-eastward to the south aisle

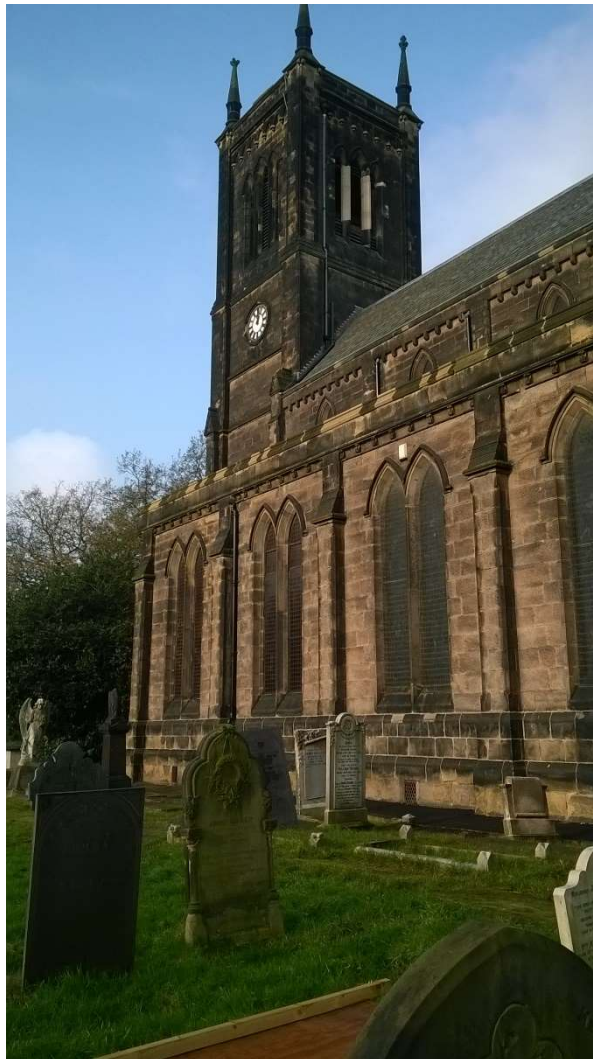
The renewal of the drains was part of wider programme of restoration work, which included repairs to the stonework, most prominently in the replacement of the two columns in the western opening of the belfry, but also along the roof parapets and elsewhere (Photo 5). Roof repairs were carried out, including the renewal of flashing between the tower and the nave roof, and the gutters and down pipes were refurbished.

5: The tower and south aisle looking north-westward

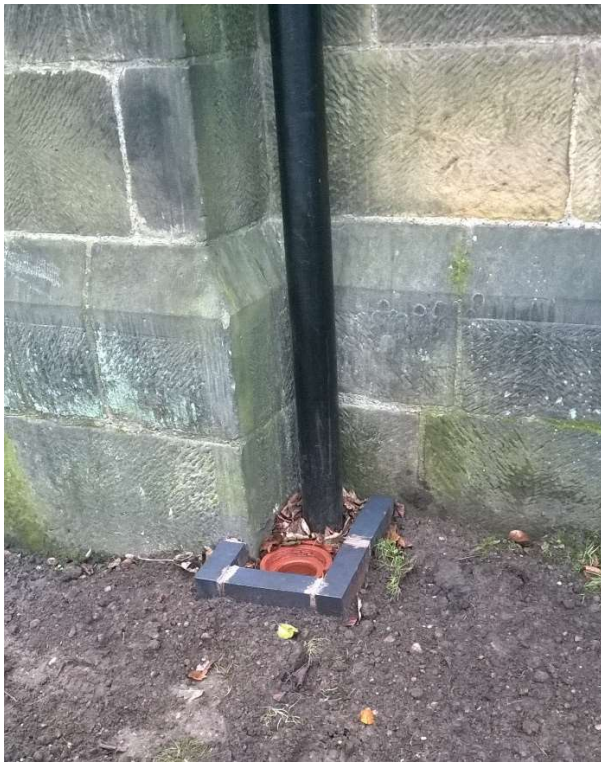
The drainage works included installing new grids and silt traps below each of the downpipes, concreted in and with a surround of engineering bricks (Photo 6). These were then connected to drains running along each side of the building, those from the south side of the building then running across the east end, joining those from north side before discharging into an existing manhole (Photo 7), which, in turn discharges into the storm-water drains in Church Street. Five Inspection chambers were installed at the junctions and of the drains at the east end of the church

6: Newly constructed gully against the north wall of the chancel

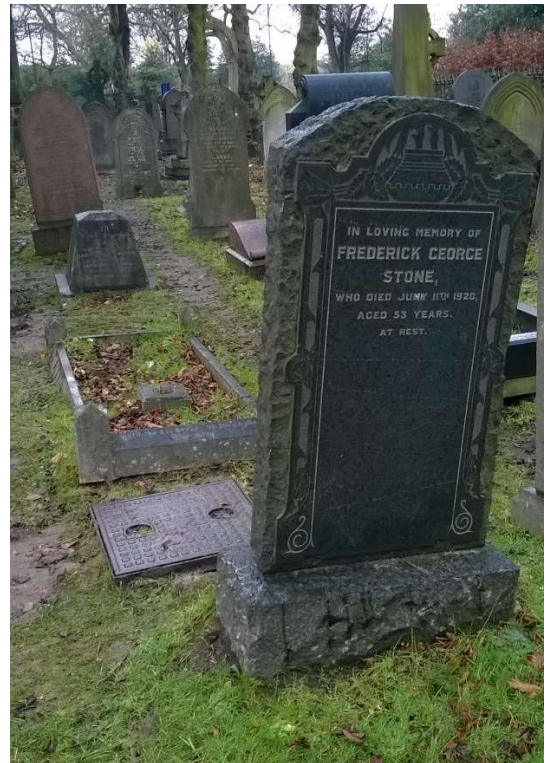
7: The existing manhole between the eastern end of the church and Church Street

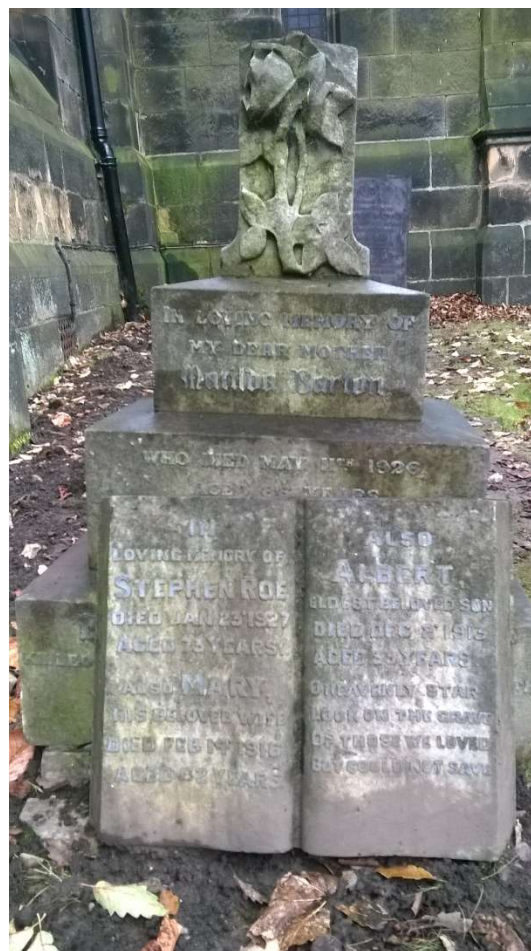
Because of the tight constraints of the memorials close the church, especially on the north side, the drains were laid much closer to the building than might normally be the case. The memorial stone for Matilda Barton, died 11th May 1926, for instance, is only 950mm from the wall of the north aisle, severely limiting the space through which the trench to take the north drain could pass (Photo 8). Space was also tightly constrained at the eastern end of the church, where the curbs of a number of large graves pressed closely on the surround of the vent from the basement boiler room (Photo 9).

8: The memorial to Matilda Barton, showing the limited space between the graves and the wall of the north aisle

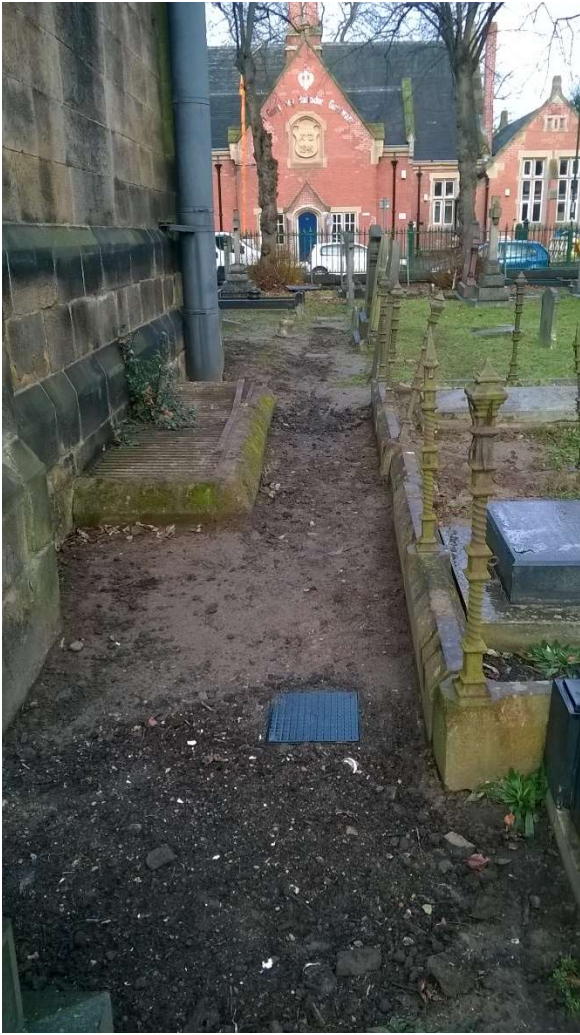
9: View northward along the east end of the chancel, showing the infilled drainage trench between the boiler room vent and the kerbed graves

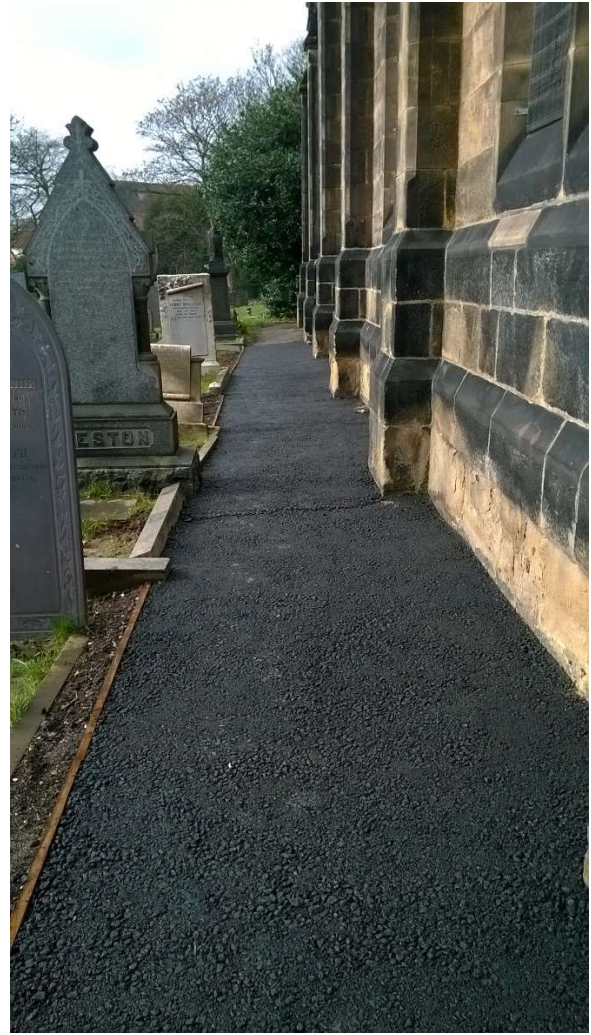
There was slightly more space on the south side, where no memorial is less than 1.65m from the wall of the south aisle or vestry. Here, the drains were laid beneath the path, and the tarmac relaid after they were installed (Photo 10). The grids in the existing tarmac surface draining surface water from the path were replaced as necessary and re-connected to the new drains.

10: The south side of the church after reinstatement of the tarmac path

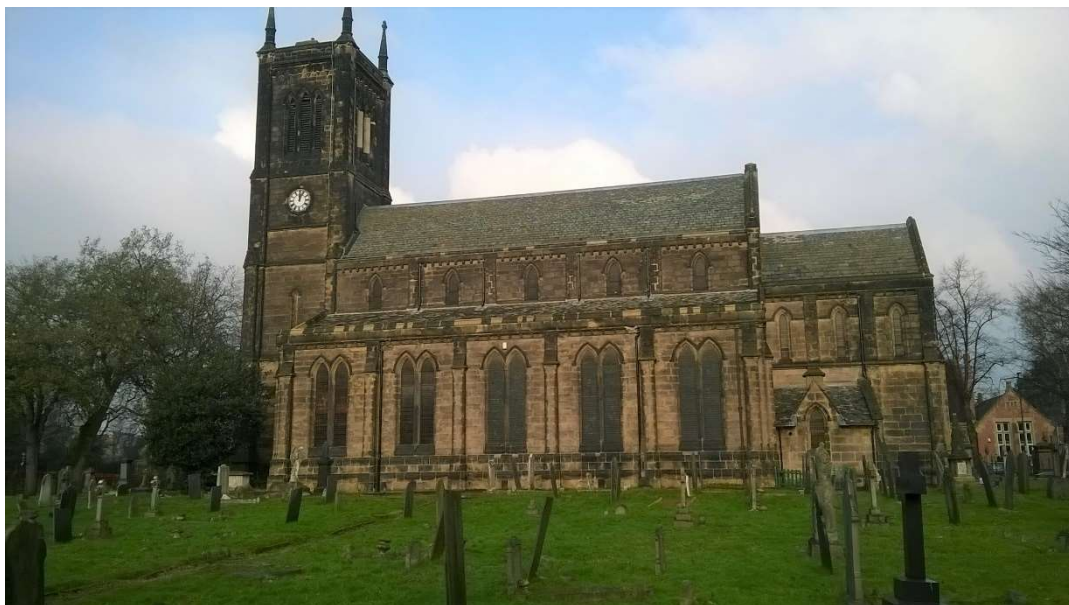
11: View of the church from the south part of the churchyard showing the arrangement of gravestones in rows, with gaps where memorials have been lost
