ST BARTHOLOMEW'S CHURCH, SPROXTON, LEICESTERSHIRE
Archaeological monitoring of installation of new
drains in the churchyard, and associated works

Project title	ST BARTHOLOMEW'S CHURCH, SPROXTON					
Document title	Archaeological monitoring of renewal of drainage, and associated works					
Report no.	17004					
Project code	SPX16					
Accession no.	TBA					
Local Authority	Leicestershire County Council, Melton District Council					
Parish	Sproxton					
Postcode	LE14 4RH					
NGR	485653 324915					
Distribution	Alex Ford, CEL Group; Malise Graham, churchwarden; Michael Hawkes, Leicester Diocesan Archaeological Advisor					
Document comprises:	Doc. Control	Contents and Summary	Text	Figures	Photos	Appendix
	1 page	3 pages	6 pages	2 (2 pages)	35 (12 pages)	1 (1 page)

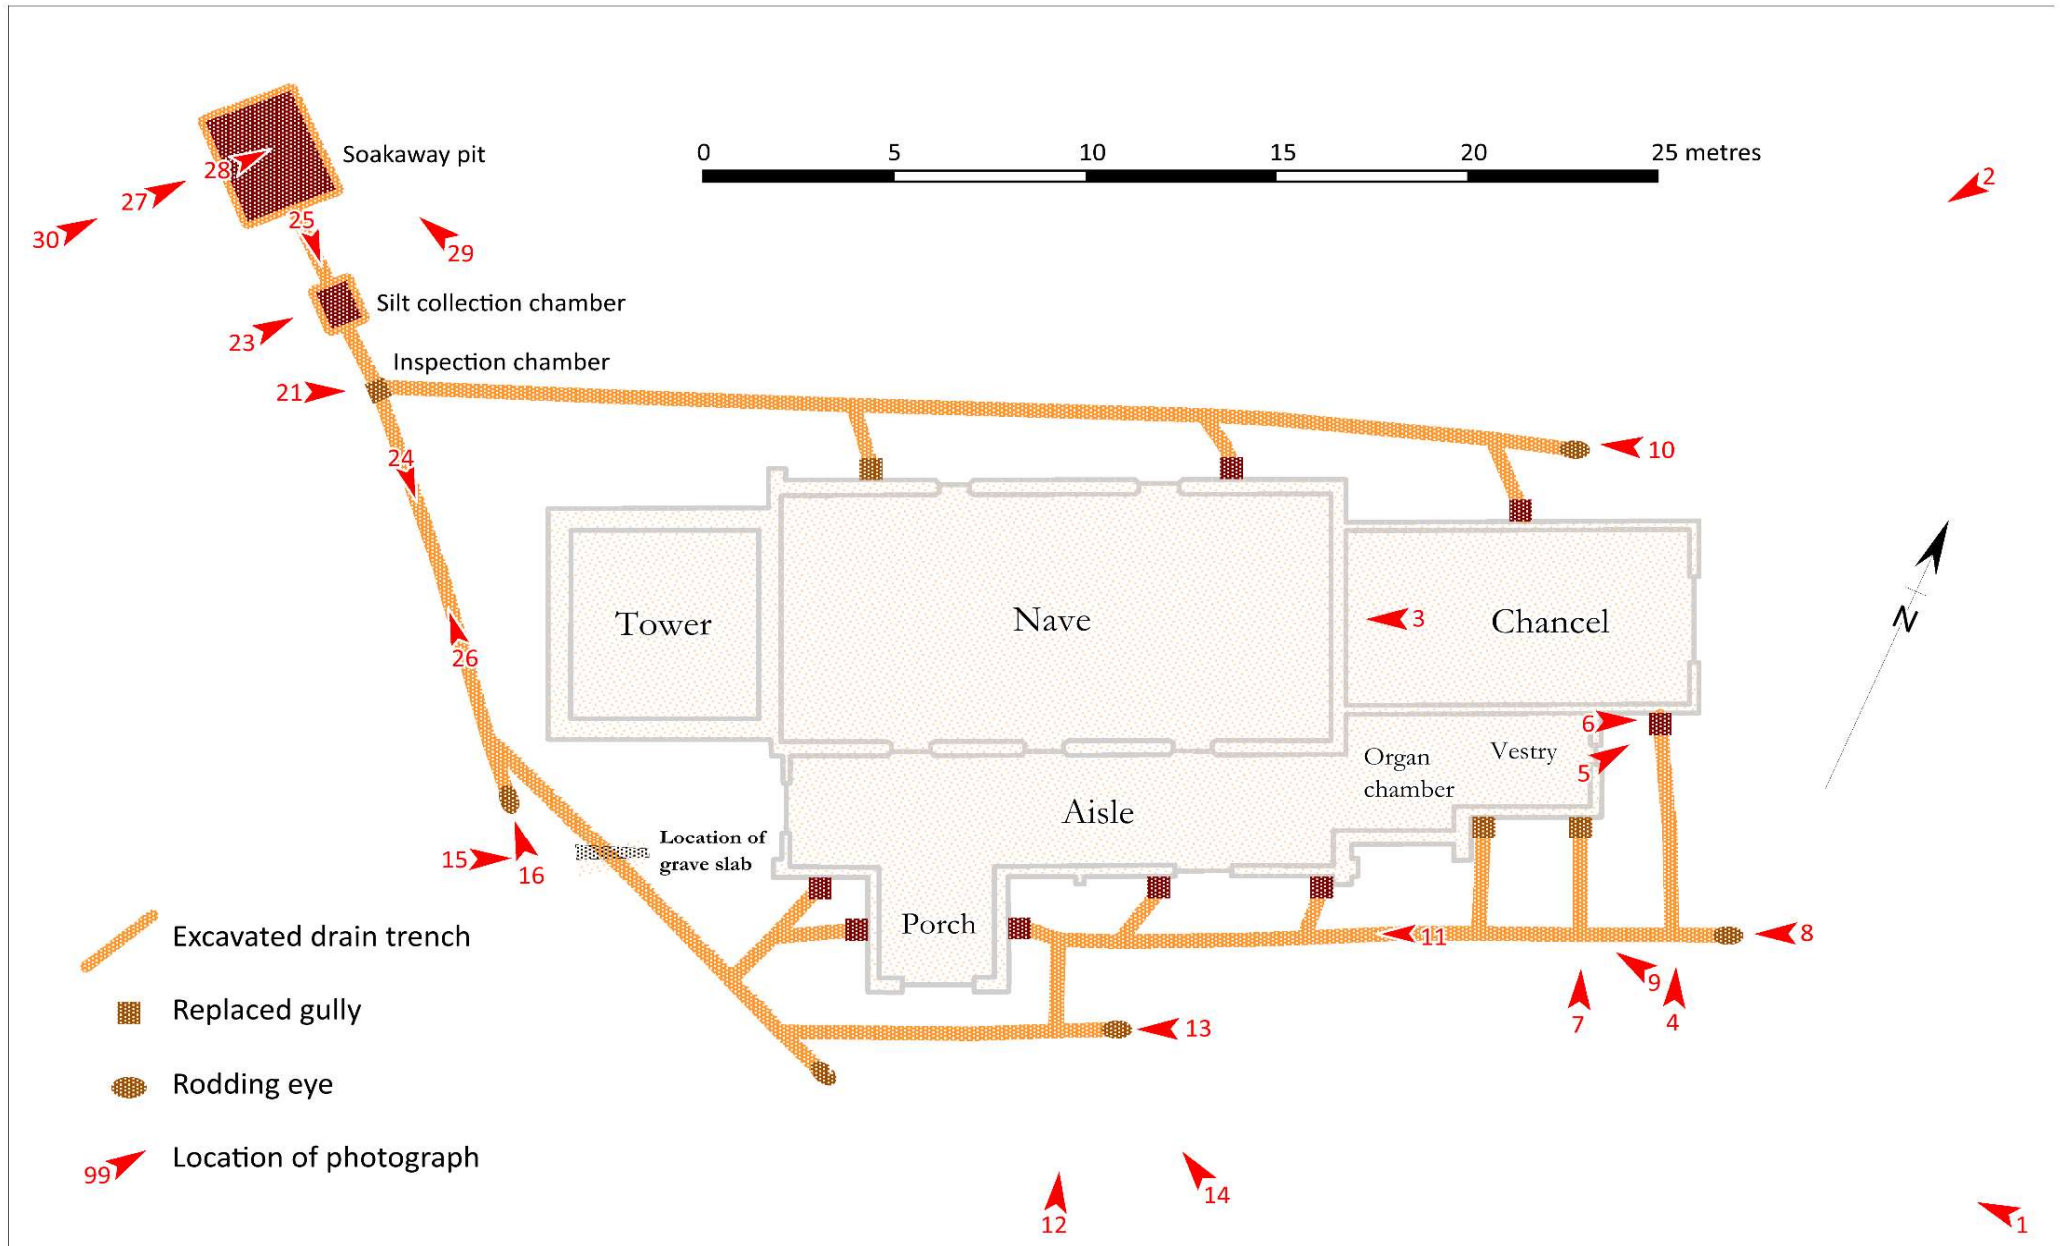
were then laid from each of these gullies, connecting to main drains on the south and north sides of the church building (Fig 2). The trenches to hold these drain pipes were machine-dug using mini-digger fitted with a 150mm-wide toothed bucket. These trenches were nowhere more than 550mm deep, the natural slope of the ground allowing a sufficient fall to be achieved along the length of the drains without much increase in their depth below the surface. As excavated, the trenches were typically less than 250mm wide at the base and 350 to 450 mm at the ground surface.

Figure 2: Plan showing layout of the drains as installed, in relation to the structure of the church, scale 1:200

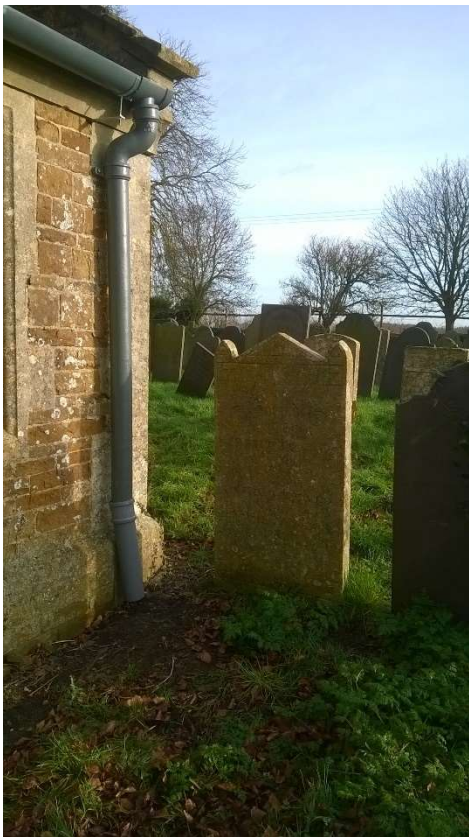
The drains were positioned to avoid any visible grave markers, although in places, notably at the south-eastern corner of the aisle, this involved squeezing the trench through narrow gaps between headstones (Photo 5).

5: The corner of the vestry, showing the closeness of the headstones to the building here, looking north-east

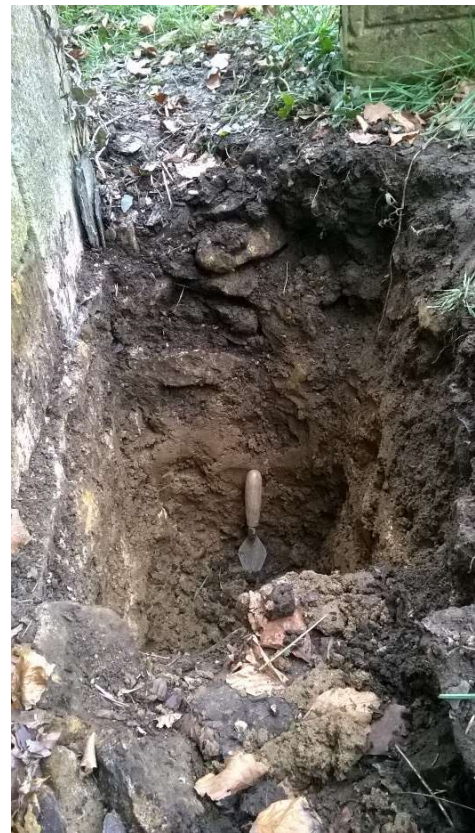
The brick surrounds of these old gullies were removed using a pneumatic breaker and new silt traps were installed in 500mm-deep hand-dug pits (Photo 6). Drain pipes, 100mm in diameter,

6: Hand-dug pit to take the trap below the corner of the vestry, looking east

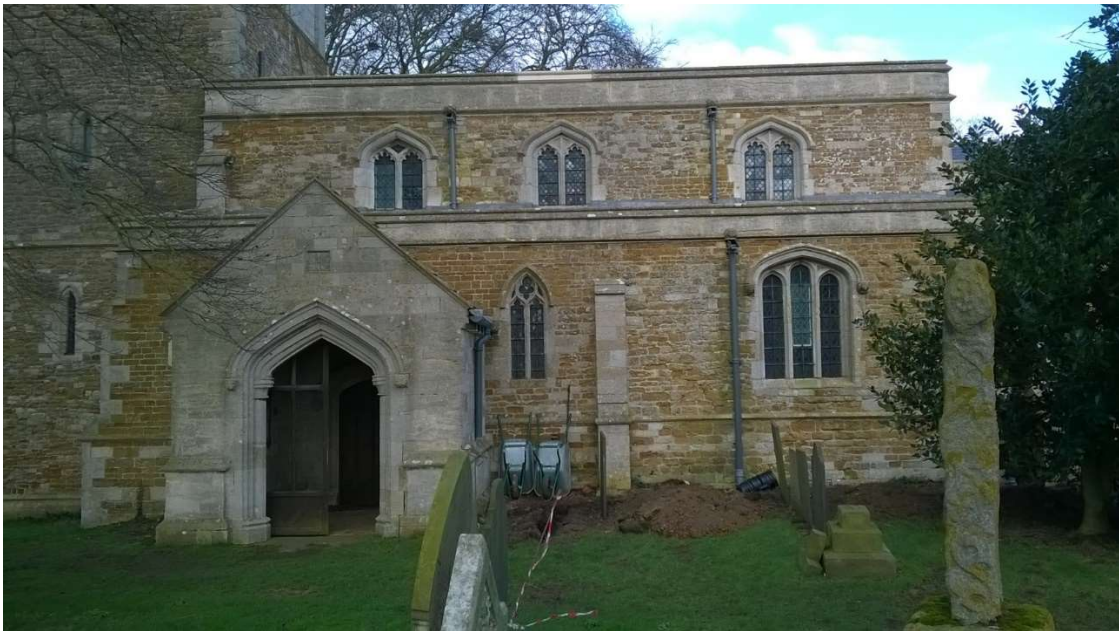
A plan of the churchyard on the wall of the vestry, undated but perhaps drawn in the 1960s or 70s, shows ten rows to the west of the cross, but there are fewer now surviving in this area (Photo 12). Some may have been deliberately cleared, either to provide a parking area or because they had been disturbed by the roots to the two large trees in this area, making them unsafe.

12: The south side of the church during the installation of the drains, showing the Anglo-Scandinavian cross, side on, on the right, and the relative sparsity of other memorials in this part of the churchyard, in comparison with the area to the east

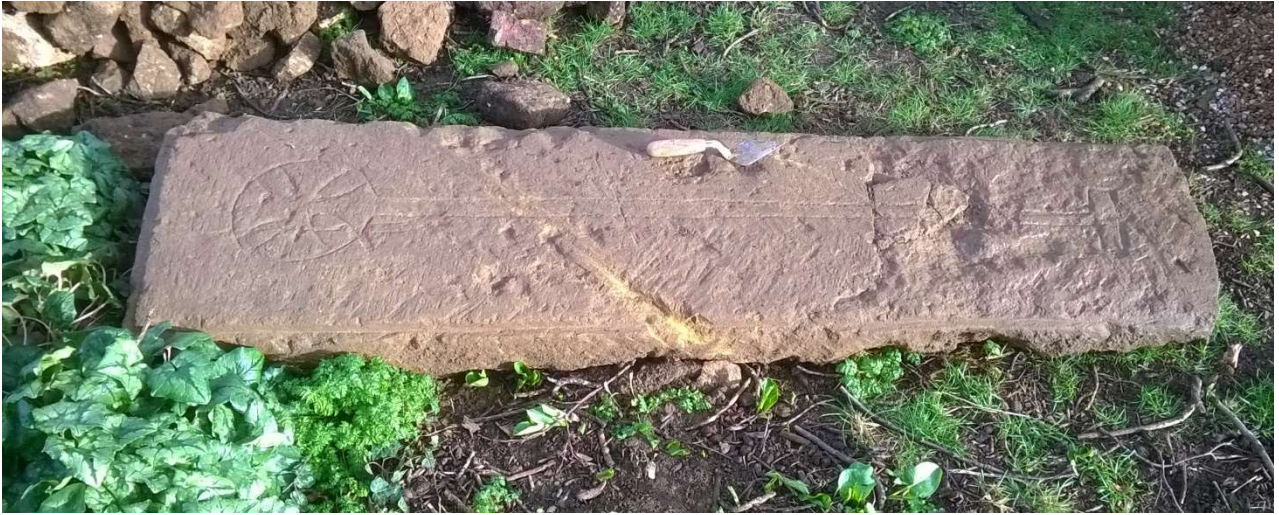
Wholly unexpected, a buried grave slab was uncovered during the excavation of the drainage trench between the south-west corner of the aisle and the corner of the tower (Photos 15, 17-20). This was roughly aligned with the southern light of the western window of the aisle, 2.80m from the aisle wall and 2.50m from the southern wall of the tower. It was covered by around 200mm of soil and turf, and there was no indication of its presence visible on the surface.

The grave slab is 1.77m long, measured along its centreline but is slightly asymmetric, the left side, when viewed from above, being 1.72m long and the right side 1.80m. Tapering from 0.52m wide at the top to 0.41m wide at the bottom, it is up to 140mm thick. The upper face has a square-sectioned chamfer, 30mm deep, all round the edge.

The grave slab was probably laid on the surface above the grave, and was buried by a combination of worm action and of overgrowth of turf, over the intervening centuries.

17: Overall view of the grave slab immediately after it had been displaced away from the construction work, trowel = 238mm

The grave slab, of probable early twelfth century date, is a significant find, and it is recommended that this should be published, possibly as a note or short article in an appropriate journal.

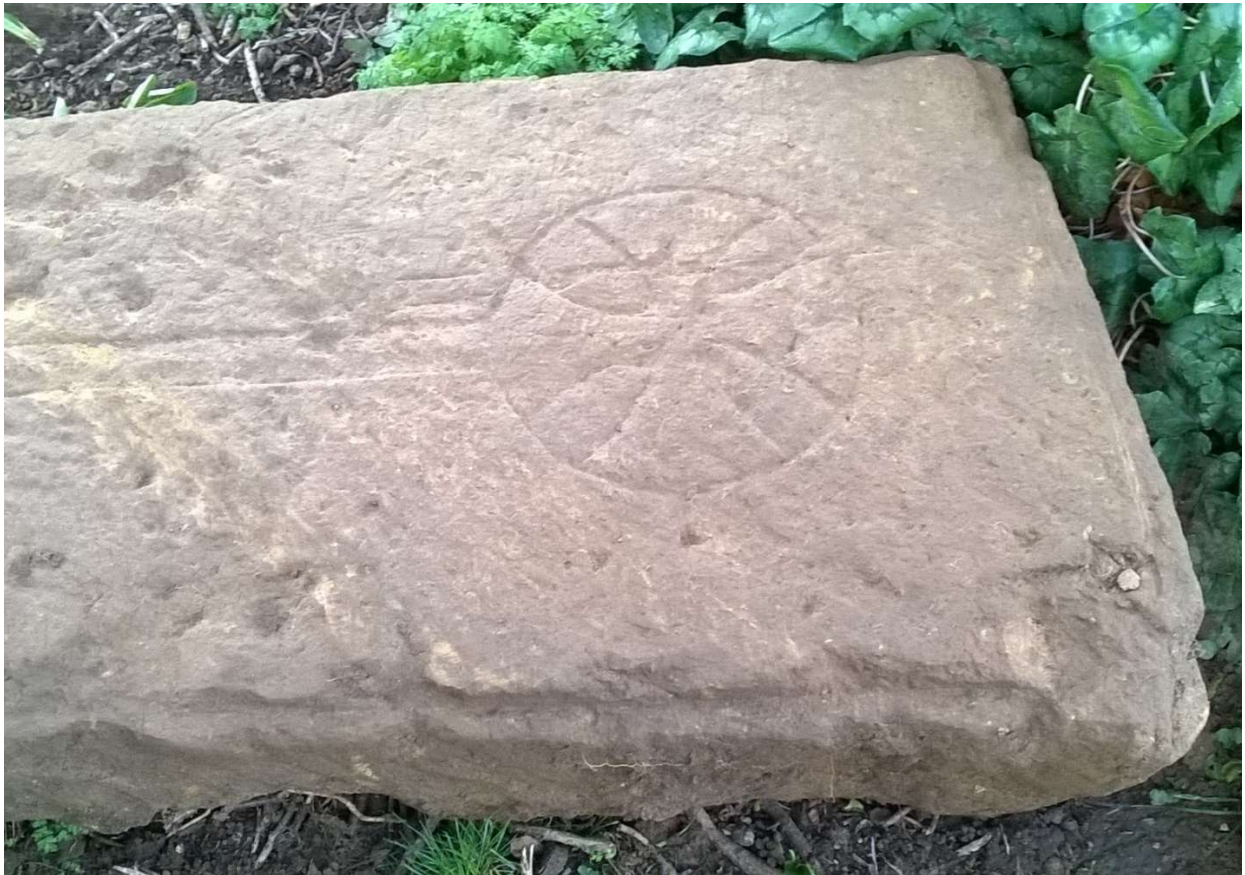
The face has an incised decoration of a simple expanded-arm circular cross-head and shaft. The cross-head is 230mm in diameter and the shaft is 1.20m long, tapering slightly along its length from 38mm wide at the top to 28mm at the bottom. A short cross-piece, 131mm wide and 42mm deep, forms the foot of the shaft; the shape and dimensions of this foot is reminiscent of the top of the handle of a garden spade.

Stone grave slabs of trapezoidal shape, used to seal and protect graves, were used from the tenth to thirteenth centuries, or perhaps longer. However, this example is probably from the early twelfth century. The most likely date is in the range AD 1100 to 1150, as the chamfered edge is characteristic of this period and the expanded-arm, or Maltese style, cross was fairly commonly

18: Detail of the expanded arm cross

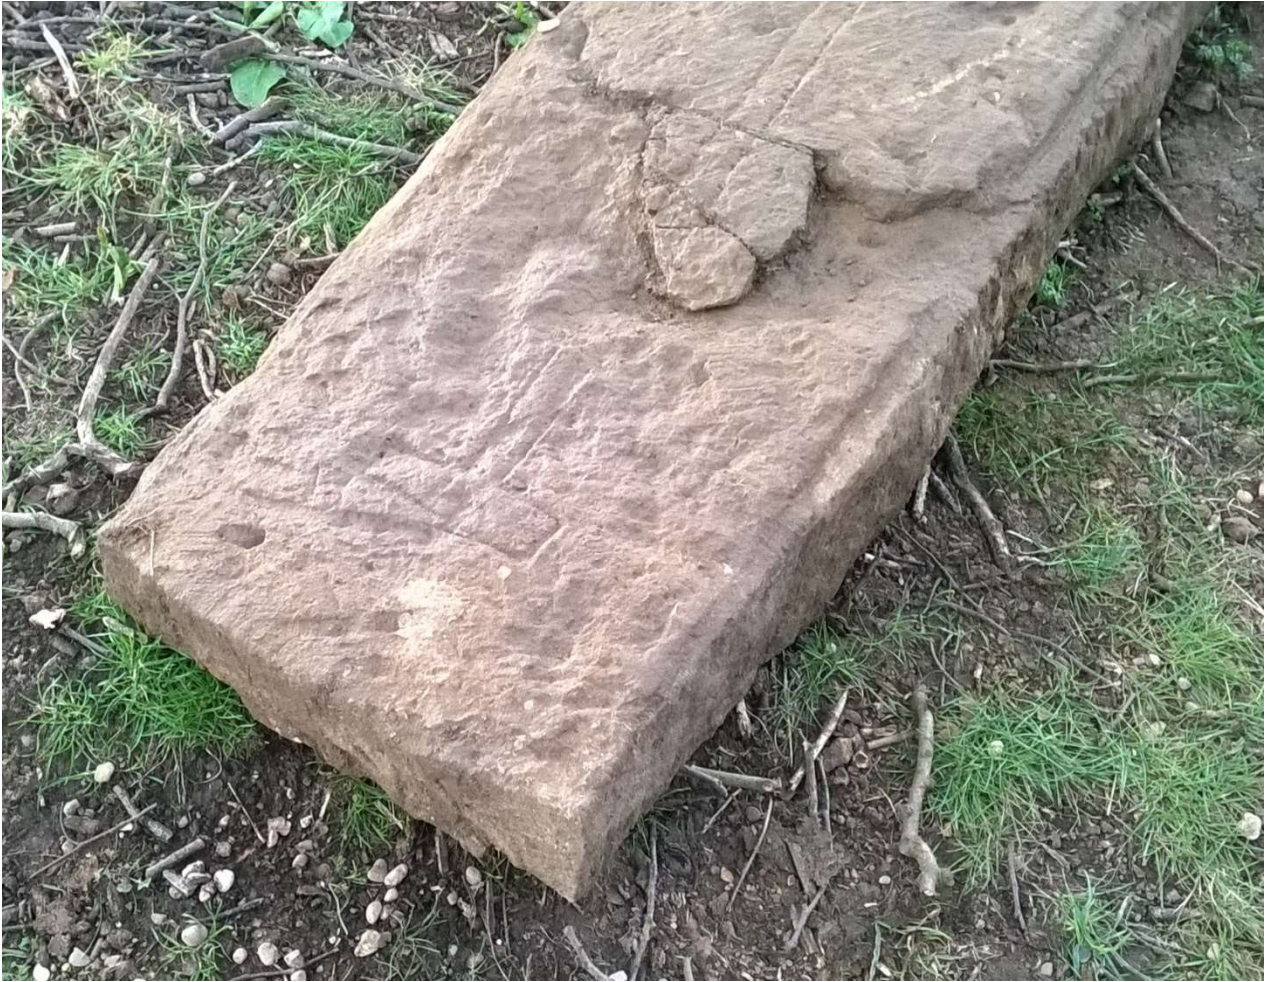
19: Detail of the 'spade handle' foot of the cross

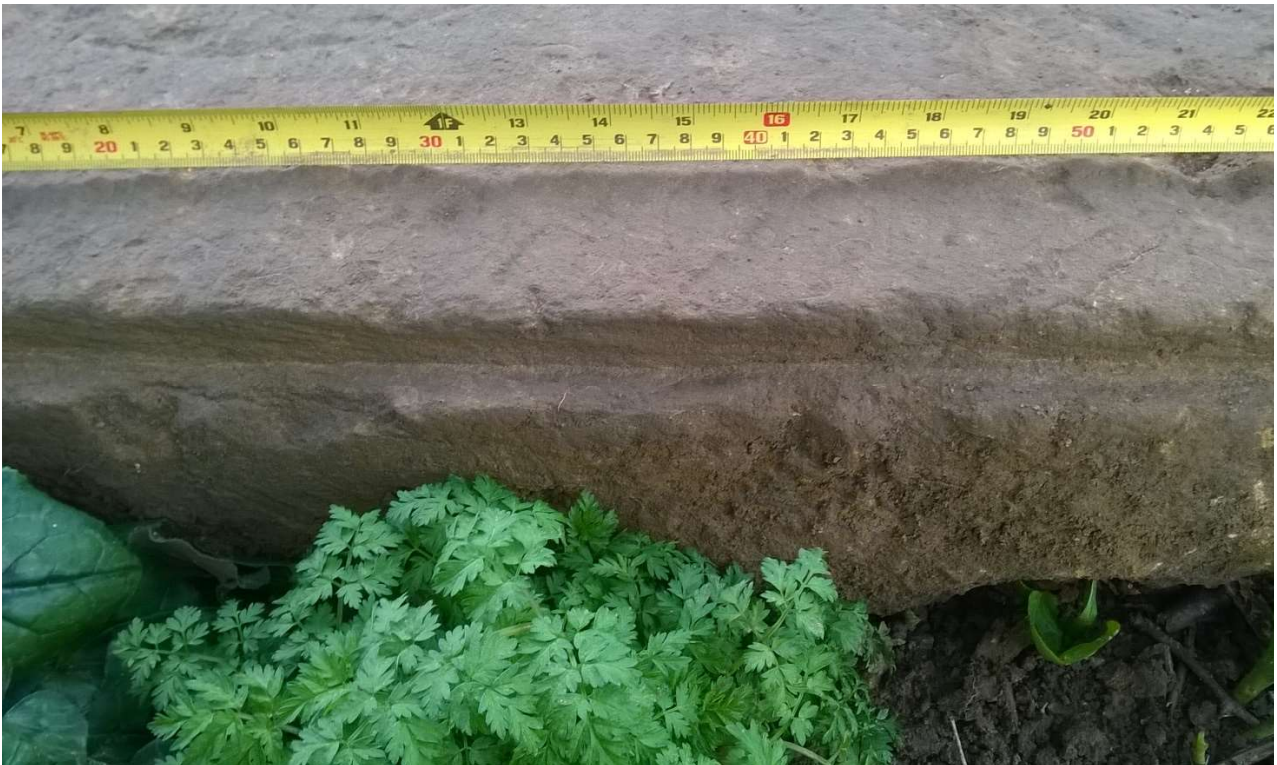
Around 1.20m to 1.40m from the top of the slab, there is a pre-existing area of damage, probably caused by frost cracking, where irregular areas of the surface have spalled off. From half-way along the left side, and angled diagonally upwards, a line of fresh damage is the result of the initial encounter with the mini-digger. Otherwise, the grave slab is in good condition, probably as a consequence of its relatively deep burial.

20: Detailed view of the chamfered edge of the grave slab

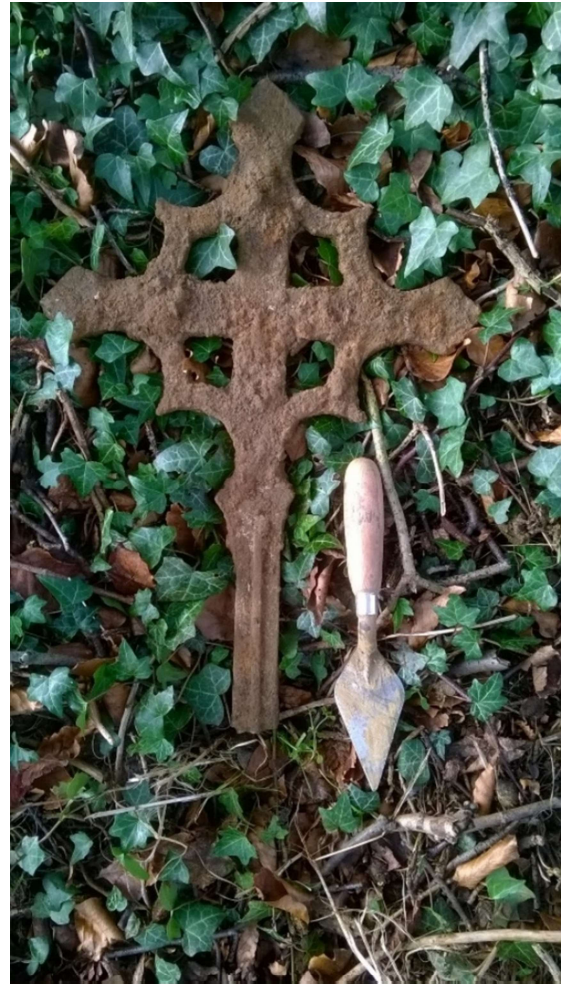
Other finds from the western end of the church include a cross of ferrous metal, probably cast iron (Photo 22). This was recovered from the drain trench just to the north of the silt collection chamber. A broken off finial from the gable end of one of the roofs, or part of an elaborate grave surround are possible interpretations. It is likely to date from some time in the nineteenth century.

22: Cast iron cross, found while digging the trench just north of the silt collection chamber, trowel = 238mm

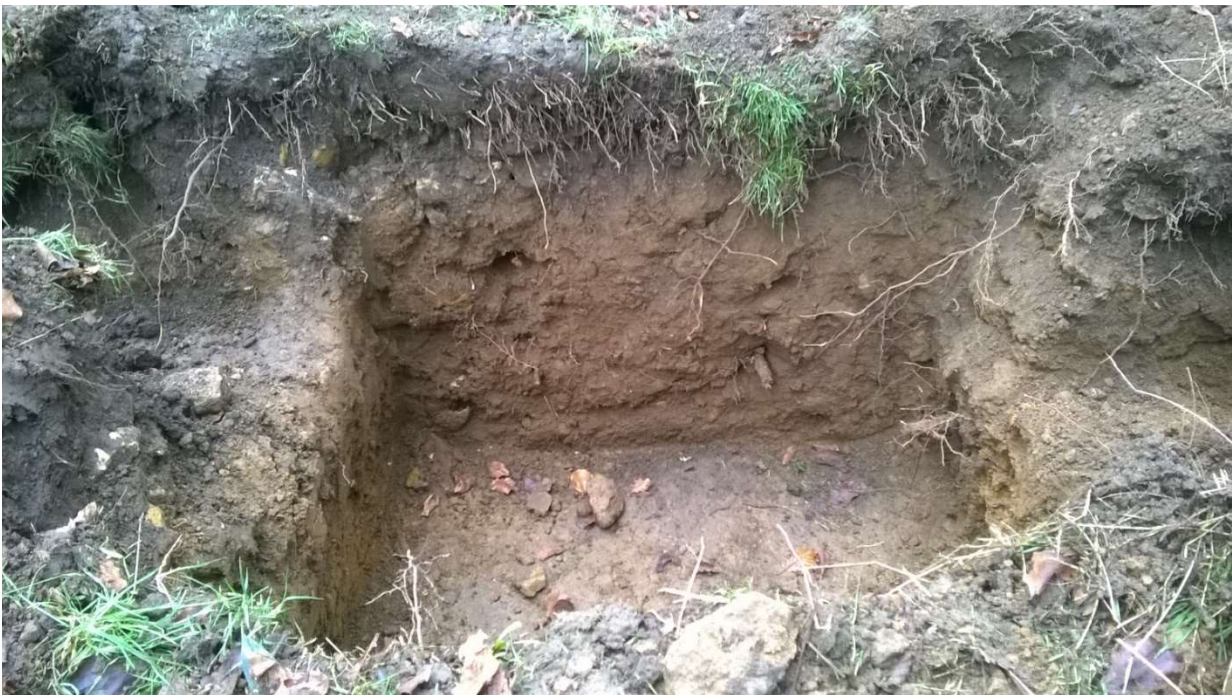
The excavation for the silt collection chamber, 1.10m square and 0.90m deep (Photos 23, 25), produced twenty-nine human bone fragments including thirteen pieces of cranium, the distal end of a humerus and eleven ribs. Continuing to the north-west (Photo 26), it was the scarcity of finds that was most notable. In particular, the excavation of the large pit, 2.90m long by 2.40m wide and 1.90m deep, for the soakaway (Photos 28-30) produced no human remains nor any artefacts.

23: Excavated 900mm-deep pit to take silt collection chamber, looking east

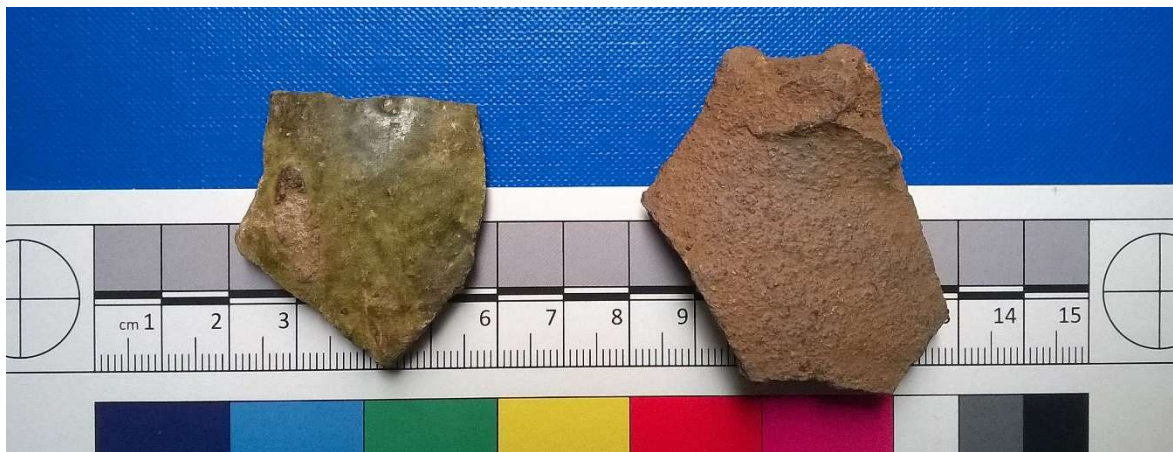
The same region of the site also produced a humerus shaft from a neonate or young infant. Other finds from this area included a bird bone, the distal end of a right tibiotarsus, probably from a member of the crow family and very plausibly a forerunner of the rooks that nest noisily in the churchyard beech trees. A single sherd of Midland purple pottery, dated to the mid-

A second piece of pottery, a body sherd from a medieval green-glazed vessel from the thirteenth or fourteenth century (Photo 3), was retrieved from the drain trench where it passed in front of the porch. A corroded ferrous object, either a nail or broken off bolt, was recovered from the same part of the trench (Photo 32 left), along with three human bone fragments, including a piece of tibia shaft.

31: Pottery sherds: medieval Green-Glazed ware (left) and late medieval Midland Purple ware

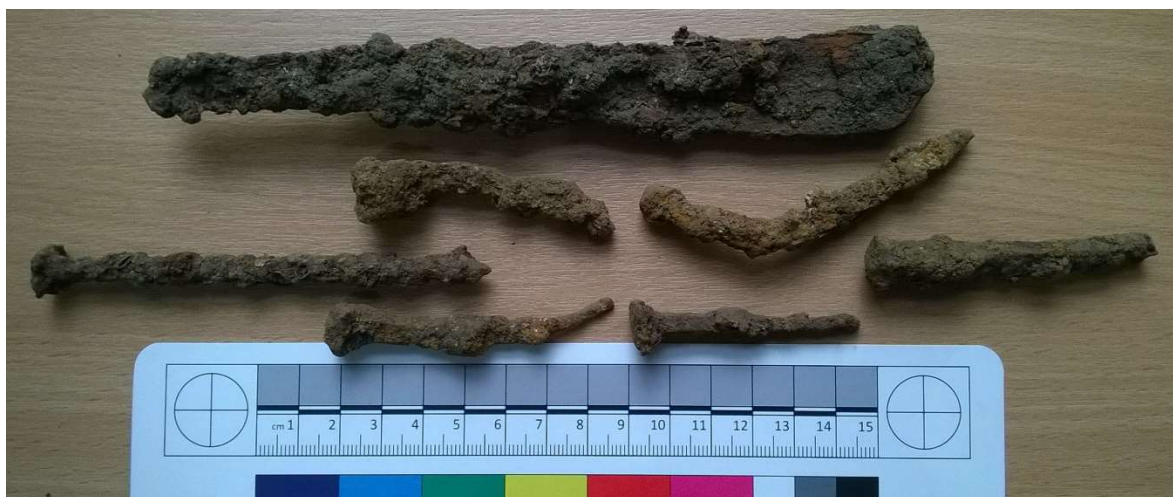
A corroded ferrous metal object, 182mm long, 8mm thick and tapering from a maximum width of 22mm, found just to the east of the angle of the aisle and the porch, is probably an old knife blade (Photo 32 top). A strip of lead, 220mm long, 6mm wide and 2mm thick, from the same area, is likely to have been fitting for a roof slate. Neither of these metal objects is readily datable. Five pieces of human bone were also recovered from this area included fragments of two ribs and two hip bones.

There were also five corroded ferrous metal nails from this part of the churchyard: two from south of the tower (Photo 32, centre right), two from west of the tower (Photo 32, centre left), and one from the silt collection chamber (Photo 32, right). These are not readily datable but at least some appear to be hand-made, presumably forged by the village smith before industrial manufacture became commonplace. It is tempting to interpret these finds as coffin nails, but in the course of centuries of repairs, alterations and additions to the building, many nails could have been lost in the churchyard.

32: Ferrous metal finds: knife blade and nails

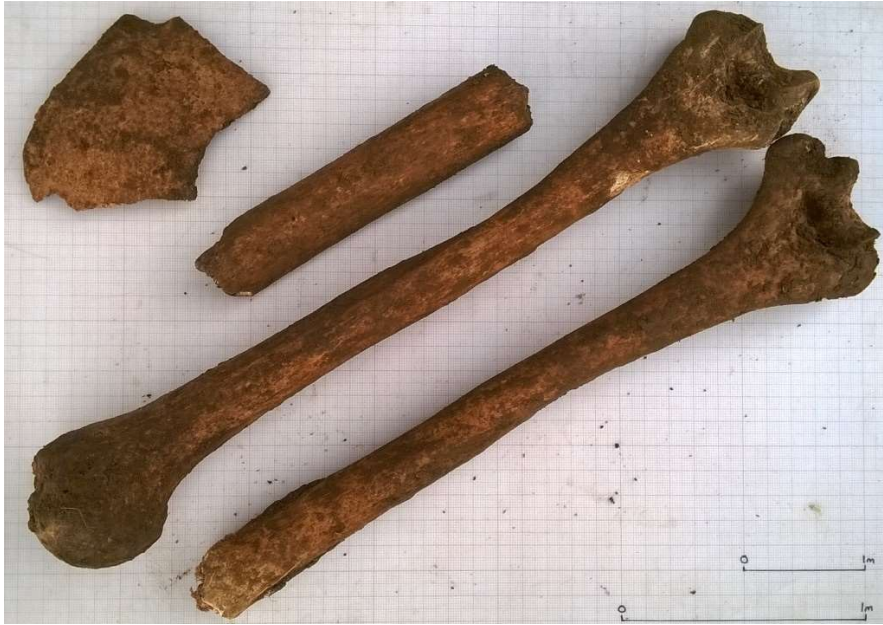
There were very occasional fragments of disarticulated human bone throughout the drainage trenches on the south side of the church (Photos 4, 7-9, 11) but the region where the drains from the vestry and the eastern end of the organ chamber discharge into the main southern drain (Photos 7, 9) produced a substantial assemblage of human remains. In all, 157 bones or bone fragments were retrieved from this area. This total included 70 cranial fragments, probably representing at least two skulls. There were five fragments of mandible, paired humerus and ulna shafts, tibia and fibula shaft fragments, two matching clavicles, seven vertebrae, five phalanges, and scapula and numerus rib fragment within this assemblage (Photos 33-35).

The distribution of bone elements, the presence of matching paired bones and absence of any obvious duplicated bones, and the overall similarities of size and robustness suggest that most of these bones were from a single skeleton. However, a second skull seems also to have been present, judging from the quantity of cranial fragments.

33: Paired human humerus bones from drains south of the vestry

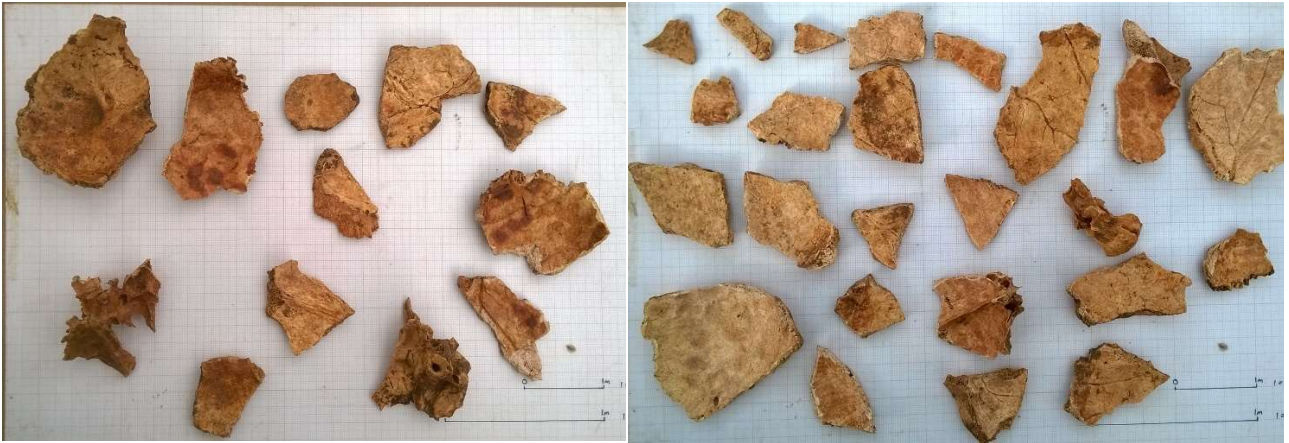
These remains were at no great depth, with the main concentration of skull fragments being no more than 280mm below ground surface. The bones were not seen to be articulated, although there was some pattern to the way they were buried, with the skulls at the eastern end of the deposit and the other bones extending to the west.

34: Assortments of skull fragments from south of the vestry

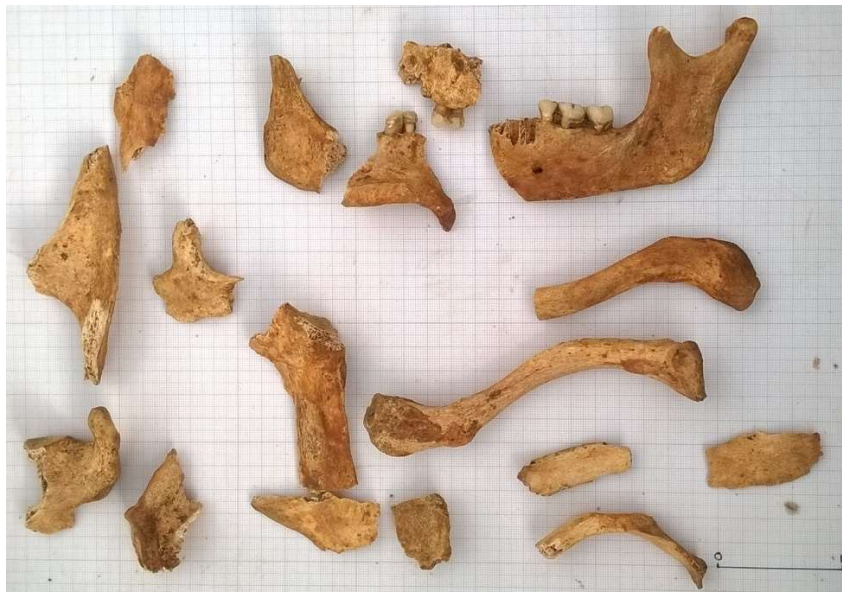
35: Fragmentary human bone including mandible, clavicles and ribs from south of the vestry
