# **Management of prehistoric monuments on Helvear Down, St Mary's, Isles of Scilly**

## **Archaeological monitoring**

**Report No: 2011/04**

**June 2011**

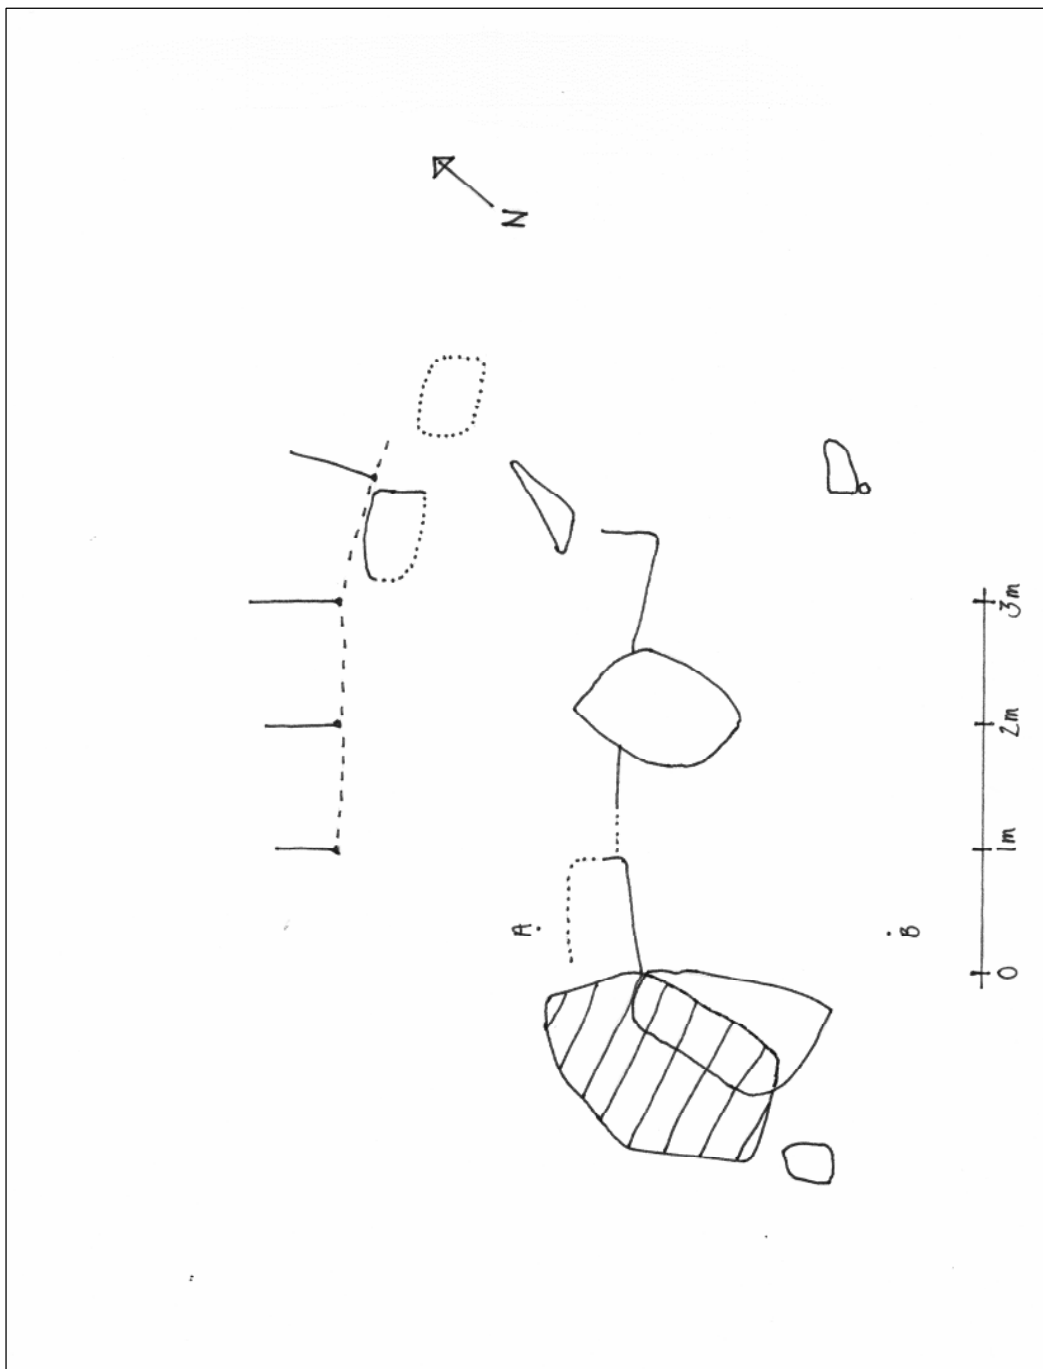
### 8.8.1 Plan of kerbed platform cairn (SM 15377)

No finds were made during the removal of loose vegetation in and around the chamber. It was drawn in plan and section at 1:20 and the chamber and mound were drawn in plan at 1:40. These are shown at appendix 8.8.

Part of the stone walling of the chamber in the kerbed platform cairn has now been revealed, together with two probable capstones. Two kerbstones were also found by probing. The surviving remains are typical of a Scillonian entrance grave.

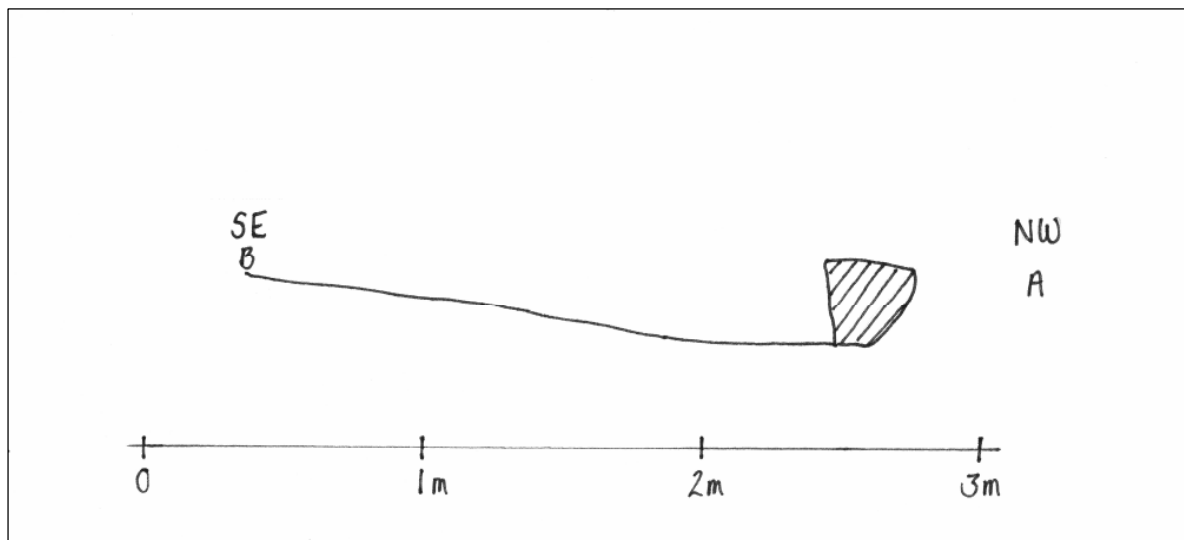
**8.8.2 Section across chamber of kerbed platform cairn (SM 15377)**  
(Stone shown hatched)

A large stone with a natural basin in its upper surface, probably a capstone, is propped up on one edge to the south-west of the endstone and another possible capstone lies across the northern chamber wall. The chamber measures approximately 3.6m in length, 1.5m in width and is currently 0.3m high, although there is accumulated dead vegetation and peat in the base of the chamber which was not removed.

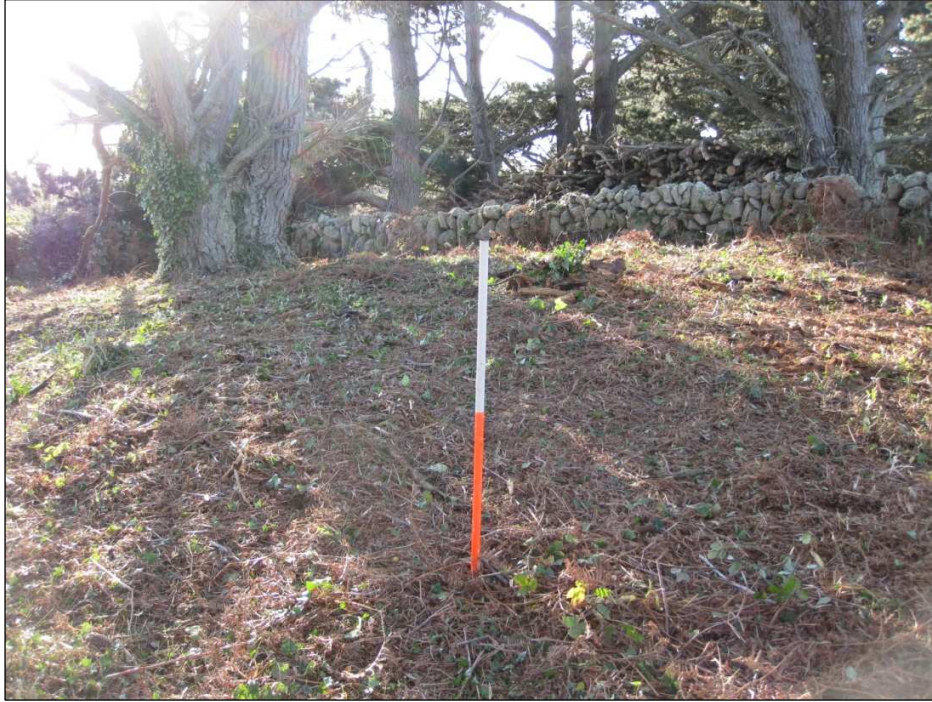
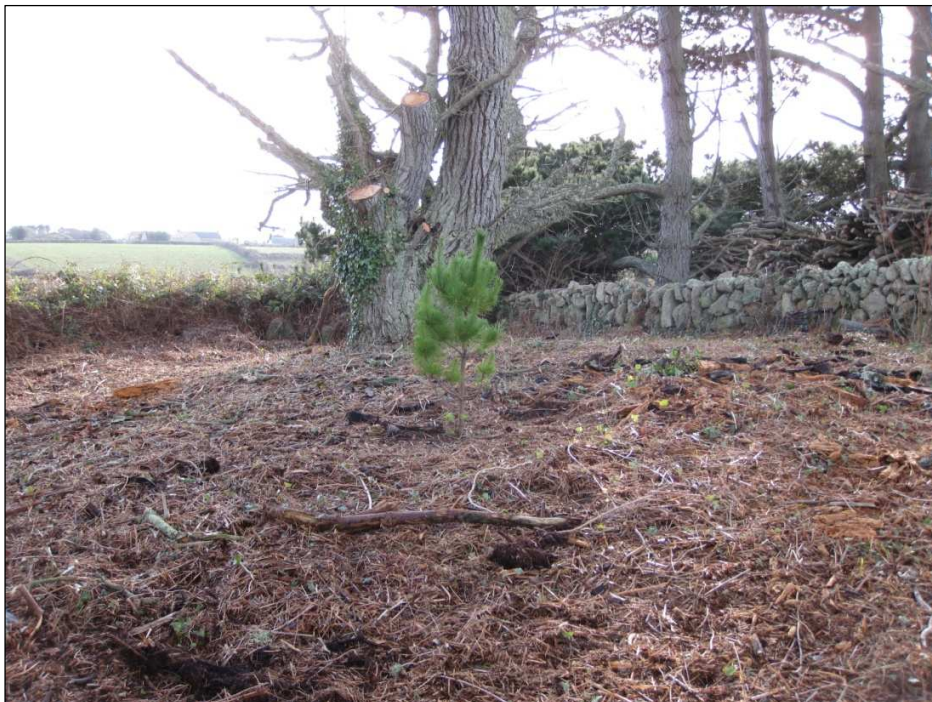
### 8.9.1 Round cairn (SM 15376) before and after tree surgery

This roughly circular mound is located against a stone wall which appears to have truncated it on its south-western side. There is no trace of the mound on the other side of the wall. There is a large pine tree on the southern side of the mound, close to the wall, as shown in 8.5.1. The dead branches of this were removed as part of the vegetation clearance and the tree is now believed to be stable and secure.

A single stone, measuring 0.55m by 0.45m by 0.3m, lies on the eastern edge of the mound and there are depressions around the perimeter on the eastern and south-eastern sides, caused either by tree throws or excavation. No trace of a kerb was found by probing and there were no finds.

During the course of this project a small conifer was planted on the north-eastern slope of the mound; this is believed to have been done by the farmer of the neighbouring farm.

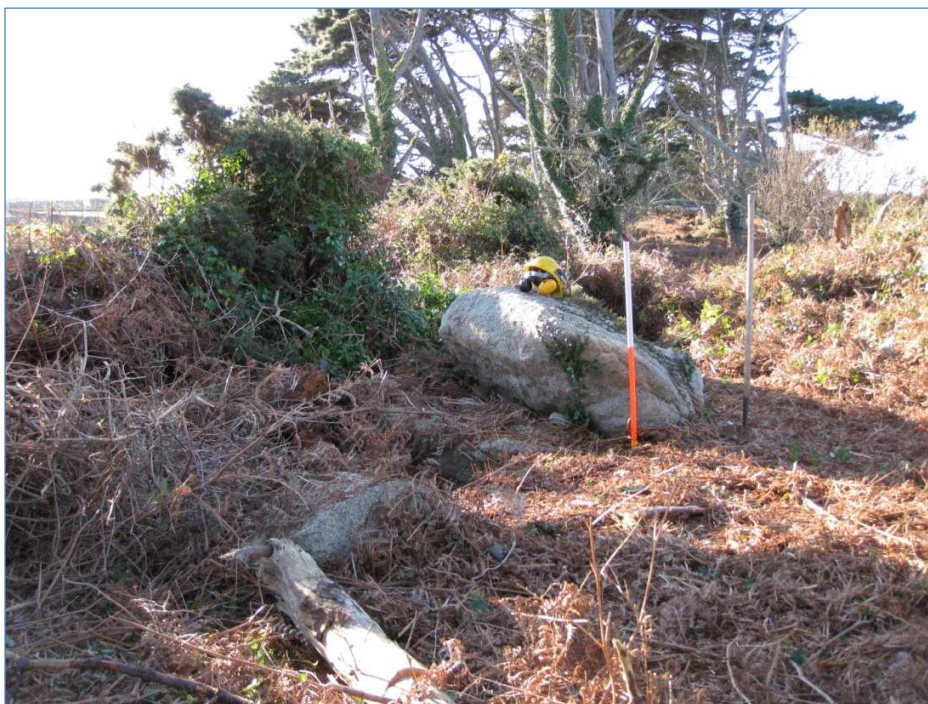
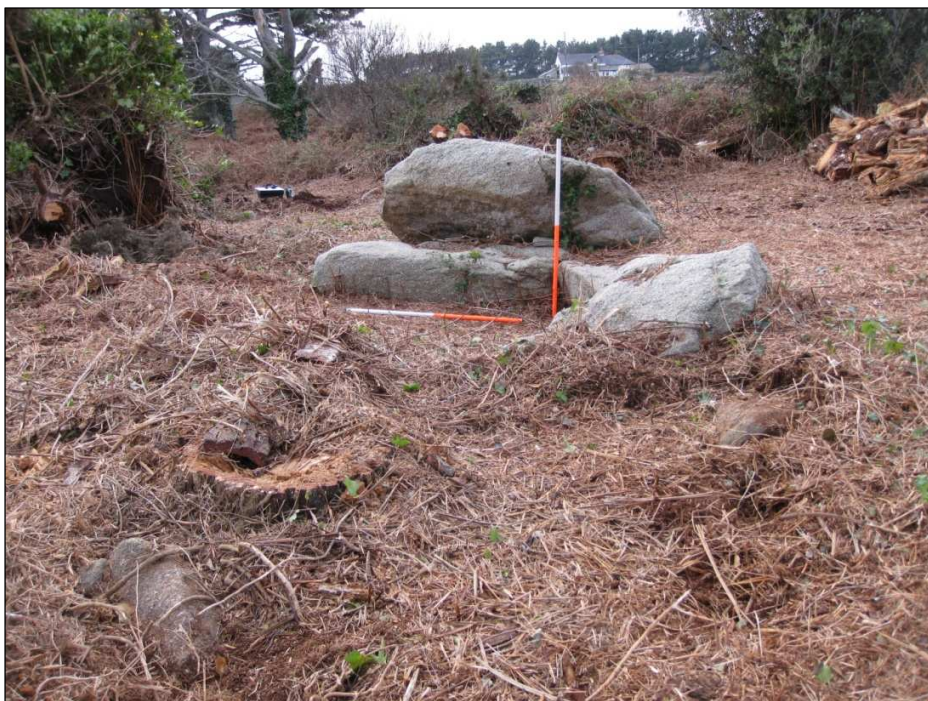
### 8.9.2 Kerbed platform cairn (SM 15377) before and after vegetation clearance

This structure is recorded as an entrance grave in the HER and conforms to the usual layout of this site type in Scilly. Its damaged state suggests that it is likely to be one of the two barrows described by Layard (1933). The remains of a chamber survive roughly in the centre of the cairn, with one stone forming the end and three surviving on the northern side. The chamber is oriented north-east to south-west, with the entrance at the north-east end.

Other small stones survive to the south of the endstone and to the east and west of the presumed entrance. The original mound appears to survive on the north-western side of the monument and two stones, probably kerbstones, were found by probing on the edge of the mound. Elsewhere the outline of the mound is not clear because of dead vegetation and stacks of wood.

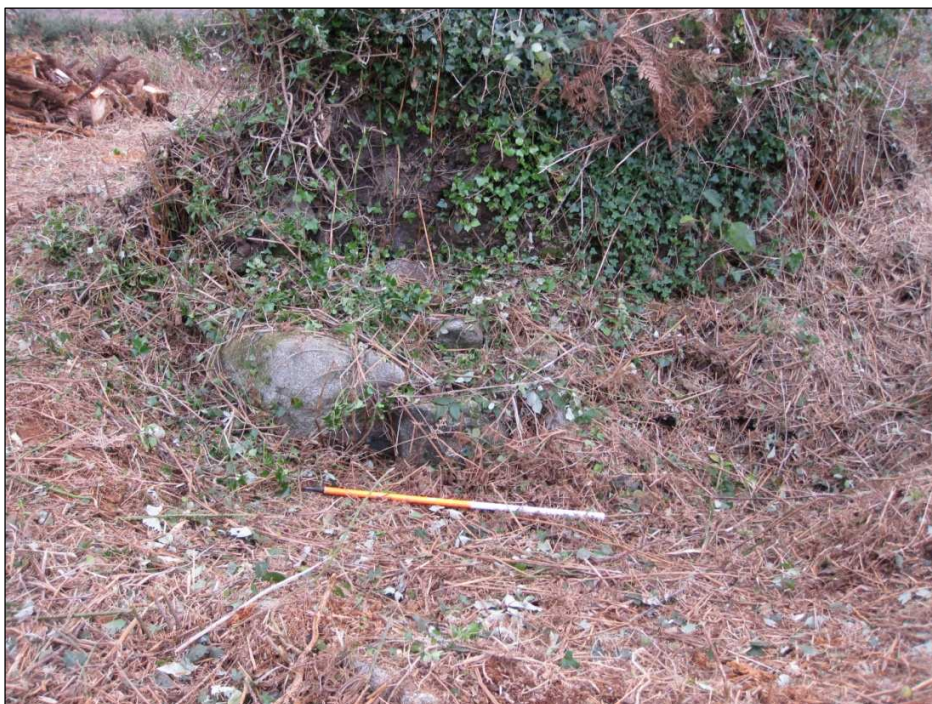
**8.9.3 Possible entrance grave at SV 92295 12366 (north side of root plate)**

This site is located about 10m to the south-west of the entrance grave described above and is probably the second barrow described by Layard (1933), which has not been satisfactorily identified to date. This site has been further damaged by the toppling of a large tree which had been planted directly over it.

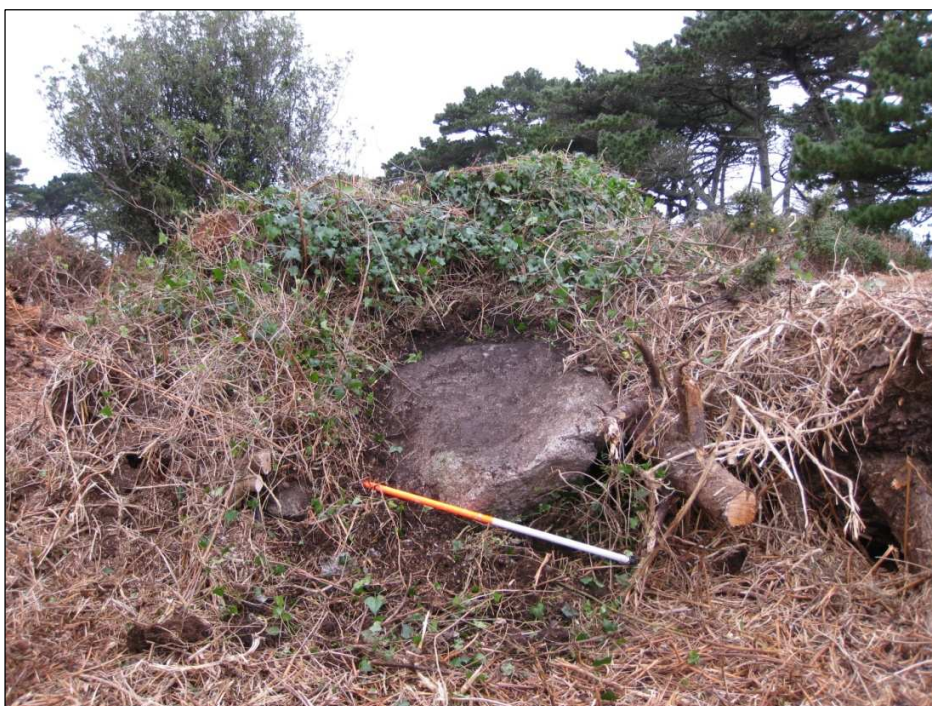
**8.9.4 Possible entrance grave at SV 92295 12366 (south side of root plate)**

The root plate has not been removed and a large stone, probably a capstone, can be seen on the upper (southern) side of the roots; this is illustrated at 8.9.4. Immediately to the north of the root plate is the roughly circular depression of the tree throw, where a number of small stones can be seen to form an arc, illustrated at 8.9.3. Further stones are apparent in the base of the root plate.

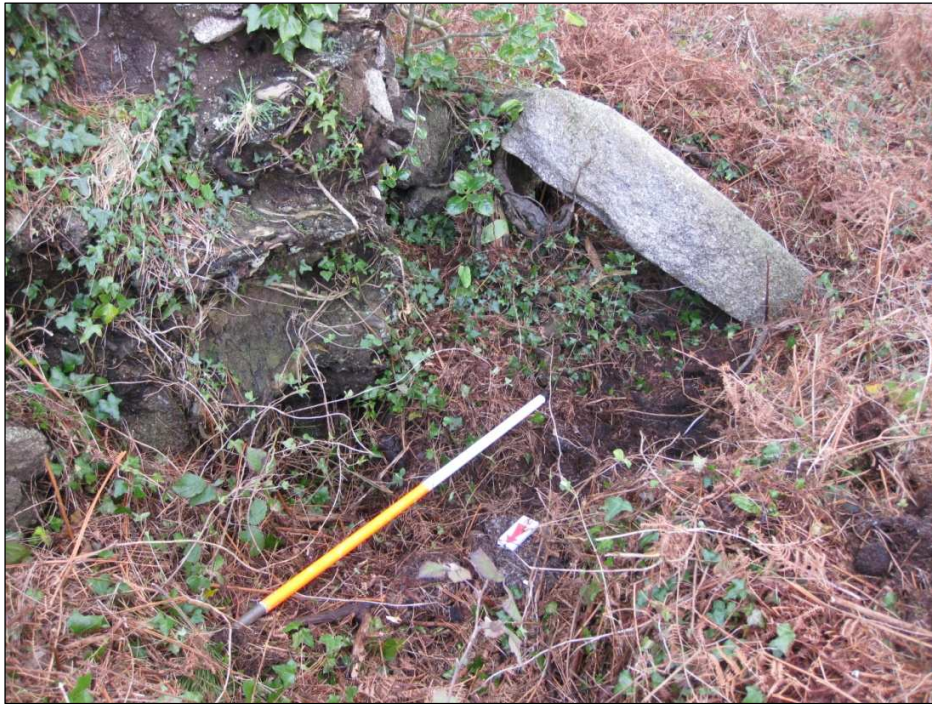
#### 8.9.5 Possible structure at SV 92271 12346 after vegetation clearance

This site is also located in a tree throw where the root plate has not been removed. A large stone is visible just to the south of the tree throw hollow and there are several other smaller stones, both in the base of the root plate and in the centre of the hollow below.

Again there were no finds and the site was recorded by photography only.

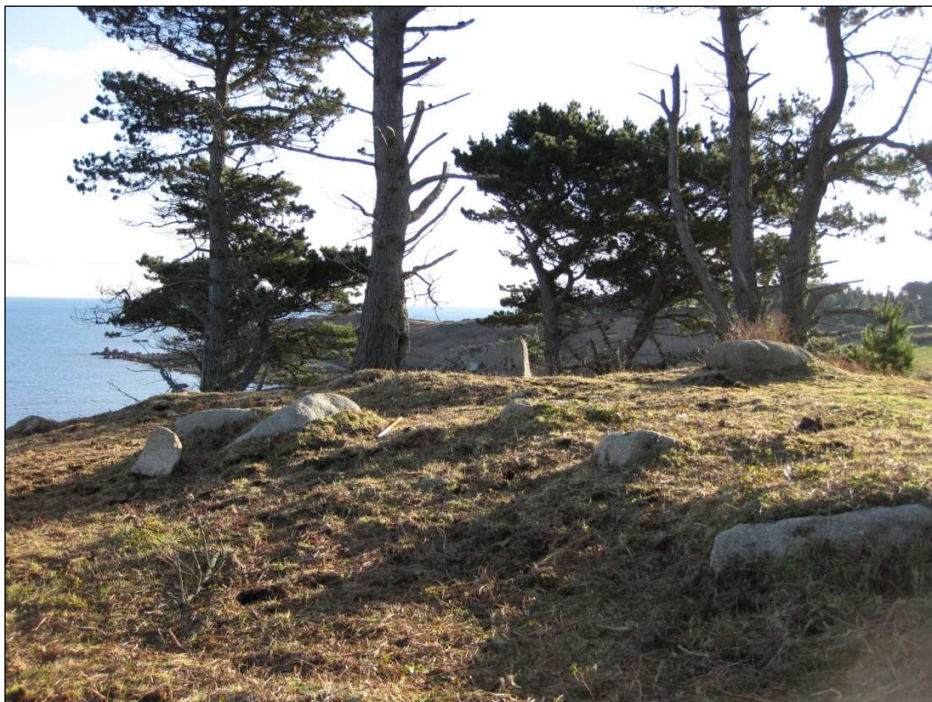
#### 8.9.6 Possible entrance grave in Civil War battery

A grouping of boulders inside the Civil War battery (SM 15378, PRN 7457) was also photographed. This is outside the project area but may represent the remains of a ruined chambered cairn. On 22 December 2010 vegetation clearance was completed and the kerbed platform cairn and the structure adjacent to it were photographed again.
