Standing Building Survey

The Cottage, Collace

Perth and Kinross

18th January 2019

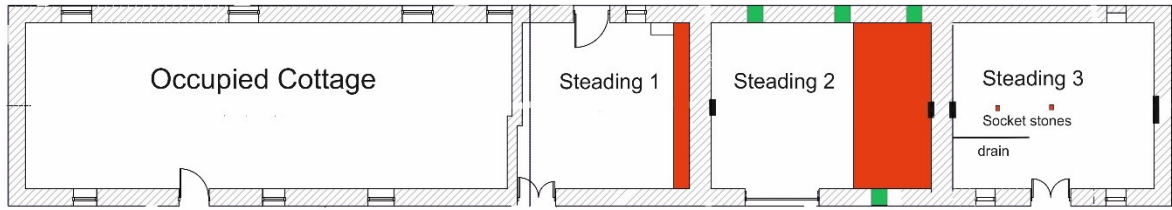
Illustration 4- Ground floor plan of The Cottage, Collace, red line in Steading 1 indicates earlier wall foundation, red area in Steading 2 indicates rough stone floor area, green squares indicate blocked windows, black rectangles show position of fireplaces (numbers refer to text descriptions of steadings) (based on supplied architect's plan)

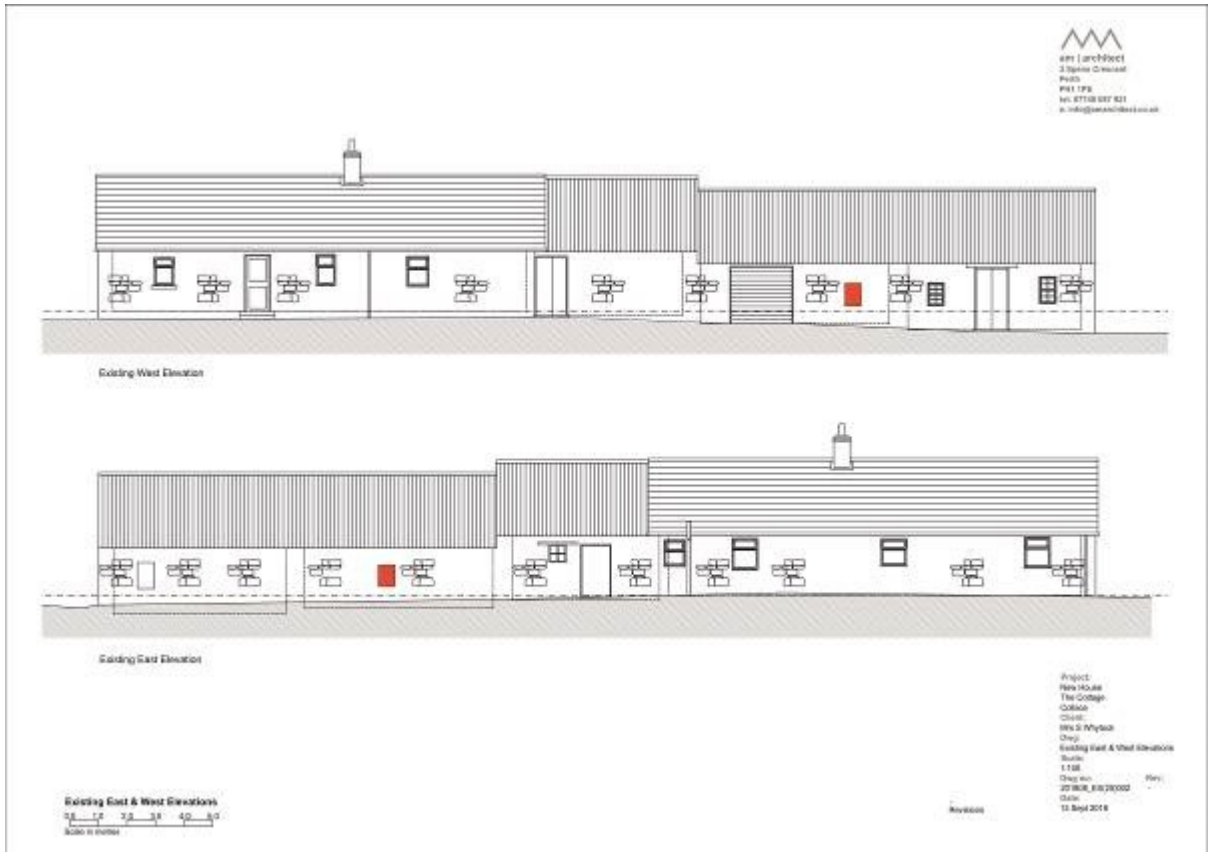
Illustration 5- Western and Eastern elevations of The Cottage, Collace showing blocked windows visible in Western and Eastern elevations in red (based on supplied architects plan)

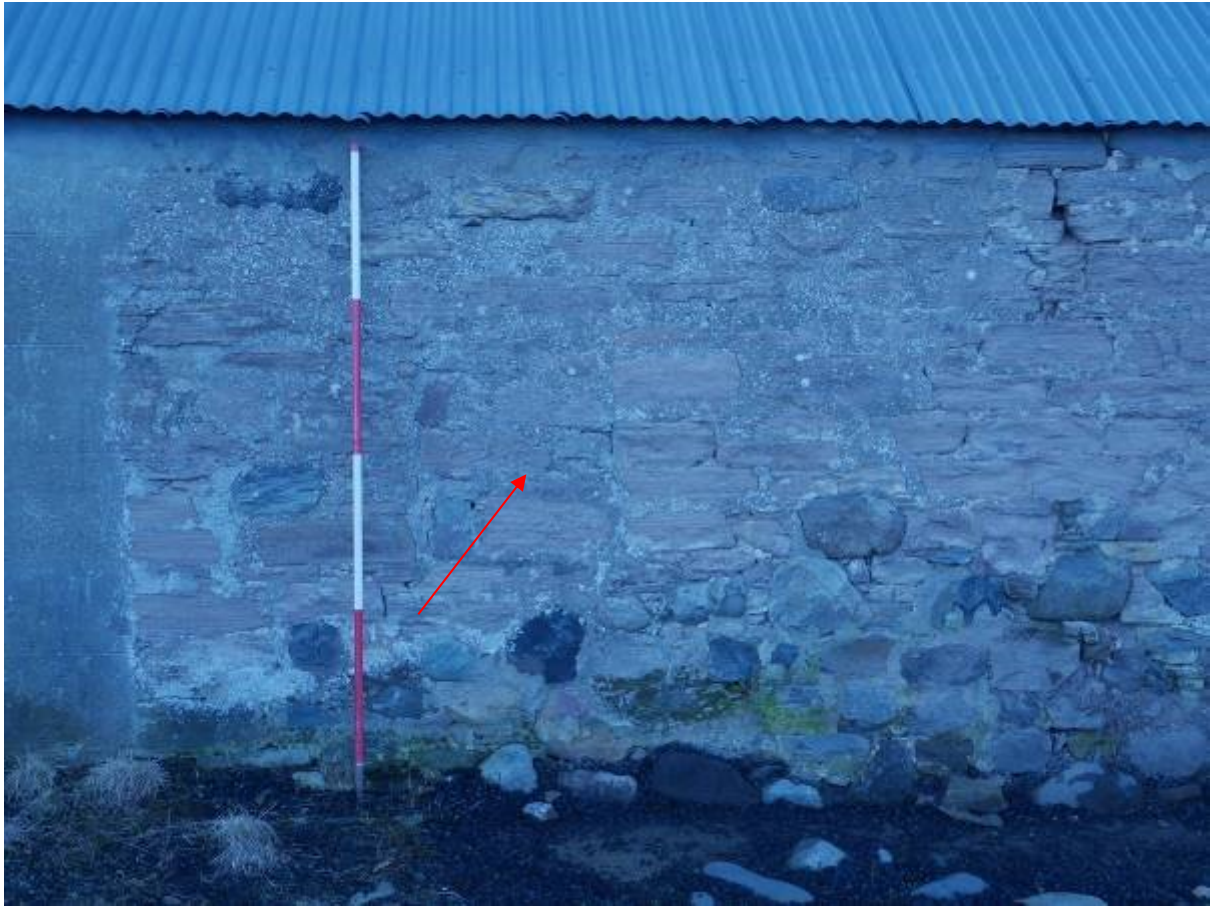
This is a rough mortared stone wall with a brick surround to the metal swinging door. It contains a blocked window (Illus 9).

Illustration 9- Detail of Western elevation showing blocked window in Steading 2 (red arrow)

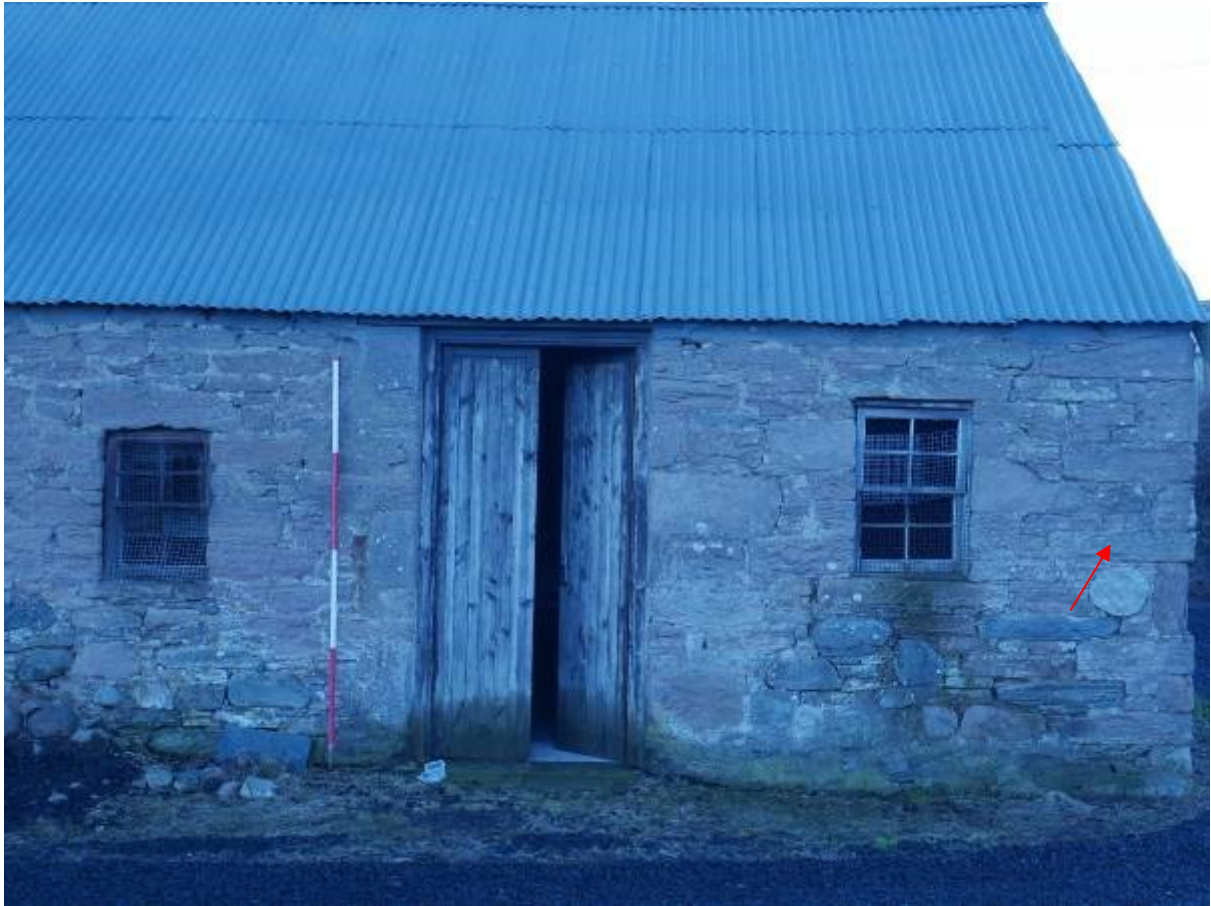
Illustration 10- Detail of southern end of Western elevation, alternate shaped quoins at corner marked with red arrow

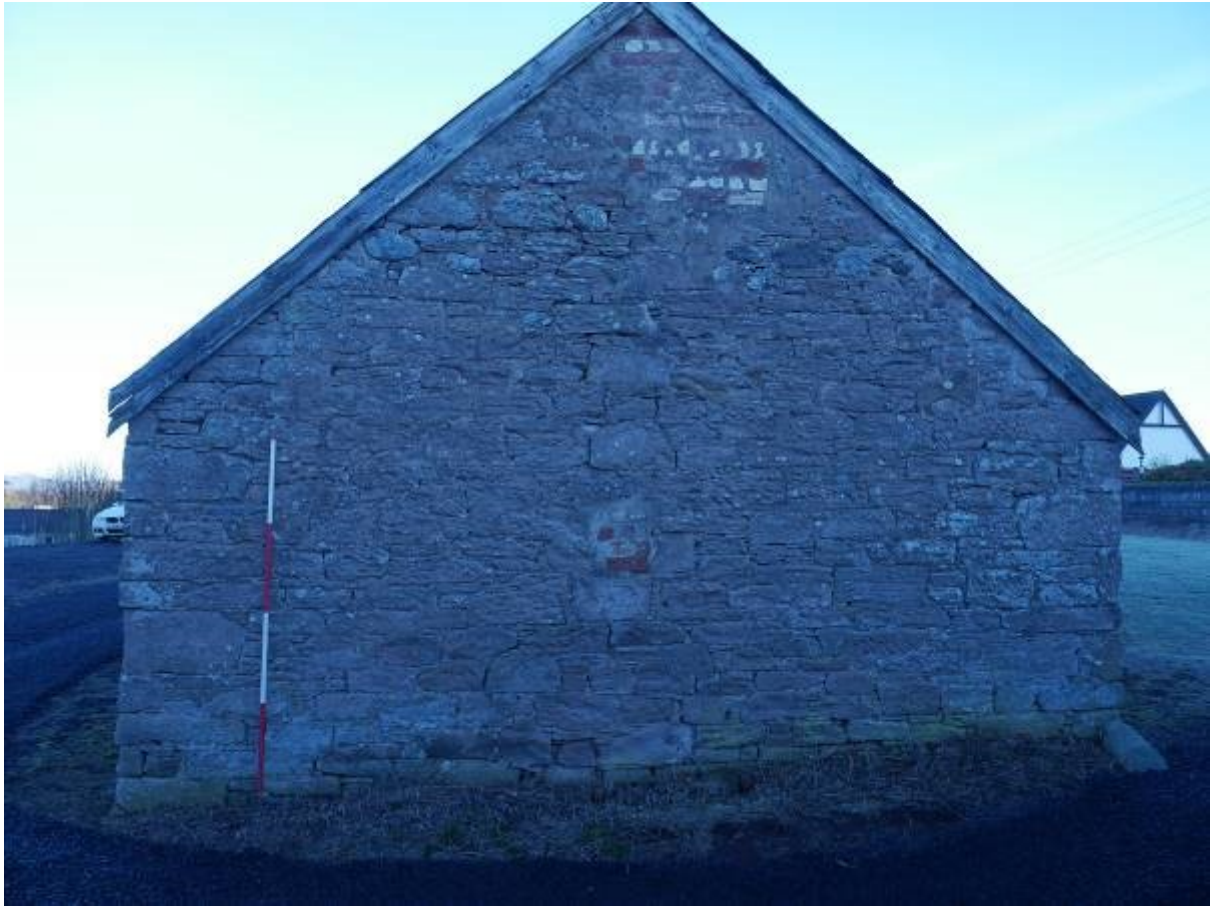
This elevation has a blank mortar bonded rough stone wall with alternate large shaped stone quoins at its Western and Eastern ends. Wooden plank roof supports run down the roof lines on the gable. There are traces of a small hole blocked with mortared bricks in the centre of this wall.

Illustration 11- Southern elevation of building

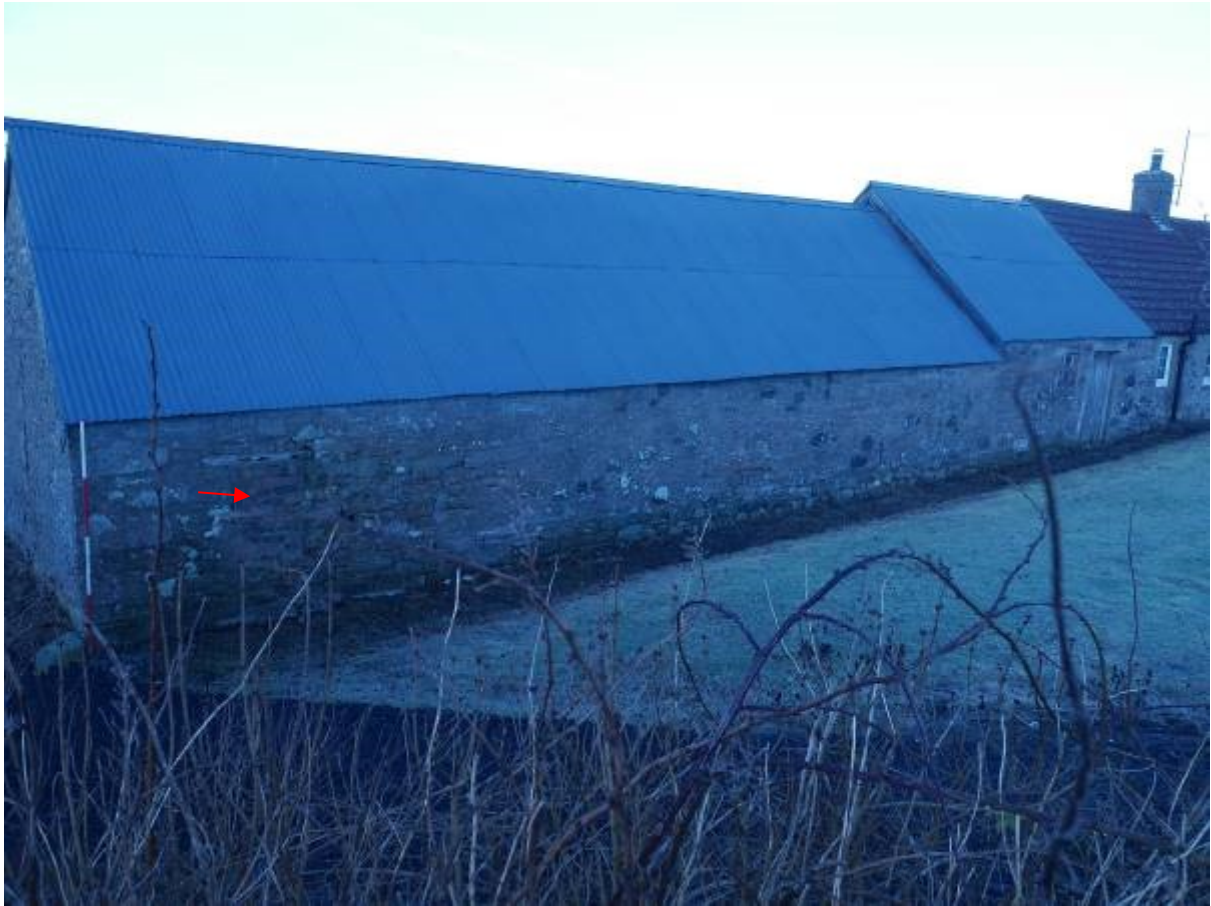
Illustration 12- Eastern elevation looking North West (blocked window marked with red arrows)

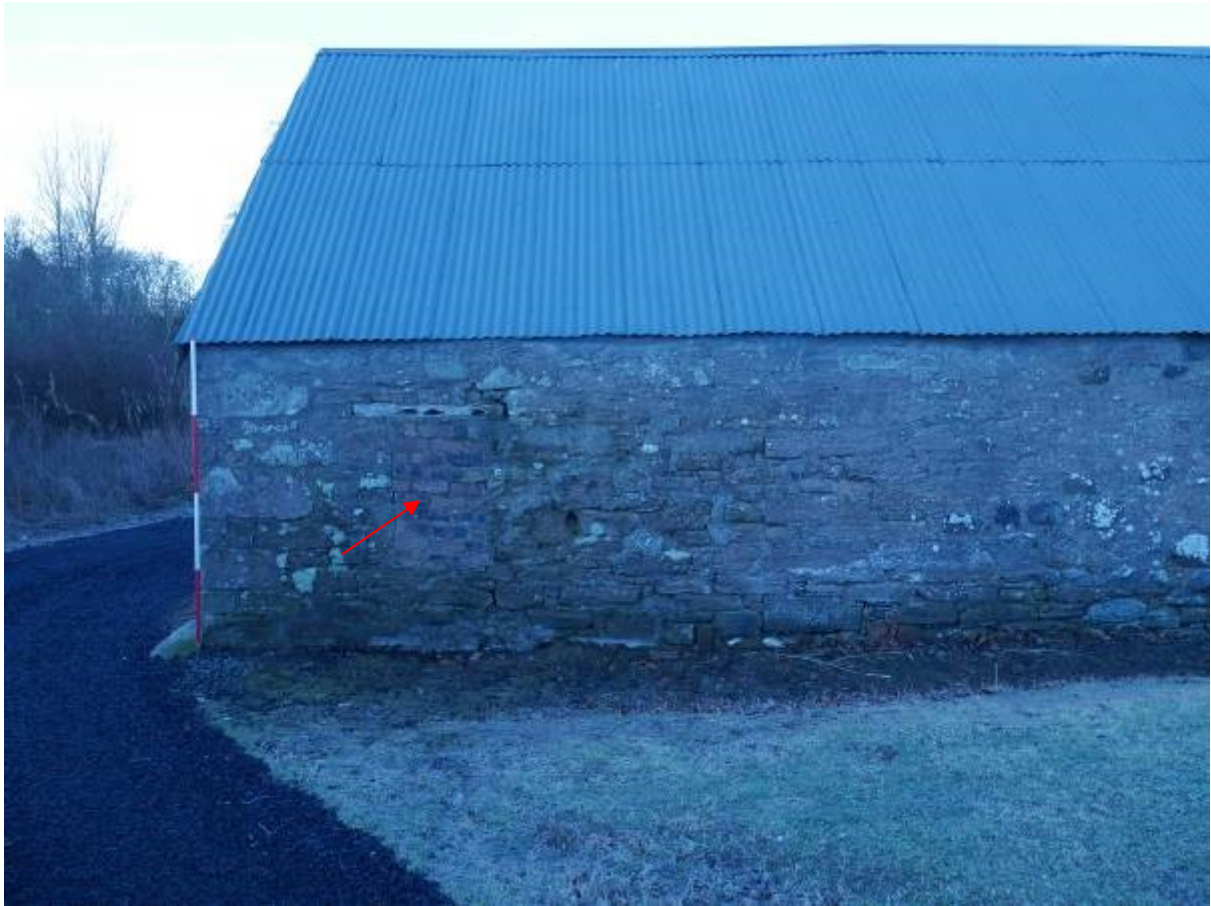
Illustration 13- Southern end of Eastern elevation showing blocked window (red arrow)

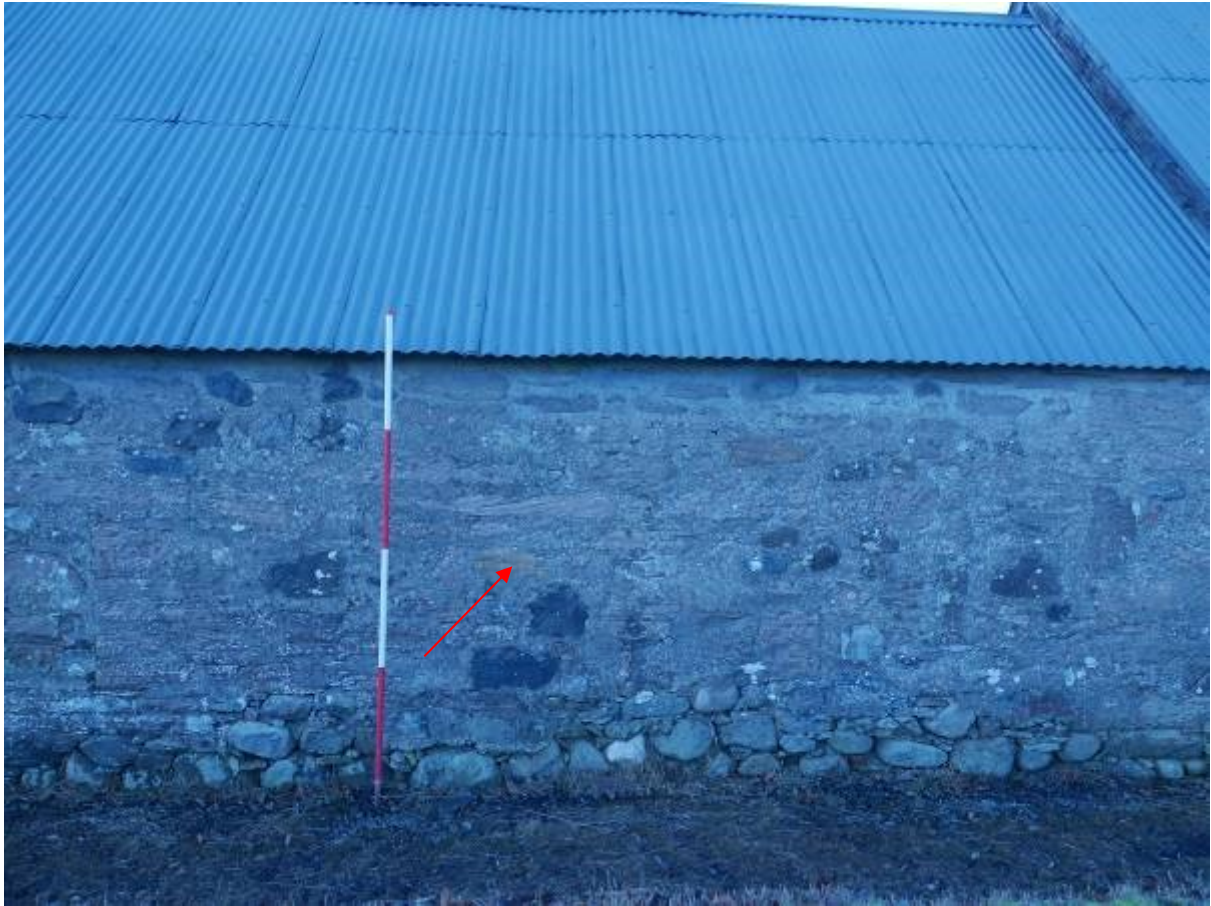
Illustration 14- Visible blocked window in Western elevation to building

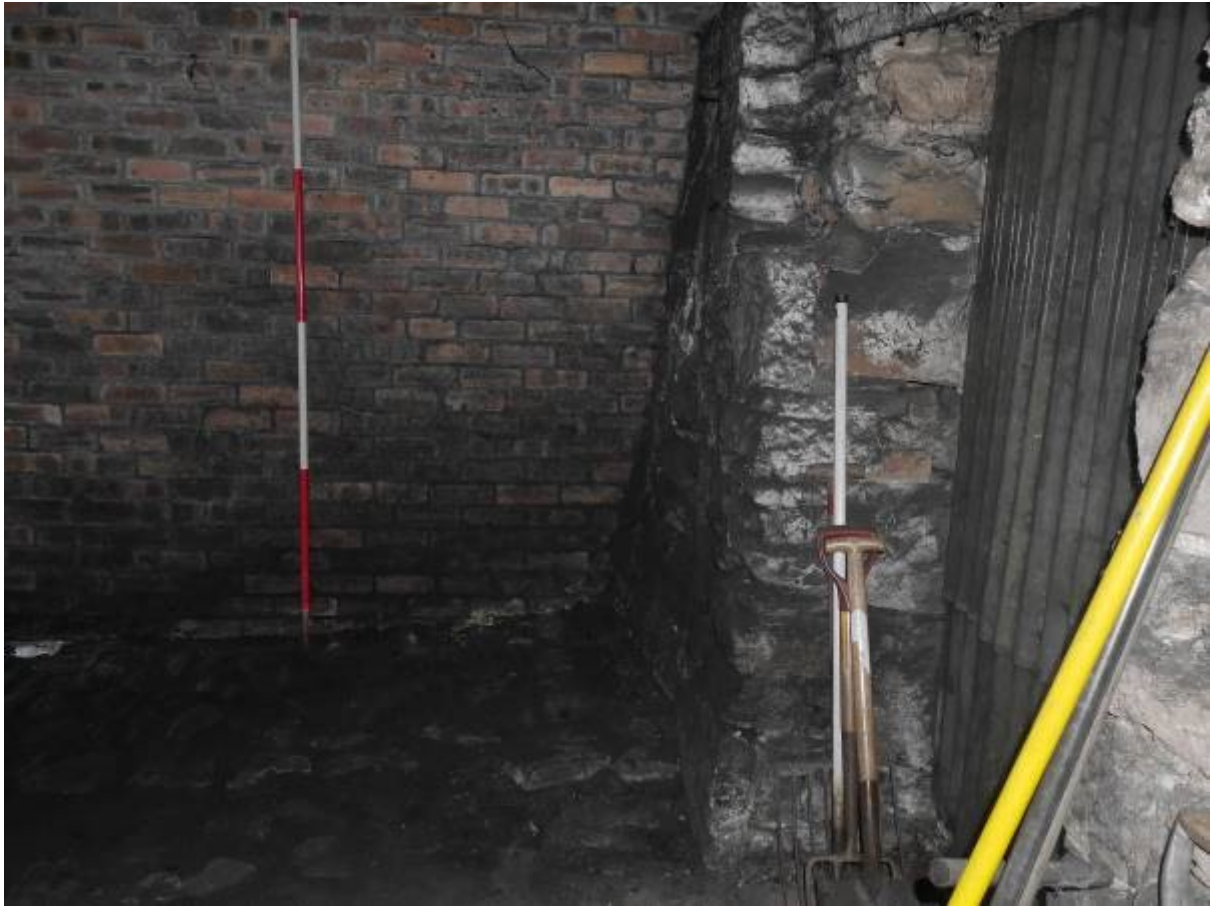
This is a blank brick wall.

Illustration 16- Northern internal elevation to Steading 1 showing brick wall, sloping face on wall of Eastern elevation also visible

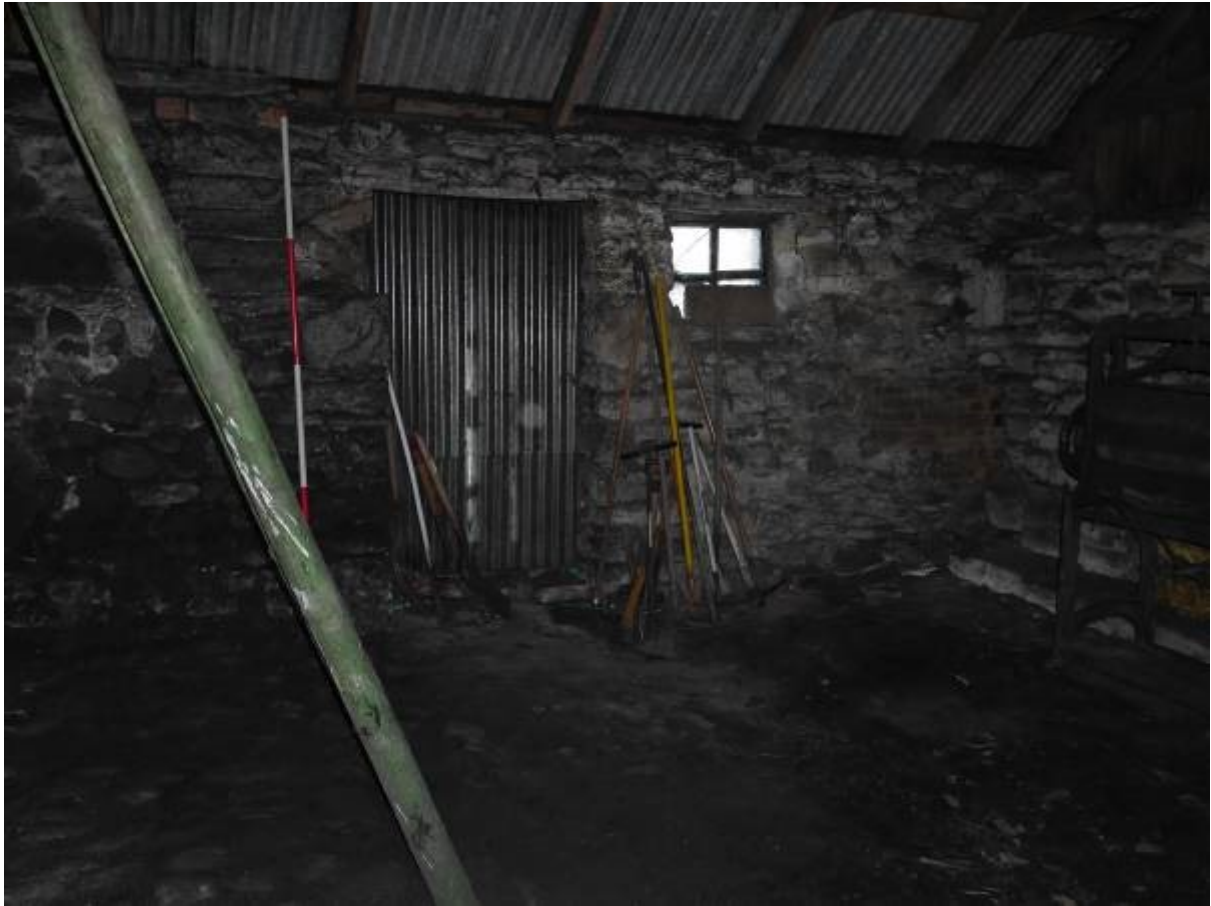
This is roughly stone built and slopes slightly inwards. There is a doorway blocked with tin sheeting and a glazed window.

Illustration 17- Eastern internal elevation of Steading 1 showing doorway and window

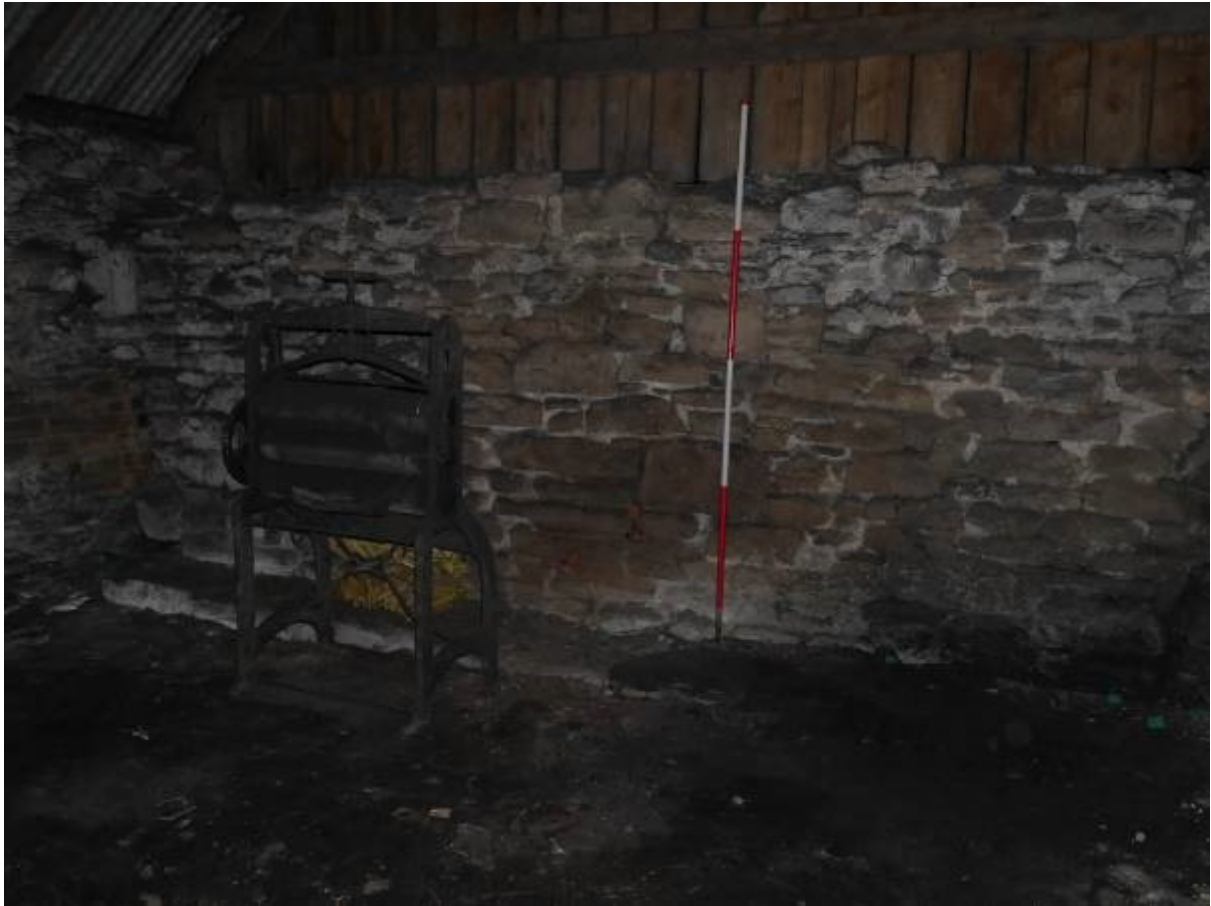
This is a roughly built stone wall which is butted against the Eastern and Western walls of the building. There is a wooden gable support for the roof built on top of the wall line. A faced wall foundation standing one course high is visible at floor level extending 0.49m north of this elevation.

Illustration 18- Southern internal elevation of Steading 1 showing slightly wider wall foundation, mangle and base of wooden roof support.

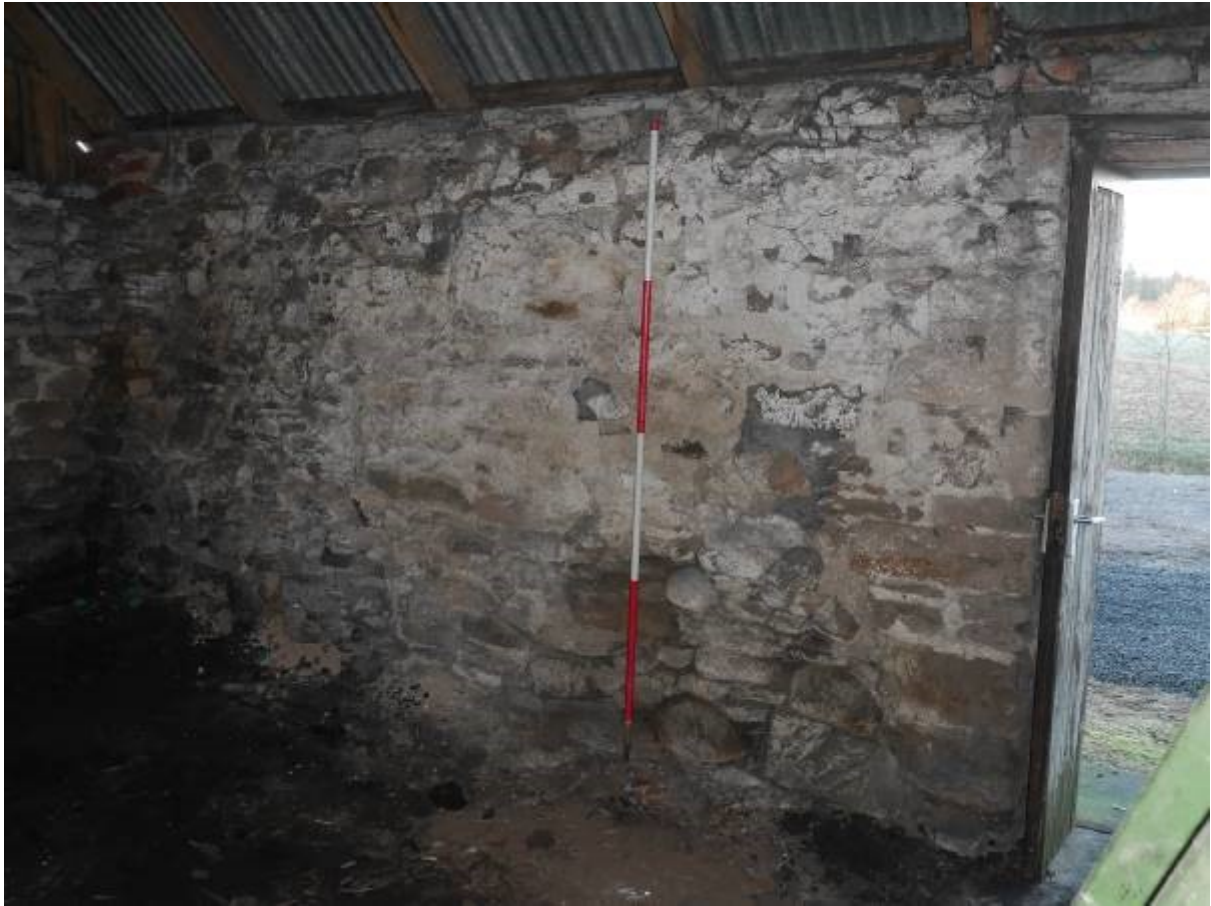
Illustration 19- Western internal elevation of Steading 1

This is a roughly built stone wall which is starting to collapse inwards.

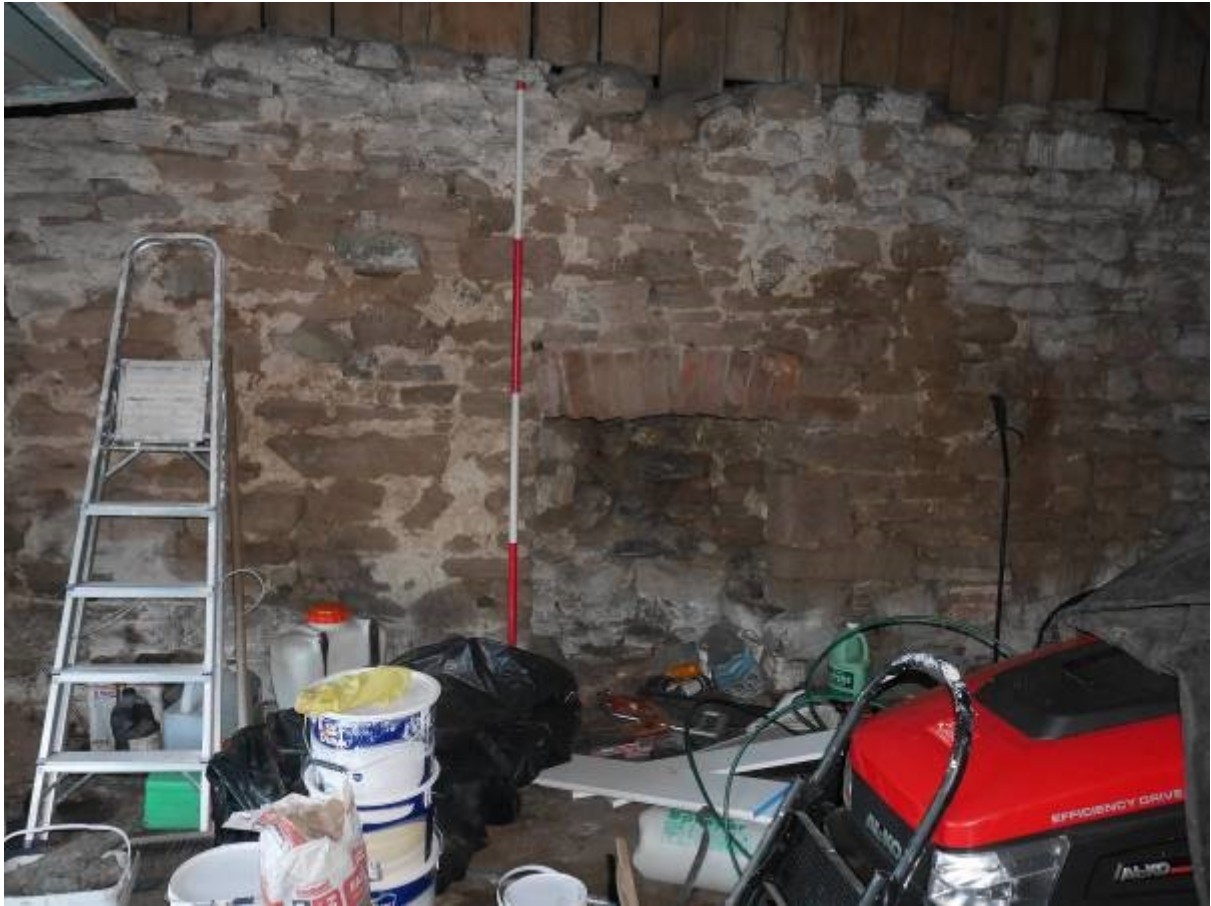
This is a rough mortared stone wall and contains a small fireplace with a brick arch.

Illustration 20- Northern elevation of Steading 2 showing fireplace with brick arch and base of wooden roof support

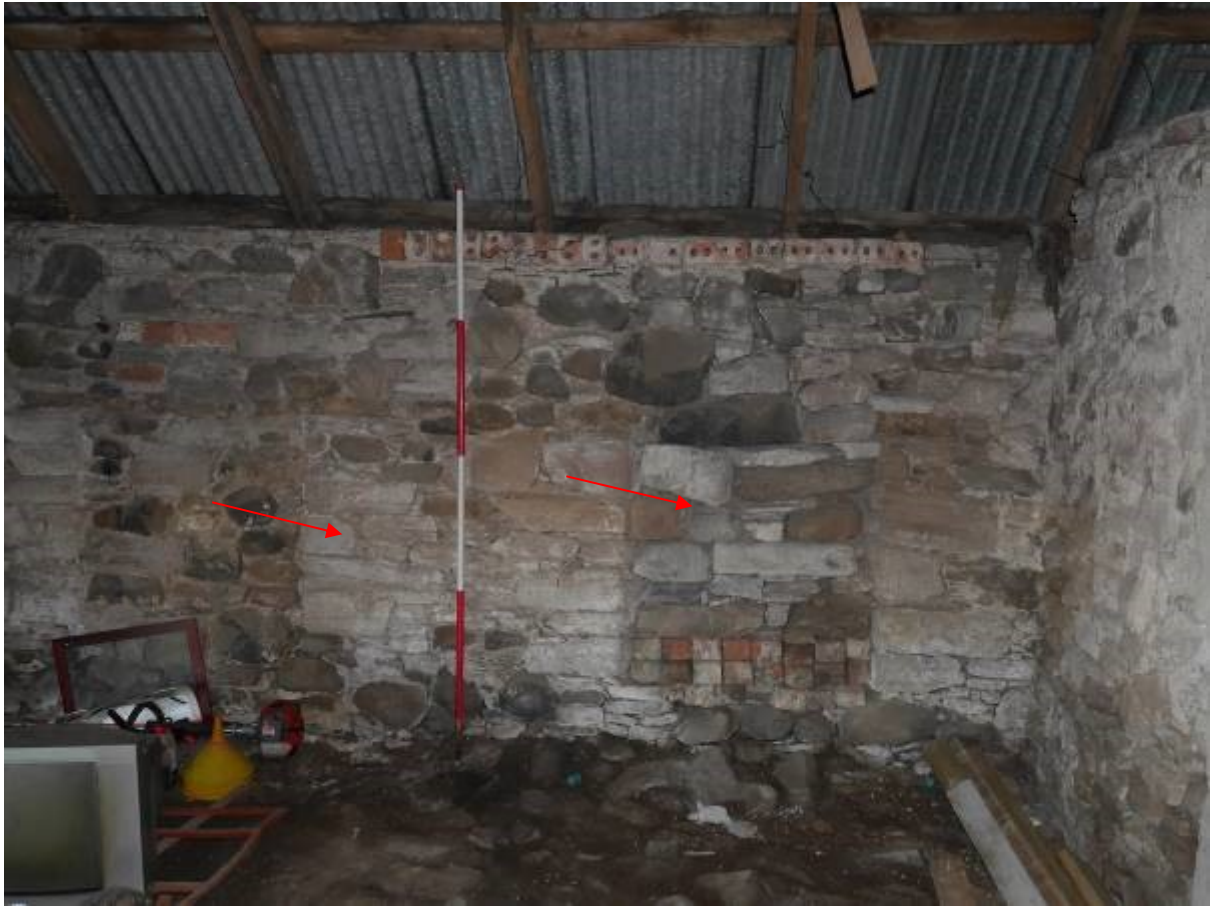
This is rough mortared stone wall that contains three blocked windows, one of these is blocked with brick the other two with stone. Only the central one of these blocked windows is visible in the external elevation of this wall (Illus 5).

Illustration 21- Eastern elevation of Steading 2 showing two blocked windows (marked with red arrows)

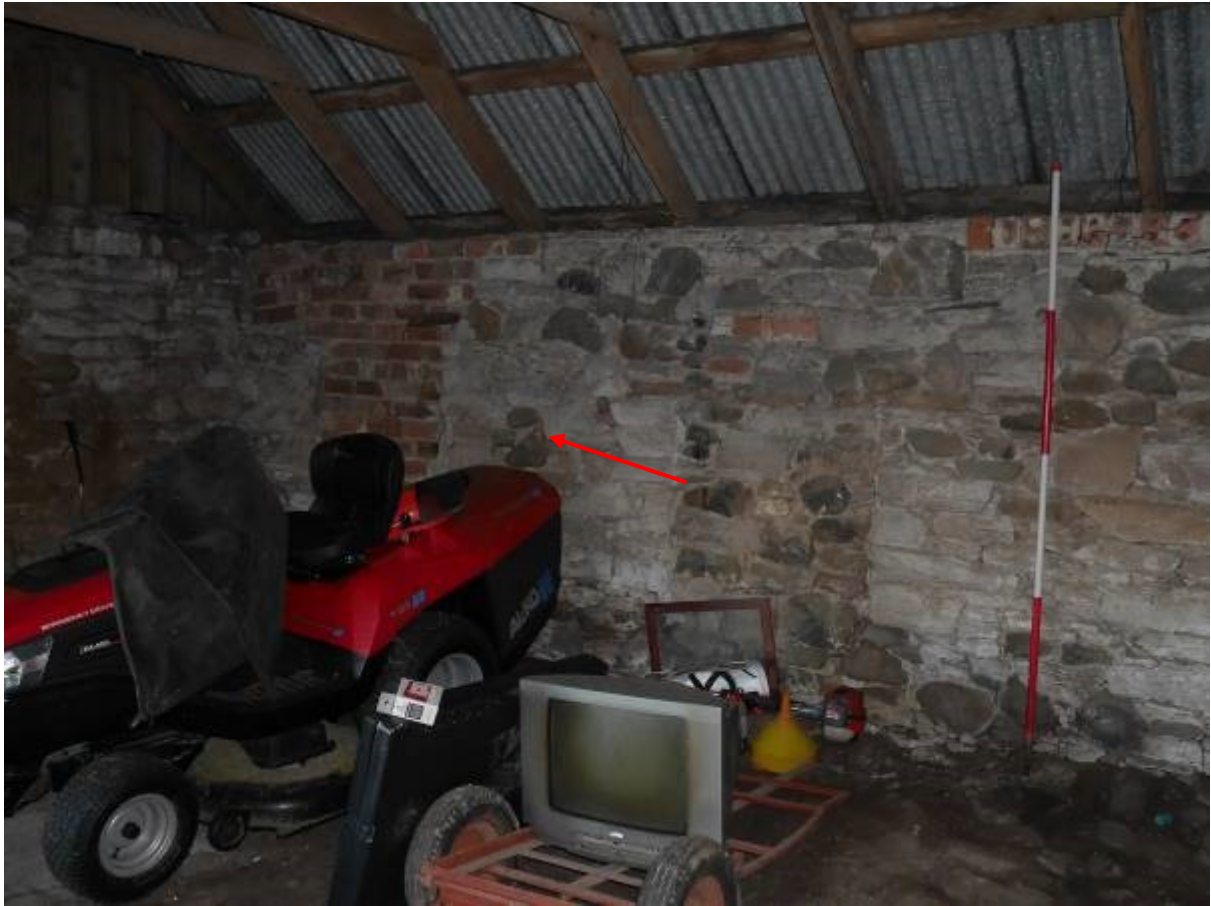
Illustration 22- Eastern elevation of Steading 2 showing third blocked window (red arrow)

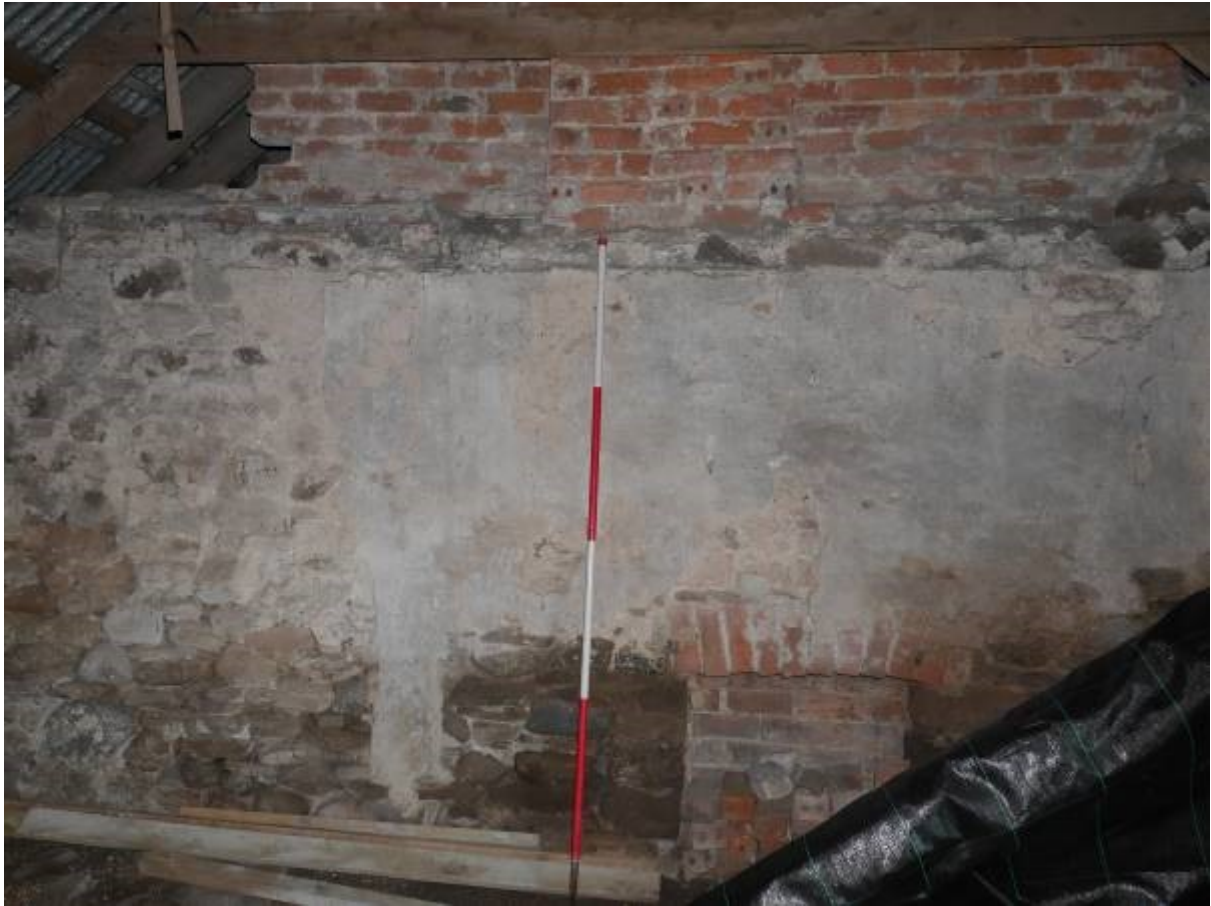
This is a rough mortared stone wall which is butted against the Eastern and Western walls of the building. It contains a small fireplace with a brick arch.

Illustration 23- Southern internal elevation for Steading 2 showing fireplace with brick arch and brick support for roof

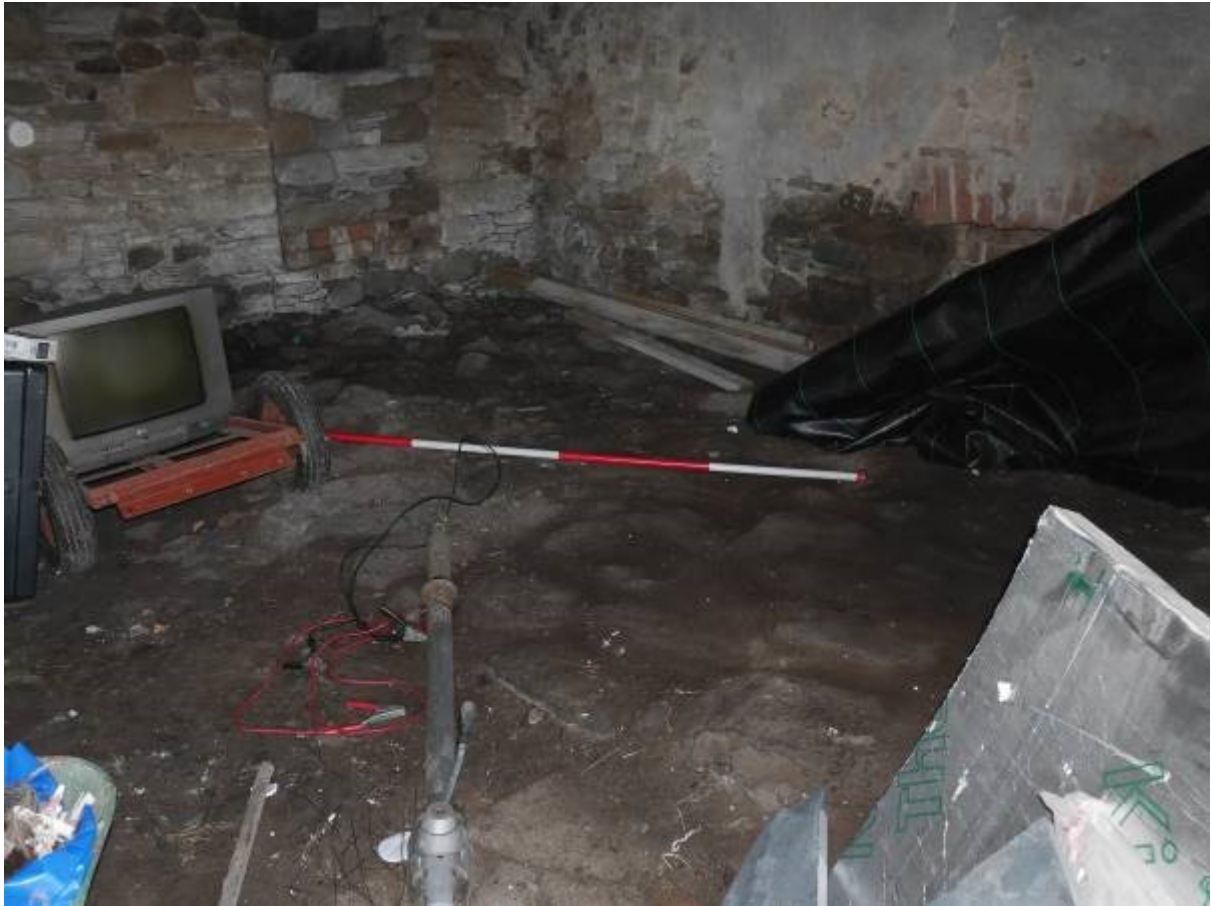
This Steading has a rough earth and concrete floor, at its Southern end there is an area of rough stone extending 2.65m north of its Southern elevation.

Illustration 24- Area of rough stone flooring at Southern end of Steading 2

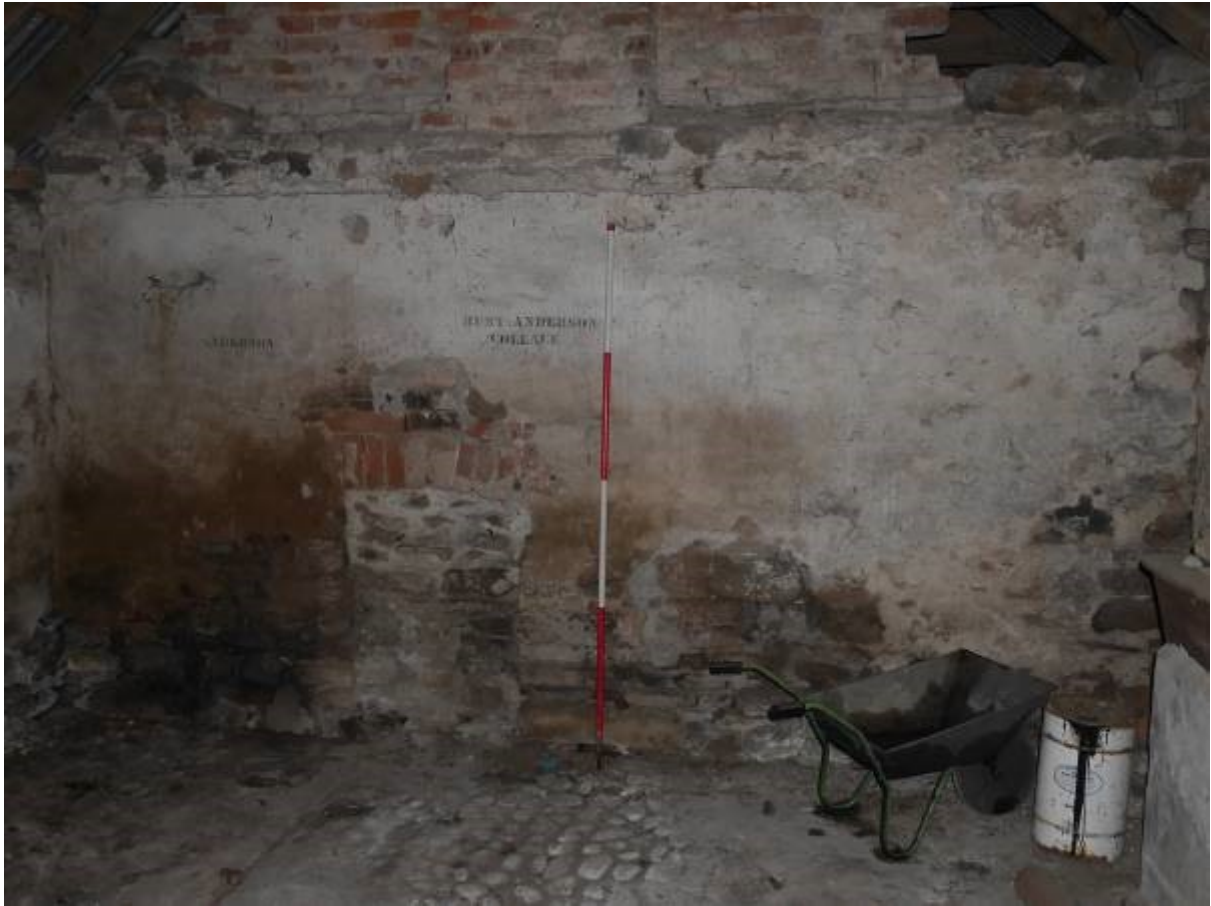
This is a rough mortared stone wall that has been painted white, it contains a blocked fireplace with a brick arch. The names 'Anderson' and 'Ruby Anderson' are stencilled in black on the wall face. A brick gable with a chimney is built on top of this wall line.

Illustration 25- Northern internal elevation of Steading 3 showing blocked fireplace, stencilled names on wall face and brick support for roof

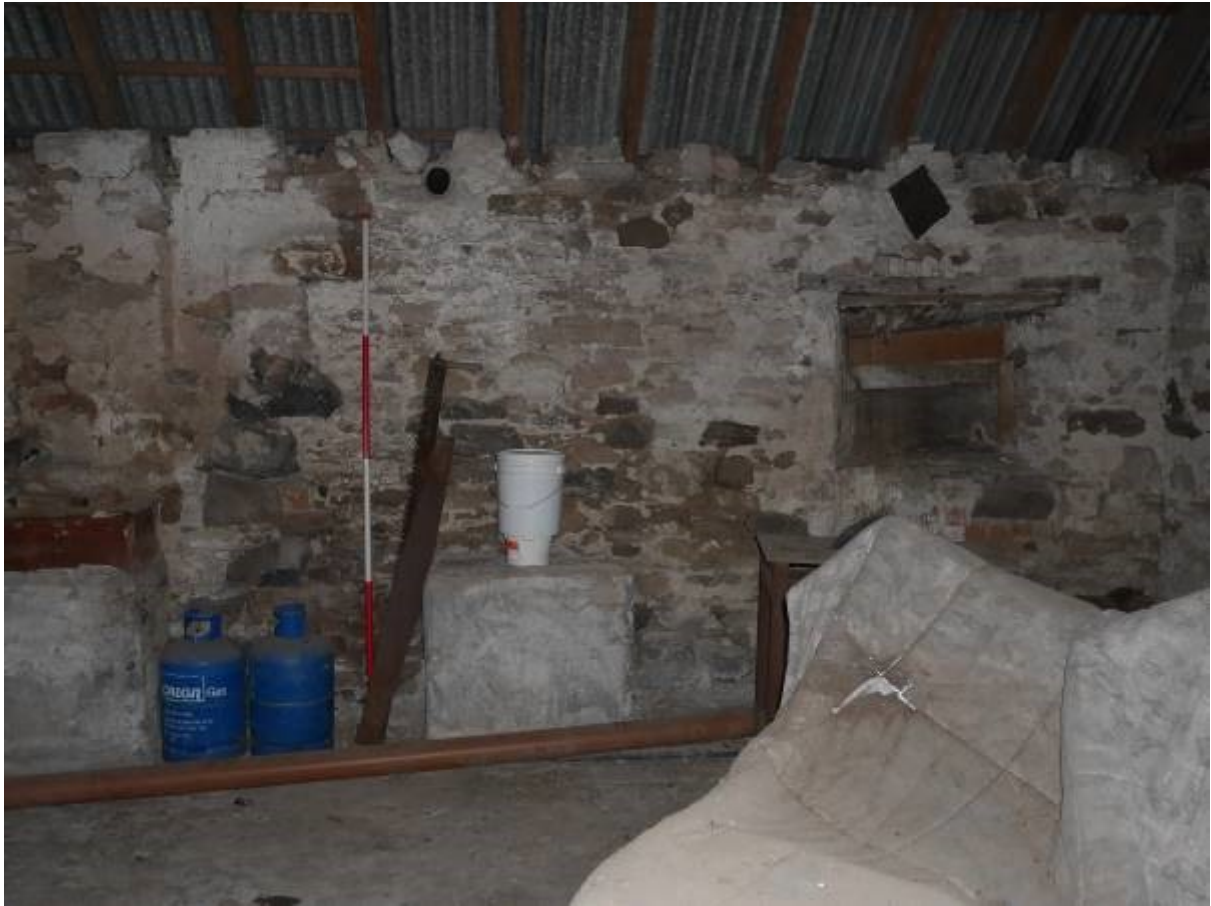
This is a rough mortared stone wall which contains a window which is blocked with timber.

Illustration 26- Eastern internal elevation of Steading 3 showing blocked window

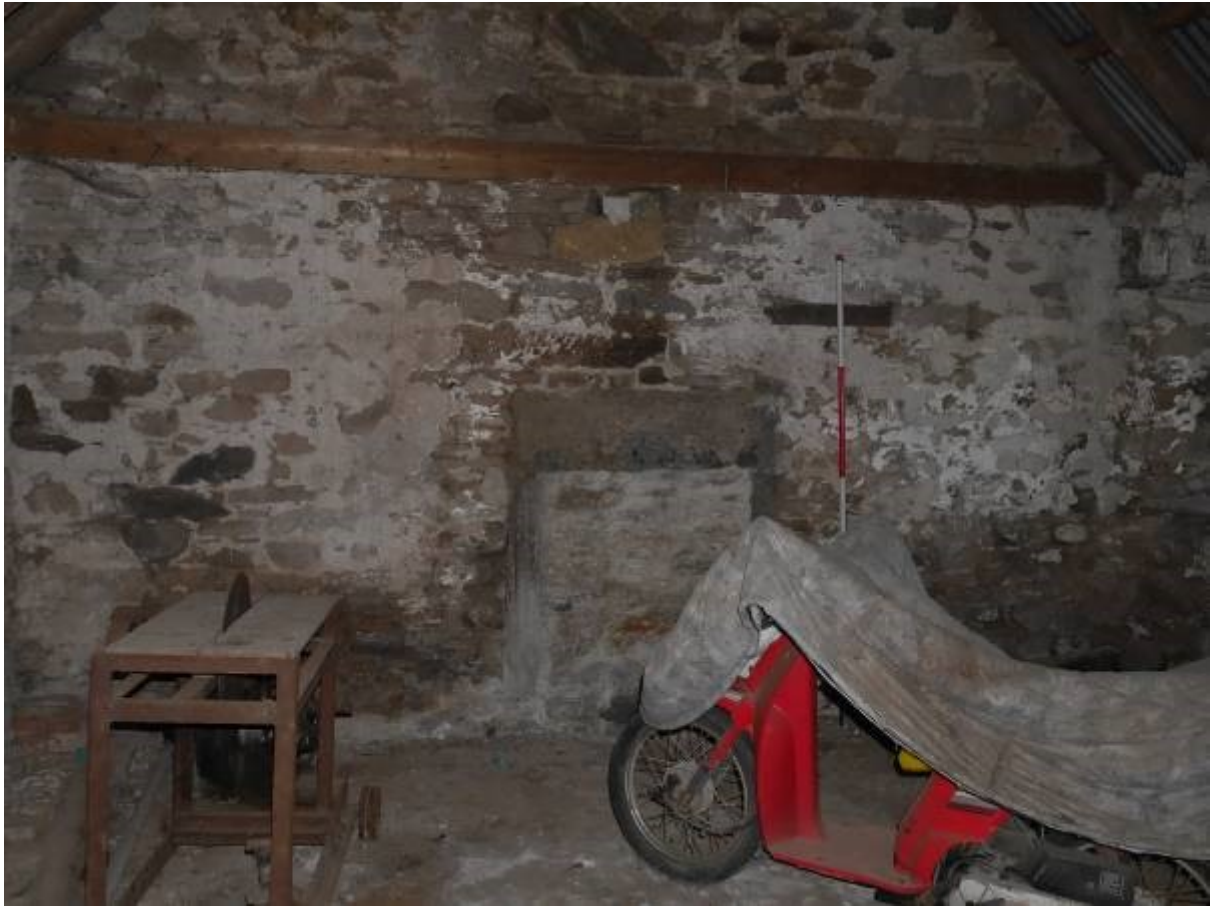
This is a rough mortared stone wall which contains a fireplace with a stone lintel and side stones, this has been blocked with bricks.

Illustration 27 – Southern internal elevation of Steading 3 showing fireplace
