Standing Building Survey

The Cottage, Collace

Perth and Kinross

18th January 2019

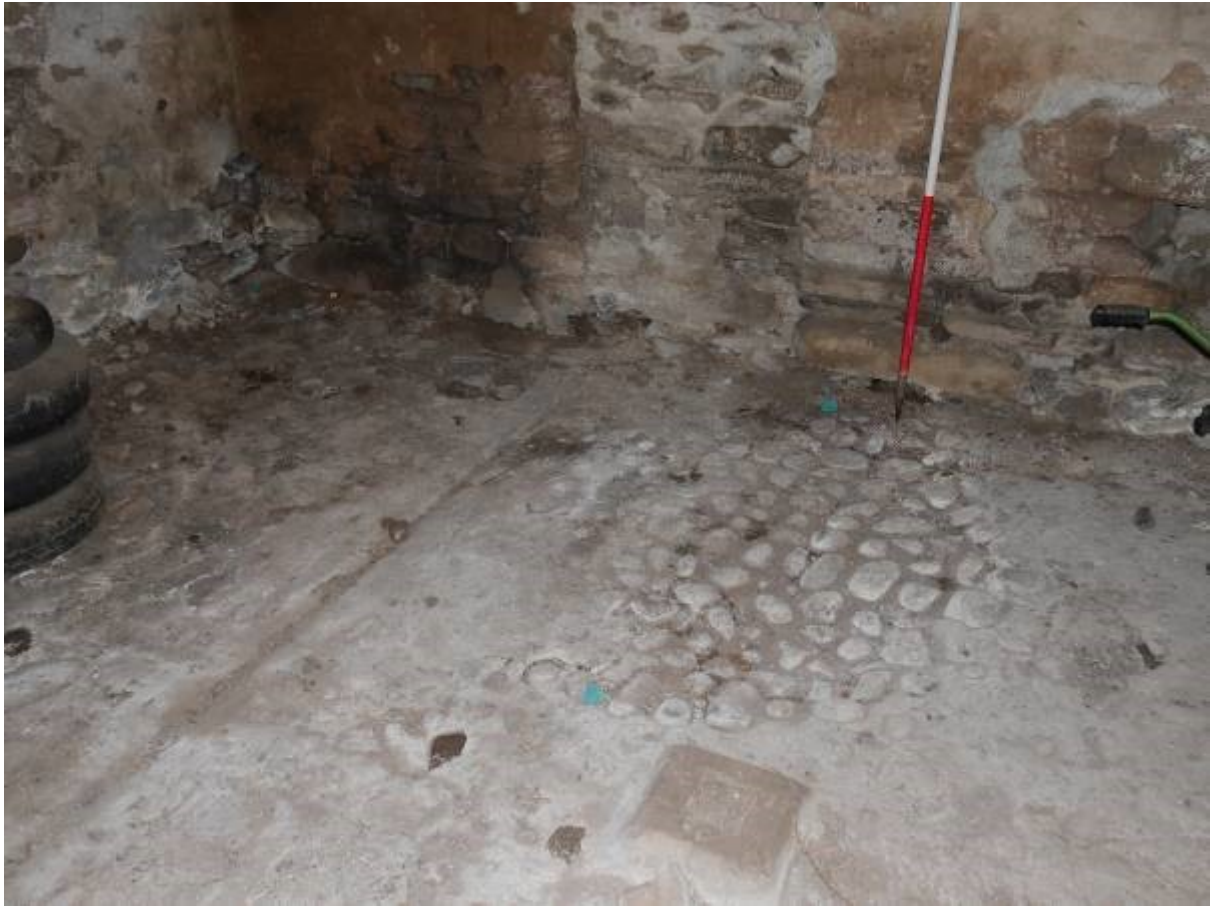
This Steading has a cobbled floor with a shallow drain visible at its Northern end. There are two raised socket stones in the floor 1.55m apart, these are both 0.32m square and the socket holes are 0.11m square.

Illustration 29- Internal floor of Steading 3 showing cobbling, drain and one of the socketed stones in the floor

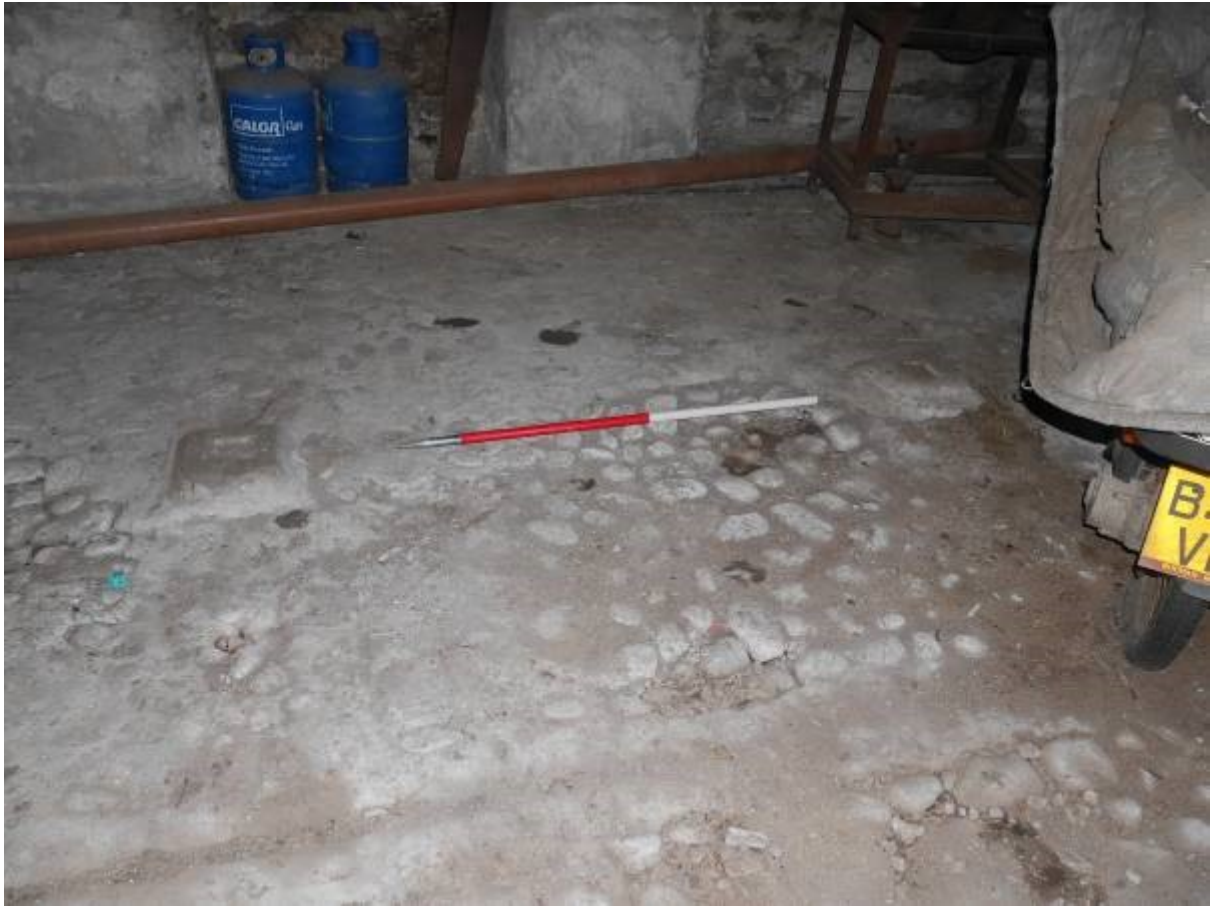
Illustration 30- General view of floor in Steading 3 looking East showing both socketed stones in the floor
