Standing Building Survey
Land 90m West of Cornhill Farmhouse
Auchterarder, Perth and Kinross

Farm steadings to be demolished at Cornhill looking South West

16th April 2019

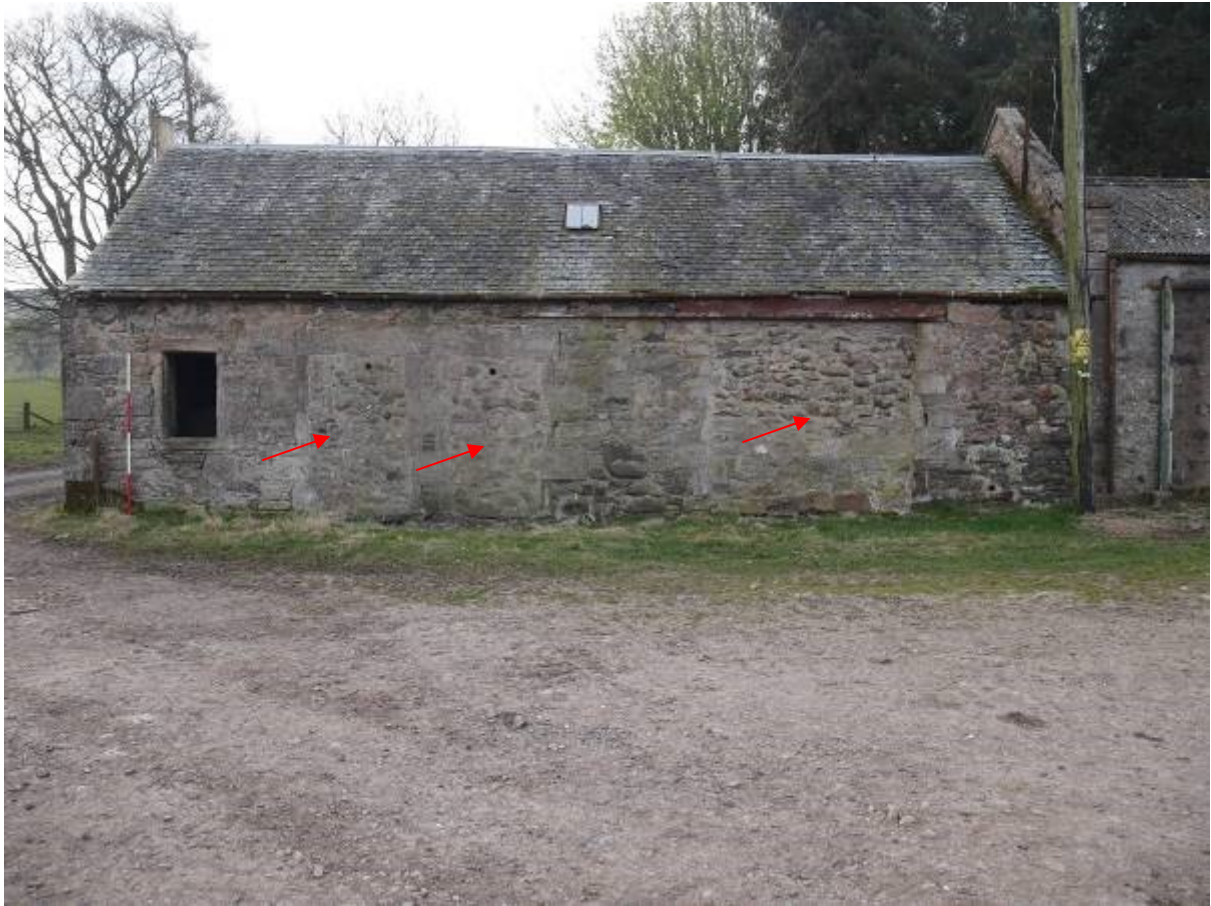
This is built of mortar bonded rough sandstones with shaped quoins at its North Western corner. It contains an unglazed open window and three blocked doorways. The first two blocked doorways are of identical dimensions and lie beside each other, the third is much wider and has the remains of a mechanism for sliding door above it. The window and the first two doorways are defined by sandstone slabs around their frames.

Illustration 6 – North Western elevation of Building 1 (blocked doorways marked with red arrows)

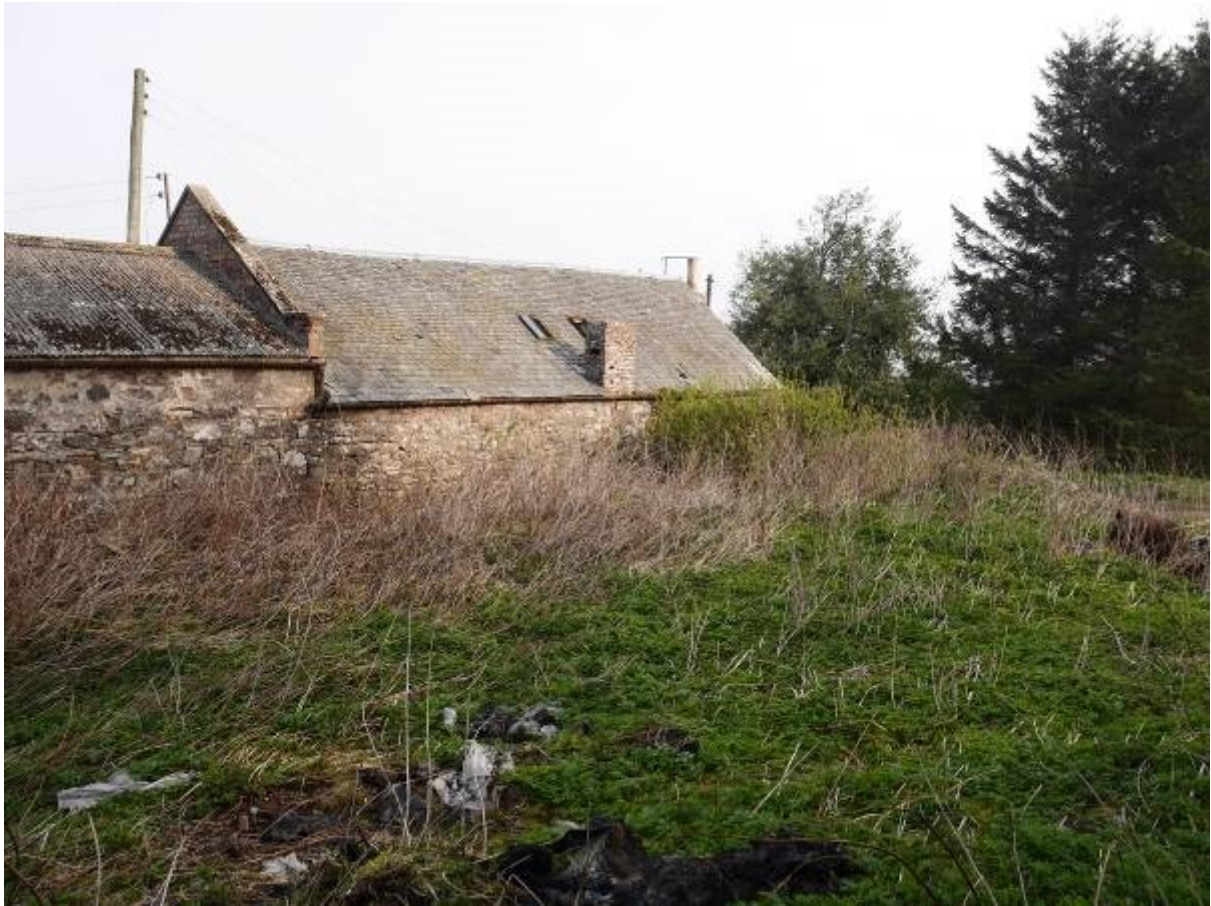
This is built of mortar bonded rough sandstones and is a blank wall face. A brick-built chimney sits just above the roofline.

Illustration 7 – South Eastern elevation of Building 1 looking North West

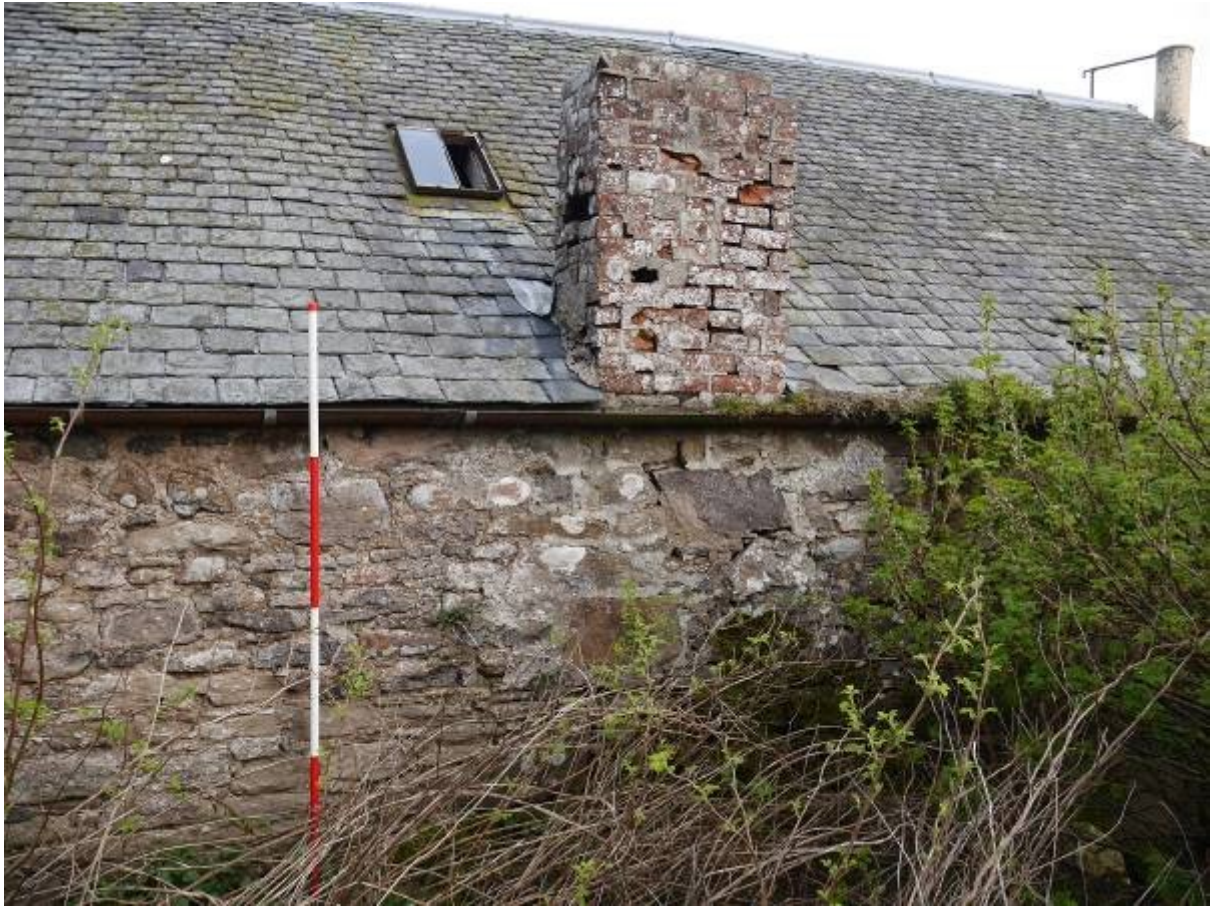
Illustration 8 – Chimney in roof line of the South Eastern elevation of Building 1

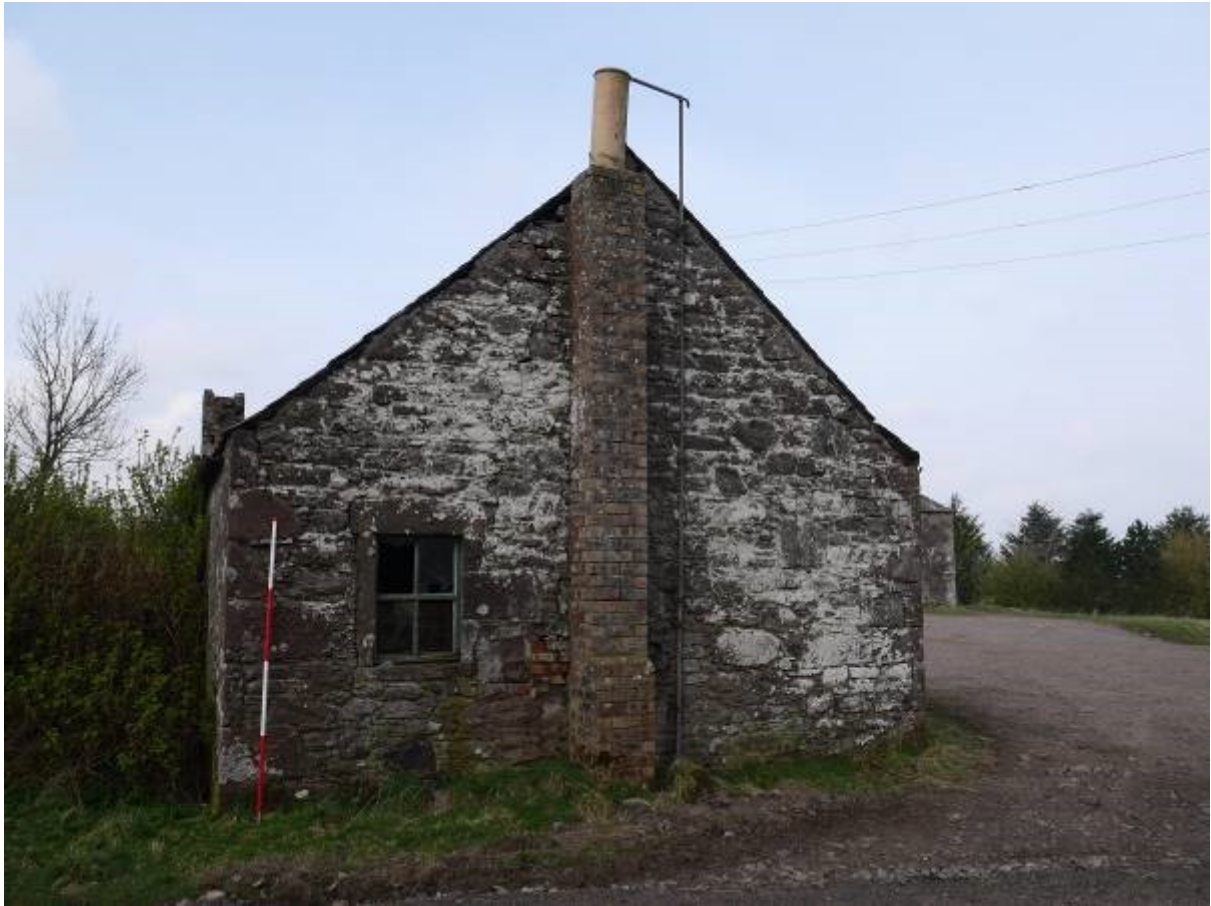
This is a gable end and is built of mortar bonded rough sandstones it contains a broken glazed window and has a brick chimney stack built against the wall face.

Illustration 9 – North Eastern gable elevation of Building 1

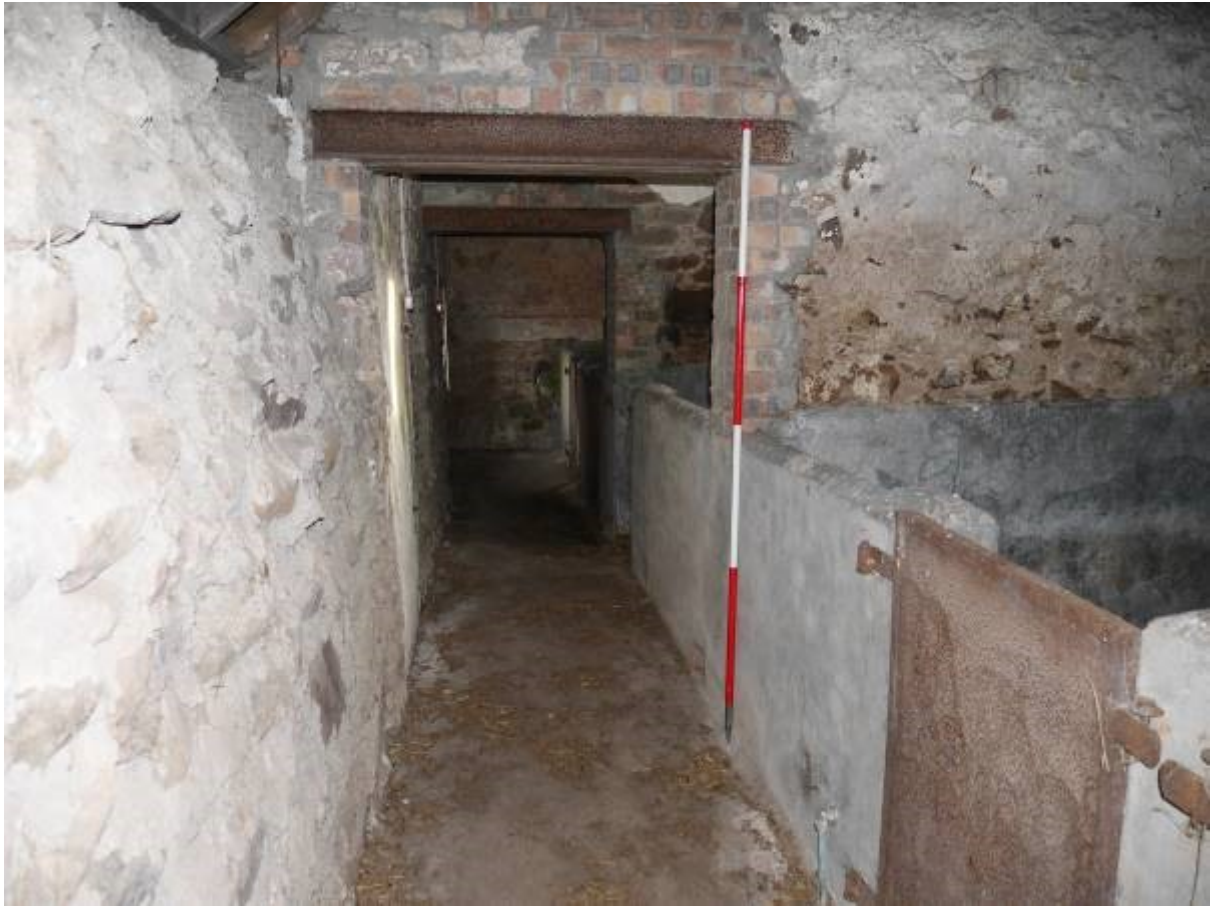
Building 1 has a corridor running along the inside face of its North Western wall and is subdivided into three rooms. The first room contains two concrete animal pens with iron doors, the second room has one concrete pen whose door is missing, and the third room has two concrete animal pens with iron doors. All of the floors are concrete and there is a planked wooden roof to support the slate roof.

Illustration 10 – Interior view of Building 1 looking North East showing corridor along North Western wall and separate rooms with animal pens

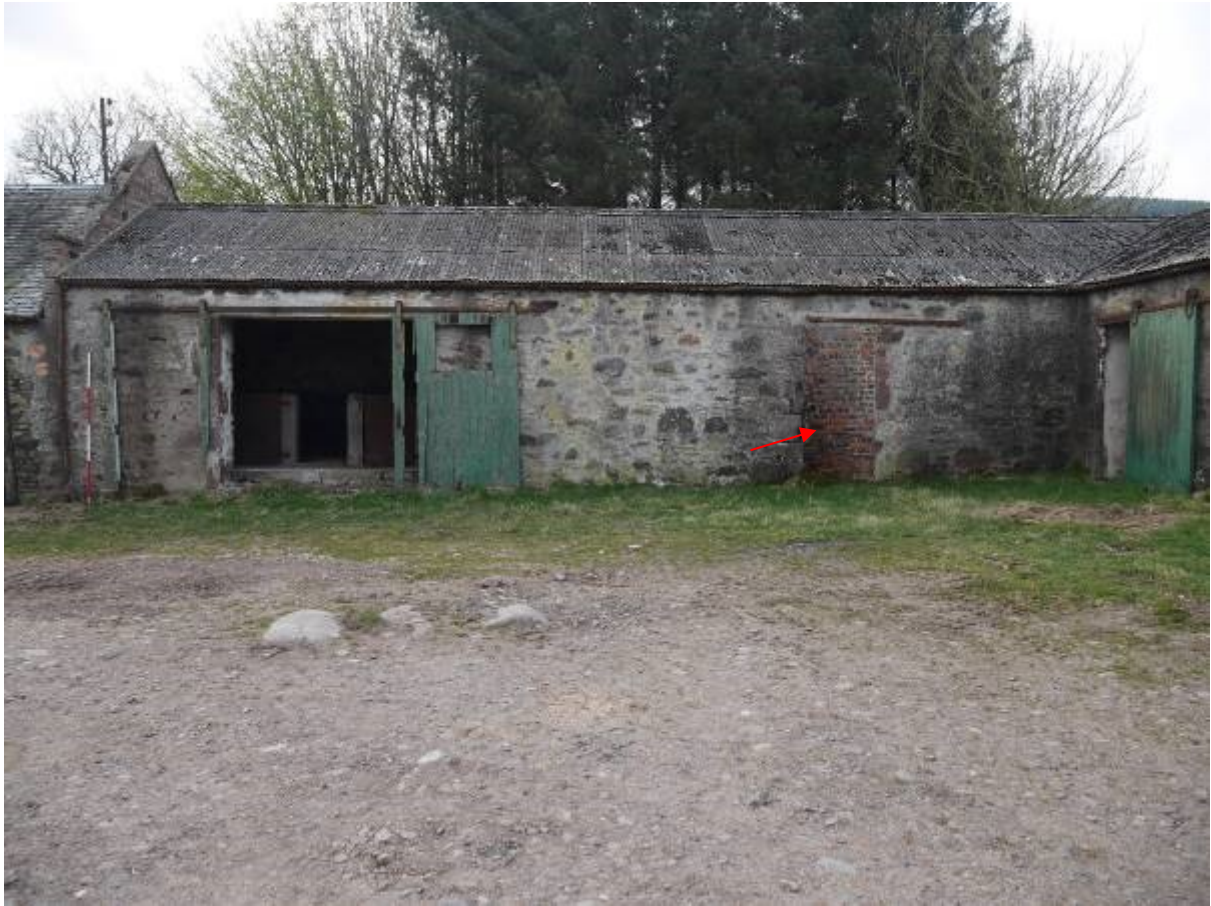
This is built of mortar bonded sandstones covered with concrete plaster. It contains a large doorway with a broken sliding door and another doorway that is blocked with mortared bricks. The remains of a sliding door mechanism are visible above the blocked doorway.

Illustration 14 – North Western elevation of Building 2, blocked doorway marked with red arrow

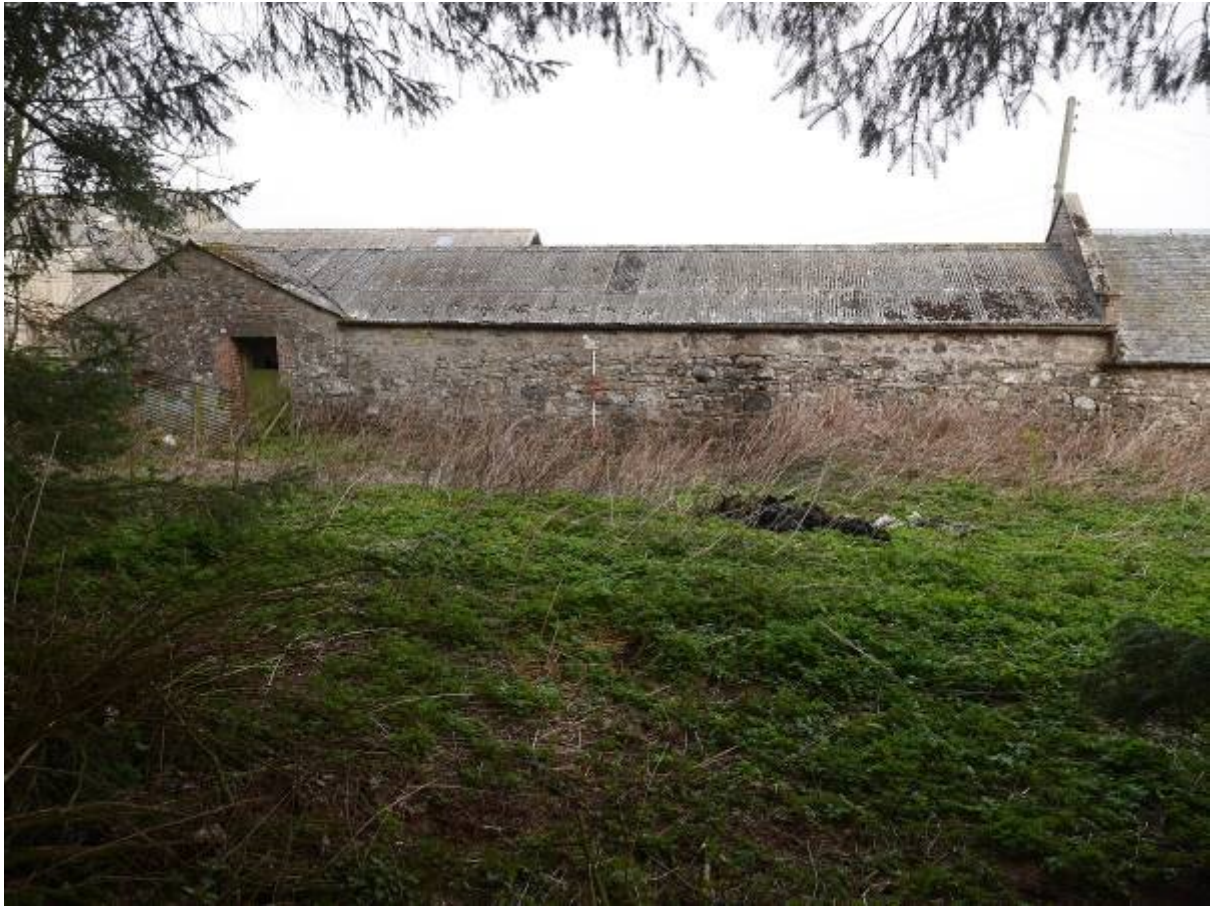
This is built of mortar bonded sandstones and is a blank wall face. There is a visible straight joint at its South Eastern end where it meets Building 3.

Illustration 15 – South Eastern elevation of Building 2

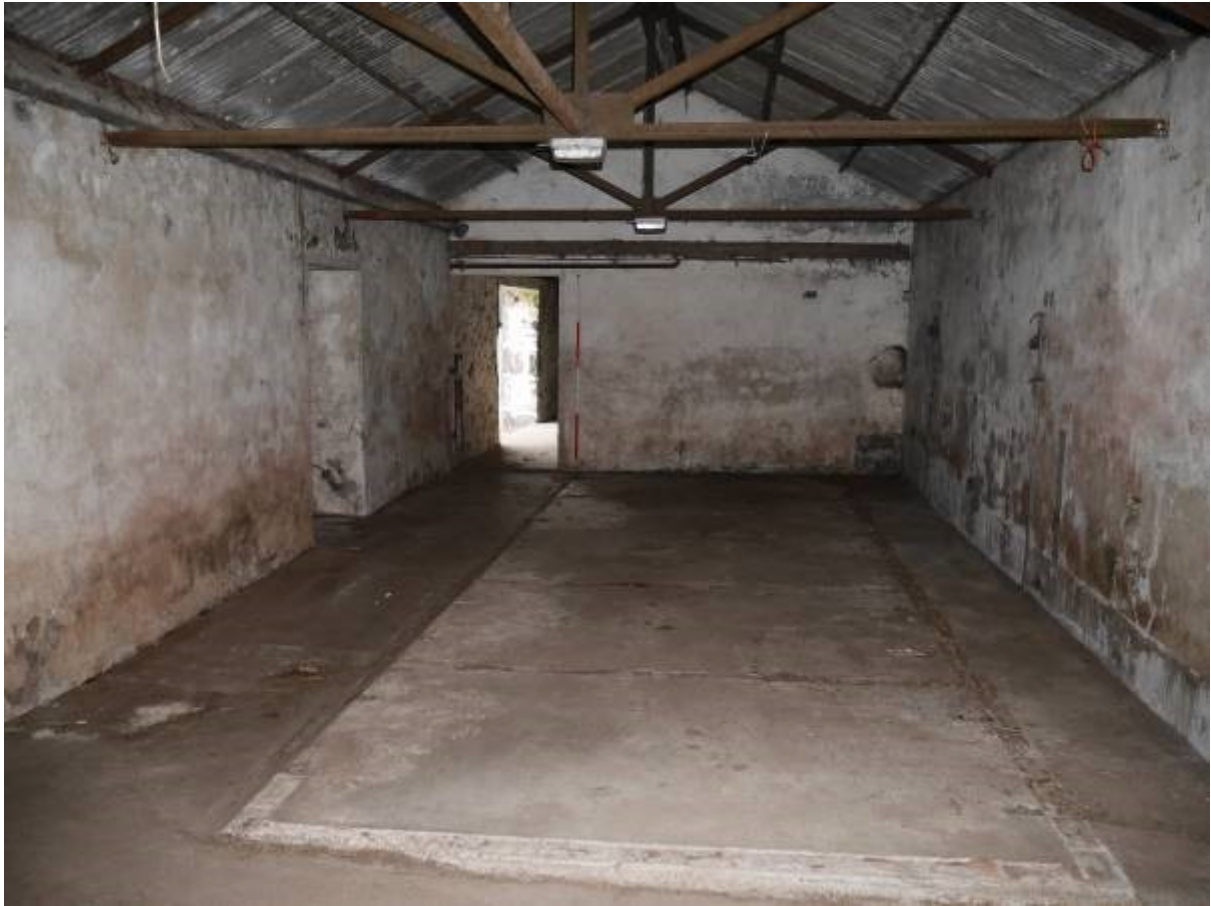
Illustration 17 – Room b in Building 2 looking North East showing animal pen foundations in floor

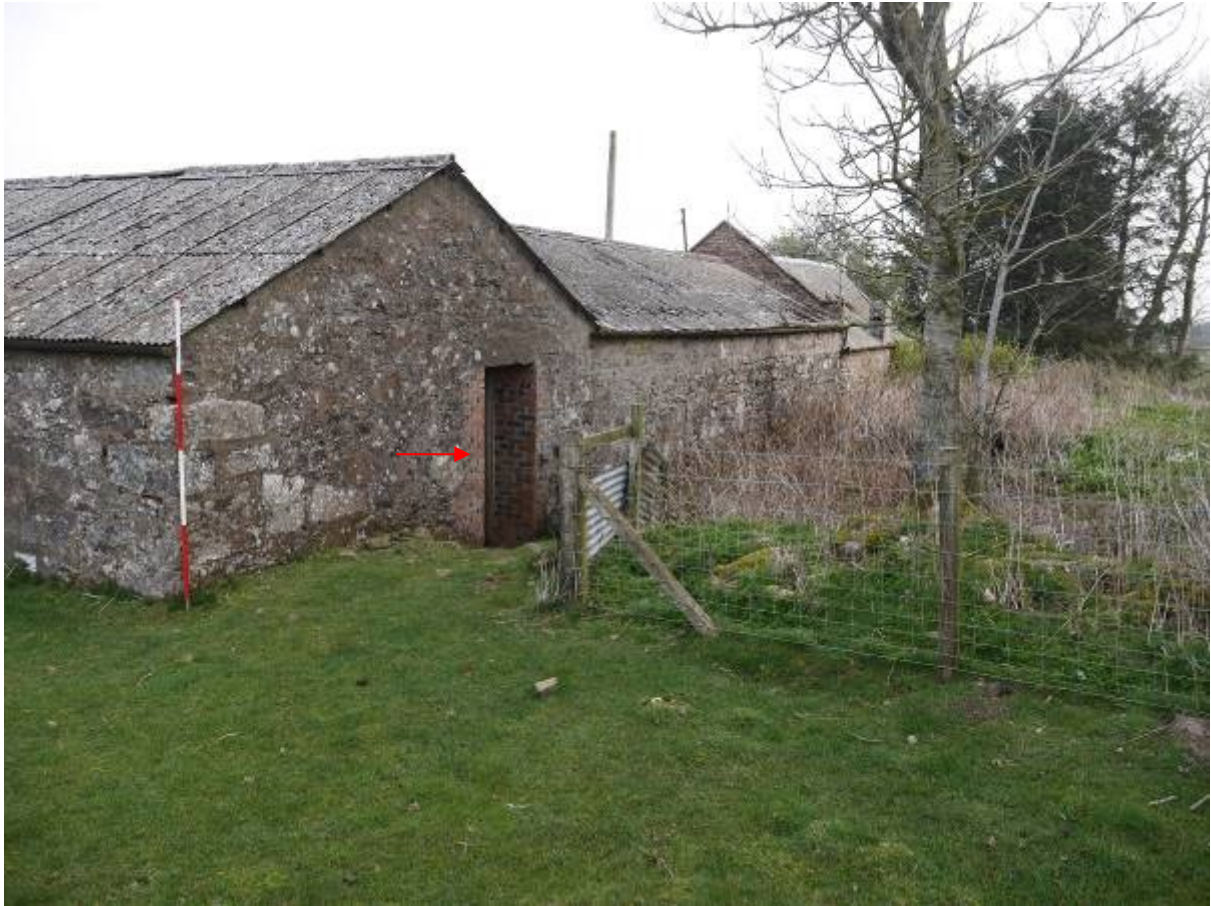
This is a gable end to the building and is built of mortar bonded sandstones with shaped quoins at its South Western corner. There is a doorway into the building with a wooden door.

Illustration 20 - South Eastern elevation of Building 3 (doorway marked with red arrow)

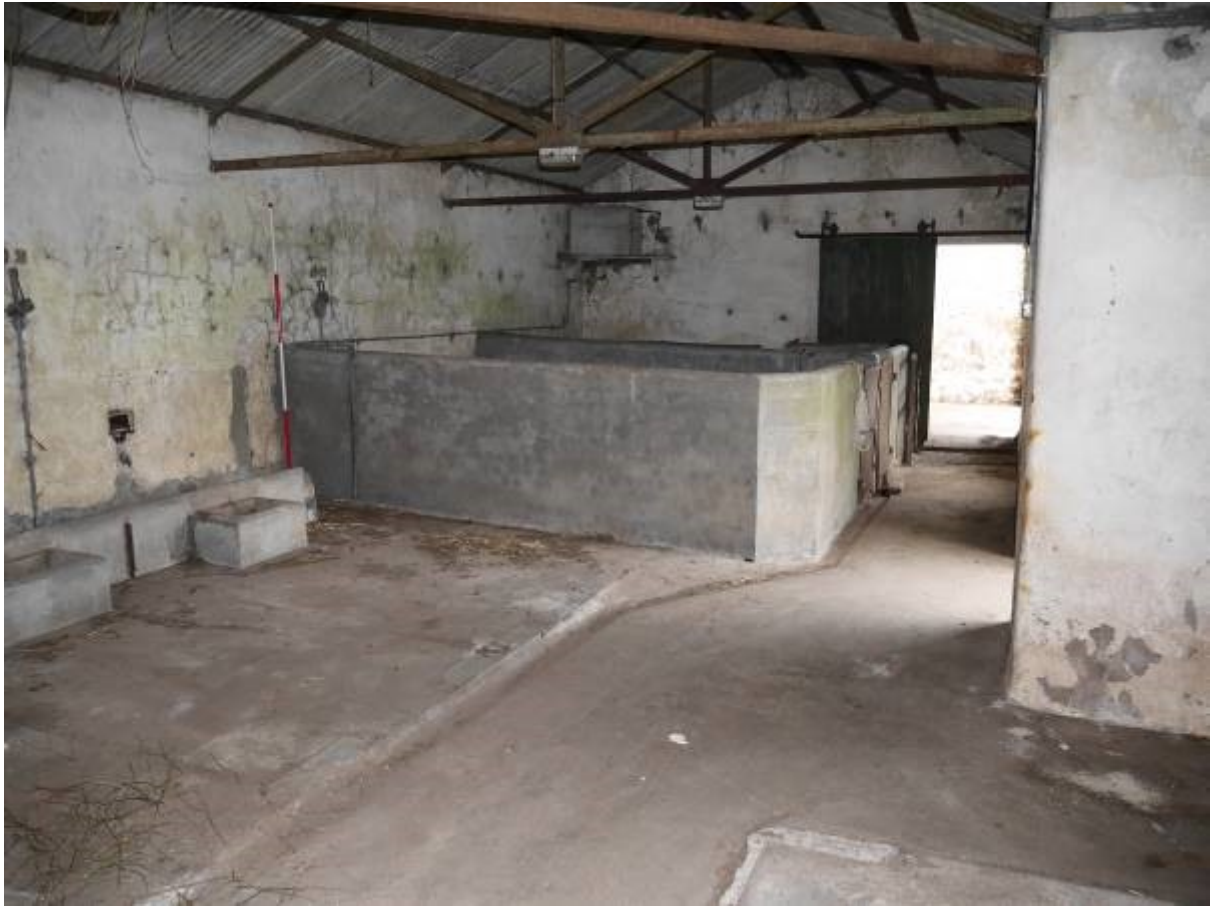
This has a concrete floor and contains the foundations of former animal pens at its Eastern end. At its Western end there are two concrete animal pens with iron doors and there are concrete animal feeders against the internal face of its South Western wall. There is a blocked doorway in the internal South Eastern elevation and a wooden door in the doorway leading into Building 4 to the North West.

Illustration 21 – Animal pens in Building 3 looking North West, concrete feed bins visible to left of scale

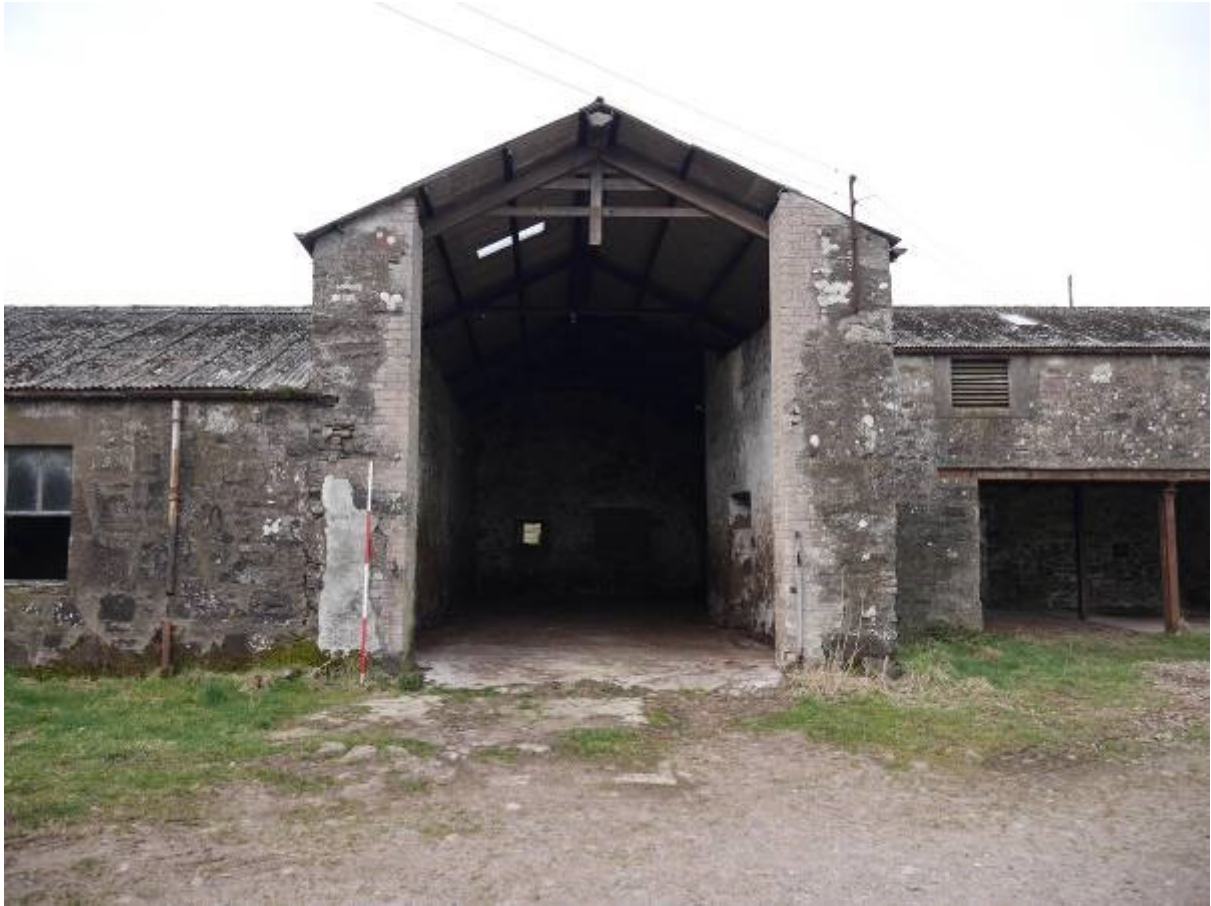
This is a gable end with a large open doorway leading into the building. It is built of mortar bonded sandstones with mortared brick repairs at the door edges.

Illustration 22 – North Eastern elevation of Building 4

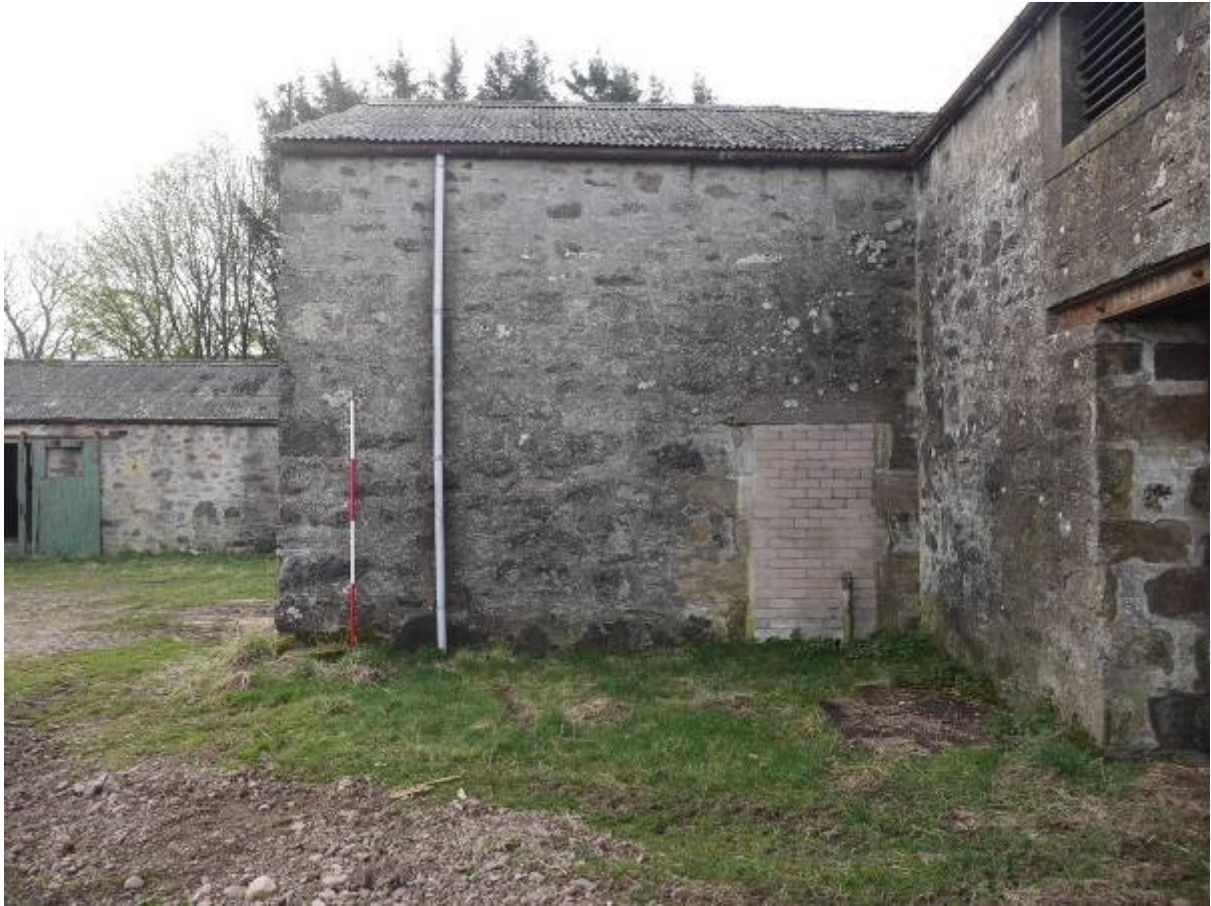
This is built of mortar bonded sandstones and is slightly plastered. It contains a doorway that is blocked with bricks. That doorway has large sandstone blocks defining its frame and lintel. The continuation of this elevation on the other side of the junction with Building 5 contains a blocked doorway in a gable at first floor level and has shaped quoins at its corner.

Illustration 23 – North Western elevation of Building 4 blocked doorway visible to right

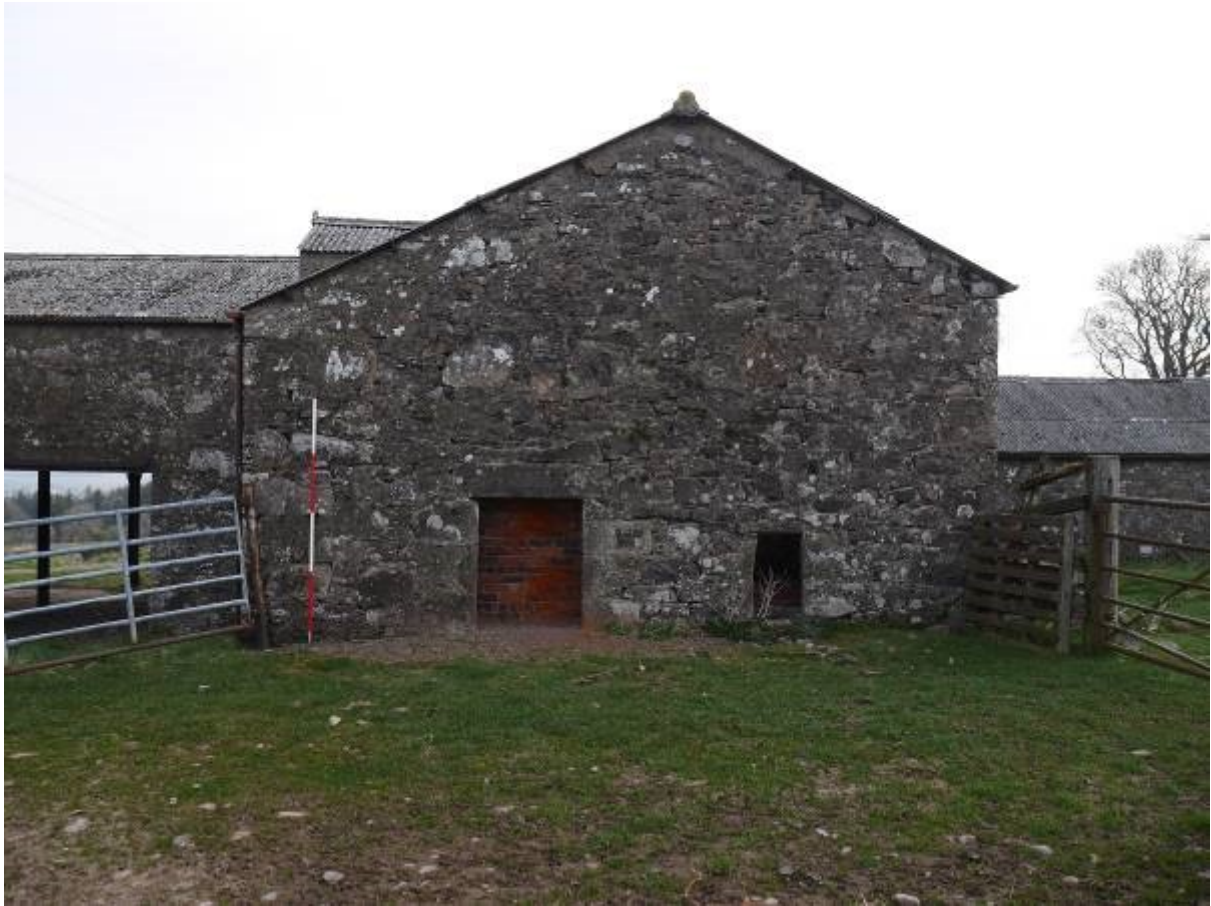
This is a gable end to this building and is built of mortar bonded sandstones with shaped quoins at the corners. There is a doorway blocked with mortared bricks and an open window with a metal lintel which is partially blocked with bricks internally.

Illustration 25 – South Western elevation of Building 4 showing internally blocked doorway and window

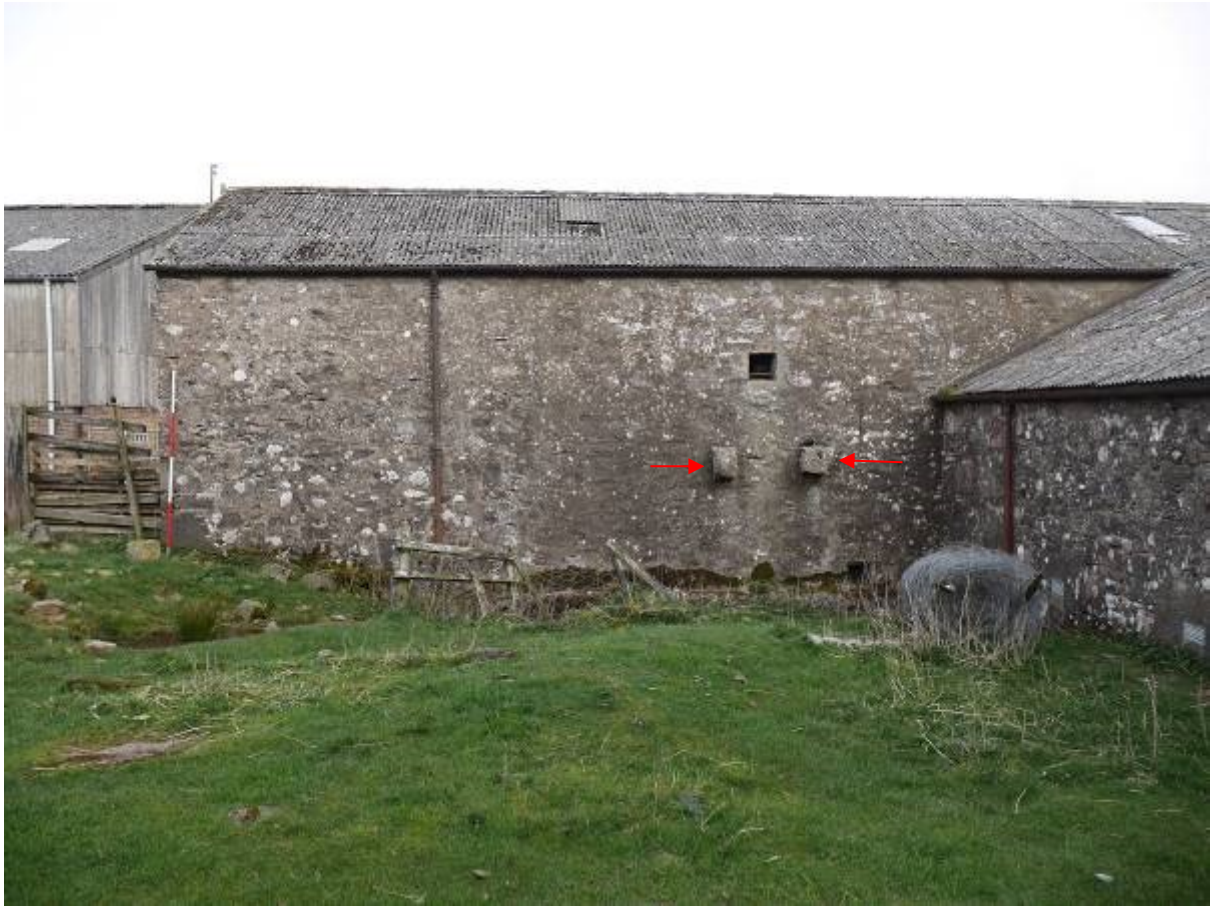
This is built of mortar bonded sandstones that are slightly plastered and has shaped quoins at its South Western corner. A water wheel pit, 1.8m deep, exists at the foot of this elevation that is fed by a lade running down from a pond in the field to the South East. There are two stone water wheel supports in the wall face and two holes, the upper one will have taken the drive shaft from the water wheel.

Illustration 26 – South Western elevation to Building 4 water wheel supports marked with red arrows, hole for drive shaft visible above

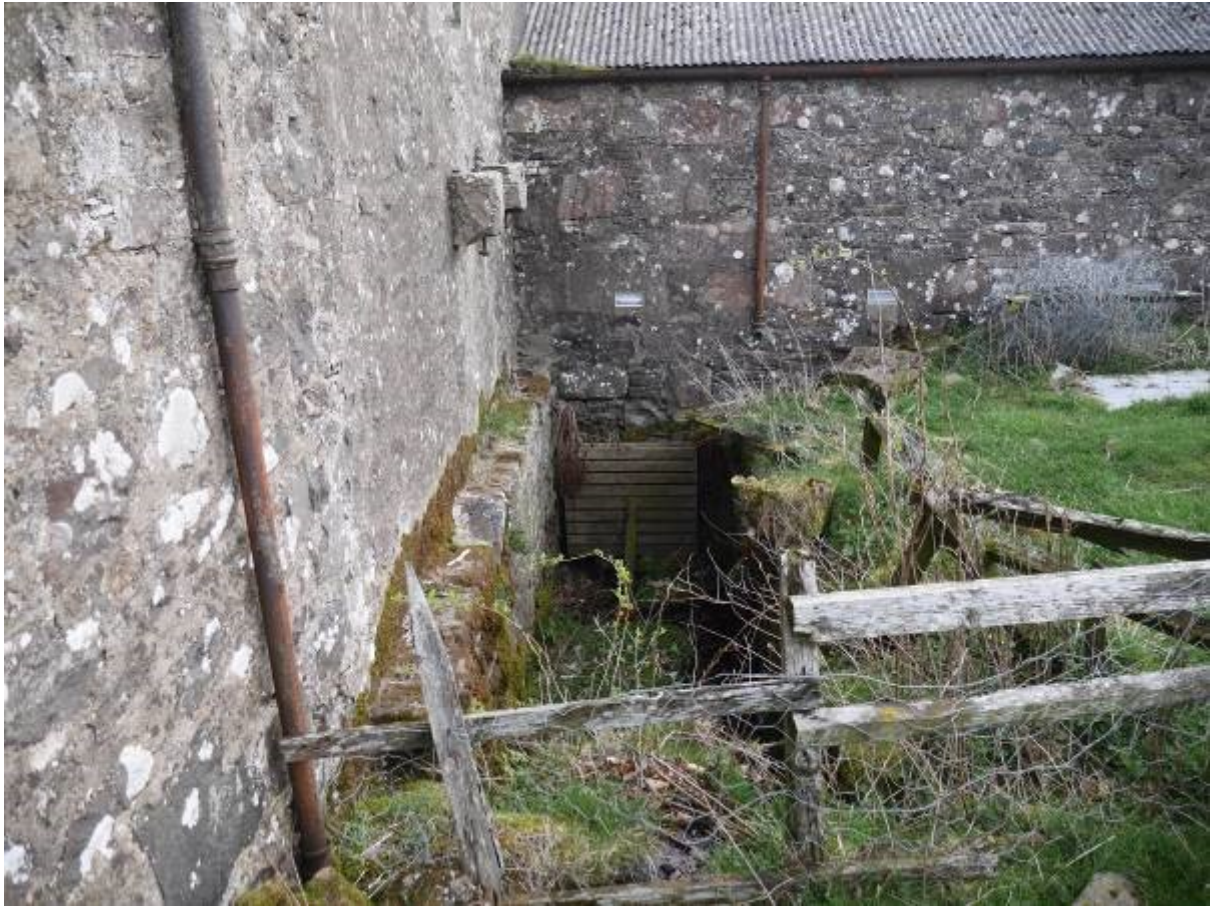
Illustration 27 – Water wheel pit against South Eastern elevation of Building 4 looking North East

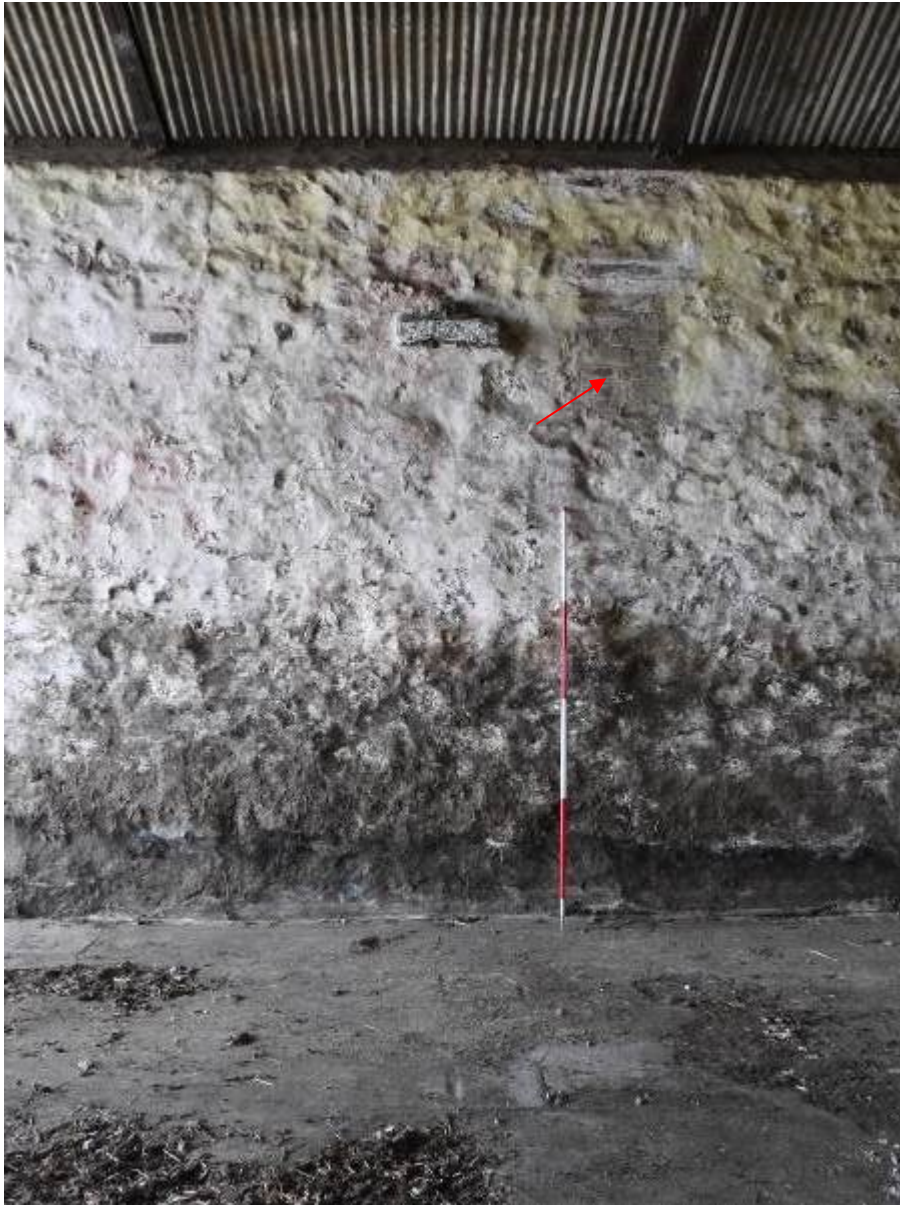
This has a concrete floor and in its last use has been an open animal shed. There is a doorway with a wooden door in its North Western wall that leads to a flight of stairs to the first floor of Building 5. The internal South Eastern elevation has the remains of the entry point for the water wheel drive shaft 2.92 m above floor level.

Illustration 29 - Internal support for pulley? And blocked hole for drive shaft for water wheel (marked with red arrow) in internal South Eastern elevation of Building 4

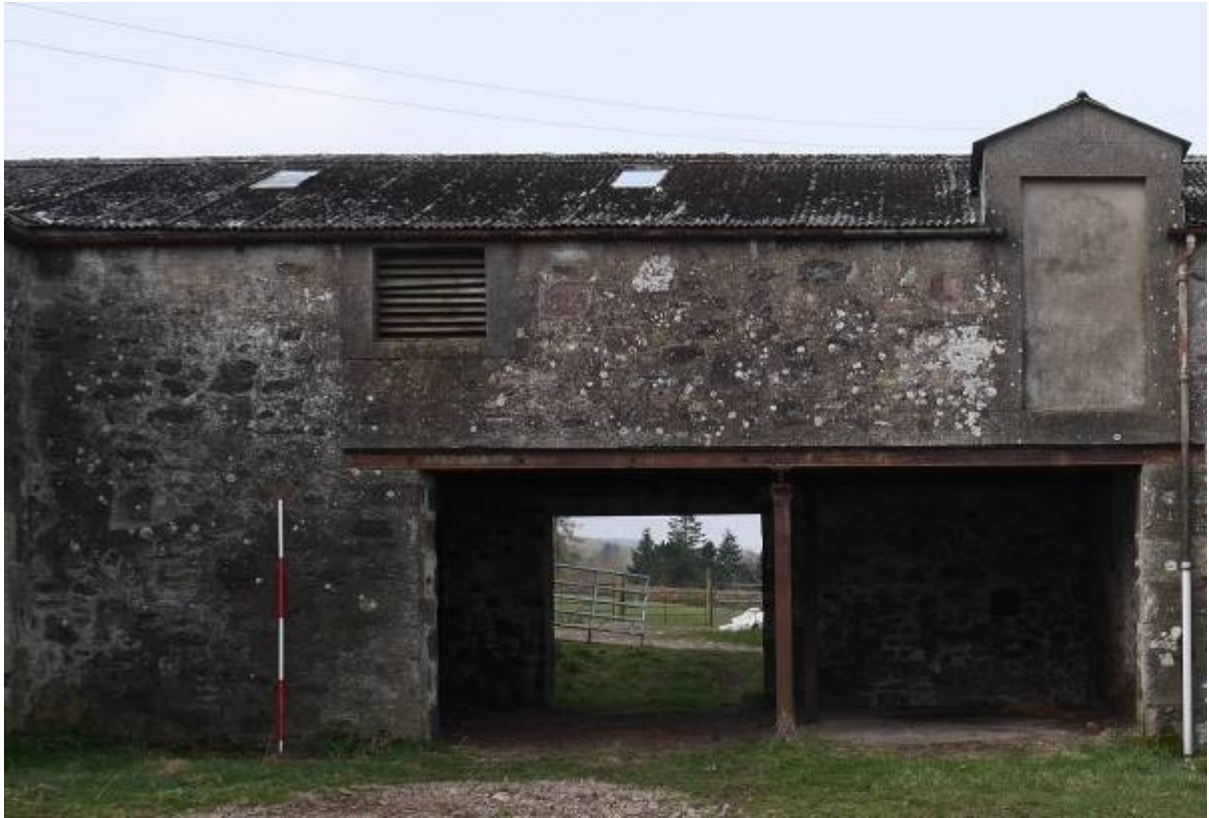
This is built of mortar bonded sandstones and has an open double doorway with steel lintels. At first floor level there is a ventilator in the wall face and a blocked doorway in a small gable.

Illustration 31 – North Eastern elevation of Building 5

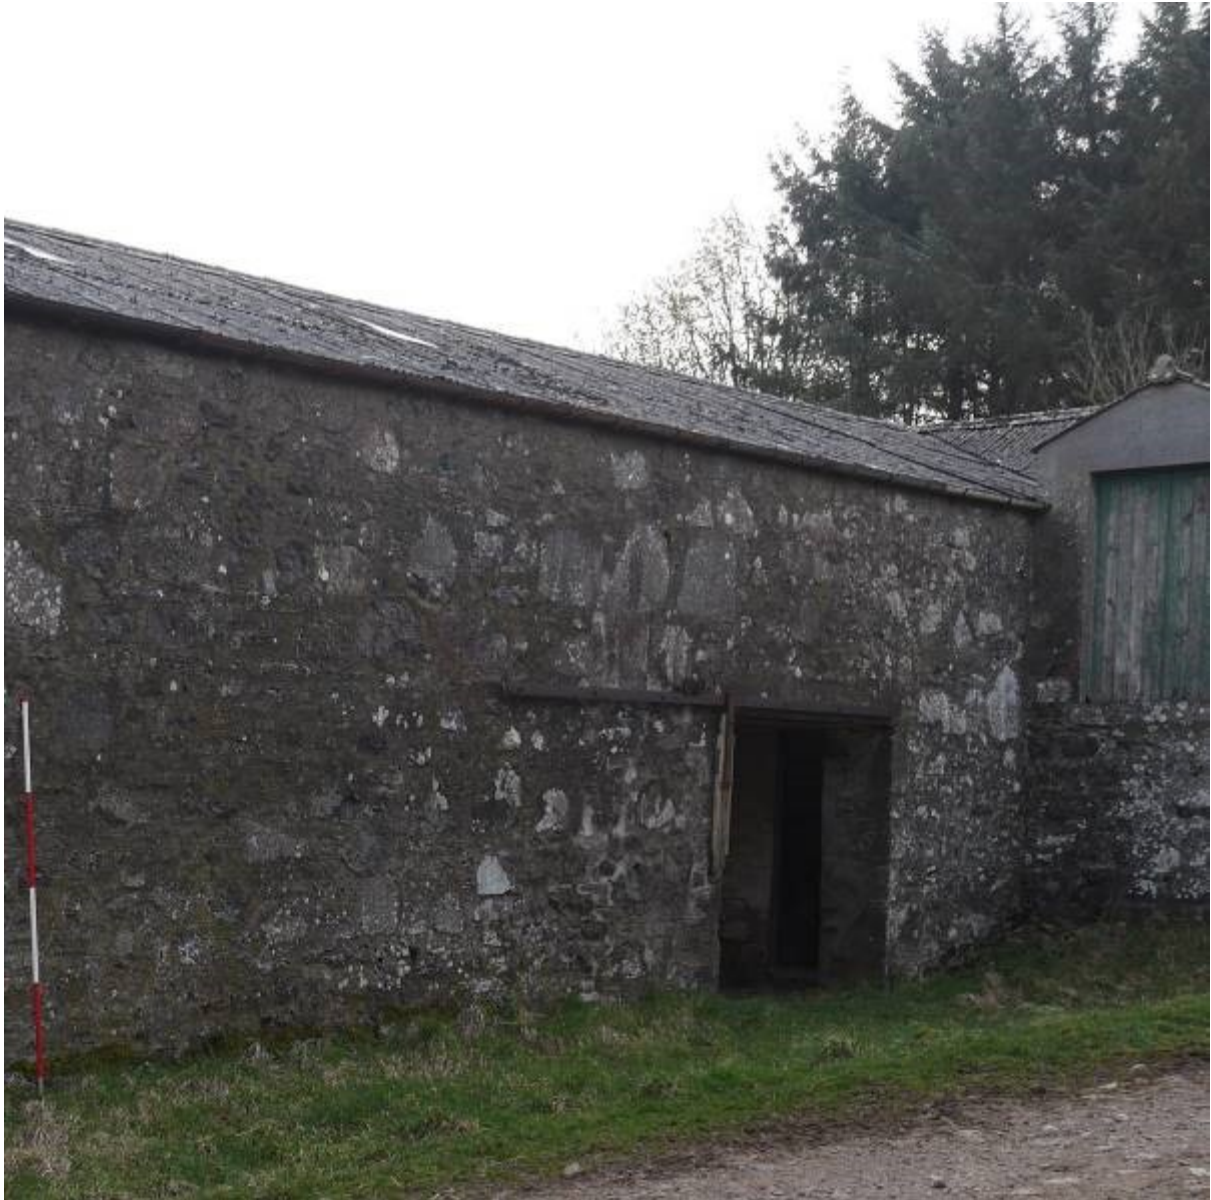
This is built of mortar bonded sandstones and contains an open doorway with a sliding door mechanism above it and a missing door.

Illustration 32 – South Western elevation of Building 5

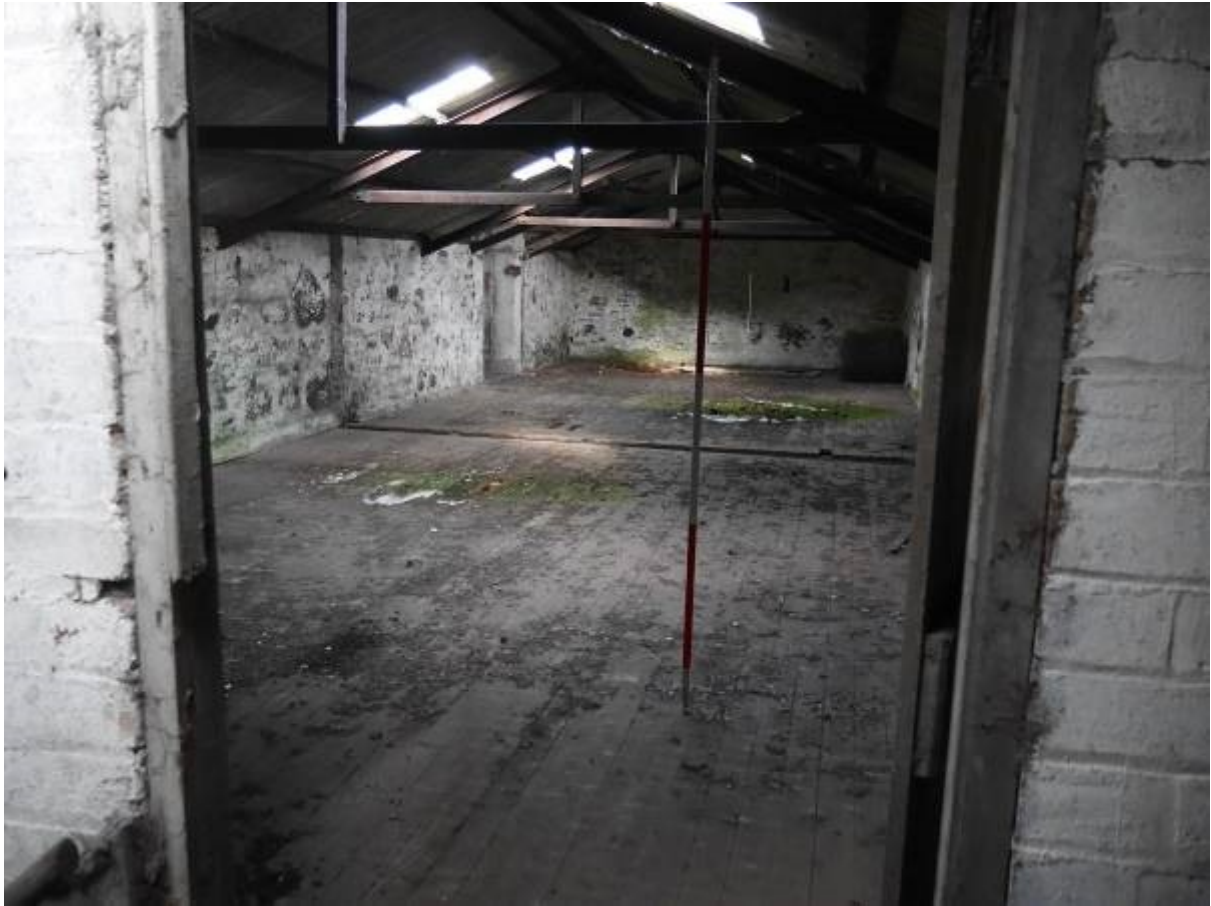
This is a hayloft with wooden floor boards and there are two blocked doorways in the North Eastern and South Western walls.

Illustration 34 – Upper floor of Buildings 5 and 6 looking North West
