Standing Building Survey
Land 90m West of Cornhill Farmhouse
Auchterarder, Perth and Kinross

Farm steadings to be demolished at Cornhill looking South West

16th April 2019

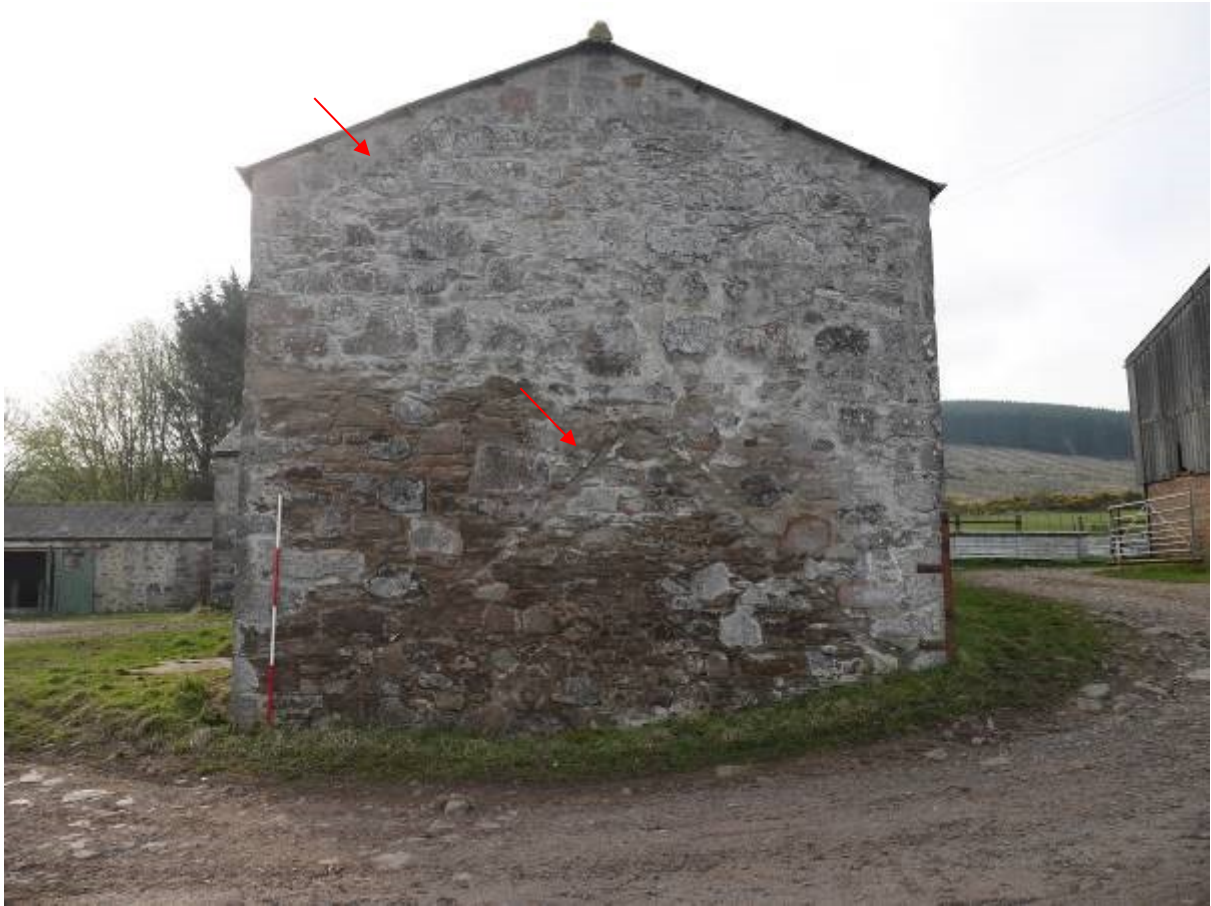
This is a gable end and is built of mortar bonded sandstones that are slightly plastered with concrete. The wall face is blank but there is a roof raggle visible which is associated with a now demolished building adjacent to this gable end.

Buildings 1 to 6 would appear to be in the same footprint as the group shown on the First Edition Ordnance Survey map (Illustration 3), another structure forming a northern part of the group has been demolished at some point and the position of its roof line is still visible as a raggle in the NW elevation of Building 6 (Illustration 36). The presence of the mill lade that runs down from a pond to the South East of the site and a wheel pit and water wheel supports against the South Eastern wall of Building 4 indicate a previous use presumably for threshing crops during the 19th century use of the building. Buildings 1 and 6 may represent the 19th century 'officehouses' referred to in the Ordnance Survey Name Book (Ordnance Survey Name Book Perthshire Volume 7 1859-62). In their last phase of occupation Buildings 1, 2 and 3 functioned as a piggery (pers comm local farmer). At the same time Building 4 was used as an animal pen and the lower floor of Building 5 was also used as an animal pen. There is a hayloft on the upper floor of Buildings 5 and 6 which has been added as part of this later use. It is possible to see where the elevation has been lifted to accommodate the hay loft (Illustration 36).

Illustration 36 – North Western elevation of Building 6, roof raggle and slight raising of gable marked with red arrows

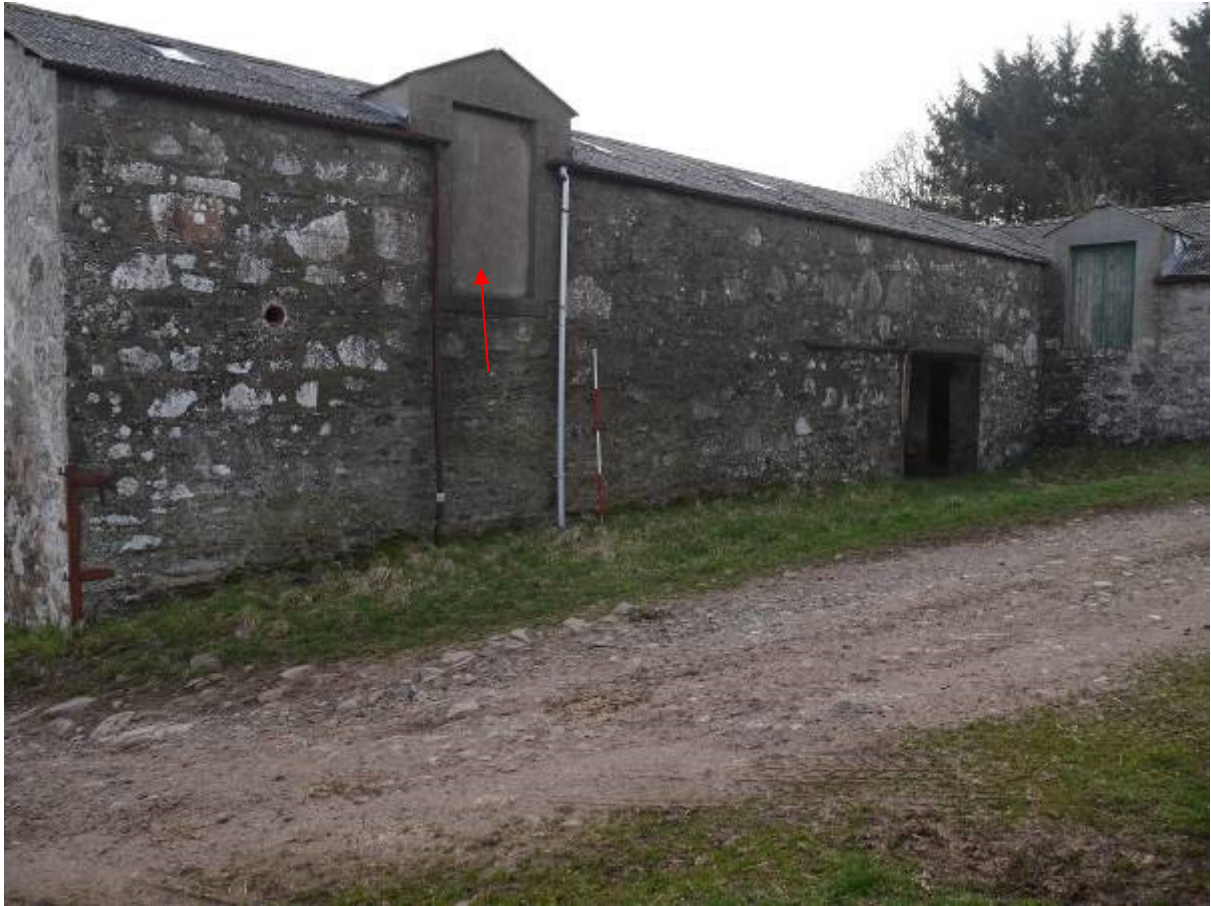
This is built of mortar bonded sandstones and has a blocked doorway in a small gable at first floor level.

Illustration 37 – South Western elevation of Building 6 with blocked door at first floor level marked with red arrow
