Standing Building Survey

Land 100m East of Whistlebare, Perth and Kinross

29th April 2021

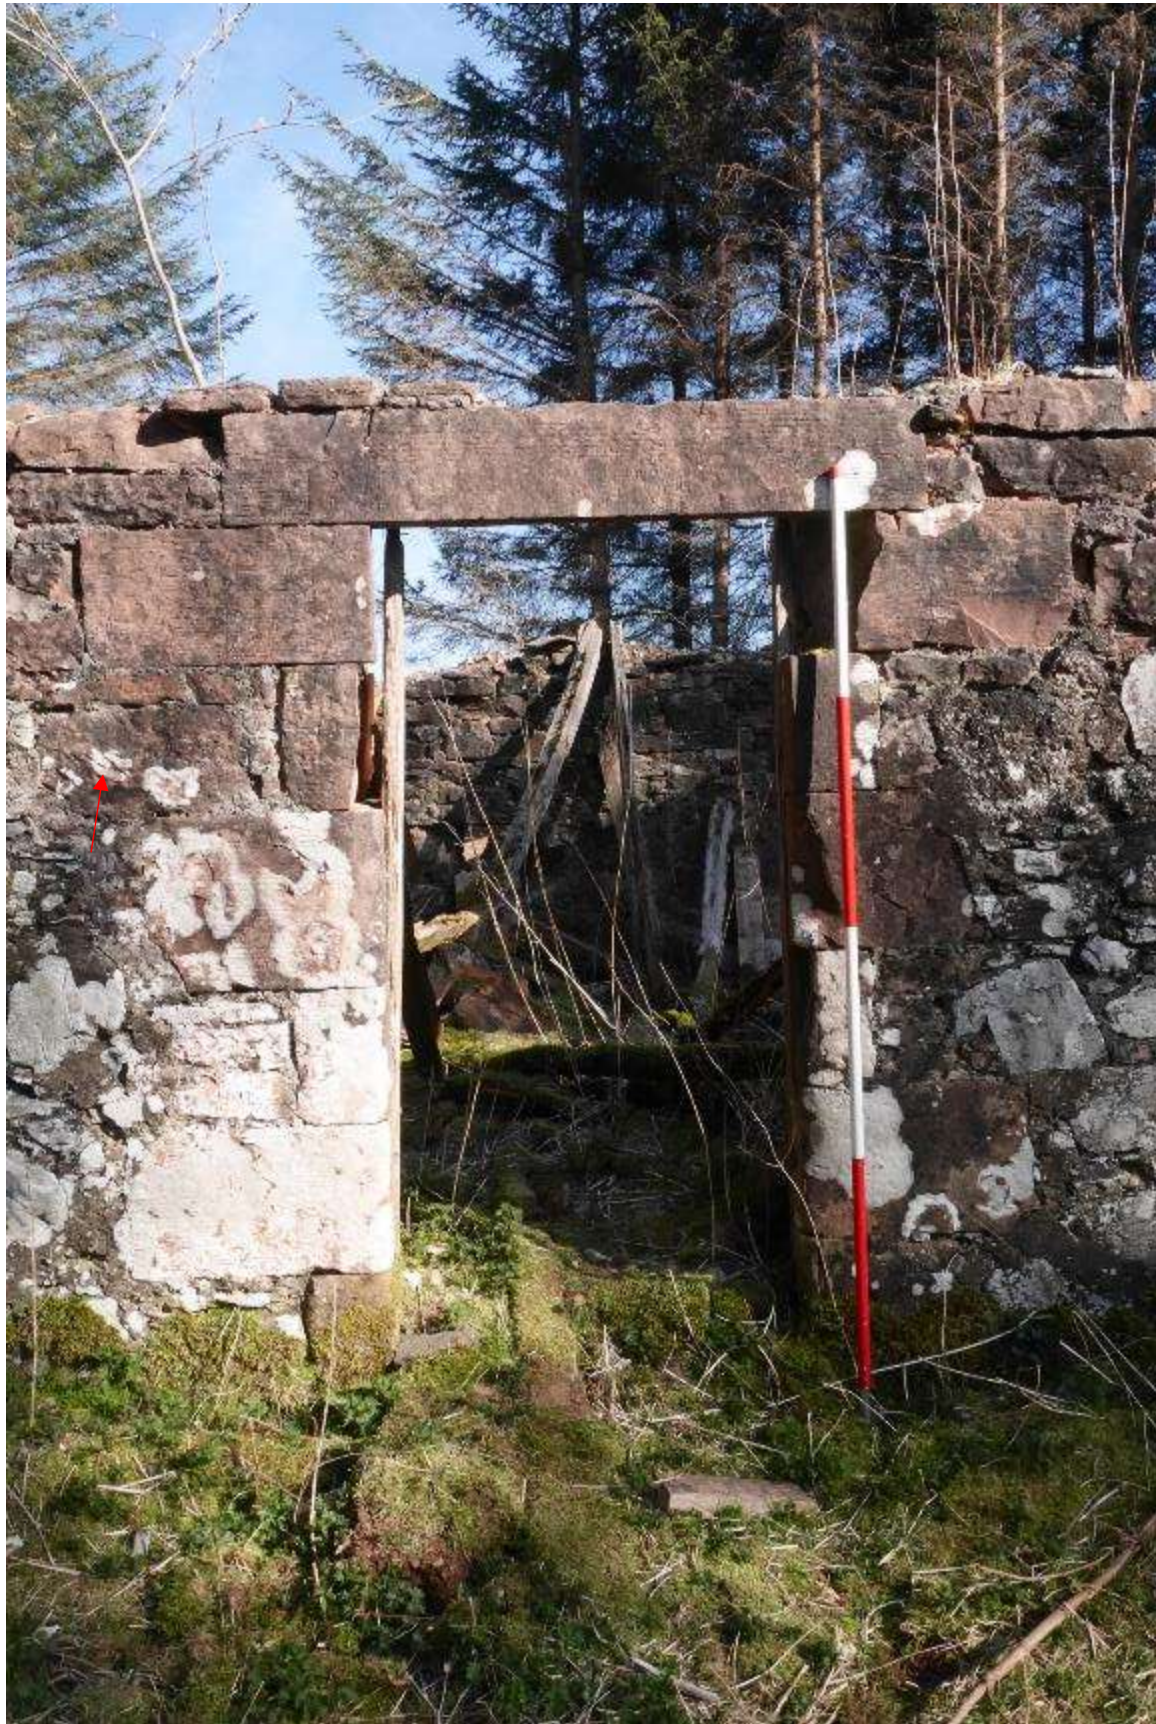
1. Southern external elevation of Room A – piece of yellow sandstone with toolmarks to West of doorway measuring 0.12m by 0.06m (Illus 14 and 15).
2. Western external elevation of Room B – piece of yellow sandstone with incised lines measuring 0.14m by 0.10m (Illus 18 and 19).

Illustration 14- Doorway Room A in Southern elevation of building, red arrow indicates stone with toolmarks (no 1).

It is recommended that some consideration is given to the possible reuse or display of the identified tool marked and incised stones (numbers 1 to 9) either in the new building or any new boundary walls on the site. The author feels that the photographic survey and written notes of the building at 'Windy Walls' are an adequate record of the building prior to its demolition. The final decision on that however rests with Perth and Kinross Heritage Trust.

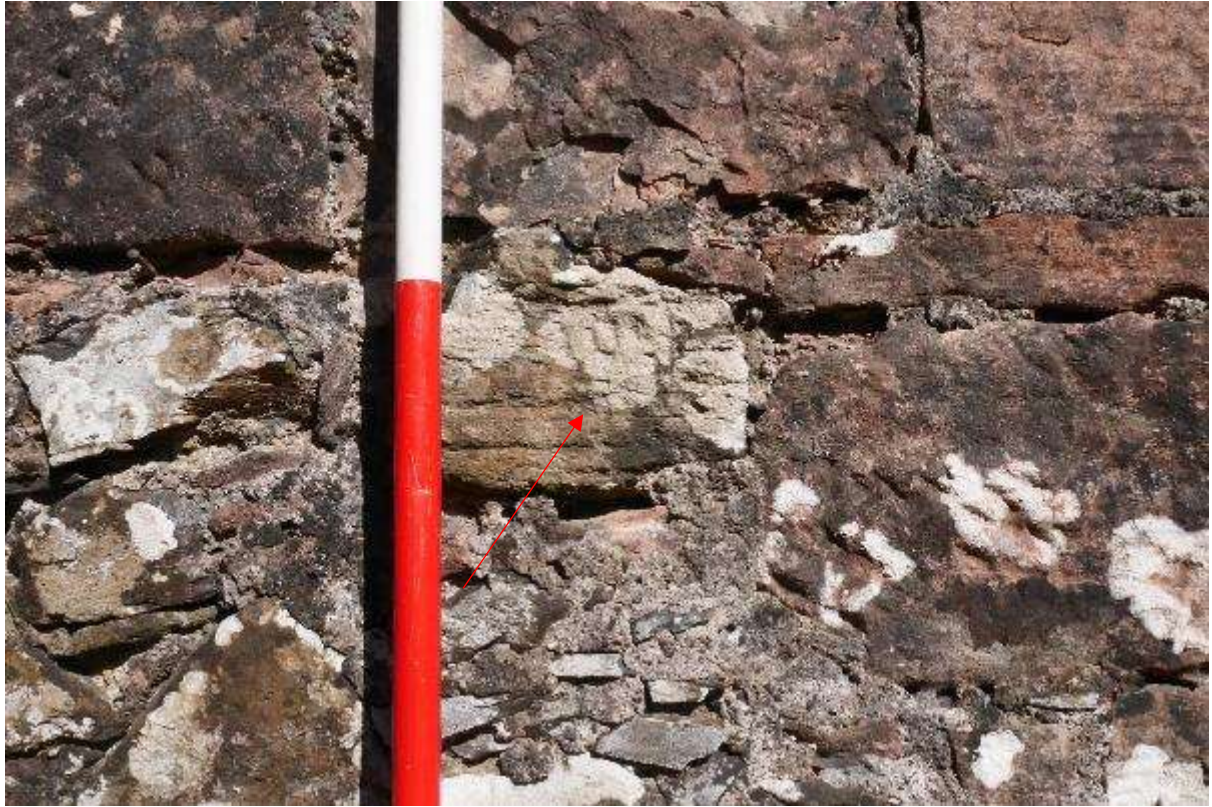
Illustration 15- Piece of yellow sandstone with toolmarks (no 1) in Southern elevation of Room A.

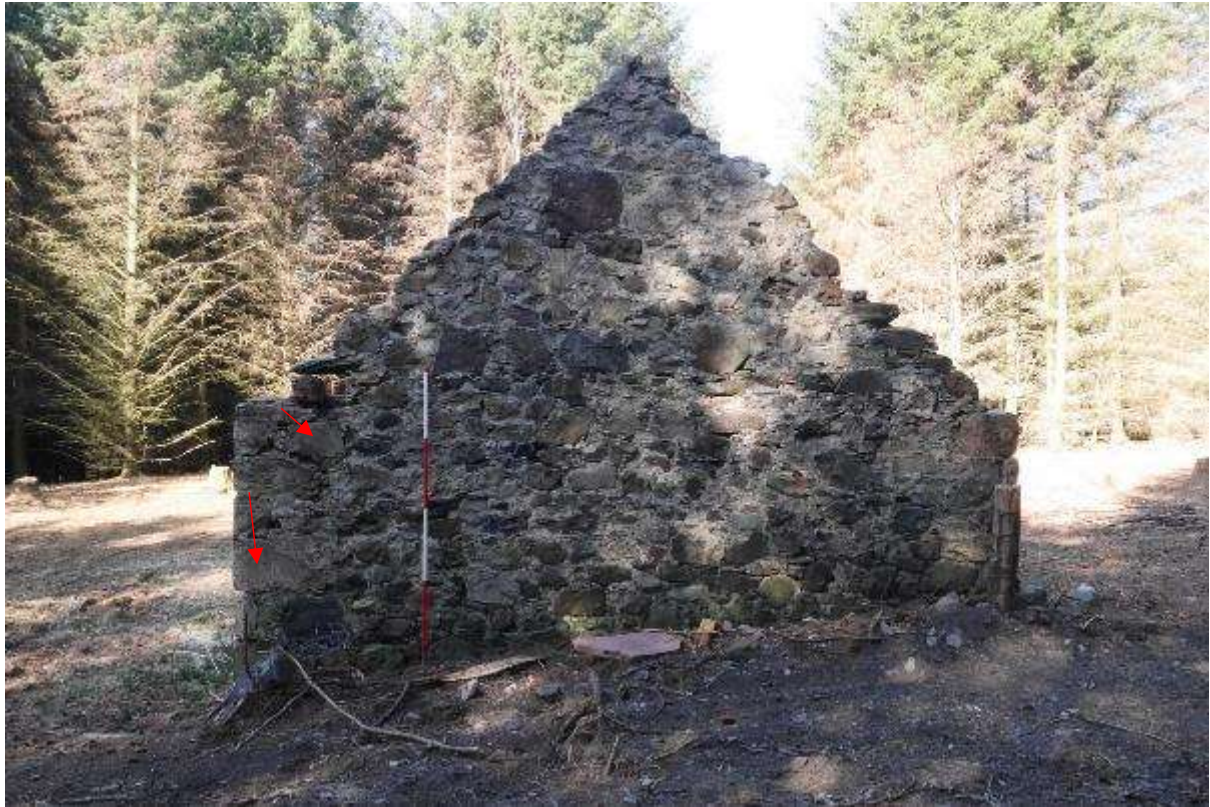
This is a gable end that is a lime mortared rubble build with red sandstone quoins at its Northern and Southern ends. The wall face is blank. A stone in this wall face is reused and has incised lines on its surface (number 2) (Illus 18 and 19), a red sandstone quoin stone at the SE corner seems to be used from an earlier building and has incised lines possibly forming a letter 'M' on its East facing face (number 3) (Illus 18 and 20).

Illustration 18- Eastern elevation of building, red arrow shows location of reused stones with incised lines (no 2 upper) and incised letter 'M' (no 3 lower).

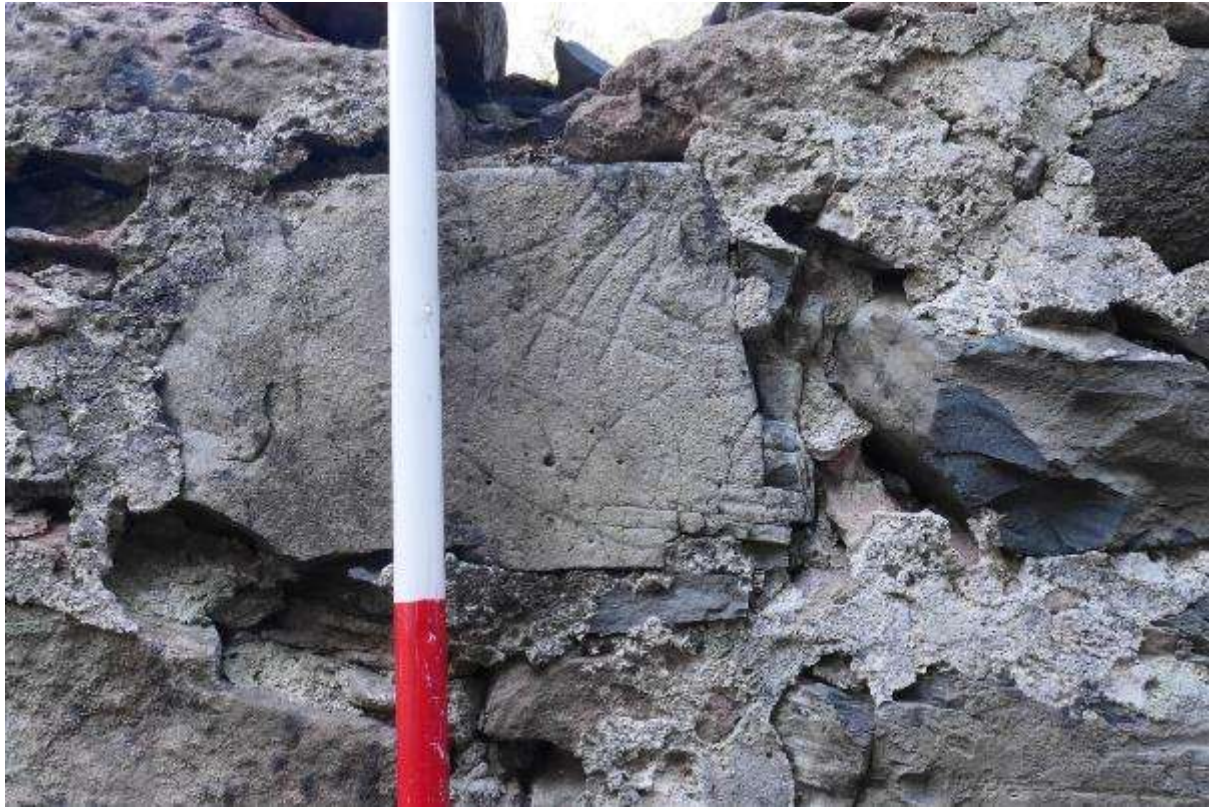
Illustration 19- Detail of upper reused piece of yellow sandstone (no 2) in Eastern elevation of building with incised lines.

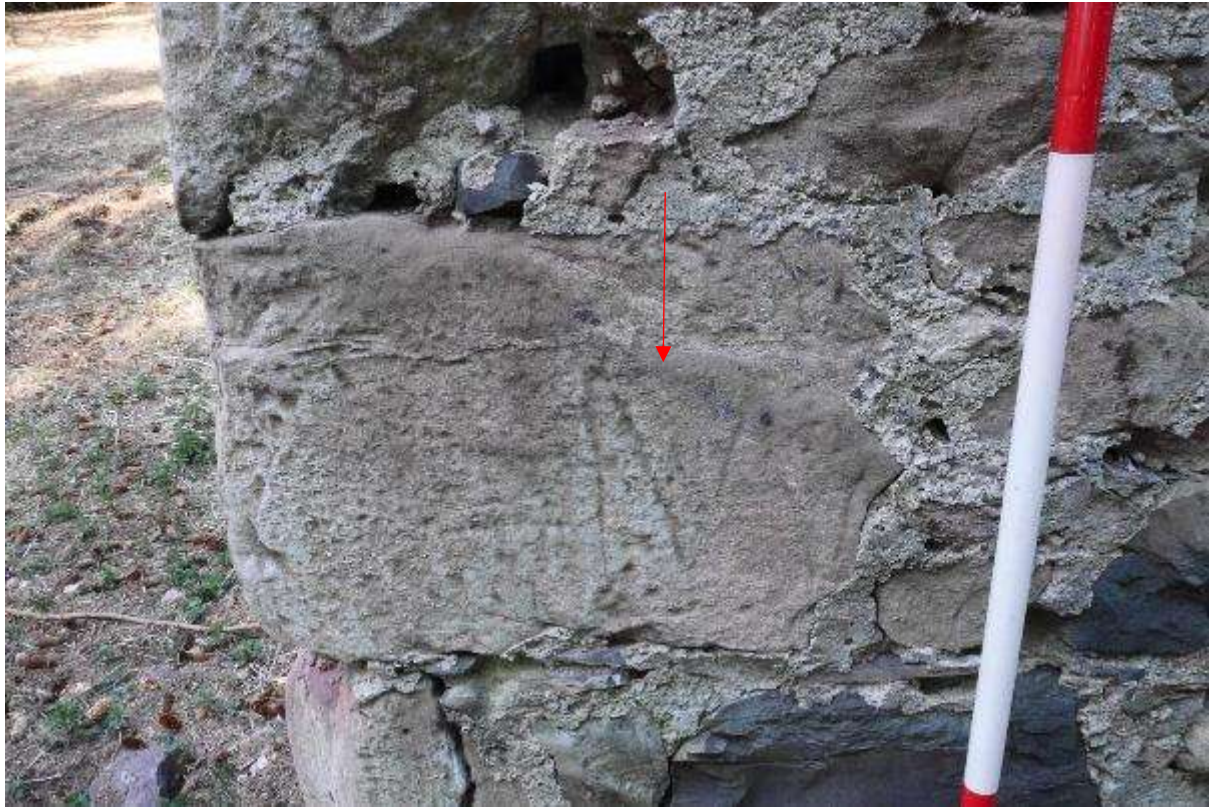
3. Western external elevation of Room B – piece of yellow sandstone measuring 0.52m by 0.35m with incised letter 'M' (Illus 18 and 20).
4. Northern external elevation of Room B – corner quoin made of yellow sandstone with toolmarks measuring 0.52m by 0.35m (Illus 22 and 23).

Illustration 20- Detail of lower reused piece of yellow sandstone (no 3) with incised letter 'M' in Eastern gable of building.

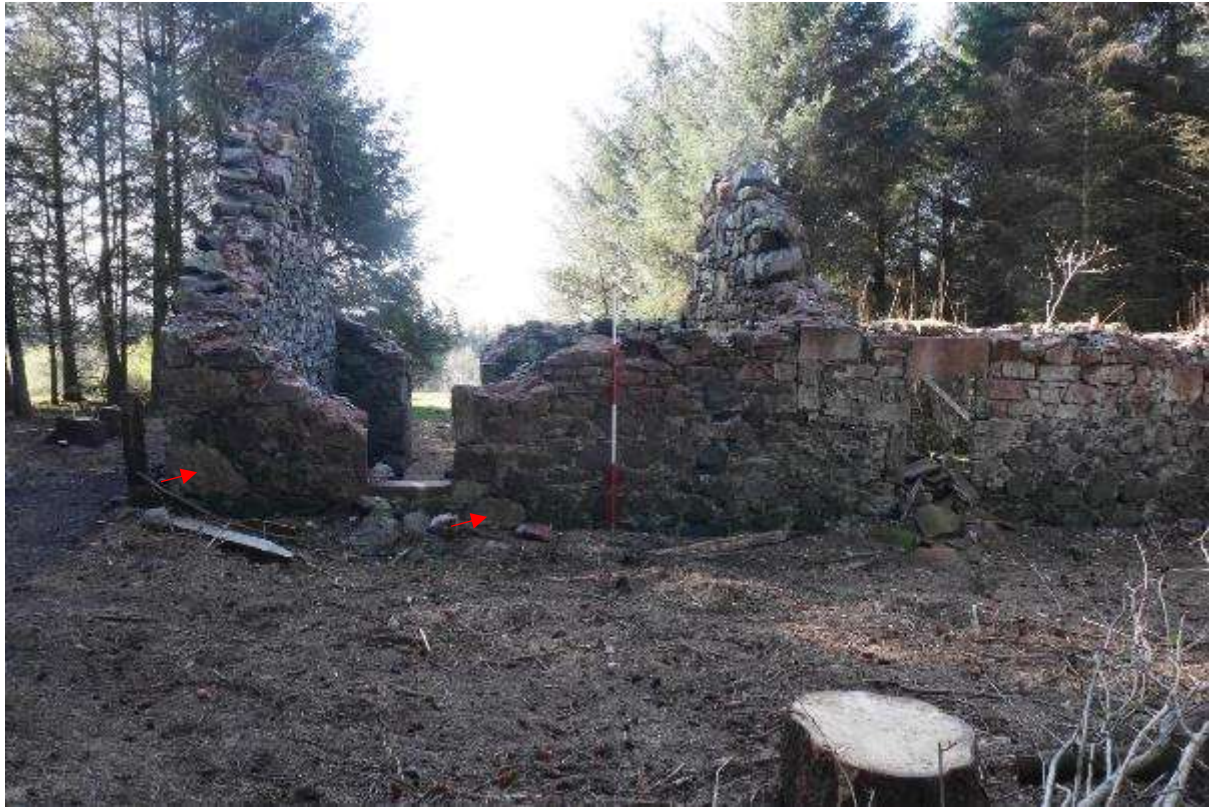
This is built of lime mortared rubble with sandstone quoins at its Eastern and Western ends. A quoin stone at its Eastern end has visible toolmarks (number 4) (Illus 22 and 23). From its Eastern end Room B has a single window, there is a stone in the wall face on the Eastern side of the window with toolmarks (number 5) (Illus 22 and 24). A straight joint is visible again between B and A and the stones at this joint have toolmarks (number 6) (Illus 25 and 26). The elevation of Room A has a window whose lintel has pecked toolmarks (number 7) (Illus 25 and 27), a small lower window and then another window. The Western side stone for the window at the Western end of this elevation would also appear to be reused from an earlier building (number 8) (Illus 29, 30 and 34).

Illustration 22- Window in Room B at Eastern end of Northern elevation of building, red arrows show location of reused stones with visible toolmarks (numbers 4 and 5).

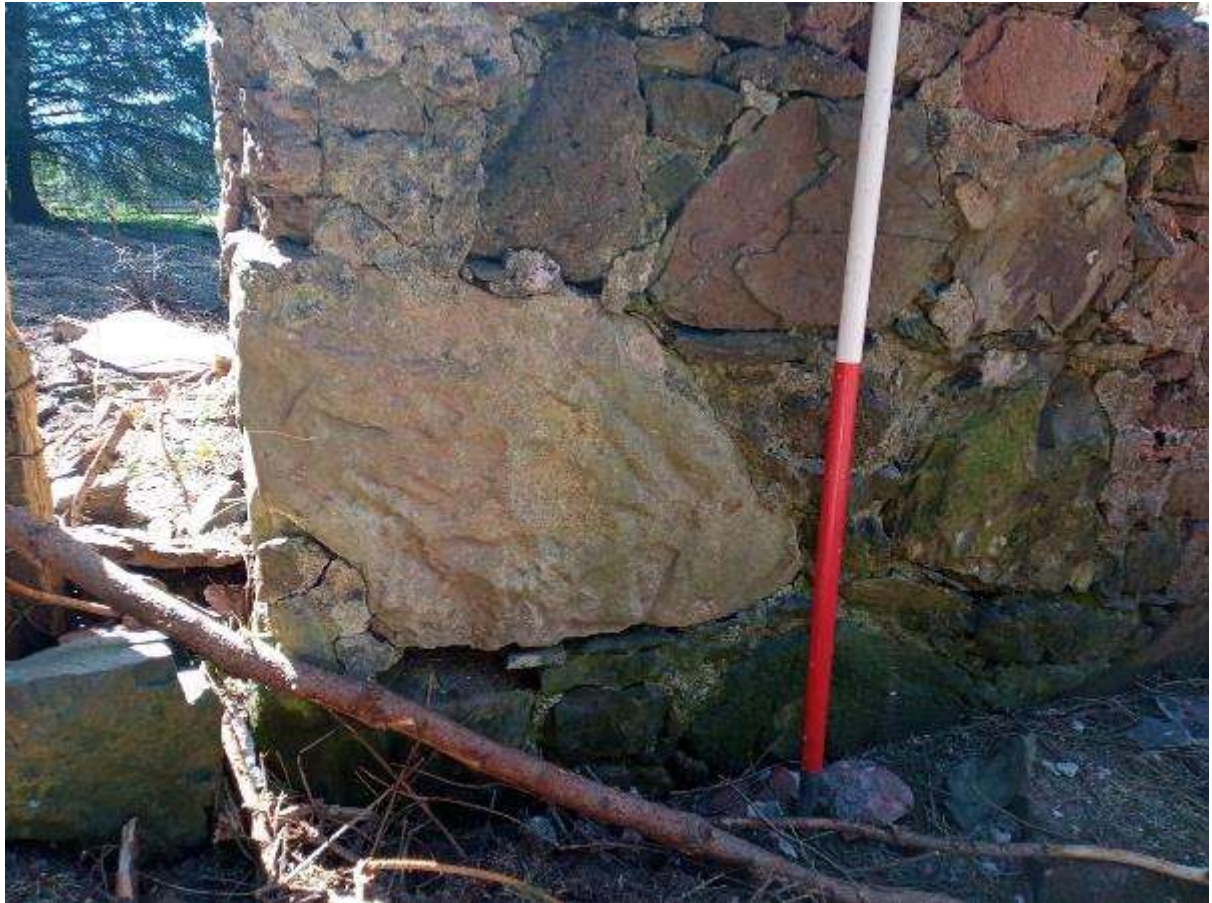
Illustration 23 – Reused piece of yellow sandstone with toolmarks (no 4) at NE corner of N elevation.

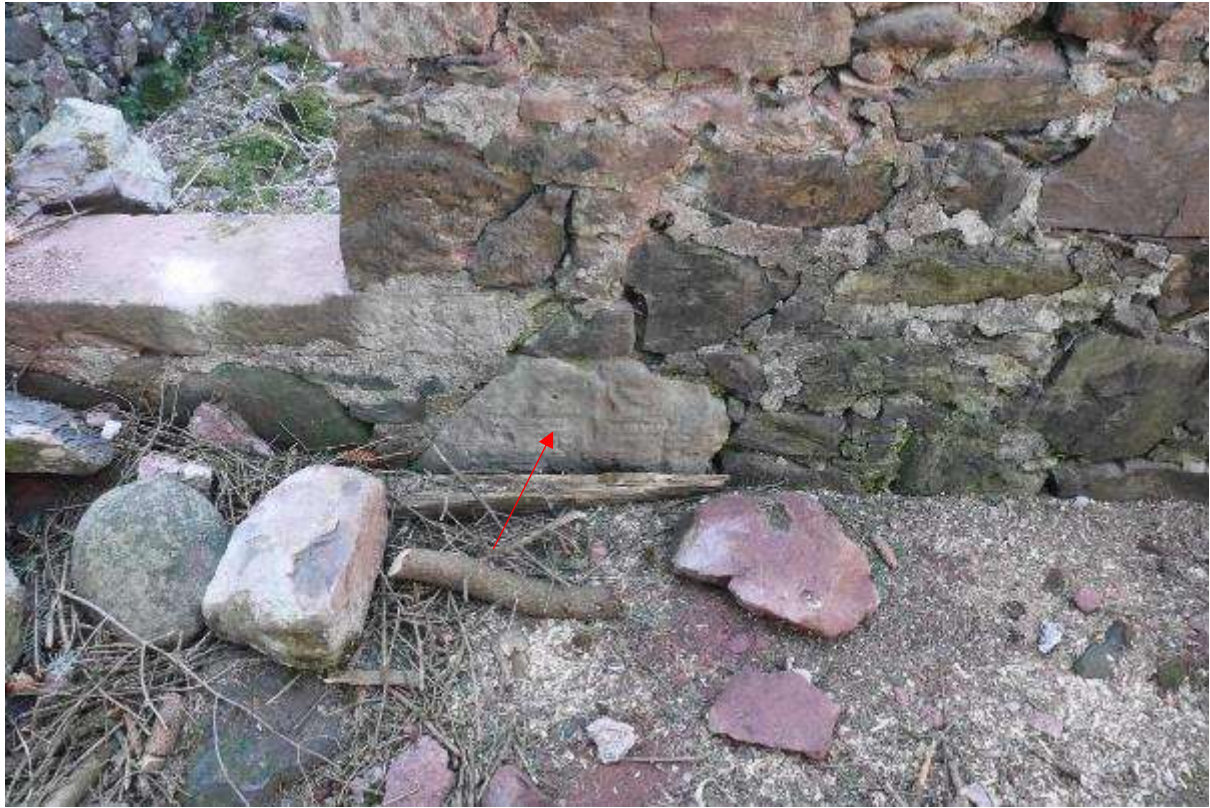
5. Northern external elevation of Room B – piece of yellow sandstone measuring 0.25m by 0.10m with toolmarks (Illus 22 and 24).
6. Northern external elevation at straight joint between Rooms A and B piece of yellow sandstone measuring 0.40m by 0.11m with toolmarks (Illus 25 and 26).

Illustration 24- Detail of reused piece of yellow sandstone (no 5) on Western side of window in Room B in Northern elevation with visible tool marks.

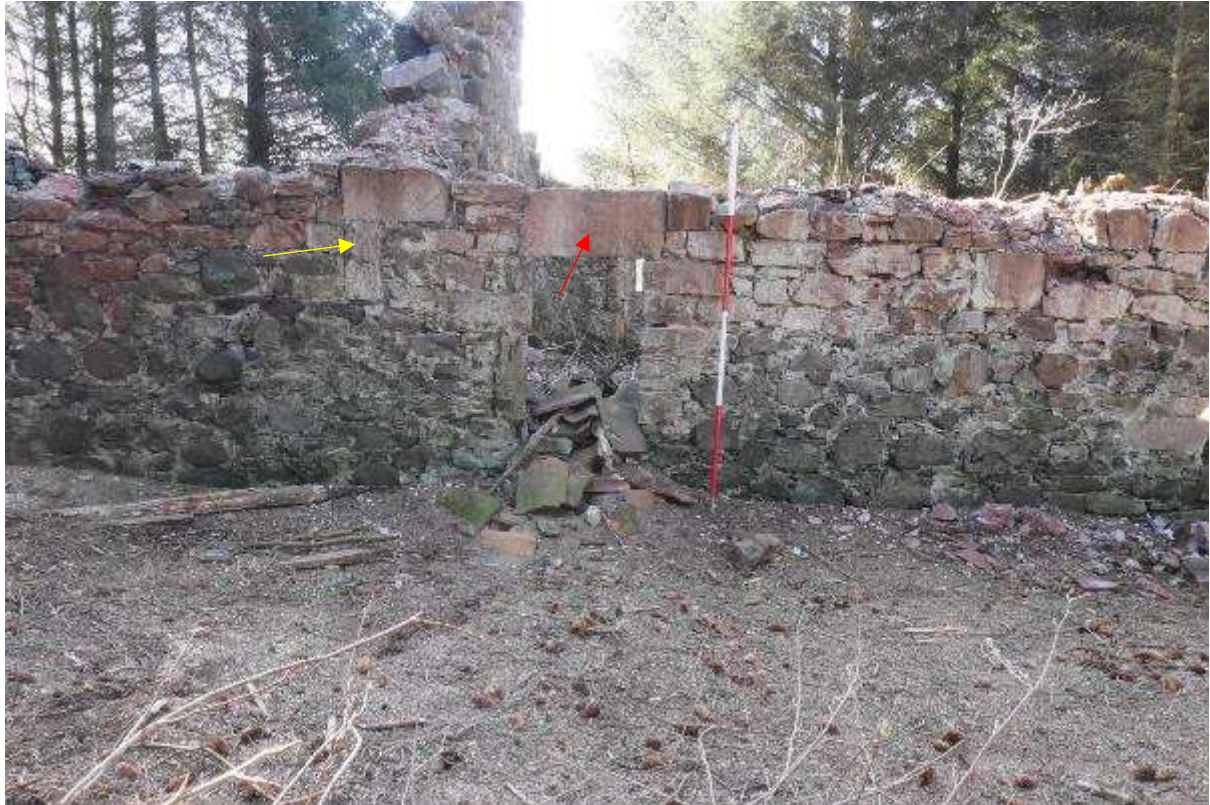
Illustration 25- Window in Room A in Northern elevation of building with collapsed ceramic roof tiles visible, yellow arrow shows straight joint between rooms A and B with tool marked stones (no 6), red arrow indicates window lintel with pecked toolmarks (no 7).

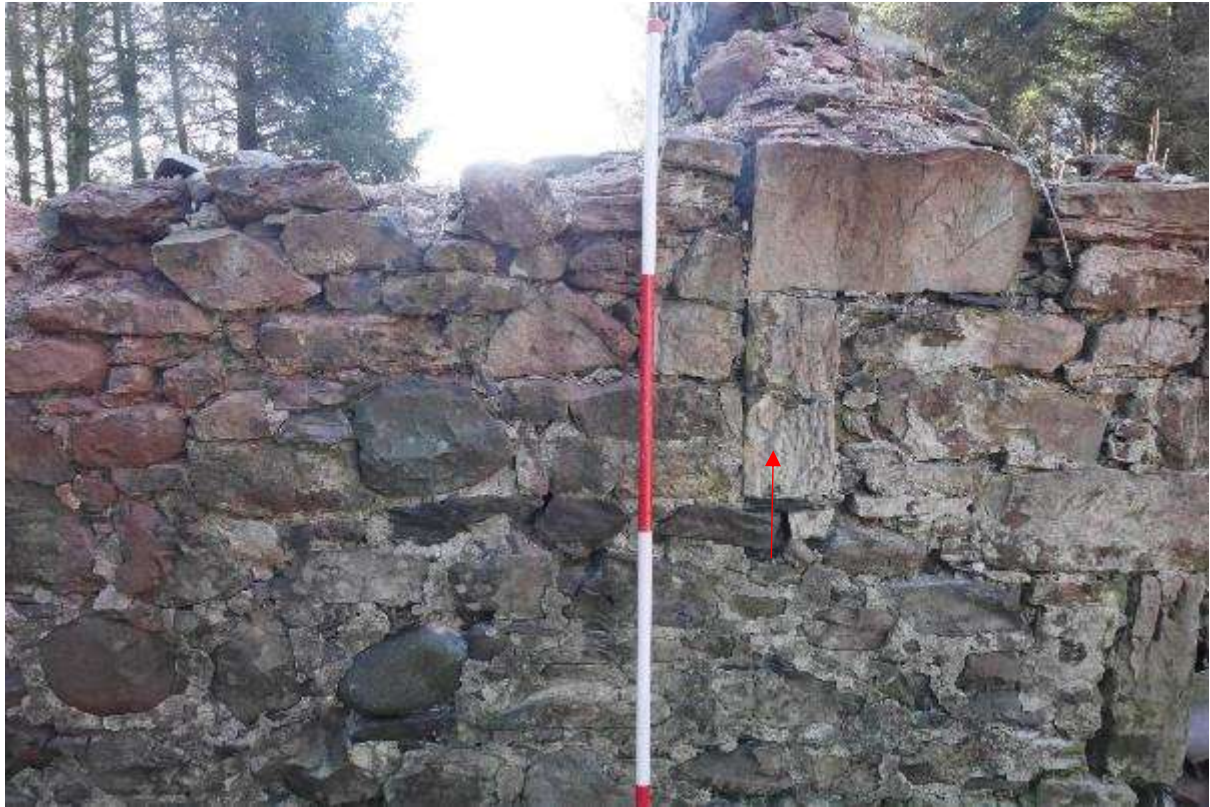
Illustration 26- Straight joint between Rooms A and B visible in Northern elevation, red arrow shows tool marked pieces of yellow sandstone (no 6).

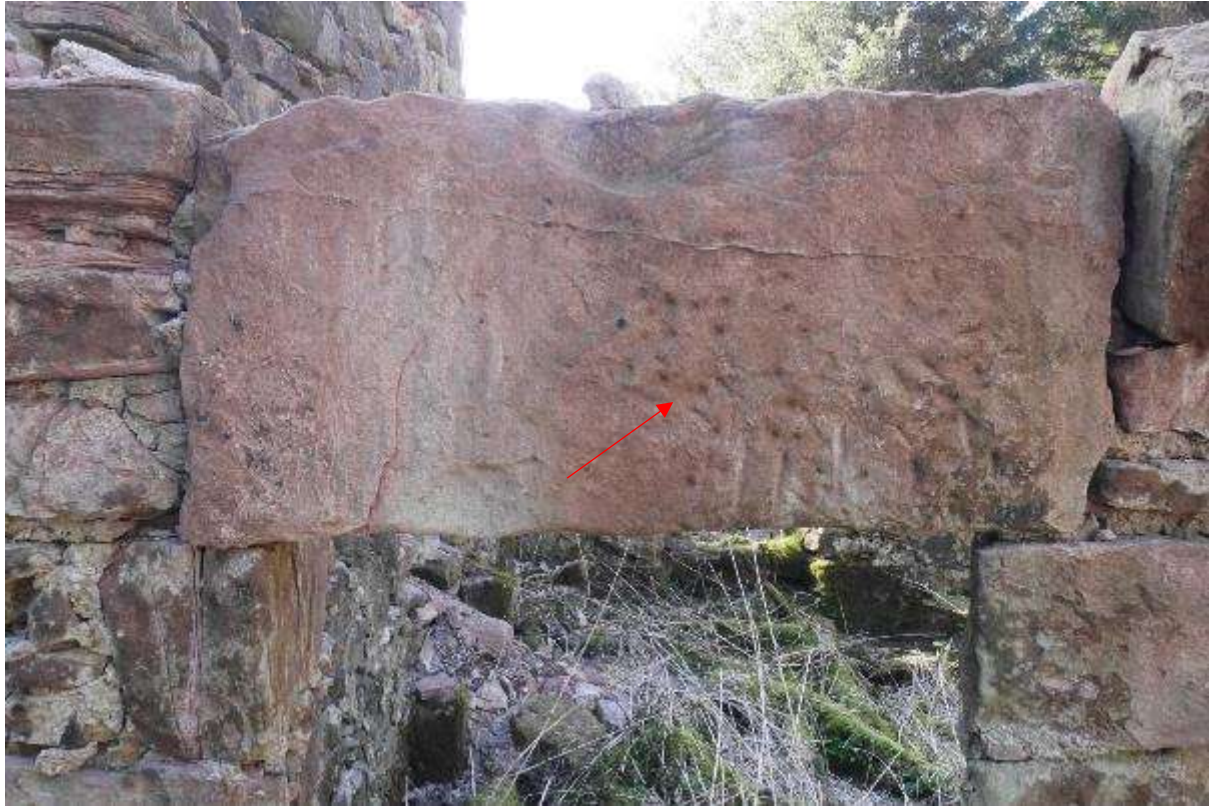
7. Northern external elevation of Room A – window lintel of red sandstone with pecked toolmarks measuring 0.75m by 0.40m (Illus 25 and 27).
8. Northern external elevation of Room A – side stone of red sandstone measuring 0.45m by 0.38m on Western side of final window is a reused architectural fragment (Illus 29, 30 and 34).

Illustration 27- Red sandstone lintel of window in Room A in Northern elevation of building red arrow shows visible pecked tool marks (no 7).

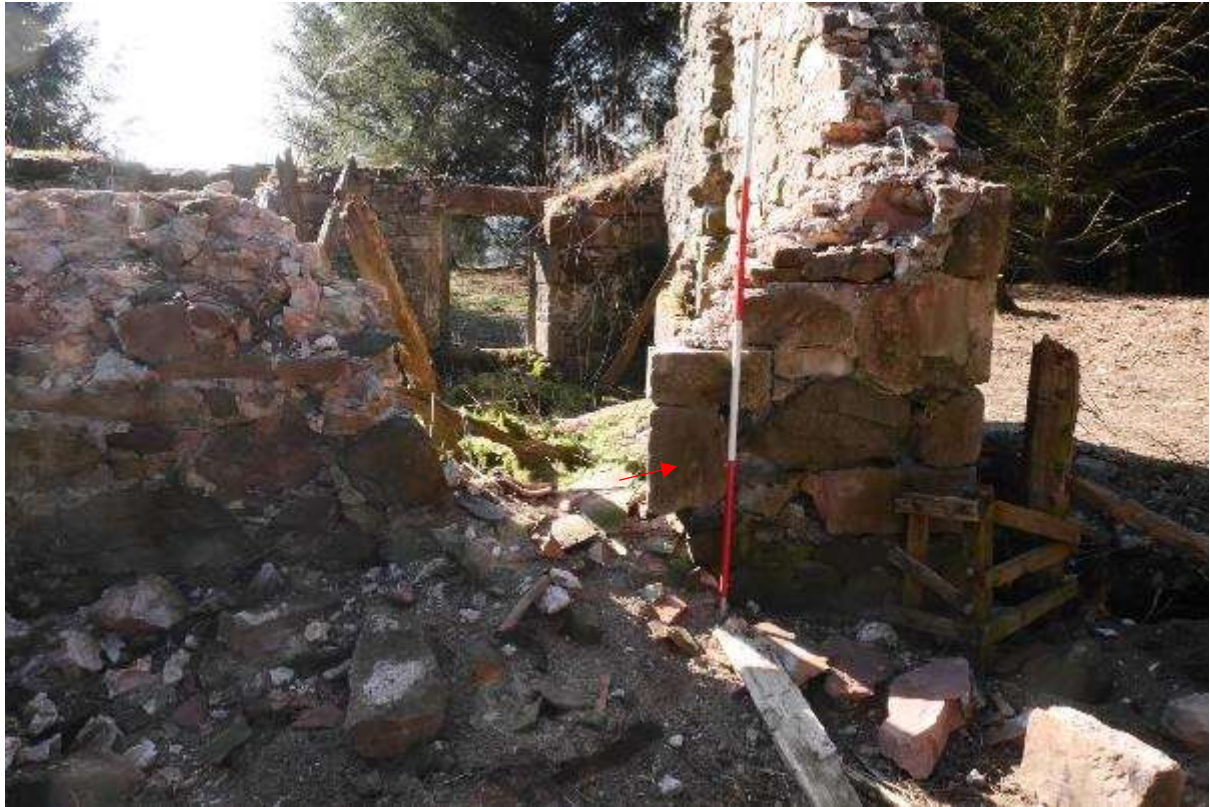
Illustration 29- Window in Room A in Northern elevation of the building, red arrow indicates reused architectural fragment (no 8).

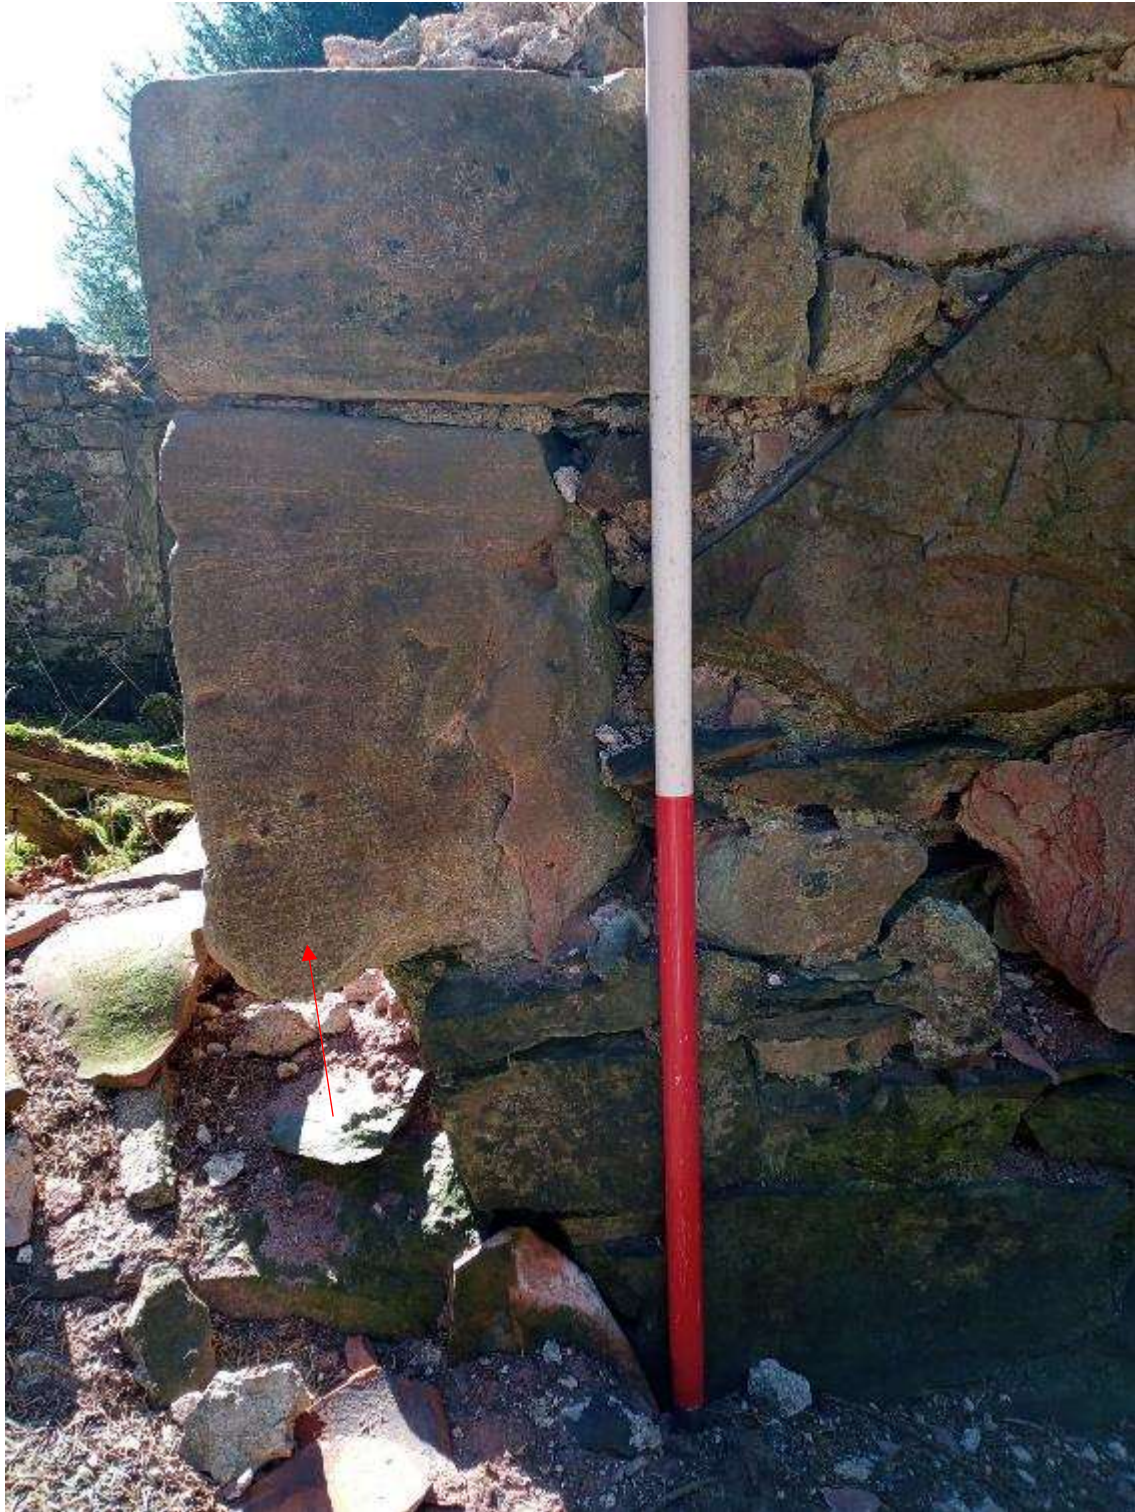
Illustration 30- Detail view of reused architectural fragment in red sandstone (no 8) in window in Room A in Northern elevation of building.

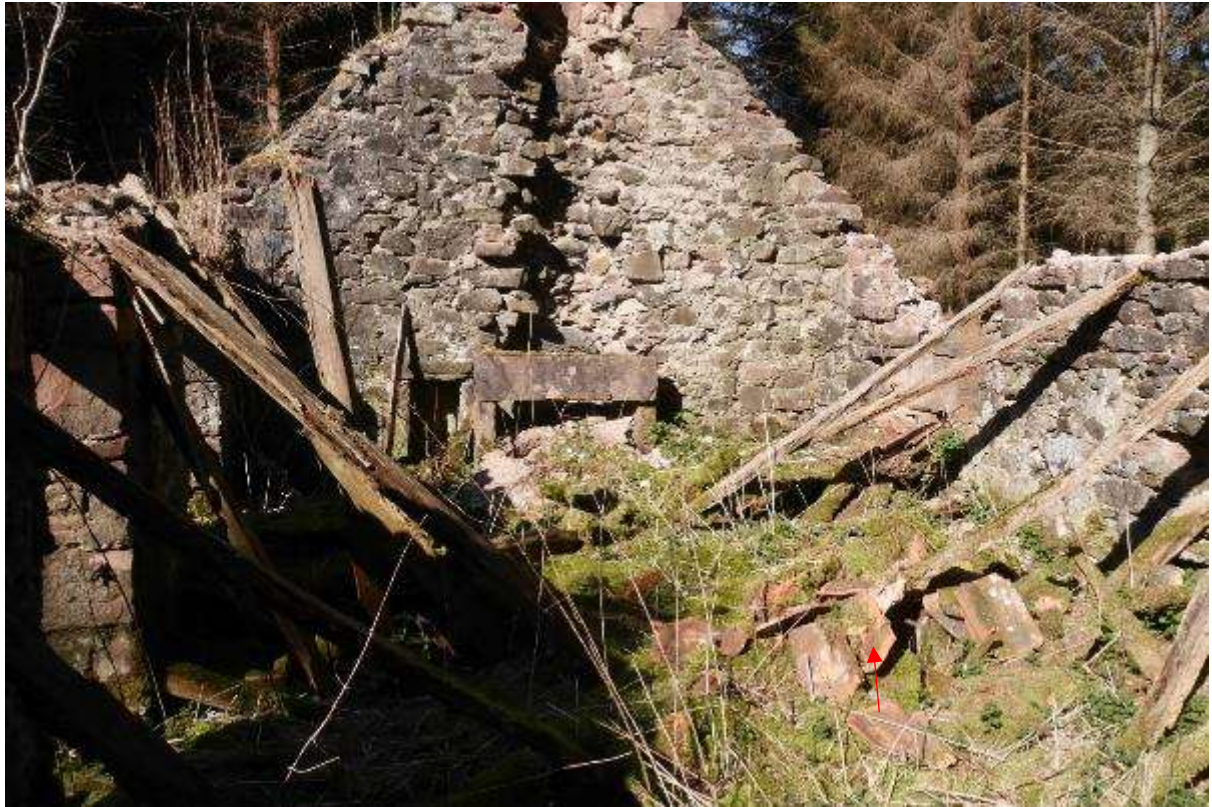
The floor of this room is not visible as it is covered with the collapsed remains of a ceramic tiled roof. Roof timbers are also present leaning against the internal faces of the Northern and Southern walls. These timbers appear to be sawn pine and some iron nails are visible in their edges.

Illustration 32- General view of interior of Room A looking West showing collapsed roof timbers and ceramic roof tiles (red arrow).

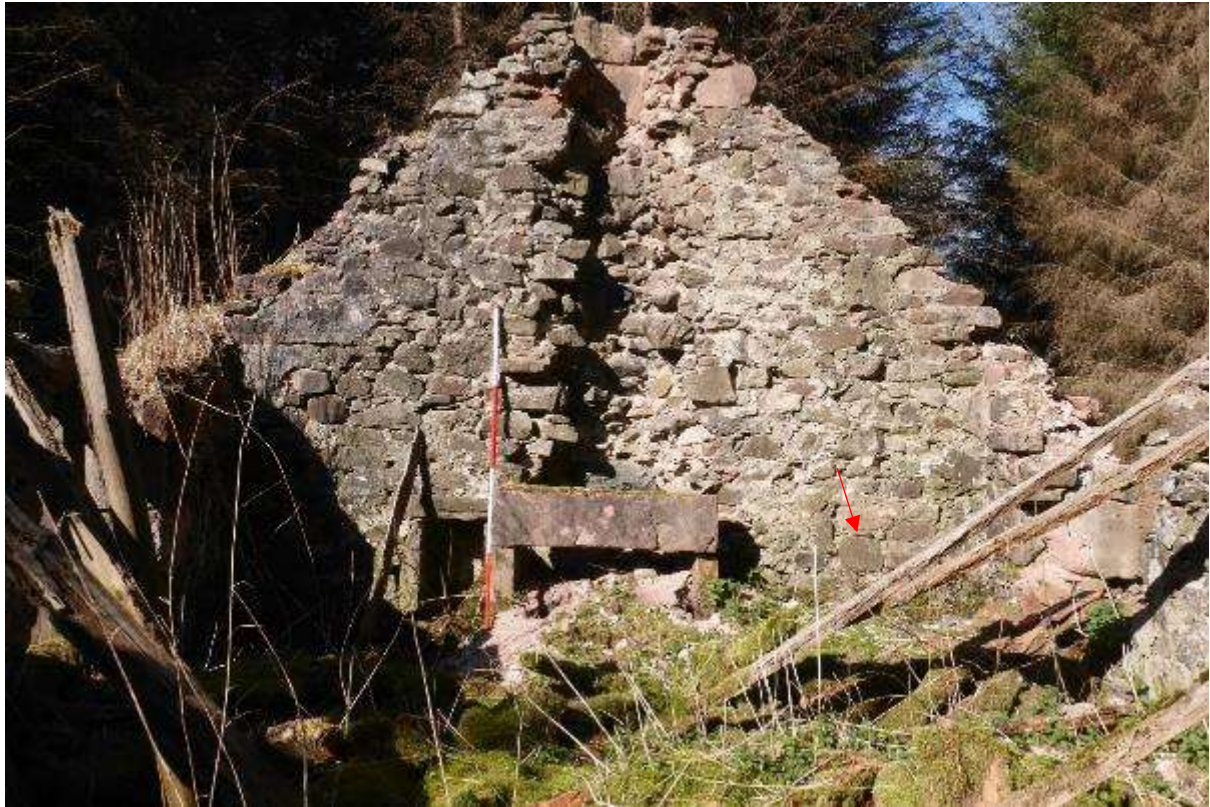
This wall face is built of lime mortared rubble and there is a central fireplace built of red sandstone slabs projecting from the centre of the elevation. The course of the chimney for the fireplace is visible in the wall face. There is a small cupboard built into the wall on the Southern side of the fireplace measuring 0.40m x 0.70m that is 0.25m deep. There is a larger blocked cupboard space visible in the wall face to the North of the fireplace measuring 0.77m by 0.60m.

Illustration 33- Central fireplace in Eastern elevation of Room A with small cupboard visible to left and blocked cupboard at red arrow, chimney scar visible in wall face.

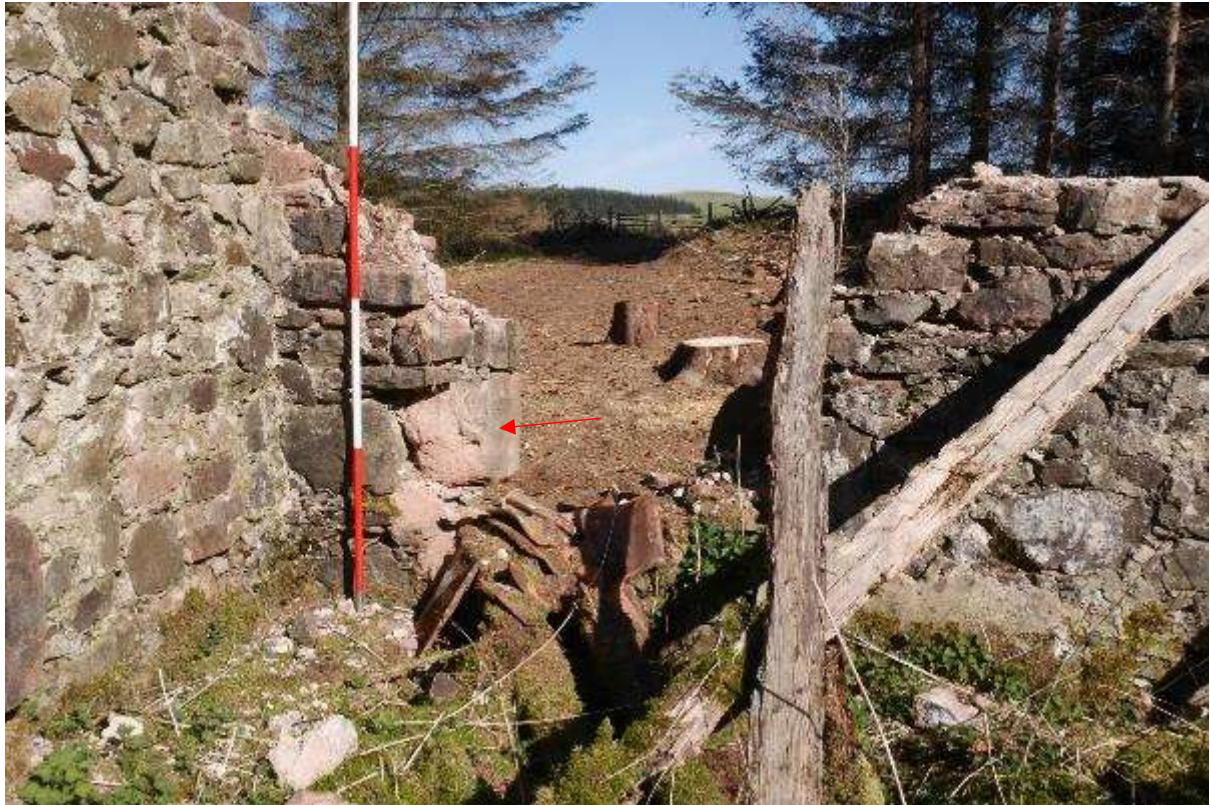
Illustration 34- Window at Western end of internal Southern elevation of Room A, red arrow shows other side of reused architectural fragment (no 8), collapsed ceramic roof tiles also visible.

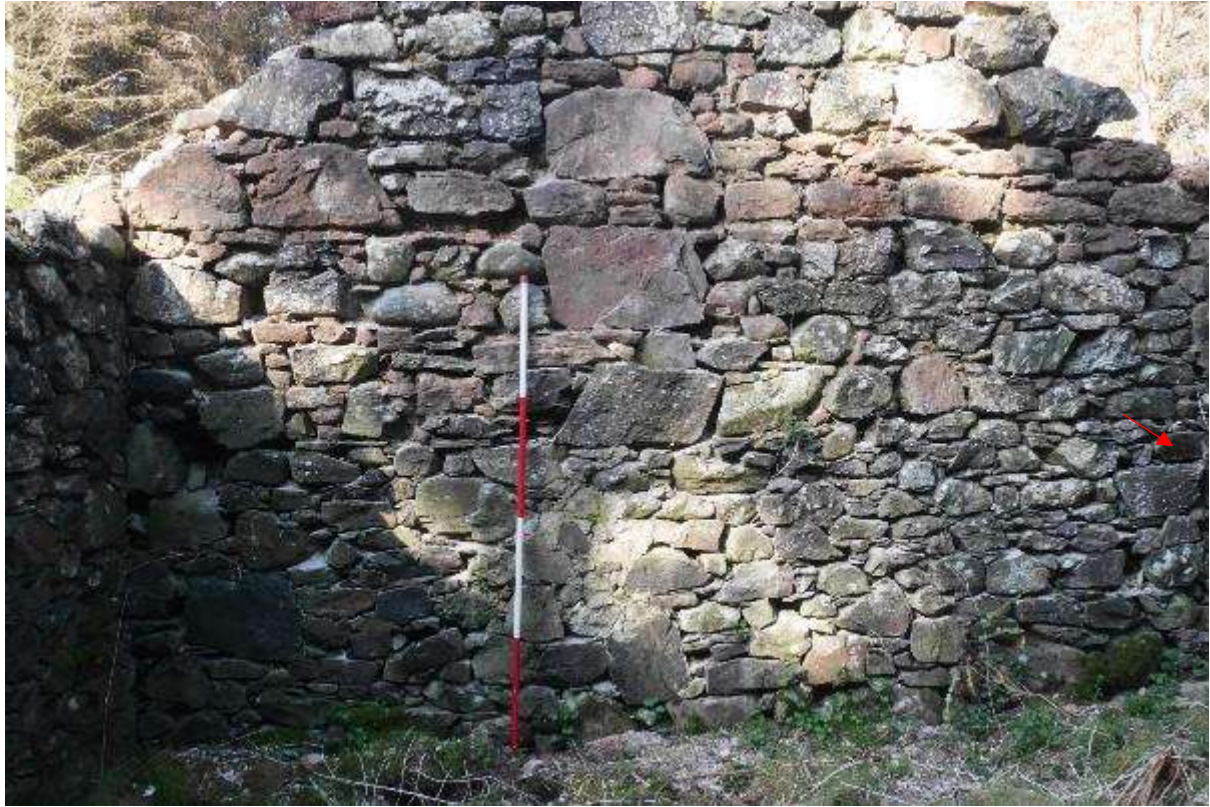
This is built of lime mortared rubble and a vertical line of flat stones defining the chimney for the fire in Room A is visible. A single stone on the Northern side of those slabs has incised lines on its surface which may be from the sharpening of a metal object (Illus 39 and 40).

Illustration 39- Western internal elevation of Room B showing flat stones marking line of chimney for fireplace in Room A, red arrow indicates stone with incised lines from sharpening of metal object (no 9).

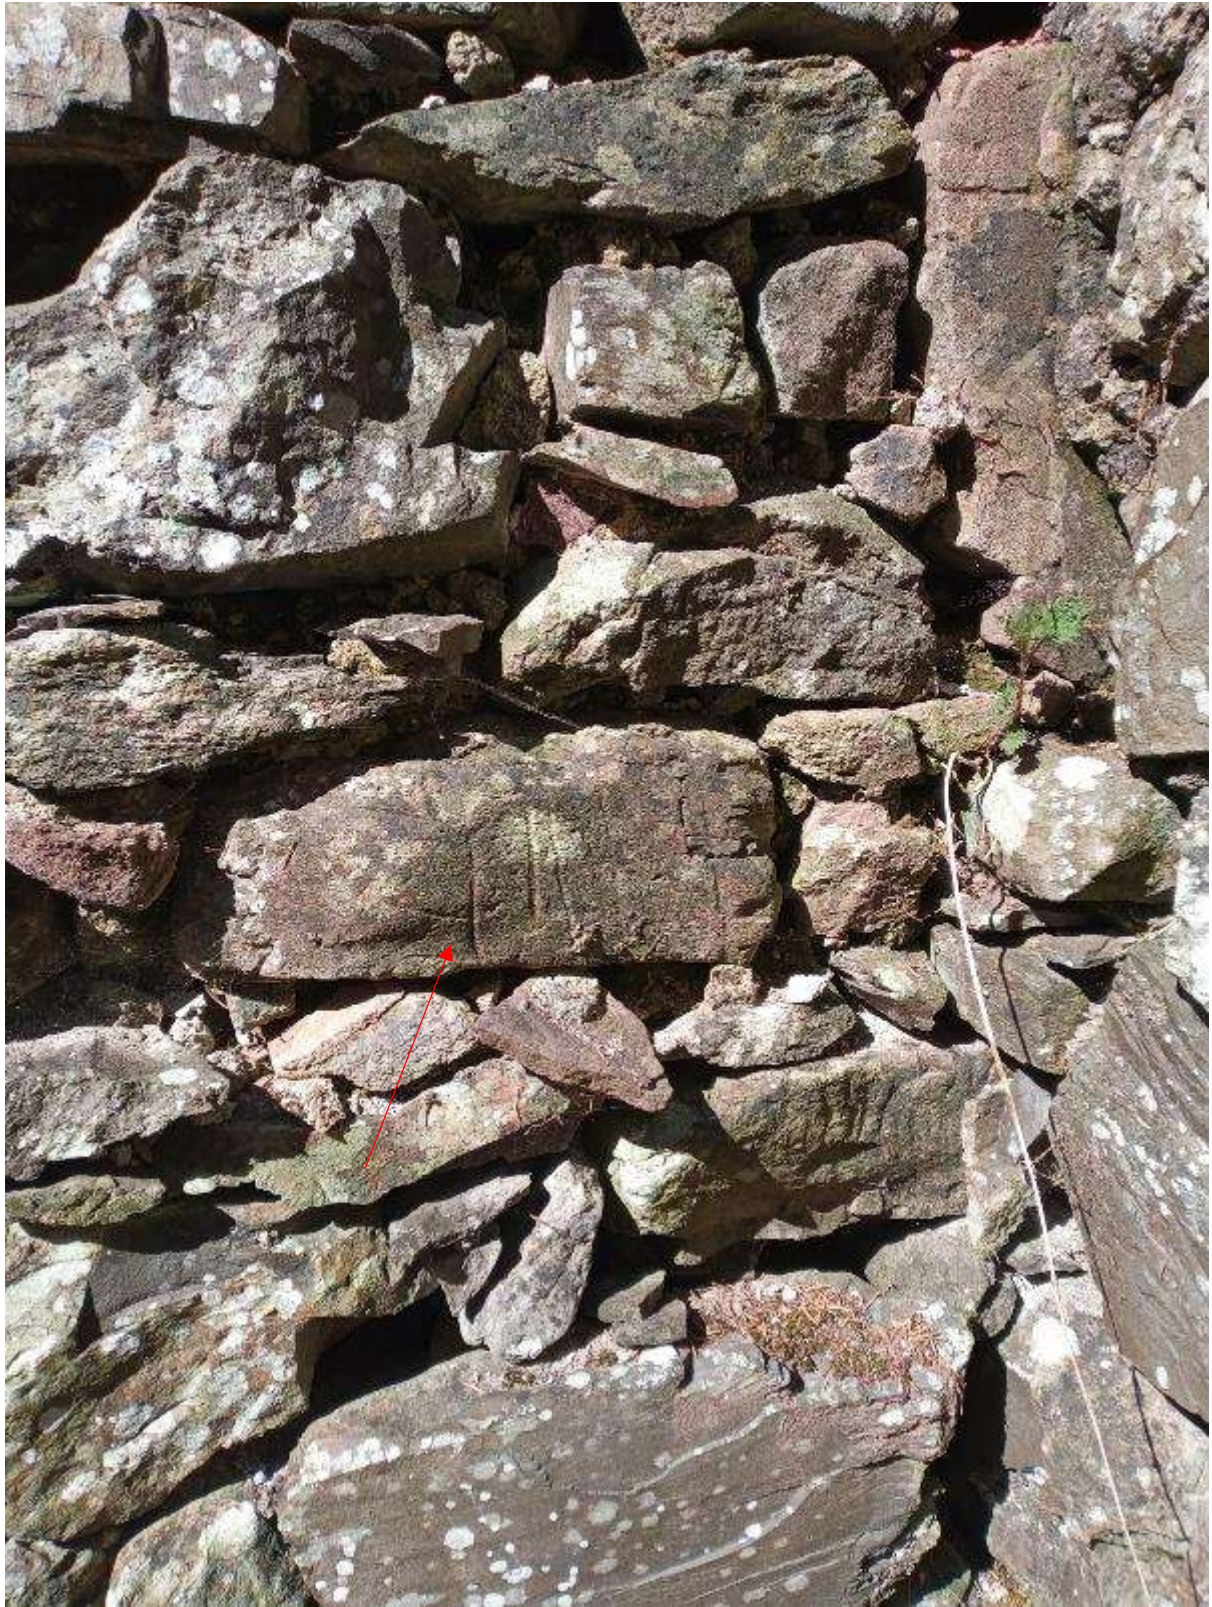
9. Internal Western elevation of Room B – stone in wall face with incised sharpening marks measuring 0.20m by 0.10m (Illus 39 and 40).

Illustration 40- Detail view of piece of mica schist with incised lines from sharpening of metal object (no 9) in internal Western elevation of Room B.
