**POST-EXCAVATION ASSESSMENT AND
UPDATED PROJECT DESIGN:
MOAT FARM
PITSTONE
BUCKINGHAMSHIRE**

NATIONAL MONUMENT I/D: 32121

April 2009

ASC: 1114/PMF/2

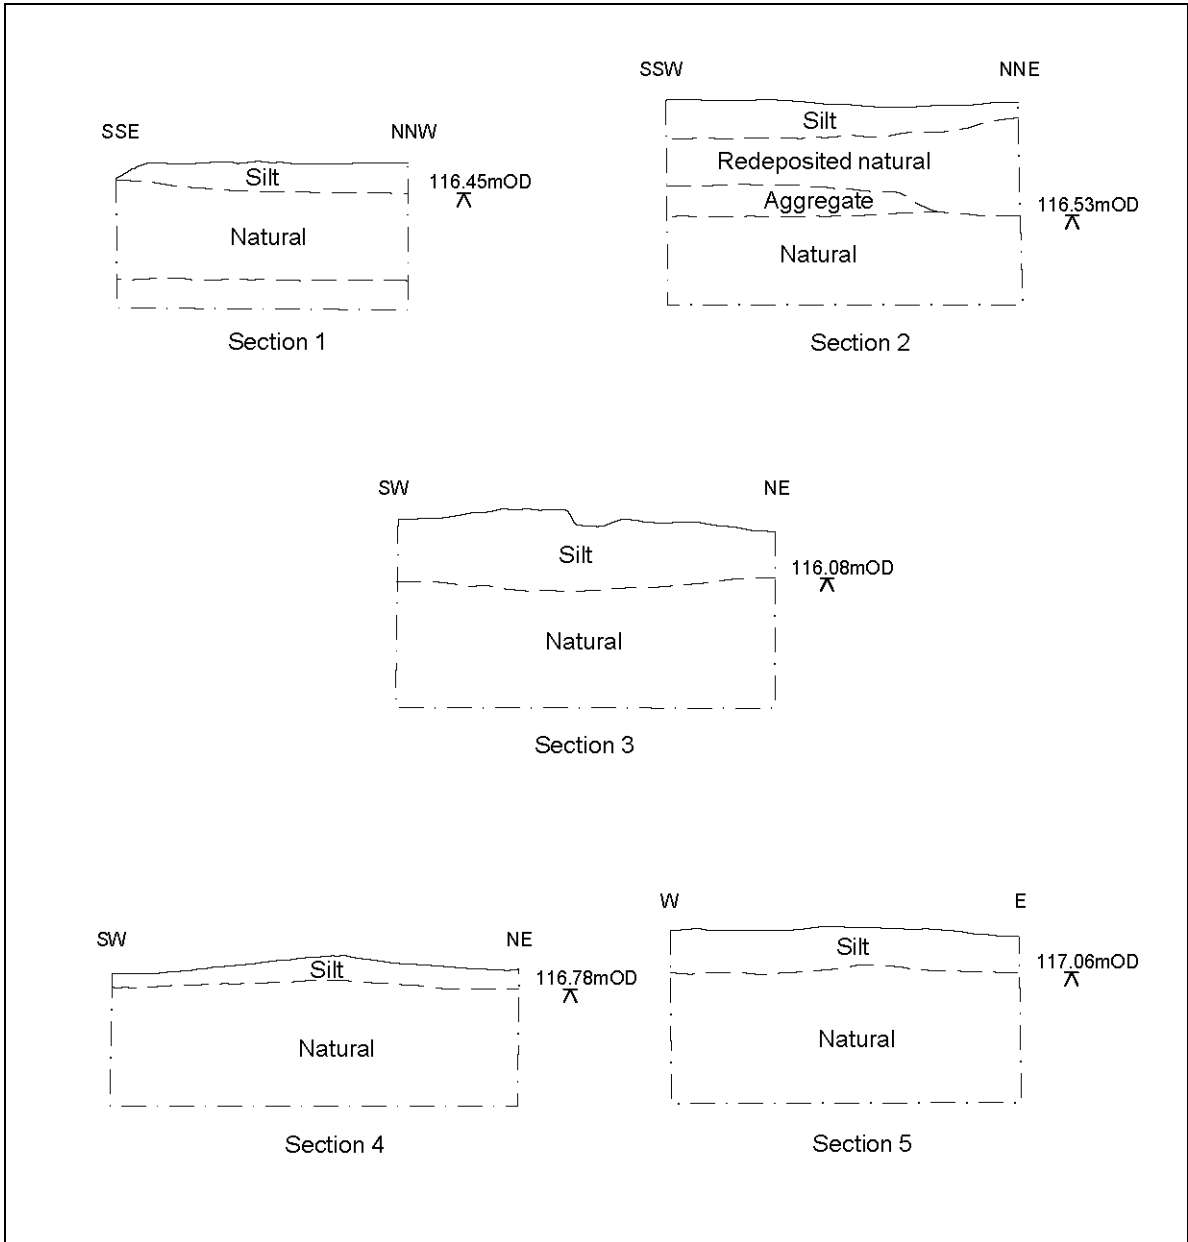
Figure 4: Trench sections (scale 1:20)

A footing trench for a proposed retaining wall has been excavated around the inside of the moat, running from the bridge in a clockwise direction. It is c.96m in length, 0.45m wide and cut the base of the moat by up to 0.48m. A 5% sample of the excavated trench section was recorded to provide an understanding of the stratigraphy of the moat and its base (Fig. 3). The results indicate that the base of moat rises 0.6m between sections 1 and 5, though there appears to be a dip of approximately 0.5m in the vicinity of Section 3 (Fig 4). The stratigraphy consisted of green-grey silty clay deposit, up to 0.4m in thickness, overlying the natural chalk base. A layer of flint and redeposited natural were noted in Section 2.

The levels taken from the recorded sections of the excavated footing trench show the base of moat rising by at least 0.5m between Section 2, at the outlet, and Section 5, at the end of the excavated trench, 66m closer to the inlet. This is probably an indication that the base of the moat follows the natural topography of Cowhill Spring. The dip in the base around Section 3 may be a natural hollow in the geology or possibly the result of erosion.

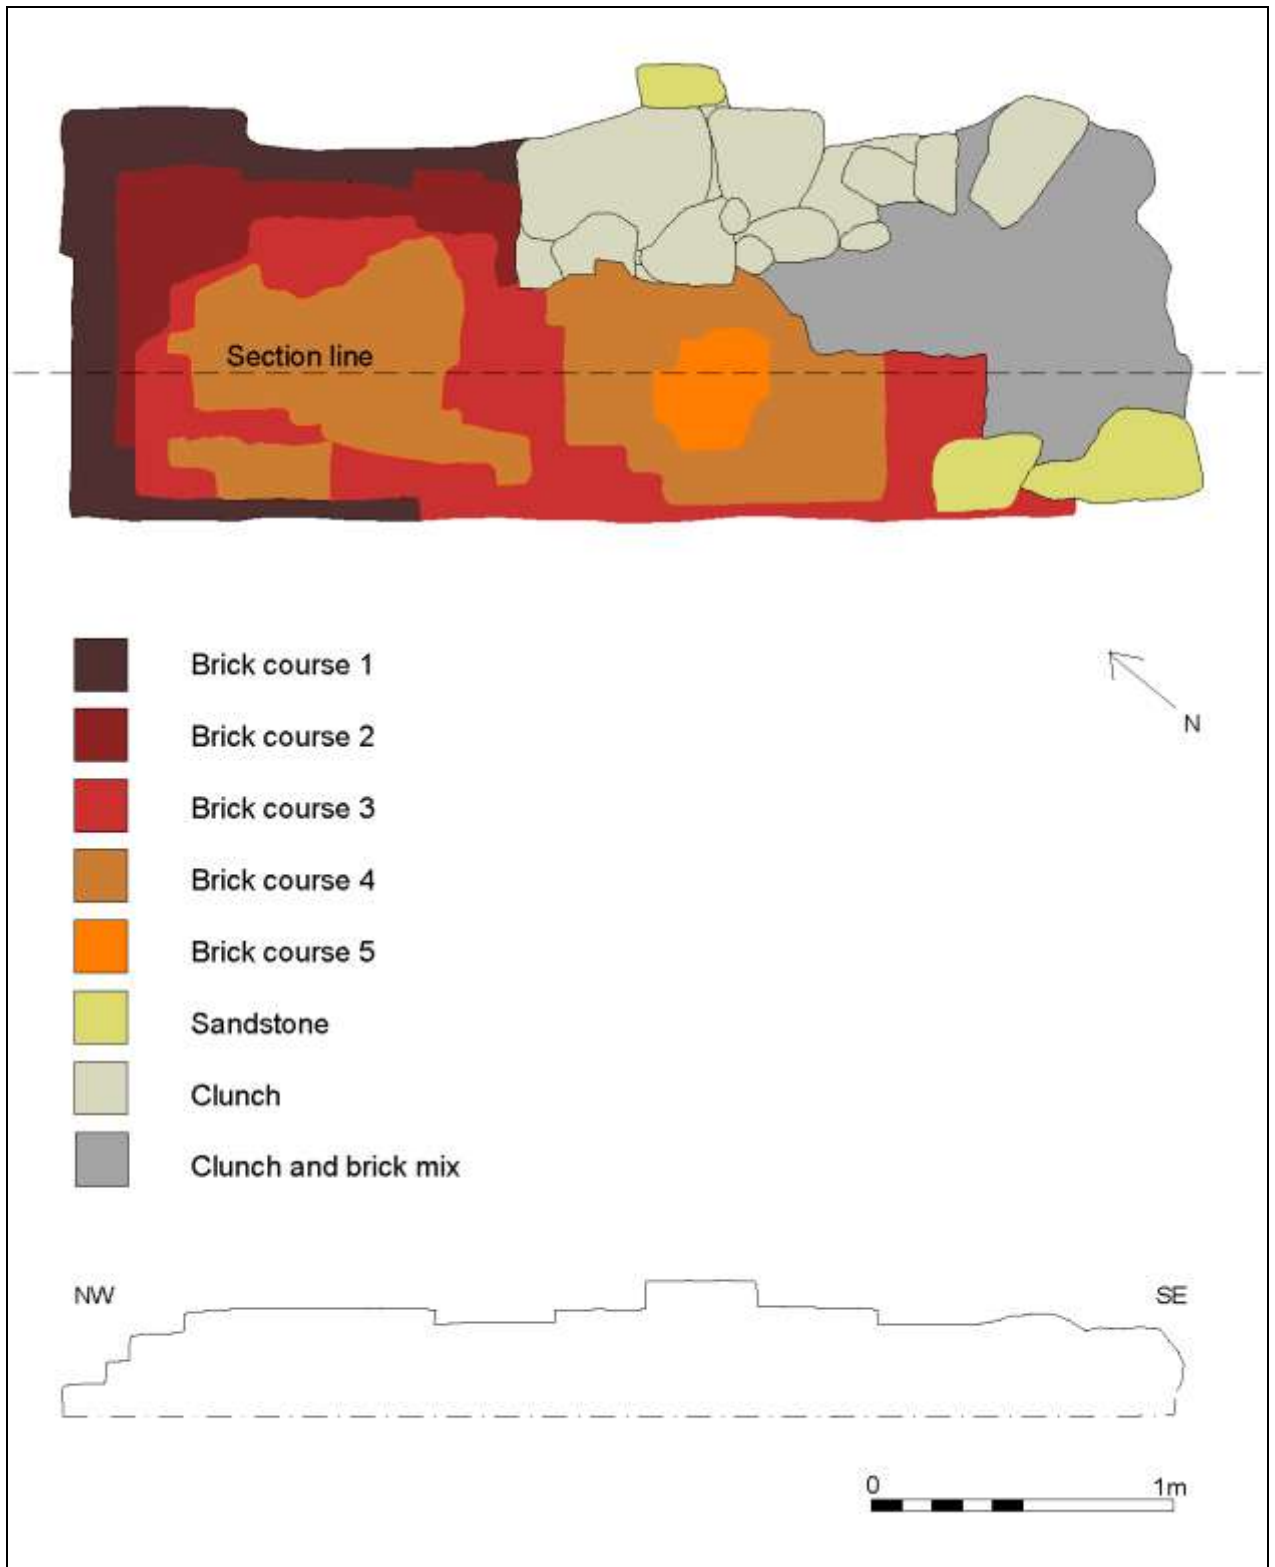
Figure 5: Plan and section of dam (scale 1:25)

The condition of the structure itself was variable. The portion to the west of the sluice was not excavated in any way, but it was noted that it was over 2m high at the bank, though the original height cannot be ascertained as some of the upper brickwork had been demolished (Plate 3). A small culvert running through the base, close to the bank, had been bricked-up on both sides (Plates 4 & 5). Some Totternhoe clunch and sandstone was also noted amongst the brickwork at the base of the structure (Fig. 5, Plates 6 & 7)

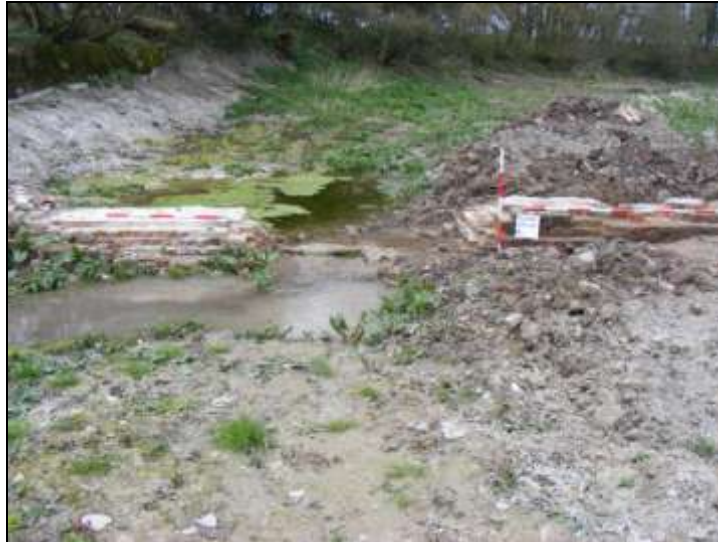
Plate 1: Footings of former dam, facing north

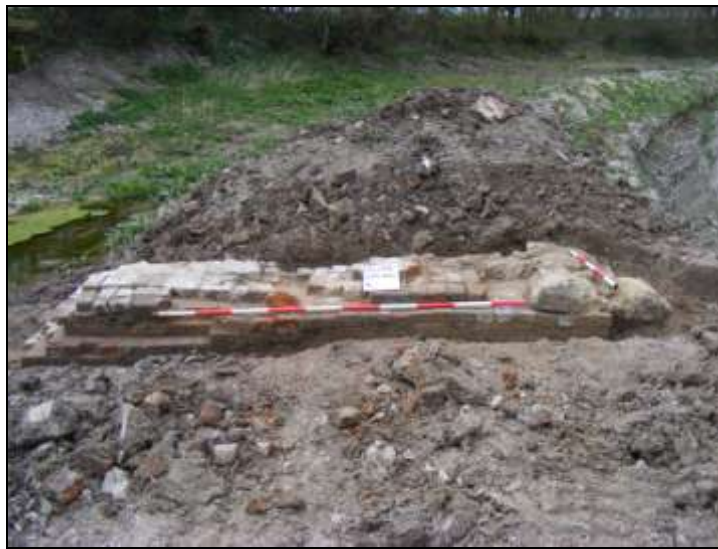
Some of the spoil from the footing trench excavation had been deposited over a portion of what appears to be the remnants of a brick-built dam, with a provision for a sluice gate, spanning the moat on the western side (Plate 1). Most of this material was removed with an excavator, after which the surface of the structure was cleaned by hand. The surrounding silt layer was also removed from a 0.4m wide slot along both main faces of the brickwork (Plate 2).

Plate 2: Eastern section of dam, facing north

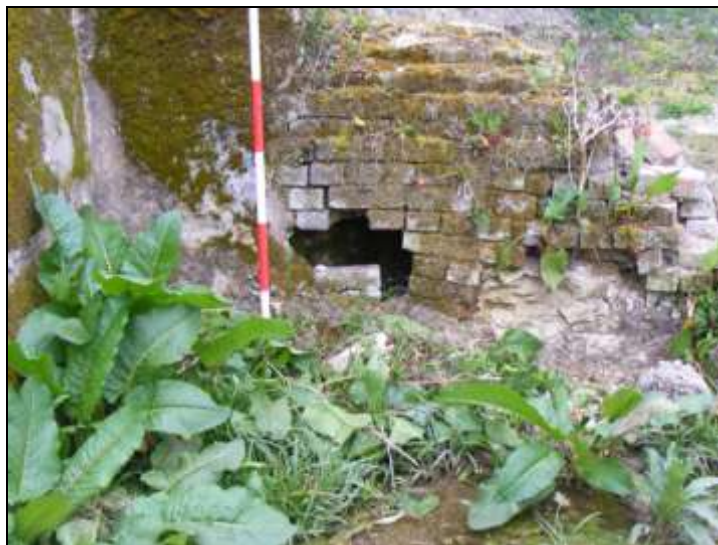
Plate 6: Clunch to the east of culvert, facing north

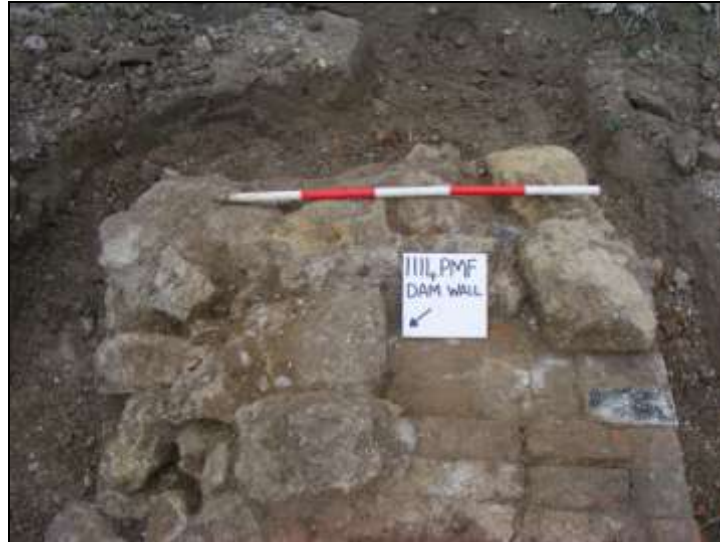
Plate 7: Clunch and sandstone in eastern dam footing, facing northeast

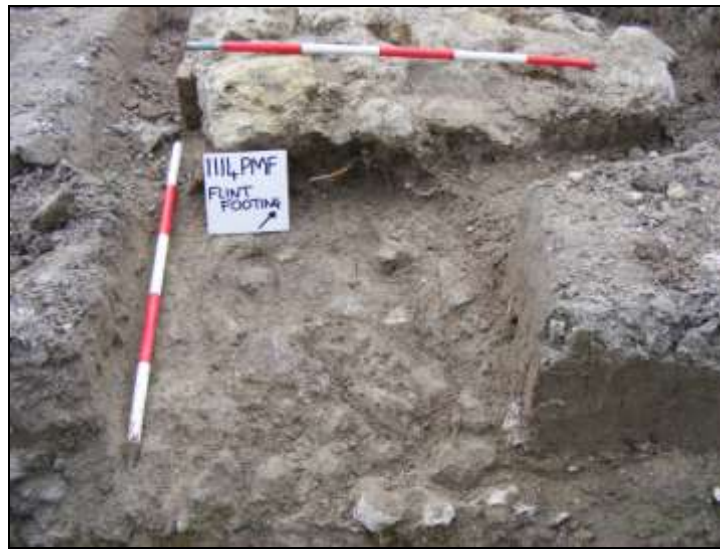
The remainder to the east of the sluice was little more than a footing, six courses high at its maximum. The bricks were principally hand-made and very lightly frogged, bonded with a strong lime mortar. Large blocks of Totternhoe clunch underlying the brickwork were exposed. Beneath this was a layer of flint field stones approximately 2m wide, extending from the island bank into the moat c.3.5m (Plate 8, 9 & 10).

Plate 8: Flint layer, facing northwest

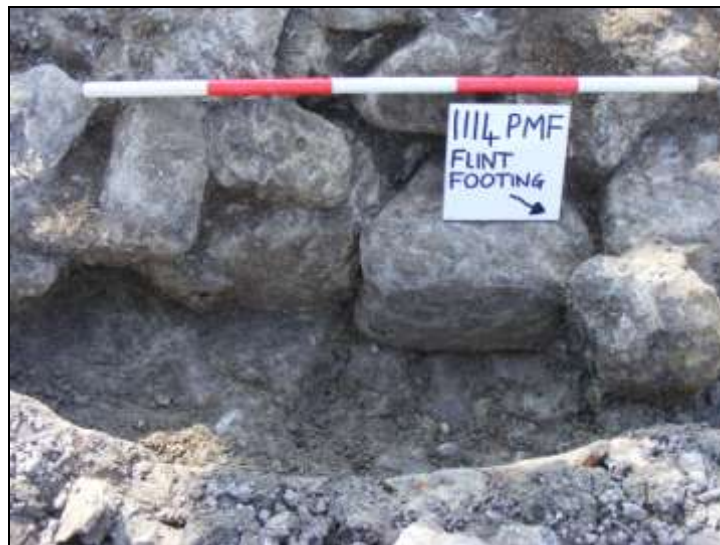
Plate 9: Clunch blocks, facing southwest

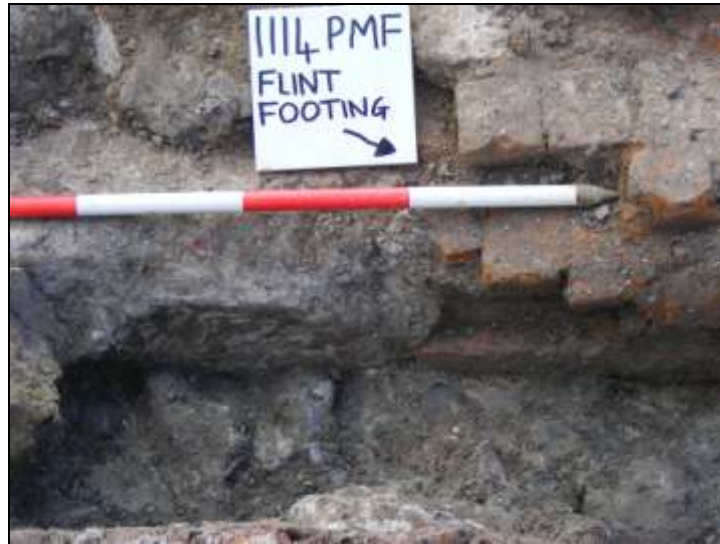
Plate 10: Clunch block, brickwork and flint layer

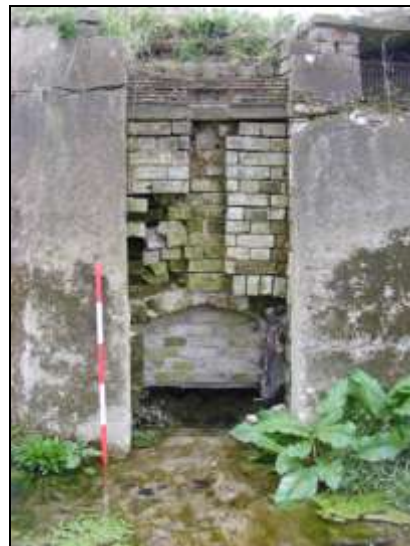
The outlet to the moat and associated sluice are located on the western bank, close to the dam (Plate 11). There is a concrete, brick and render retaining wall approximately 50m in length running from the bridge, clockwise round the moat (Plate 12). The bridge itself is a double span, brick-built structure. The northeastern arch shows evidence of having been bricked-up on both sides (Plate 13), while the southwestern arch has been blocked only on the southern side and a sluice gate installed (Plate 14).

Plate 11: Outlet sluice, facing west

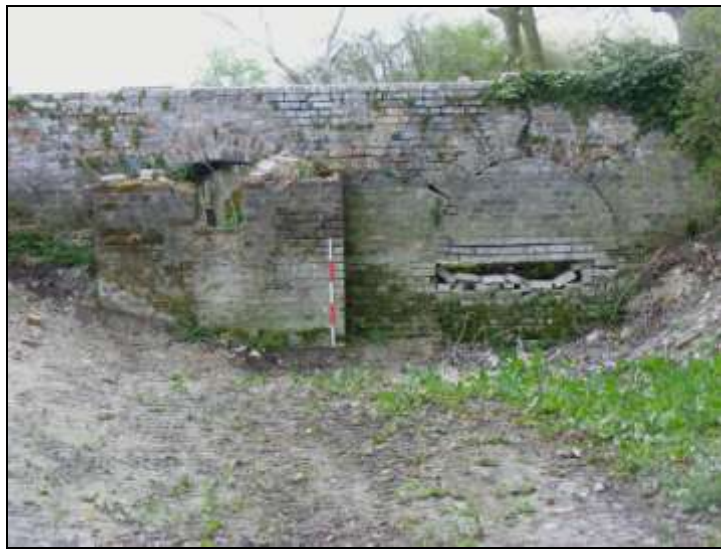
Plate 14: Southeast side of bridge, facing northwest

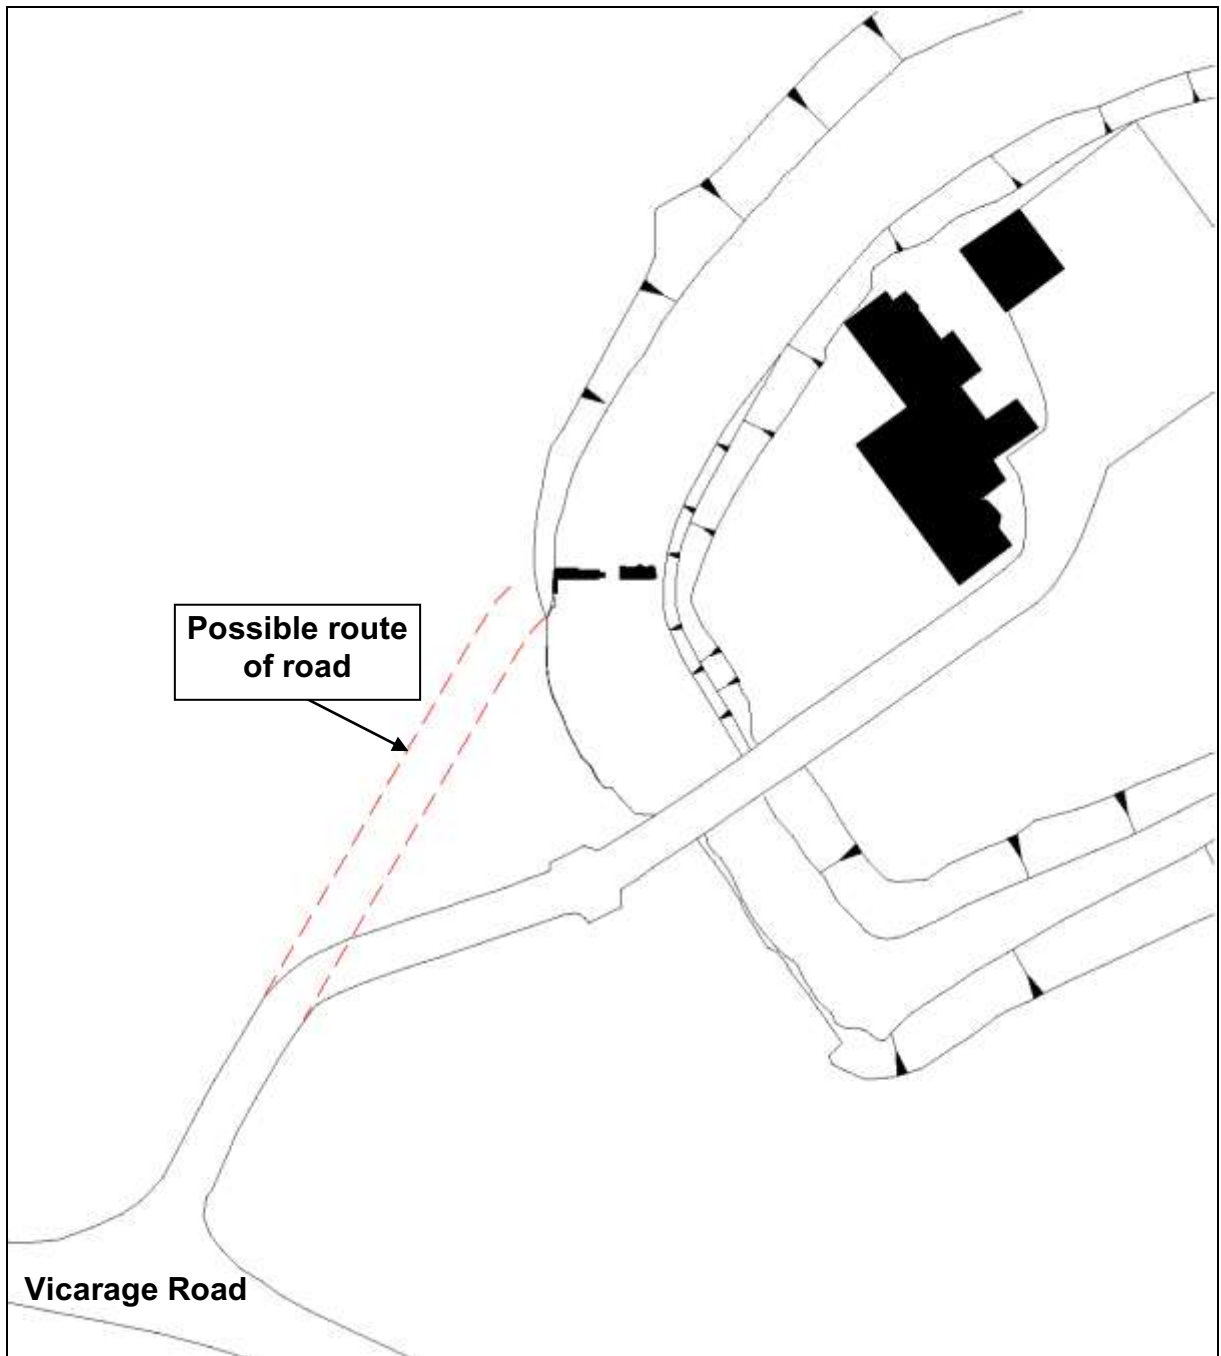
Figure 6: Possible location of earlier road

- 5.1 The structures in the southwest quadrant of the moat appear to be contemporary or near contemporary. The bridge is probably 19th century and may be a replacement for an earlier structure that stood where the remnants of the dam are now situated. The clunch blocks and flint layer revealed during excavation may have formed part of the original footing. The clunch is only visible in two discrete areas at the edges of the dam, suggesting that if it is associated with an earlier bridge then that structure was probably single span. Supporting evidence for the presence of a bridge at this location can be seen in the line of the existing road. Once on the site from Vicarage Road it turns sharply eastwards to form the driveway across the bridge towards the house. However, if the road once continued in a straight line it would reach the edge of the moat where the former bridge might once have stood (Fig. 6).

- 6.1 The archaeological works carried out at Moat Farm revealed the possible existence of an earlier, stone-built bridge at the location of the dam remains. Should the opportunity present itself, it would be of value to pursue this investigation further. The footings of the western portion of the structure could be excavated and recorded in a similar way to that of the eastern side, and an assessment of any subsequent features made. The possible existence of an approach road could be investigated in a similar fashion.

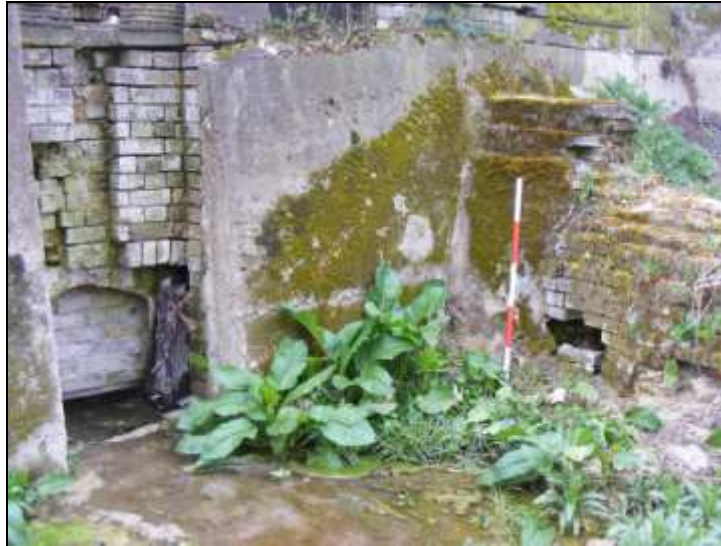
The brick, concrete and render wall on the southwest side of the moat appears to be contemporary with the dam, with the render covering part of both (Plate 15). The current sluice and outlet are probably built into this wall, though the extensive nature of the rendering makes an assessment of the exact relationship impossible. It may be that the two structures were built at different times and subsequently rendered together.

Plate 15: Rendered retaining wall, facing northwest

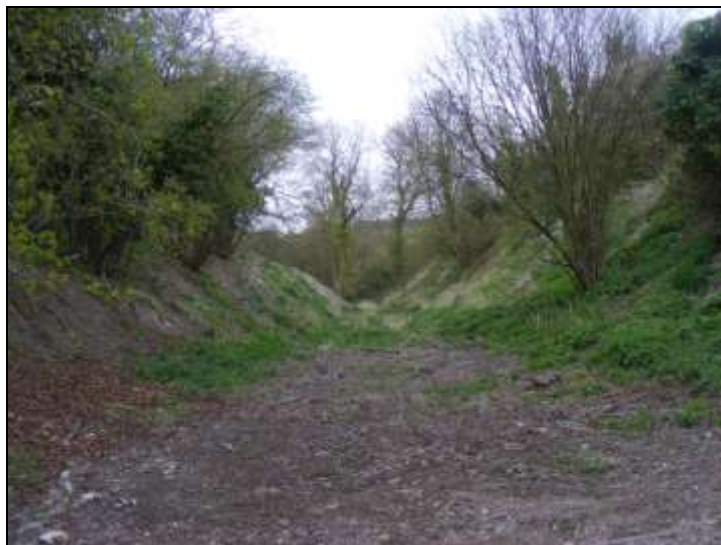
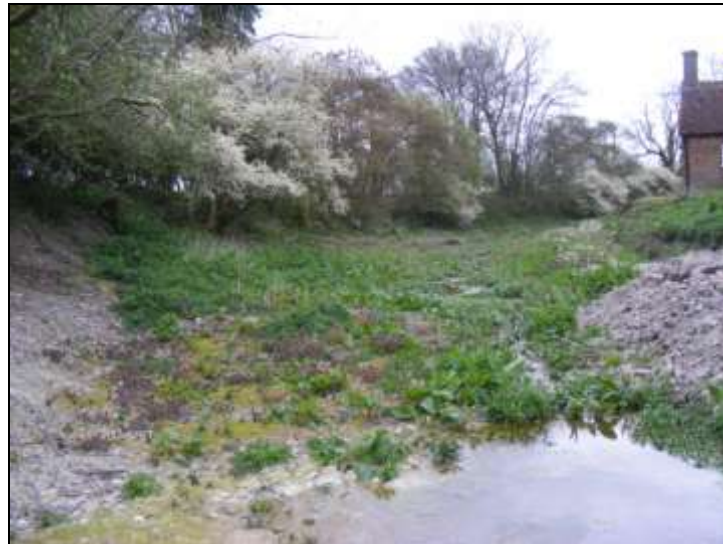
The extent of the erosion can best be seen by comparing the profile of the straight arm with that of the curved (Plates 17 & 18). This erosion may have been sufficient to fatally undermine the old bridge. The concrete and render wall appears to have been constructed in an effort to prevent further deterioration in the most heavily damaged area, and the dam with its sluice was designed to control the volume and direction of water reaching the outlet.

Plate 17: Profile of the moat's straight arm, facing northeast

Plate 18: Profile of the moat's curved arm, facing north-northeast

There is a possibility that the flow of water within the moat is eroding both sides of the cut on the curved section of the 'D'. It would be of significant value to monitor the rate of degradation of this feature, and assess whether the process is ongoing and what risk it poses to the extant buildings.
