Walkover Survey  
Along The Bannock Burn  
Near Muirpark Farm  
Stirling  
ST22

**ARCHAEOLOGICAL WALKOVER  
SURVEY ALONG THE BANNOCK BURN  
NEAR MUIRPARK FARM  
STIRLING**

**ST22**

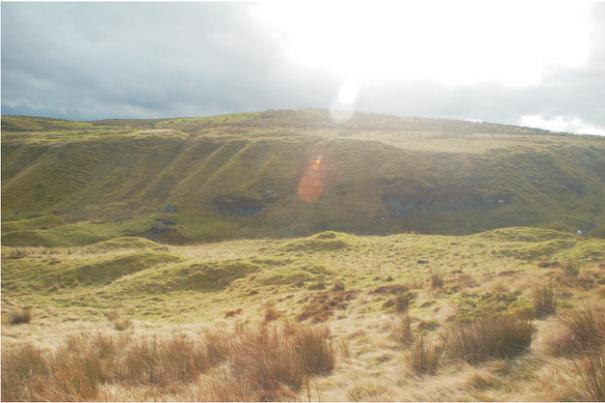
Sites 13, 14, 15, 16, 17

14	A turf covered roughly horse-shoe shaped bank with an entrance to NE. Material of bank is unknown as no stones visible. Overall the structure is roughly circular in plan (c 5m x 6m) with banks rising c 0.3m measured from internal depression. To the NE of the entrance, the banks partly project around a roughly flat oval area (3m x 4m). Interpretation: lime kiln/clamp with working area. NGS: NS 74444 87695	Yes
15	A turf covered horse-shoe shaped bank with entrance to NE. Composed of stones and boulders. Overall the structure is circular in plan (c 6m in diameter) with banks rising c 1m measured outside (SW side). There are many stones visible in the central depression. To the NE of the entrance is a roughly flat oval area (3m x 4m) partly cut into the hillside and partly formed by a projection in the SE bank. Interpretation: lime kiln/clamp with working area. NGS: NS 74434 87694	Yes
16	A turf covered roughly horse-shoe shaped bank with an entrance to SE. Composed of stones and boulders. Overall the structure is roughly oval in plan (c 7m x 6m) with banks rising c 0.7m measured from outside (up slope). There are many stones visible in the central depression and several are highly vitrified. To the NE of the entrance, the banks partly project around a roughly flat oval area (5m x 3m). Interpretation: lime kiln/clamp with working area. NGS: NS 74436 87679	Yes

17	A small turf covered horse-shoe shaped bank with entrance to E. Seems to be composed of stones. Overall the structure is circular in plan (c 5m in diameter) with banks rising c 2m measured outside (down slope). There are many stones visible in and around the entrance. To the E of the entrance is a roughly flat rectangular area (3.5m x 4.5m diameter) partly cut into the hillside and partly formed by a projection in the S bank. Interpretation: lime kiln/clamp with working area. NGS: NS 74416 87687	Yes
18	A very subtle turf covered horse-shoe shaped bank with entrance to N. Seems to be composed of stones and boulders. Overall the structure is oval in plan (c 5m x 6m) with banks rising c 0.6m measured from central depression. There are few stones visible sticking out of the bank. To the NE of the entrance is a roughly flat area. Interpretation: lime kiln/clamp with working area. NGS: NS 74335 87709	Yes

Kiln remains (including working areas) should be avoided when tree planting, erecting fences or when driving vehicles across the two areas. We recommend using a handheld GPS to avoid the sites. A safer level of mitigation would be to tape off the sites prior to tree planting.

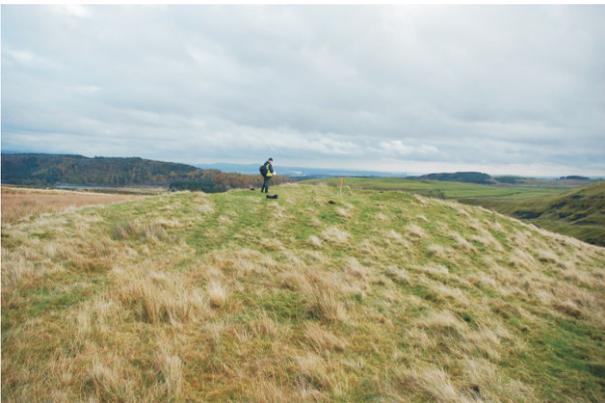
Site 23

23	Structure comprises a semicircular low earth bank (c 0.4m high) enclosing a flattish area with a wide gap or entrance to the W. There is also small depression or gap to the SE which might be an entrance. Overall the structure measures 6m by 8m. The structure sits on a prominent knoll with good views in all directions. Interpretation: Possibly the damaged remains of a small prehistoric roundhouse or later medieval / post-medieval building or more simple enclosure. NGS: NS 74523 87764	No
24	A turf covered horse-shoe shaped bank with entrance to E. Composed of stones. Overall the structure is circular in plan (c 6m in diameter) with banks rising c 1-1.2m measured from central depression and outside (up slope). Interpretation: lime kiln/clamp with working area. NGS: NS 74859 87657	No
25	A turf covered horse-shoe shaped bank with entrance to E. The S bank has partly tumbled down the slope towards the burn. Composed of stones. Overall the structure is oval in plan (c 6m x 5m) with banks rising c 1m measured from outside (up slope). There are many stones visible where the S bank has tumbled. Interpretation: lime kiln/clamp with working area. NGS: NS 74913 87645	No

Care should also be taken to avoid driving over the 4 sites outside the main tree planting areas when erecting fencing, particularly site 23, which may be early in date.

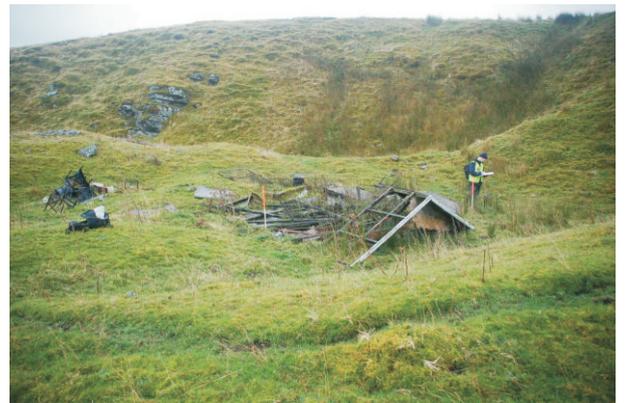
Site 08

08	The remains of a building measuring c 3.5m x 4m Plywood and thin planks used in construction. Remains of a bed and several chairs noted close by. Interpretation: 20 <sup>th</sup> century building, unknown function. NGS: NS 74374 87631	Yes
09	A large turf covered horse-shoe shaped bank with entrance to E. Composed of stones and boulders. Overall the structure is roughly circular in plan (c 7m by 8m) with banks rising c 1m measured from central depression, but bank much higher if measured from the N. Many stones and boulders noted in central depression and outside entrance. Interpretation: lime kiln/clamp. NGS: NS 74532 87679	Yes
10	A turf covered horse-shoe shaped bank with entrance to N. Seems to be composed of angular stones. Overall the structure is circular in plan (c 6.5m in diameter) with banks rising c 0.5m measured from central depression. Few stones visible on bank but there are many stones in the central depression and outside the entrance. Interpretation: lime kiln/clamp. NGS: NS 74564 87654	Yes
