M25 JUNCTIONS 7 TO 8, WIDENING TO D4M:

Archaeological Monitoring at Markedge Lane, Reigate

August 1995

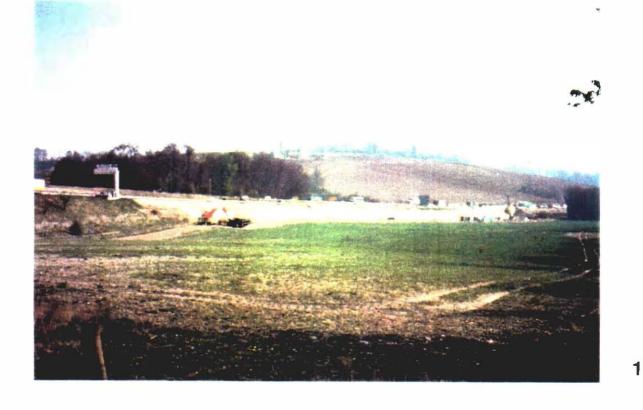
- 1.1 RPS Clouston were commissioned by Parkman in March 1994 to undertake a watching brief of the construction of the retaining wall at Markedge Lane (photograph 1).
- 1.2 Reference was made to the attached engineering contract drawings 10204/OB220/01,02.
- 1.3 The site was visited on the occasions listed below and the observations recorded.
- 1.4 The Environmental Statement, Volume II, Part 7, Cultural Heritage concludes in Section 4:

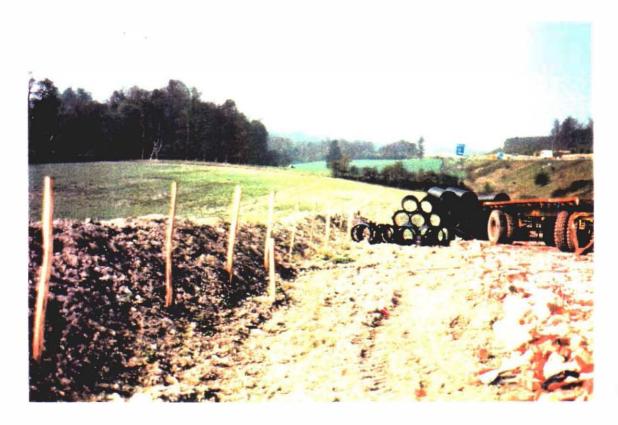
The area to the south-west of Markedge Lane had been partially stripped of topsoil and a temporary road covering covered with terram sheeting and brick rubble had been laid (photograph 2).

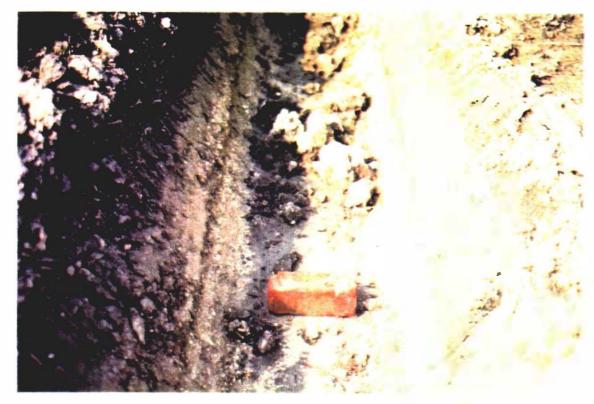
The sheeting obscured observation of the stripped area, but as part of the existing topsoil and the subsoil remained in situ, observation would not have been informative. Monitoring of the spoil heaps produced no surface finds. A small drainage ditch to guide surface water away from the workface via temporary underground plastic hoses was being constructed on the southern side of the stripped easement. A section

through this showed the continued existence of a partially truncated topsoil (photograph 3).

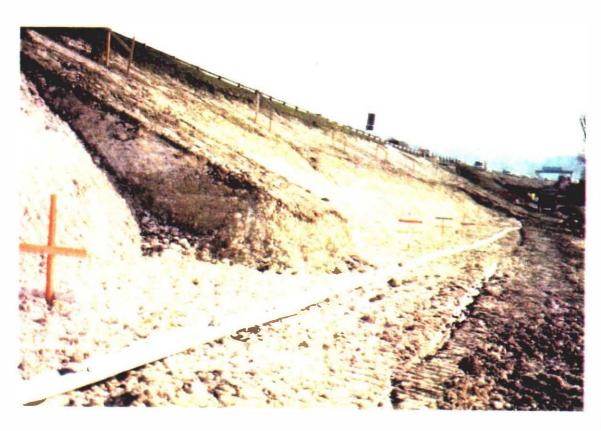
The purpose of this visit was to inspect the construction of footings for the retaining wall. It was observed that the material being cut back to receive these was the manmade bank (photograph 4) and that the line of the footings correspond to the area previously stripped during the initial construction phase (photographs 5, 6 and 7). This was confirmed by the inspection of the inner (southern) section of the cut where it could be seen that no top or sub-soil remained (photograph 8).

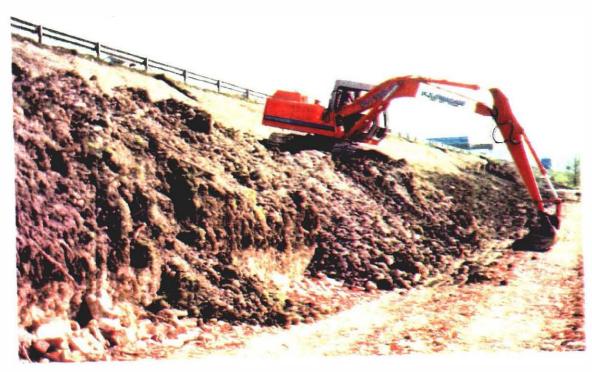
North-east of Markedge Lane the width of the easement was limited by established woodland. Topsoil had not been cleared on the southern side of the rubble road (photograph 9). Here again earthmoving operations were restricted to previously disturbed areas (photograph 10). At the north-eastern end of the works, beyond the woods, the area south of the rubble road had been disturbed during the earlier phase by the construction of a storm water lagoon.
