AYSCOUGHFEE HALL SPALDING, LINCOLNSHIRE

CONSERVATION PLAN SECOND DRAFT: JULY 2000

ANDERSON & GLENN, BOSTON (UK)

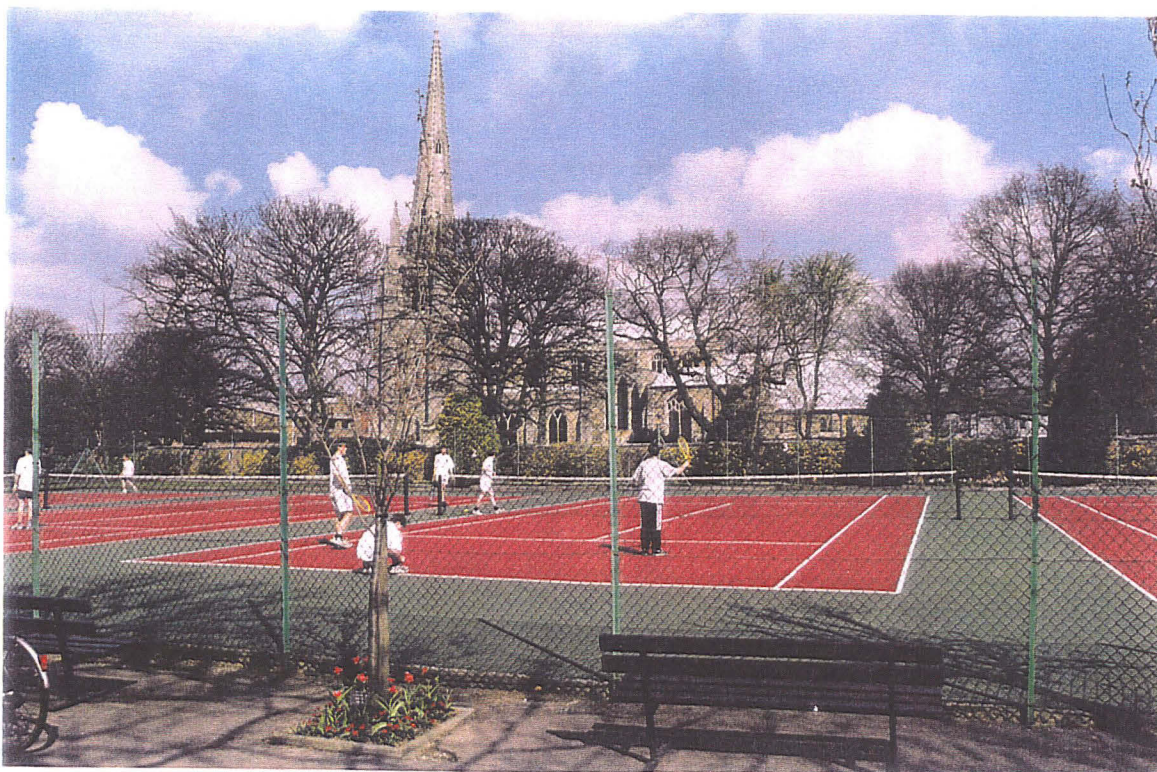
Plate 2 [Area F]
Bright red surfaces on the tennis courts intrude into views of the parish church.

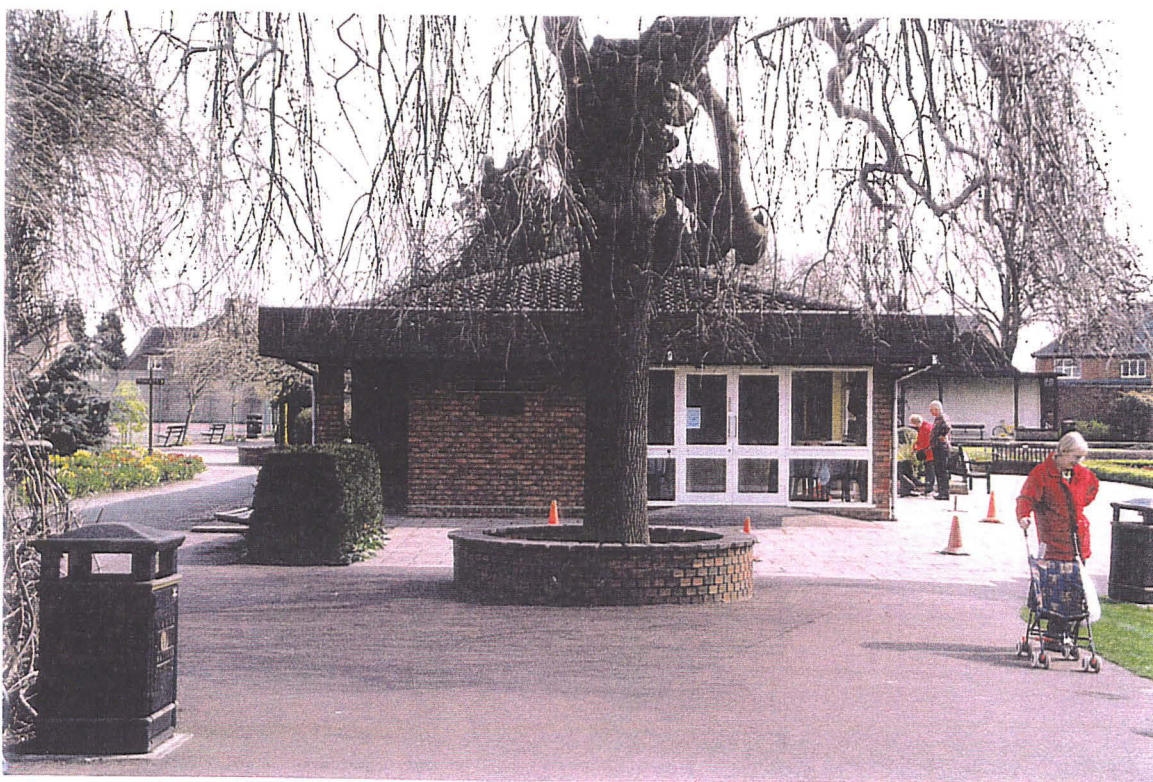
Plate 3 [area F]
The Pavilion with harsh surfacing and brick tree surrounds.

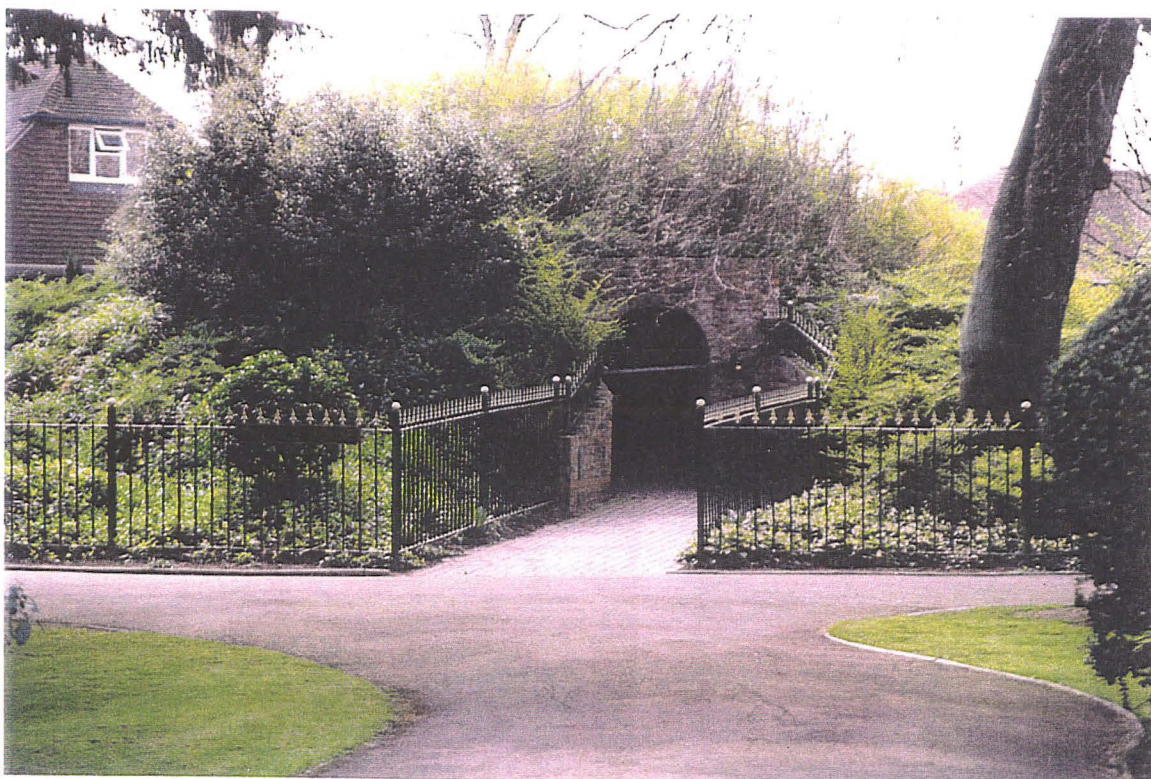
The unlisted late 18th century ice house, with thin modern railings surrounding it.

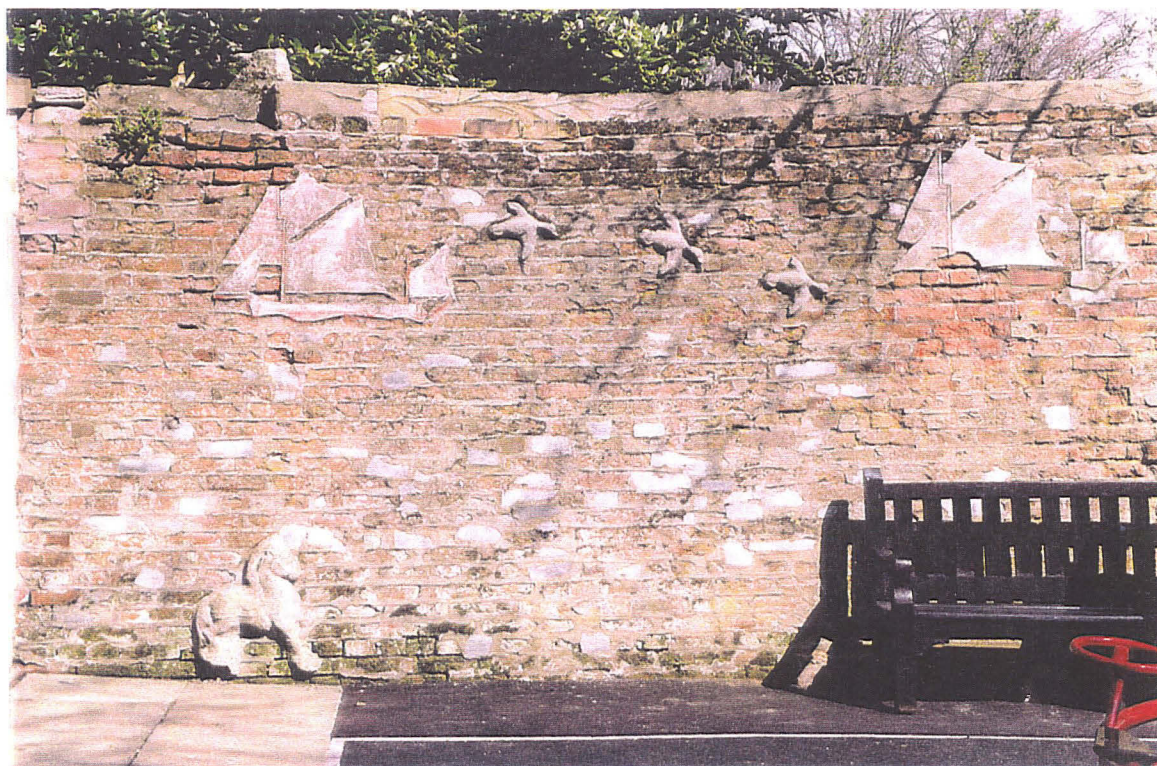
3.5.11 Other walls around the site are 19th or 20th century. Many areas have had cement based animal sculptures applied to them. Generally they have all been poorly repaired in harmful and unsightly hard cement mortars. *Plate 8*

Plate 8
Boundary wall with cement patching and animal sculptures.

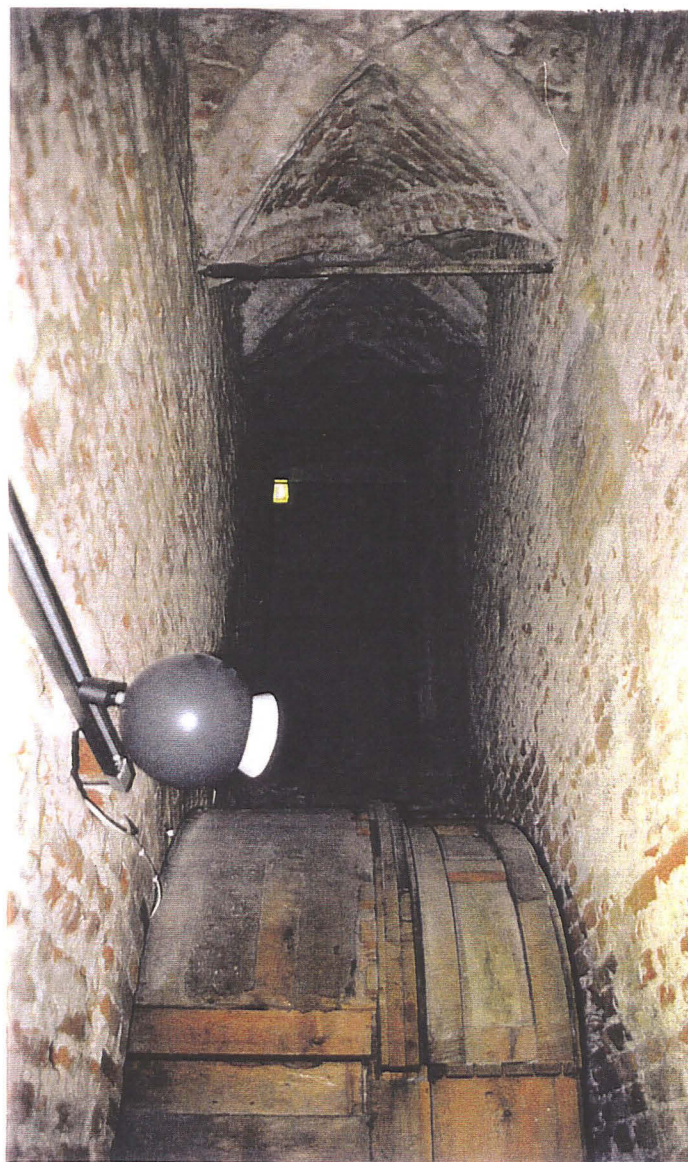
Plate 14
16th century staircase and brick
vault interrupted by early 19th
century yew bookcase to library.

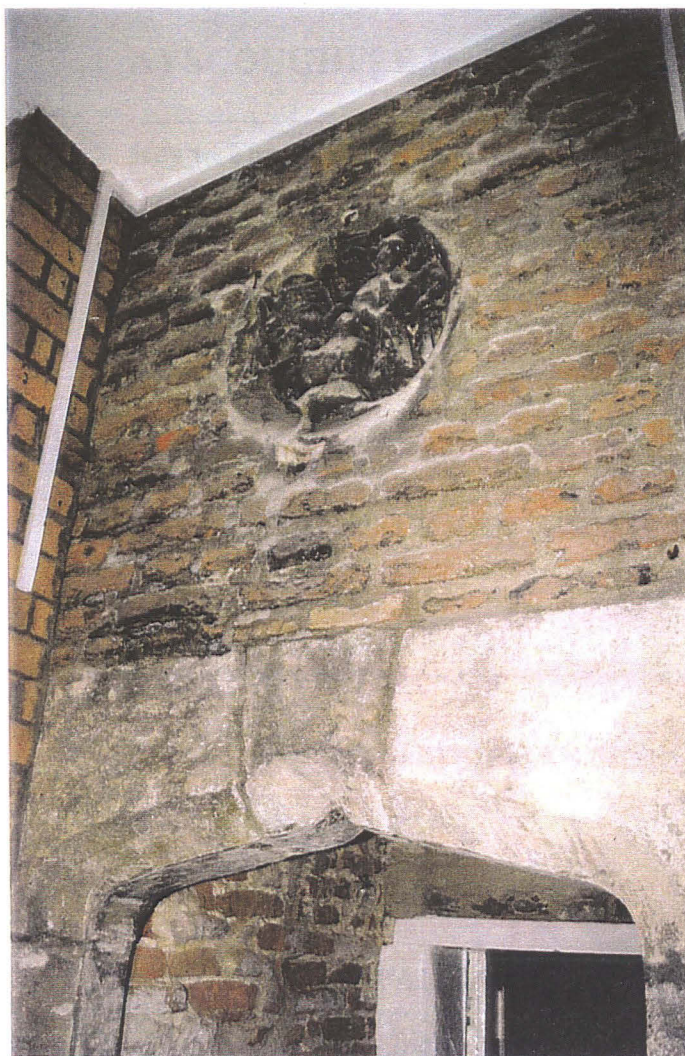
Plate 15
Roundel over Tudor
doorway, to south wing.
Note plastic trunking over.

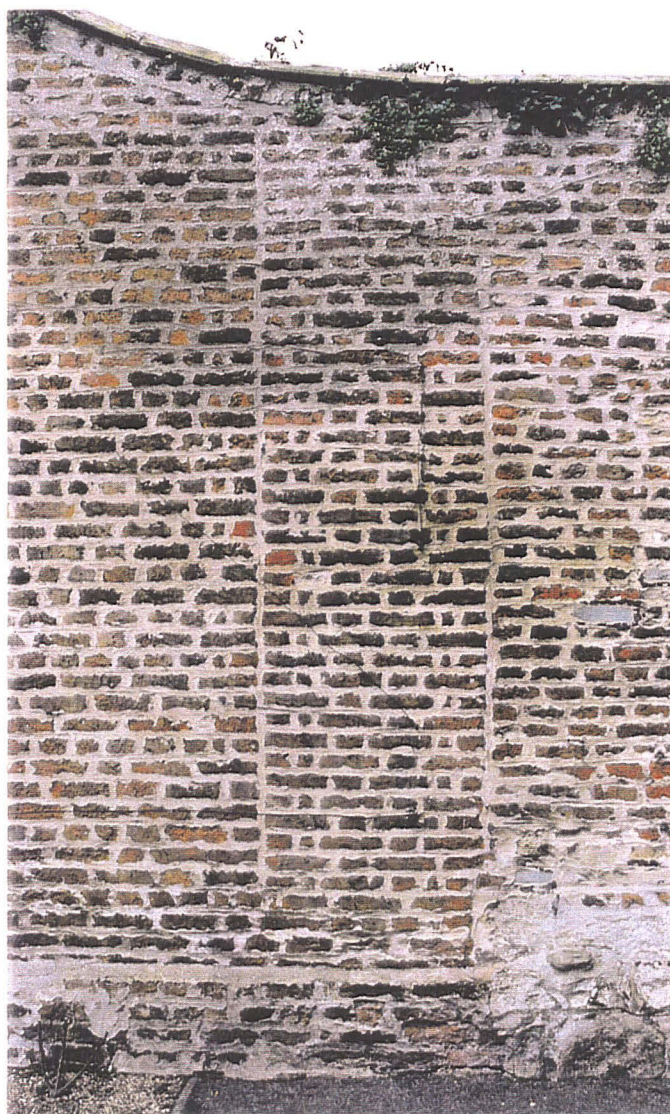
- 5.1.9 There has been an extensive use of dense cement pointing used throughout the building and also on the boundary walls. *Plate 16* This has caused untold damage to the early brickwork. Some of the worst areas are on the northern wing. Even as recently as the 1980s alterations, there are internal areas of exposed brickwork which have had cement mortar smeared over them in sensitive locations such as at the base of the narrow late medieval stairs adjacent to the library room.

Plate 16
Inappropriate dense cement
pointing to wall by Garden
room.
