LANGTOFT HALL FARM
ARCHAEOLOGICAL EVALUATION

June 1991

LINDSEY ARCHAEOLOGICAL SERVICES
FRANCIS HOUSE SILVER BIRCH PARK GREAT NORTHERN TERRACE LINCOLN LN5 8LG

LANGTOFT HALL, LANGTOFT **Archaeological Evaluation**

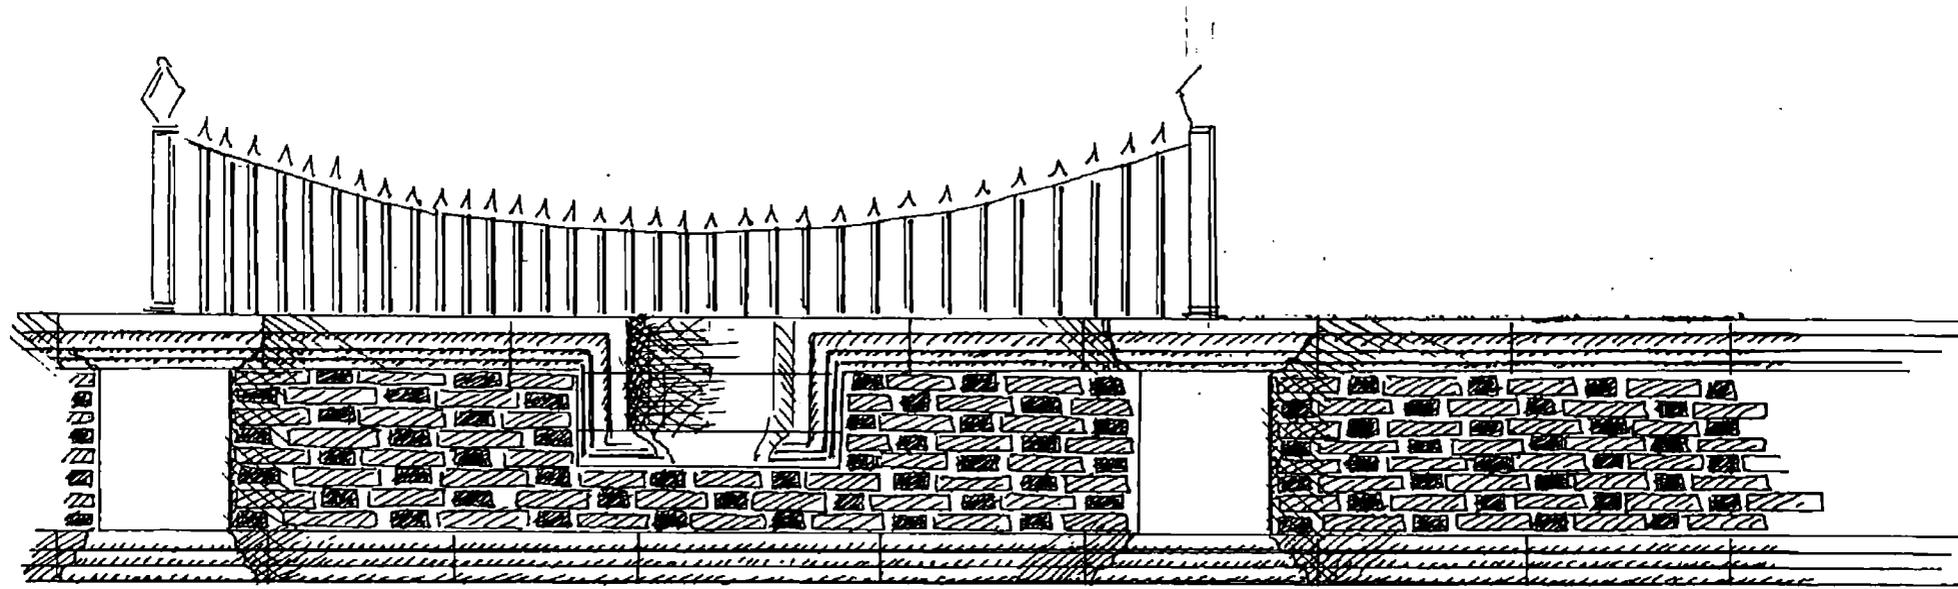
W3 continues south along the north-west boundary of the proposed development area (P30). This is a highly ornate brick wall with limestone decorative features on both faces standing to a height of 1m (to the top of the coping). The brickwork is a decorative Flemish bond with scorched headers forming a chequered pattern. The wall is built on a decorative limestone plinth and is capped with a limestone coping. The style of the moulding on these features is similar to that found on the gate pier fragments of W1.

There are rectangular limestone tablets 0.54m high and 0.42m wide on both faces of the wall (P31). Seven pairs existed along the wall, although one tablet on the external face is now missing (P30). Additionally, on the internal wall face there are two open-top limestone niches, 0.23m deep, built into the thickness of the wall and of unknown function (Ps 32-34).

The decorative limestone coping has diagonally opposed sockets, 40mm², and c. 12 cm from centre to centre (P35), for iron railings, or possibly a balustrade on top (see reconstruction in fig.5a). Some of the projecting copes have a large centre recess as if for a main stanchion. The two measured examples were c.70mm² (not diagonally opposed) and 3.04m from centre to centre. One recess contains an iron stump c. 18mm² and set in lead.

a) Suggested reconstruction of wall W3

1. The garden walls. It is strongly recommended that W7 and W3 should be retained and restored where necessary to form a unique feature of the development. The plainer walls W1, 2 and 5 are also valuable features and should be retained.

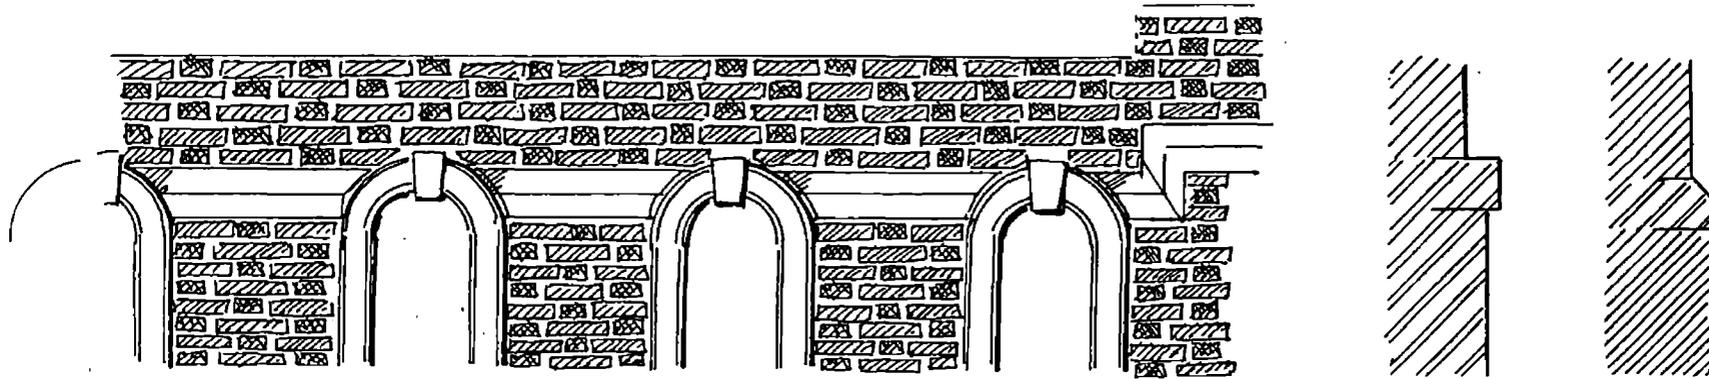
b

b) Reconstruction of wall W7

W7 continues the boundary of the orchard to the drain and the main road (P40). It is another remnant of the 17th century but it is not clear whether it is contemporary with the orchard walls W1 and W5. Much of it is in a poor state and has been replaced with a simple wooden fence (P40). The internal elevation, facing into the orchard, contains the remnants of fourteen projecting stone arches. Only three complete examples survive, numbers 10,11 and 12, counting north-west from the main road. The remains of the others can be found strewn in the undergrowth (P47). The arches have the same moulding as the re-used stone details in the farmhouse, B5, see above. Each of the surviving arches has a tapered projecting keystone (P46) and are linked by a chamfered stone plinth, shaped to fit the arches at half-springer height. The arch tops and the keystones project beyond the brick wall-face. It is uncertain whether these were originally through features as they have been blocked from the rear with reused brick. Projecting brickwork and limestone slabs on the rear (south-west) face may represent part survival and repair of features behind the arches or could simply be clumsy attempts to underpin collapsing portions of the wall (P48).

The wall survives to a maximum height of only fourteen courses of brickwork, some four courses above the complete arches. There is an interval of only three brick lengths between the arches. The small length of wall beyond arch 14 (P46, Right) extends for at least 5 brick lengths without interruption suggesting that arch 14 was the last and the wall may have ended or returned close to this point.

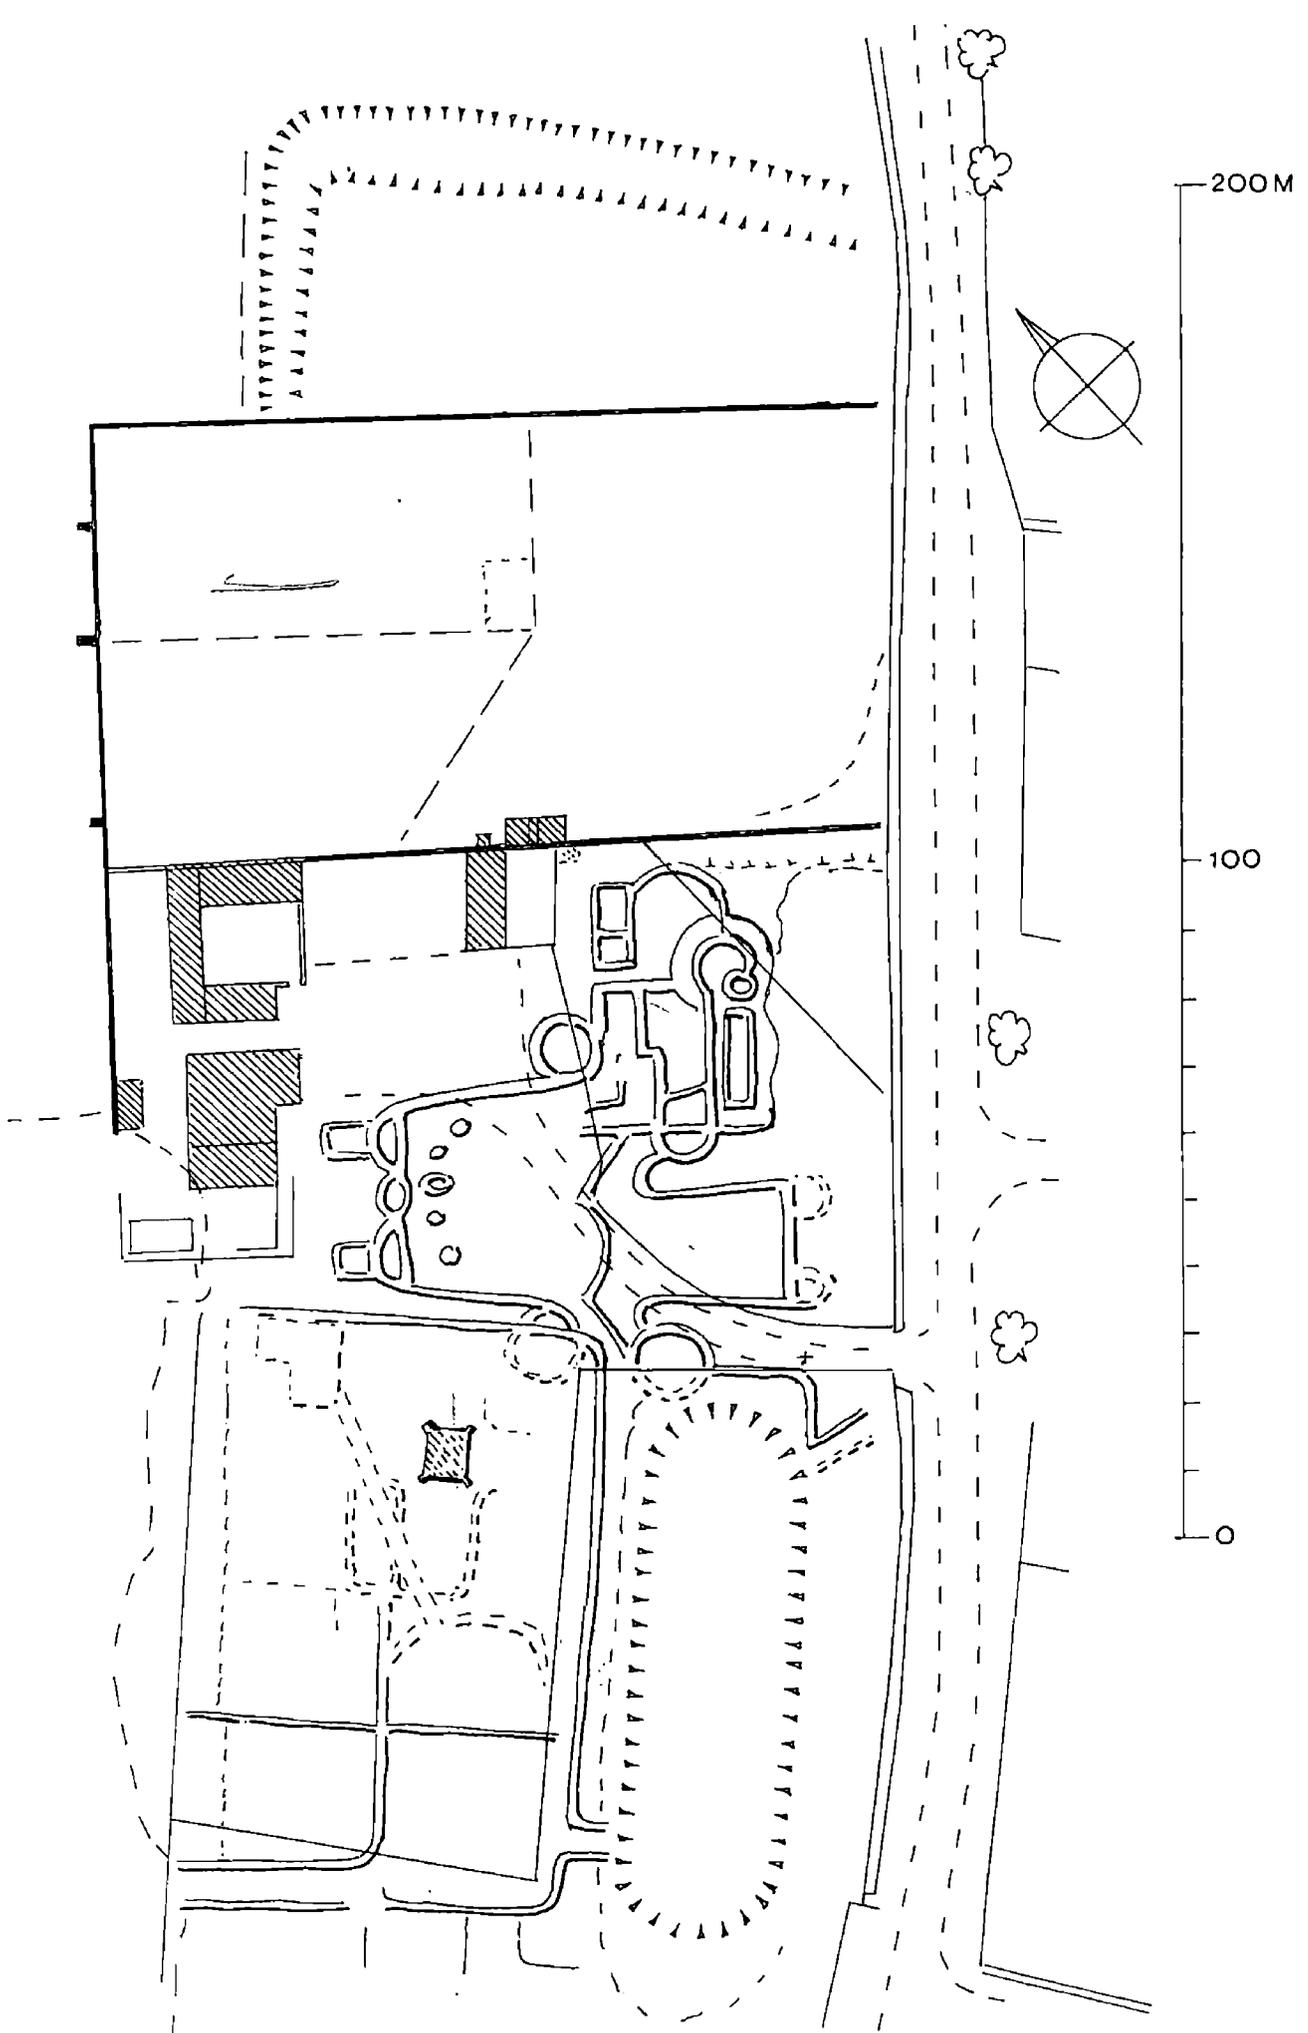
A sketch plot of the earthwork remains is shown on fig. 6. The majority of the remains occupy a central position on the site. The curving lines and circular features are more indicative of flower beds than buildings. The features on the west side, closest to the modern outbuildings are the clearest. Geophysical survey was not possible because this area now lies beneath hardstanding where probes could not be inserted into the ground.

To the north the pattern is more disturbed and there is more than one phase of activity represented. This part lies in the grass paddock adjacent to the main road and geophysical survey located some of the features. The features are recorded as areas of high resistance which means that there are the remains of walls beneath the ground (fig. 8b). This would be in keeping with an interpretation of raised flower beds which form part of a formal garden. Some of these remains may belong to buildings which pre-date the laying out of the gardens.

It seems unlikely that such a grand scheme would belong to the present farmhouse and the style of the layout suggests a date in the 17th century. These gardens must have belonged to the Hall which was demolished in the 18th century. It is therefore suggested that the lost Hall lay not in the paddock but in the area to the north-west, now occupied by the crewyard and farmhouse gardens. Geophysical readings in Grid area 3 did not indicate the presence of any buildings other than the dovecote.

Fig.6
Sketch plan of earthworks as surviving in 1947, transcribed
from an RAF vertical aerial photograph.

1. Areas of particular interest already identified are the earthworks adjacent to the road and the dovecote.

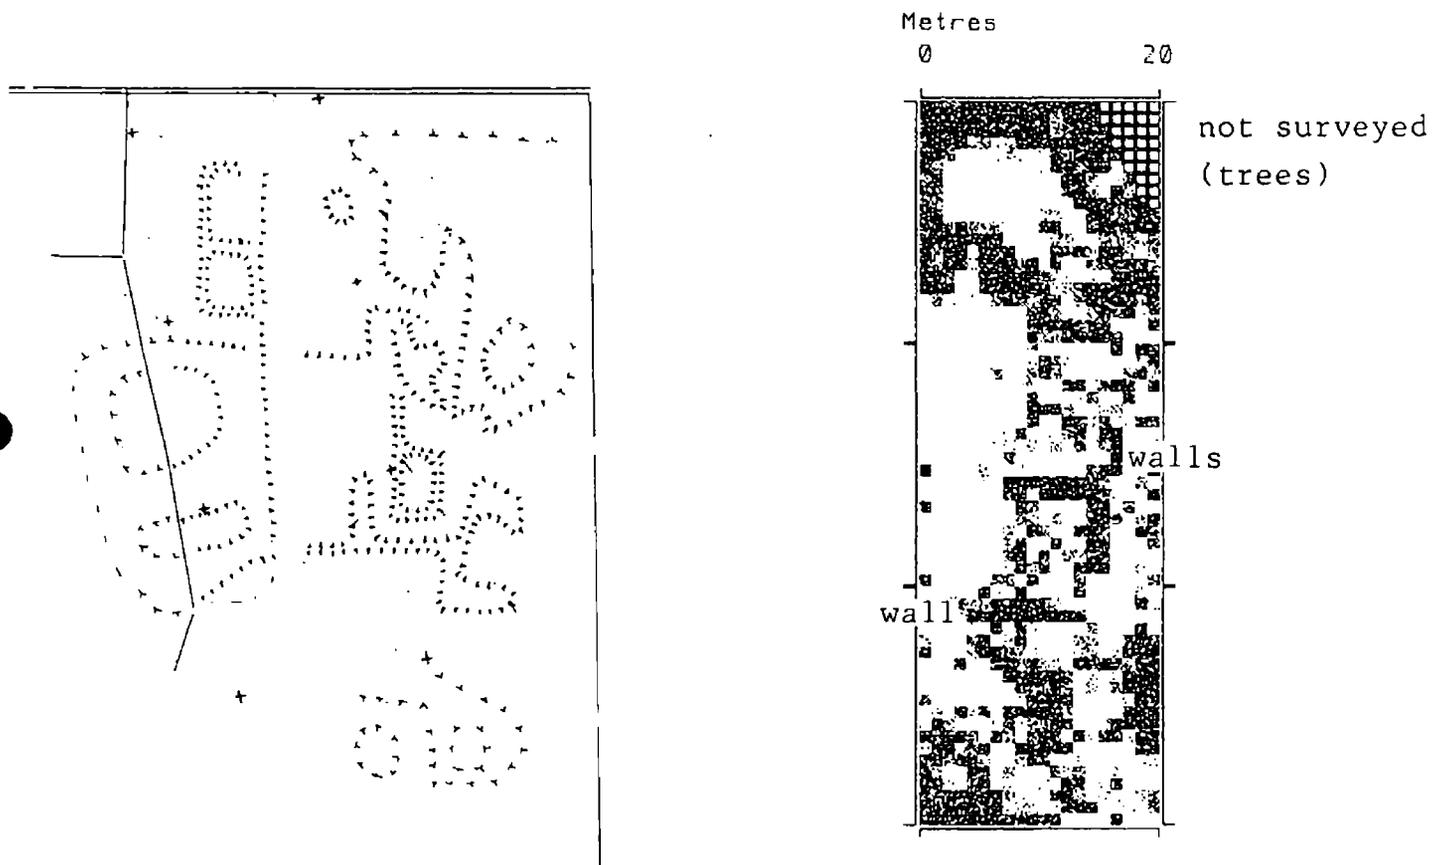
Fig. 8

A sample survey of the earthworks was carried out using a theodolite (fig. 8a). Although the results were not very illuminating they served to substantiate and locate the features plotted from the aerial photograph. At least some of the surface undulations represent ground disturbance rather than structures.

The geophysical survey covered an area 20 x 60m and identified several high readings which may be robbed walls. Their shape and size is more in keeping with retaining walls for flower beds rather than buildings.

- a) Area 1, earthwork survey. Resistivity grid marked +
- b) Area 1, resistivity survey. High resistance shows as dark areas, rectangular configurations are remains of wall foundations. (NB top grid surveyed after a rainfall and produced darker results which are not archaeologically relevant).

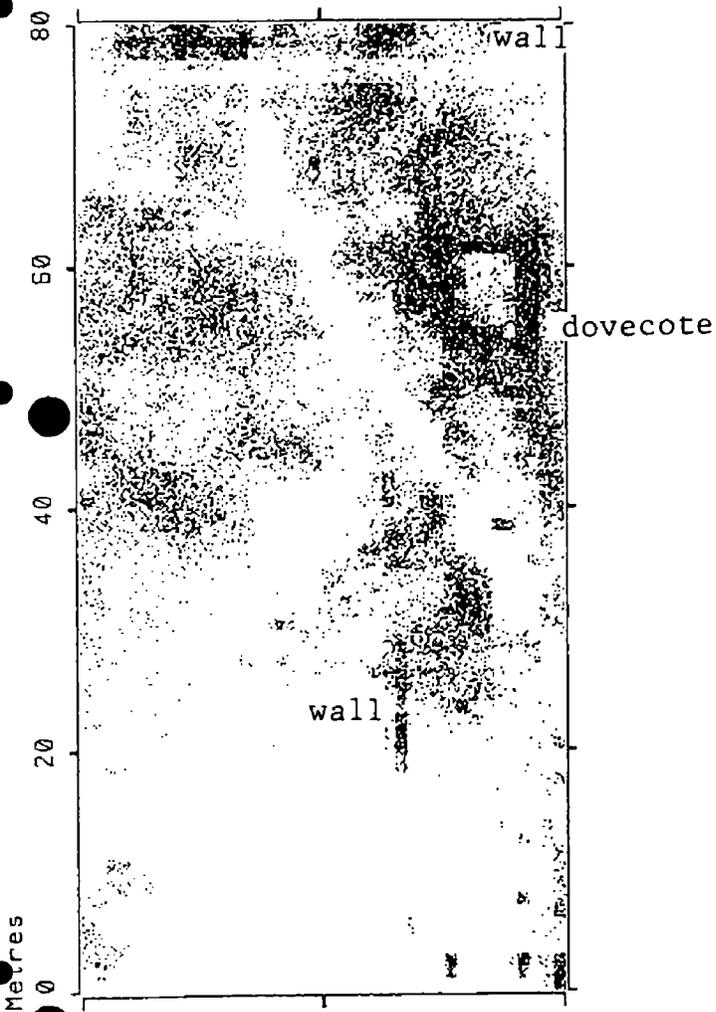
Fig.9

An area 80 x 40m was surveyed to the north of the present fishpond and revealed three features. Fig. 9a shows areas of high resistance. The small square outlined in the south east corner of the survey is very clear and represents the remains of a dovecote, marked on the OS map. The foundations are visible as a parchmark in the grass 7m x 6m and has diagonal corner buttresses. The building was still standing in 1947 and is visible on the RAF vertical photograph of that year.

On the eastern edge of the survey is evidence of a wall running north-south. This coincides with a change in ground level and may represent a retaining wall of a terrace. However, it might be the wall of a building lying further to the east.

- a) Areas of high resistance revealing wall foundations
- b) Areas of low resistance revealing possible ditch

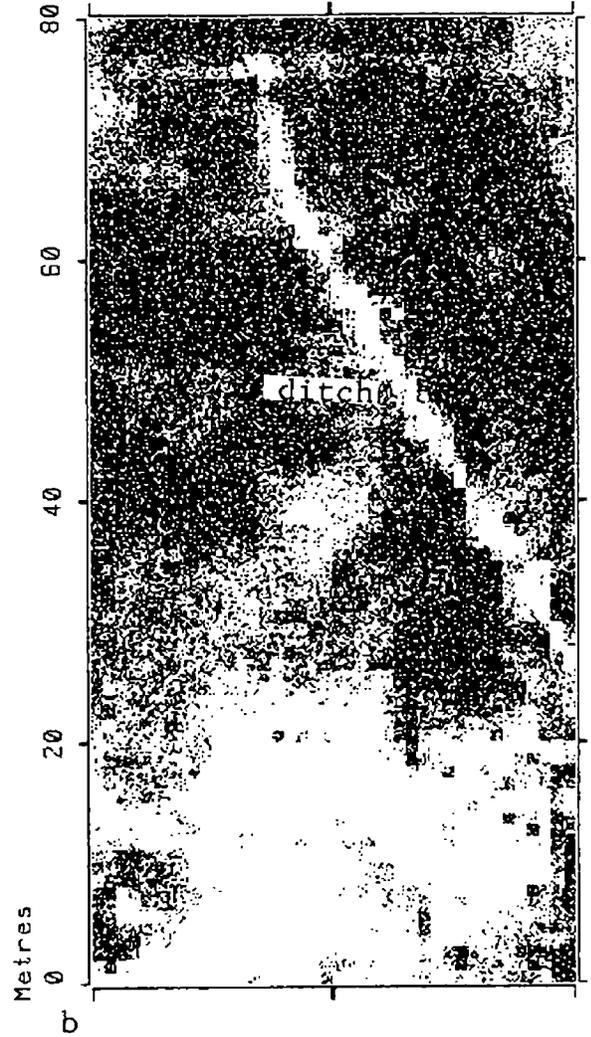
Fig. 9b shows the same area highlighting the low resistance readings. A diagonal white line across the survey area represents a feature c.2m wide which may be a narrow ditch or possibly a path.

In the south west corner is evidence for a rectangular feature, perhaps a wall which has been completely robbed out. This feature is also visible as an earthwork on the 1947 RAF photograph and may be part of the garden. There was no indication of any more fishponds.

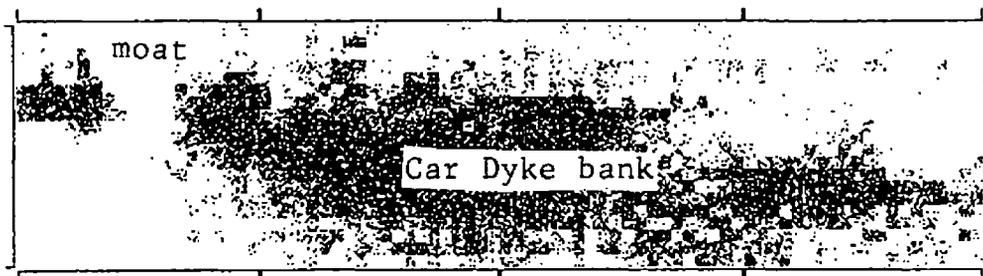
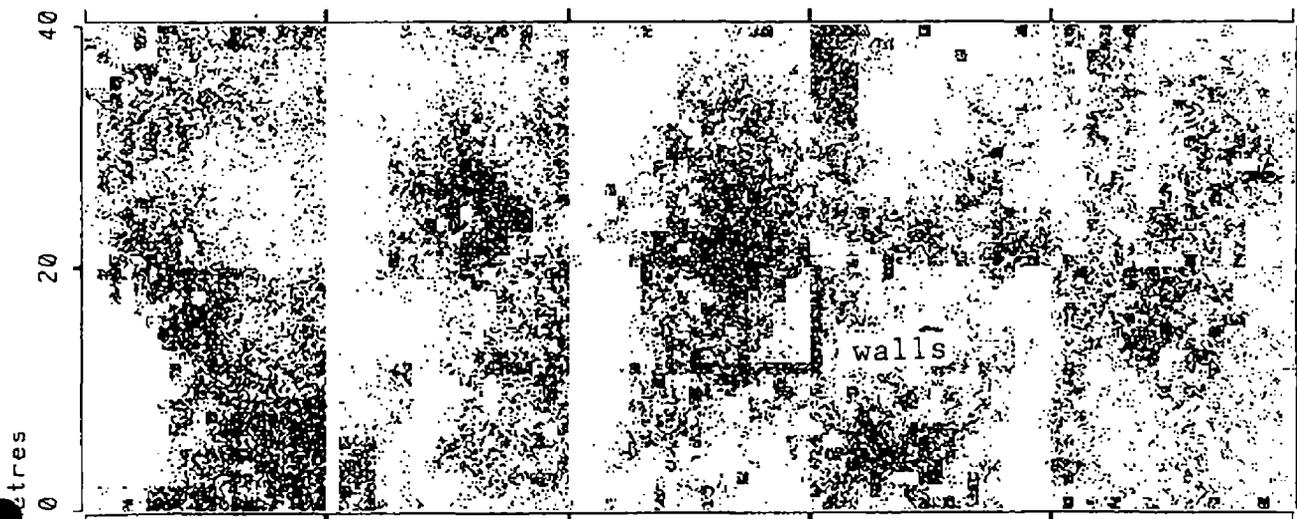
Fig. 10

A grid 100m x 40m was examined. This area is under grass and contained fruit trees, most of which have been removed. This has probably resulted in the ground disturbance which can be seen in the results (a,b).

There was only one definite feature located within the survey, a rectangular foundation. The presumed line of the moat was not visible on the computer print out. Manual interpretation of the raw data located a line of readings which varied by 3-4 ohms across the presumed line of the moat. A magnetometer was used

and some indication of the moat was detected at the junction of the brick and stone wall. It is thought that the ground conditions were too dry to locate even such a large feature as a moat. An alternative possibility was considered where the return of the moat would run parallel to the orchard wall making it similar in shape to the moat lying to the north-west. There was no evidence in the data and this theory was discarded.

A sand bank was found running parallel to the garden wall along the full length of the surveyed area. Whilst this could be a natural feature it is probably a part of the Roman Car Dyke bank which runs along the Fen Edge. The northern arm of the moat clearly cuts through this bank at the north end of the survey area. no internal features were identified. It is possible that buildings within the moat were built in timber and would not show well in a survey of this kind. A second moat to the north of Langtoft Hall appears to have been deliberately built over the Car Dyke and the Hall moat also probably took advantage of the dyke to fill its ditch. (This phenomenon has also been observed at Sempringham Priory, another monastic site on the Car Dyke).

Area 3 shows remains of rectangular wall foundations near centre.

Area 4 shows dark band which is the bank of the Car Dyke. The break on the left hand side shows the moat cutting through the bank.
