# SOAKAWAY TEST PITS CASTLE FRASER WALLED GARDEN ABERDEENSHIRE

### - Archaeological Watching Brief -Carried out 20<sup>th</sup> April 2011 by Murray Archaeological Services Ltd

Report No: MAS 2011-13 by H K Murray

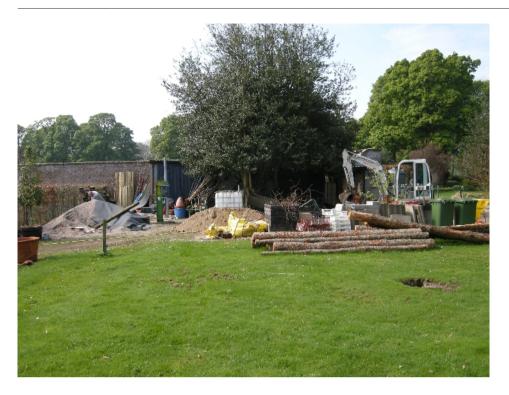
Illus 1 Location of test pits looking W

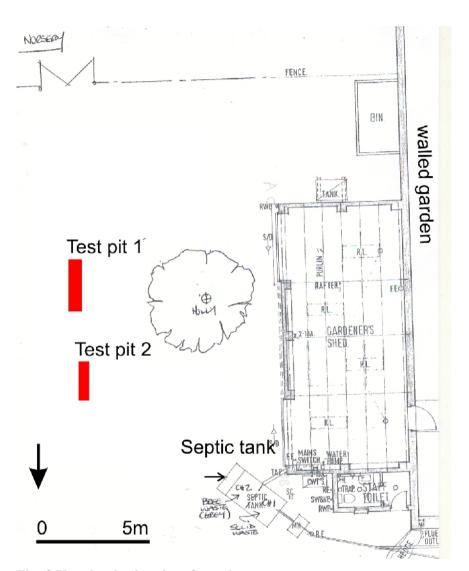
3.1 Two test pits (Illus 1, 2) were dug by a mini- digger; a straight-edged bucket was used for the upper horizons but the lower *c* 500mm of test pit 1 required to be dug with a toothed bucket. Both were observed, planned and photographed by MAS Ltd.

Illus 2 Plan showing location of test pits

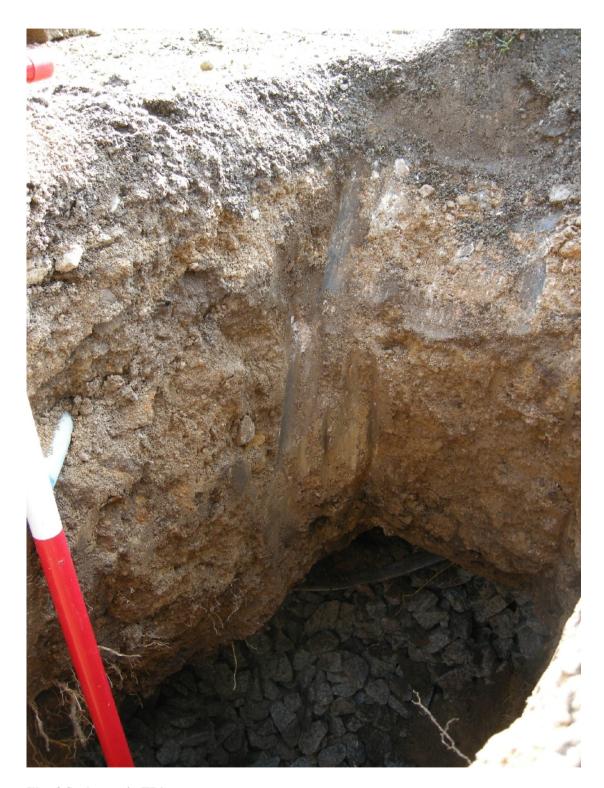
The S half of the test pit was cut into the top of an existing soakaway formed of small angular stones covered by a membrane of plastic (Illus 3). This extended to the S and E of TP1 from a depth of c 700mm below the yard surface to the base of the test pit. A clay drain led into it from the NE corner of TP1. It was sealed by yard makeup (*c* 200mm) and redeposited topsoil. It was cut into

clean hard natural glacial deposits. The stratigraphy at the N and W sides of TP1 showed *c* 200mm yard make up over c 300mm of disturbed and mixed topsoil and subsoil over natural.

Illus 3 Soakaway in TP1
