DB 11/2/8

COWING
112

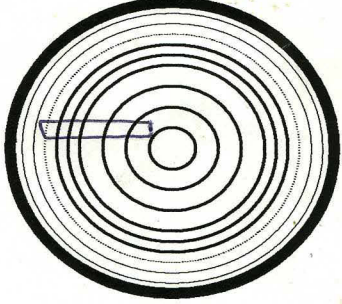
Cow Tag 112	Function Code 55.4	
Brief Description: [timber element, p/s, condition, fragments] solid plank, good condition		
Notable Features: [tool marks, scribed lines, decoration, repairs] POINTS TO LOOK OUT FOR WHEN RECORDING ufos JB: 7 inscribed lines on face down to land. Type 2 (4 lines, curving) IB: Clamp impression x 2 Through Hole on Aft Scarf of 540 55-3 Does not appear to go through 112 55-4 Forward Scarf		
Wood Science: [rings, ARW, knots, sapwood, conversion] Tangential at aft scarf. Sapwood along lower edge i.e. pith beyond upper edge 110H+5S. ARW ≈ 225/115. Least knots

Recommended action: [samples, additional photos, moulding, queries and problems] NOT VERY WELL CLEANED (ESP. ON UPPER EDGE + OUTBD LAND) POSSIBLE CLAMP IMPRESSION MARKS ON INBD. FACE, FORW. OF AFT END		
Cleaned: MS, VT, UB 23/05/06	Recorded: 26.05.06 AK	Photos:
Checked: [corrections needed] ✓	Initials & Date: NN 14/6/6
