**HIGH CAYTON  
DESERTED MEDIEVAL VILLAGE**

**GAZETTEER OF EARTHWORKS**  
SCHEDULED ANCIENT MONUMENT NO: 465  
NORTH YORKSHIRE  
SE 28670 63000

*HARROGATE MUSEUMS AND ART GALLERY SERVICE*

*March 1996*

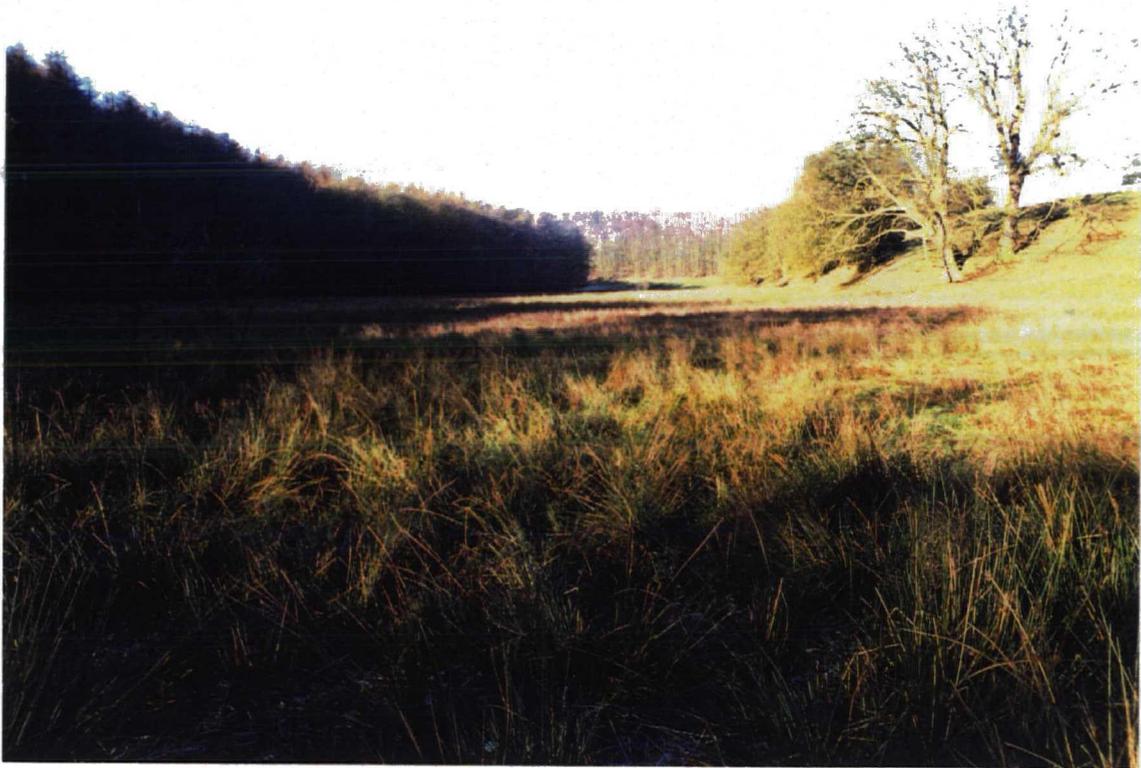
**PLATE 9**

The site of the medieval fishponds,  
within the Gill Bottom, facing north.

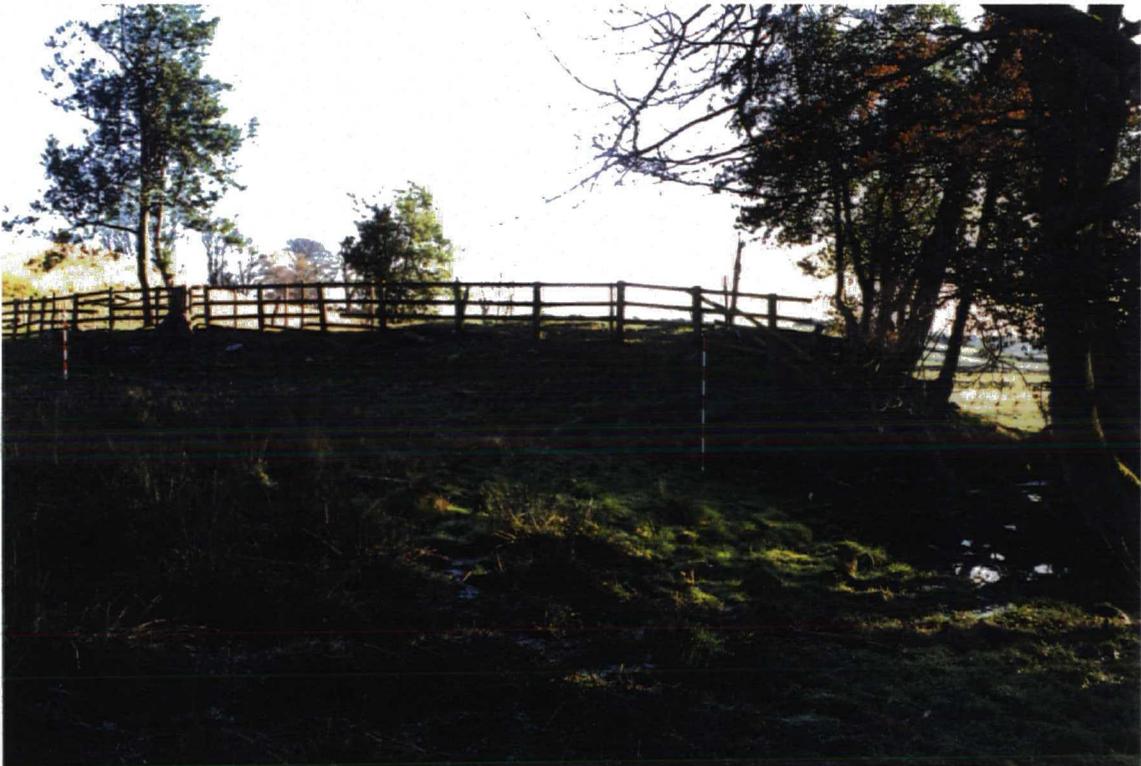
**PLATE 10**

The breached earthen dam that contained  
the medieval fishponds, facing south.

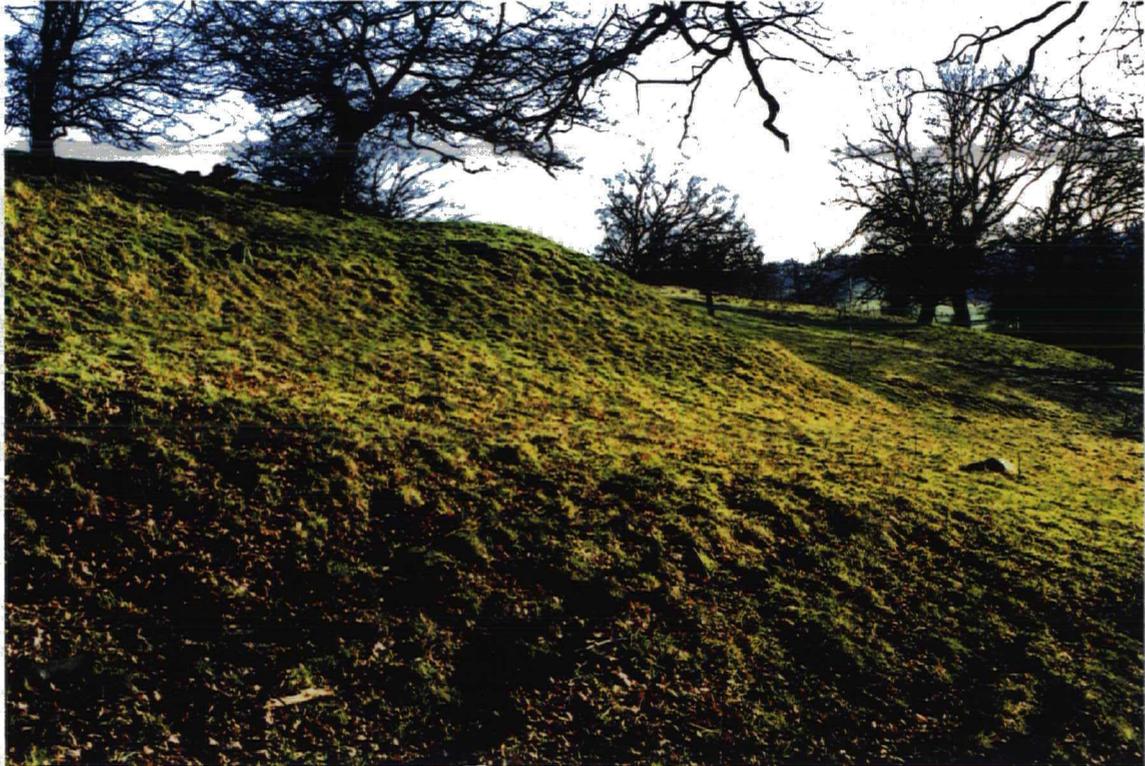
**PLATE 11**

The spur like projection of made up ground that would have supported the late medieval pottery kiln, facing south.

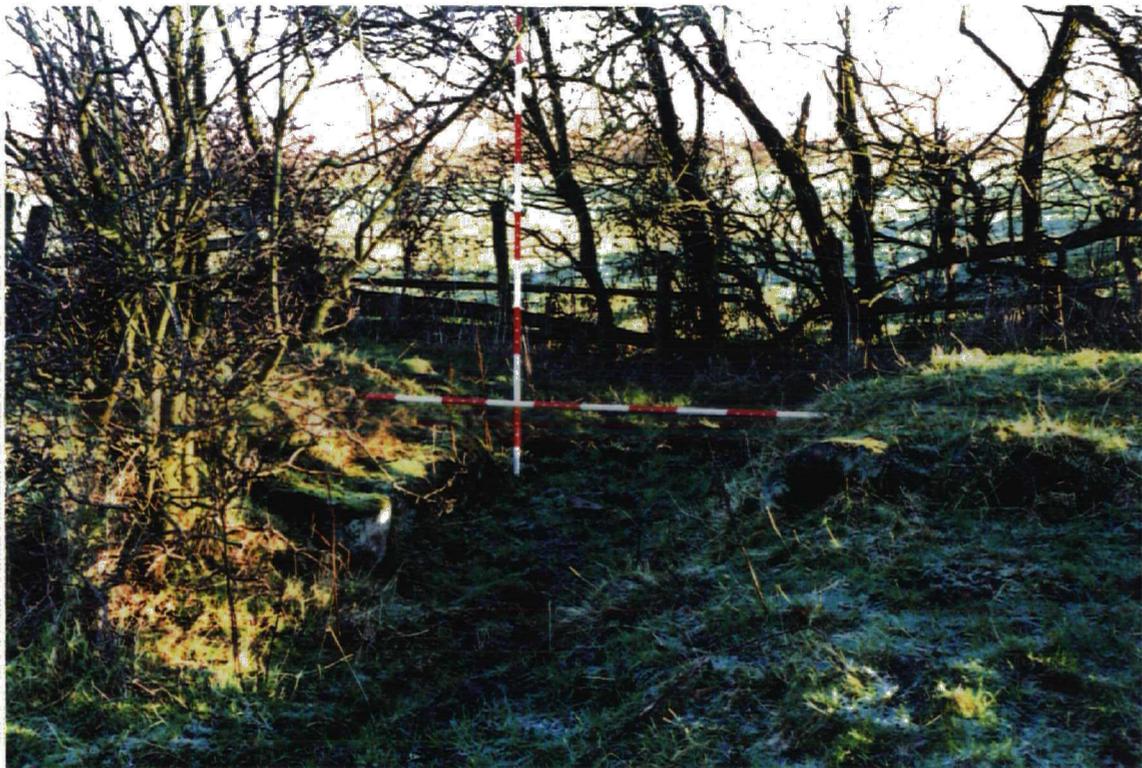
**PLATE 12**

The revetted conduit that has been identified as the site of a post medieval sheepwash, facing east.

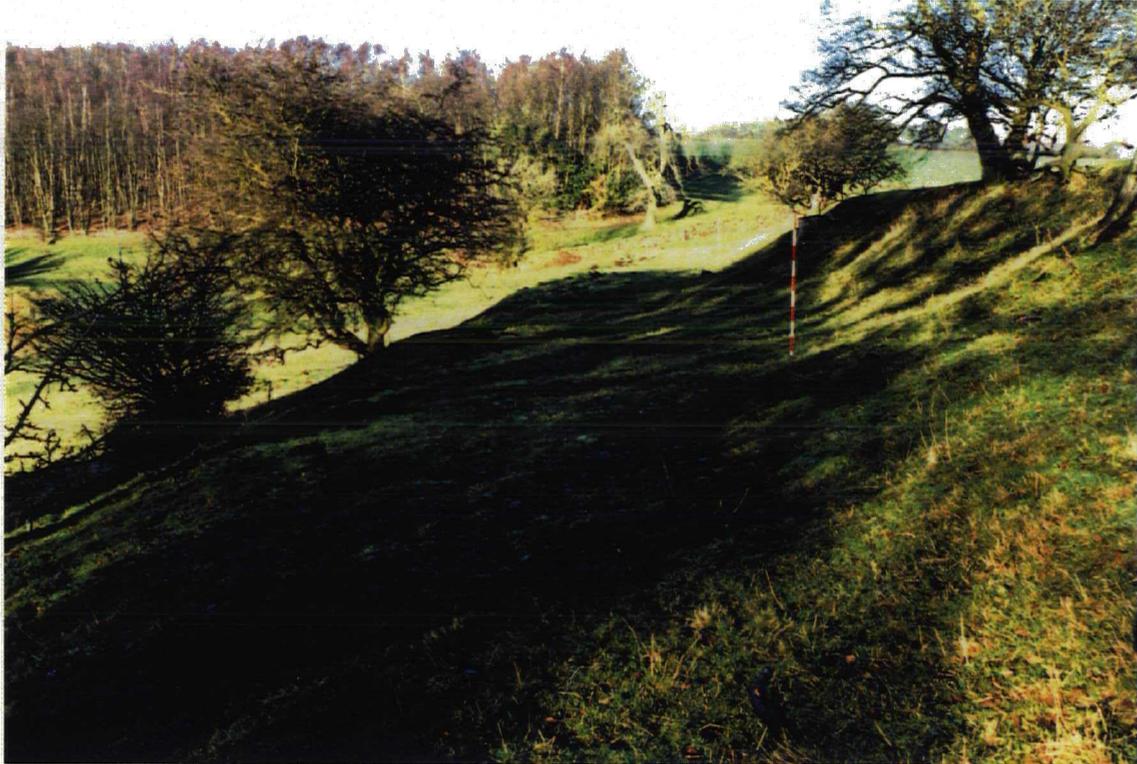
**PLATE 13**

**A detail shot of the medieval trackway that traverses the steep valley sides of the Gill Bottom, facing north.**

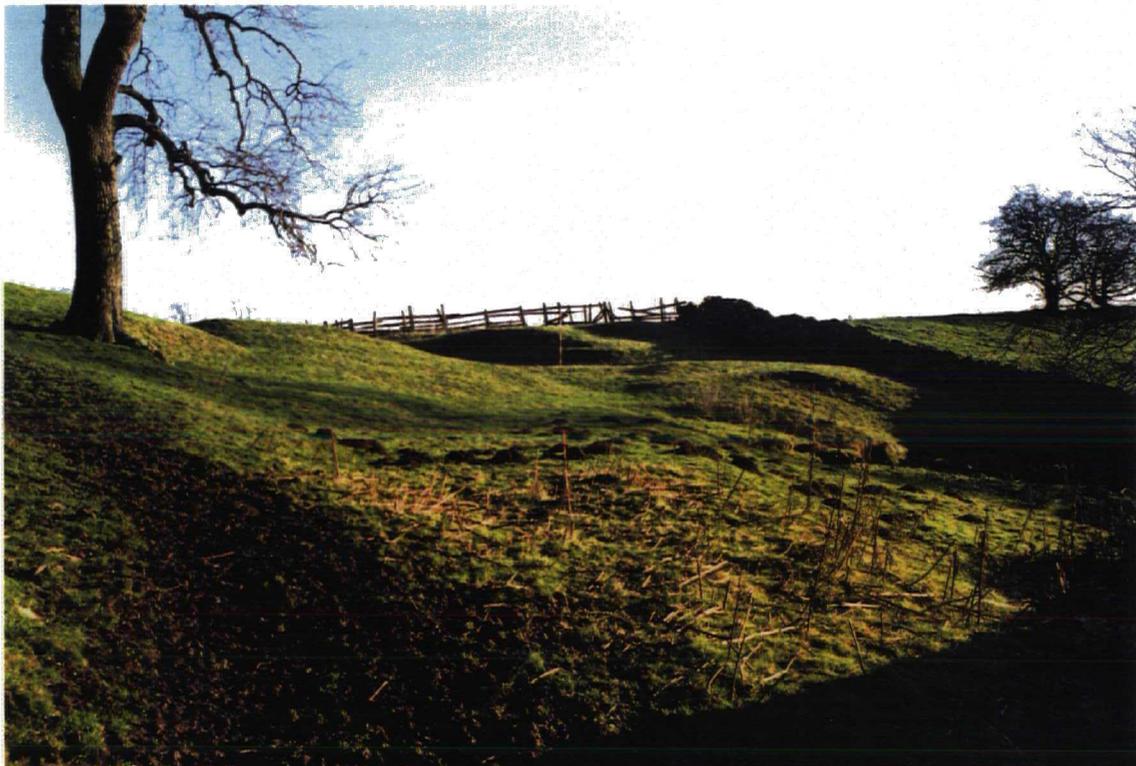
**PLATE 14**

**The convergence of trackways within the western extent of Crag Wood Ends, facing south east.**

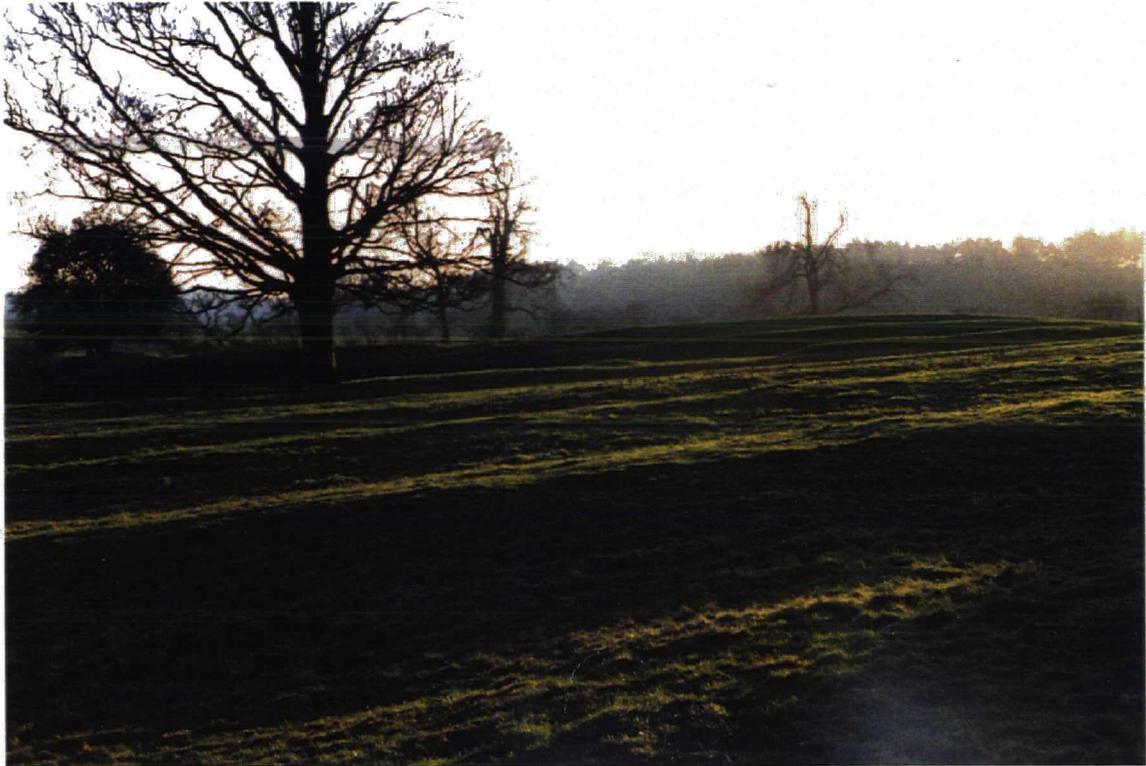
**PLATE 15**

A detail of the medieval ridge and furrow earthworks identified within Horse Park, facing south west.

An area of ridge and furrow situated at the northern extent of the site, the structure is contained to the north by a hedgeline that runs adjacent and parallel with the existing farm track, to the south by an enclosure bank (Feature 3) that is contemporary and associated with this area of cultivation. To the west the structure has been cut by the High Cayton Farm complex, to the east the ridge and furrow is contained by the holloway (Feature 2a). The structure falls with the natural gradient on a gradual slope from west to east. The structure has been previously identified on a high oblique aerial photograph, taken in 1954, where it is shown as being part of a much larger field system that extended further north. The ridge and furrow noted within the field known as Lease Hill has since been destroyed by ploughing.

The ridge and furrow appears to be medieval in origin and is part of the in-field system situated on the northern fringe of the settlement.

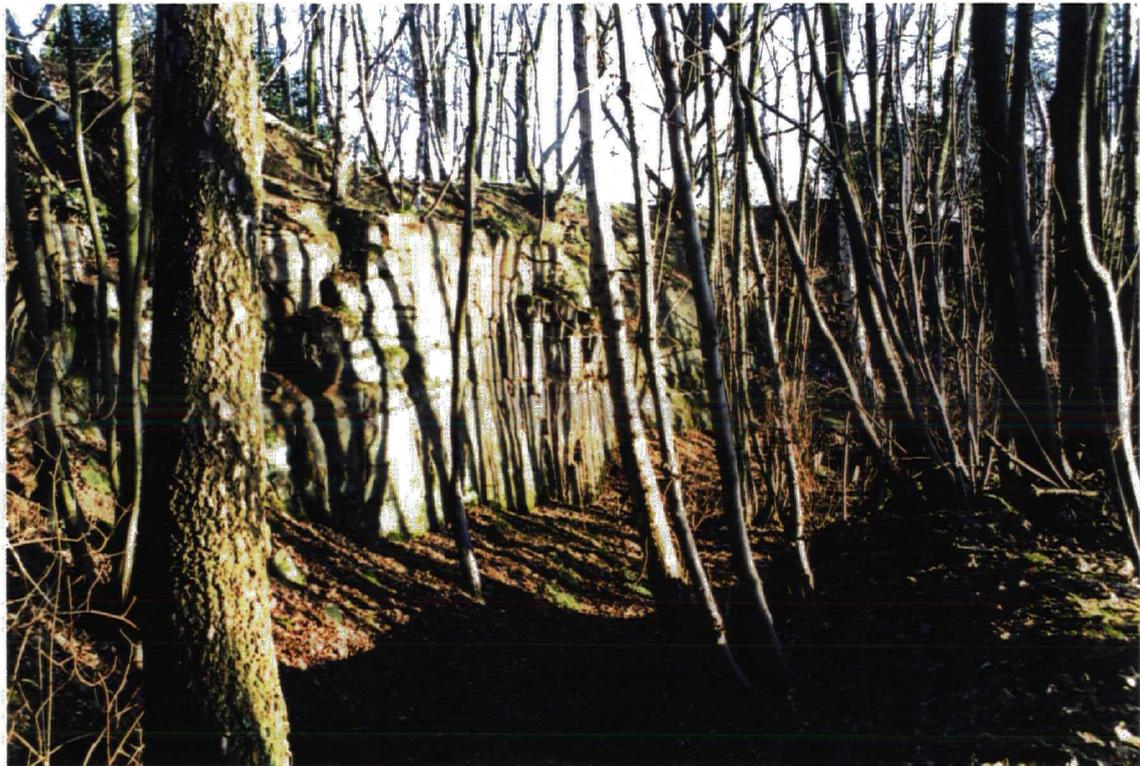
**PLATE 16**

The medieval sandstone quarry face within Crag Wood, facing east south east.
