**Friary West
Carmelite Way
Maldon
Essex
CM9 5FJ**

3rd November 2014

**Trial Trenching on behalf of
Architect Annabel Brown**

**TOUCHSTONE ARCHAEOLOGY
THE RIDINGS
WHITE ELM ROAD
DANBURY
ESSEX
CM3 4LR**

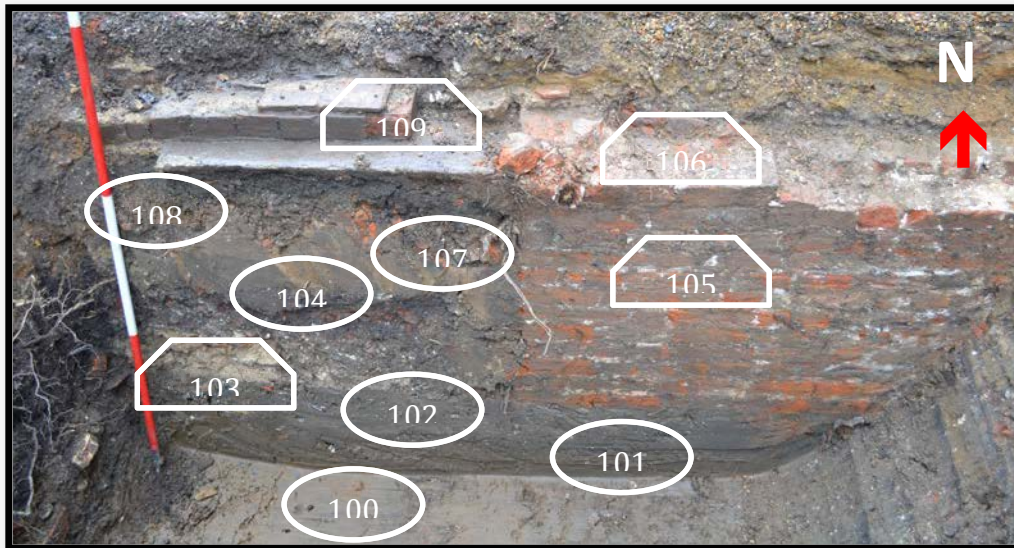
Fig.5. Site: FW14 – Area: B2 – Trench: 1 – Section: 1 - North

Section 1 - Context Description:

109 – West - Abutting brick wall (105) - 2no Flagstones supporting dark red/brown bricks laid on a yellow sandy mortar base in stretcher bond, finished with a mortar bed and a layer of creasing tiles.

105 – East - Orange/red handmade brick in varying sizes with white limestone mortar, possibly header/stretcher bond set on to London blue/grey clay base (102). Bricks approx. 8" x 2 $\frac{3}{8}$ " (203mm x 70mm) – Three courses approx. 8 $\frac{5}{8}$ (215mm) First two courses extend west by 50mm.

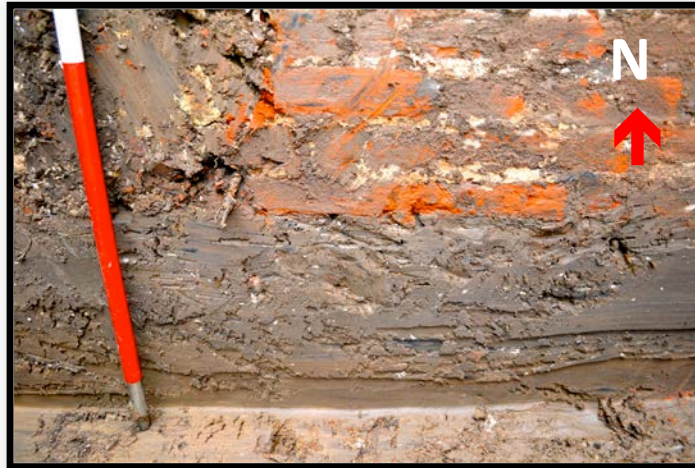
Fig.6. Context 105 – Brick wall set on natural London clay base 102

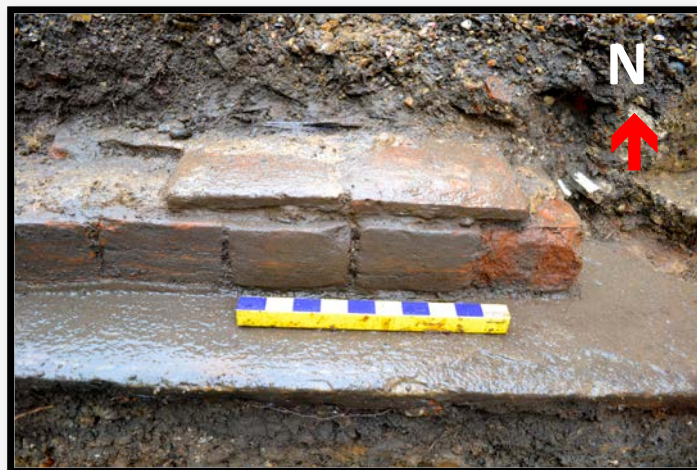
Fig.7. Context 109 – Flagstones supporting bricks and creasing tile

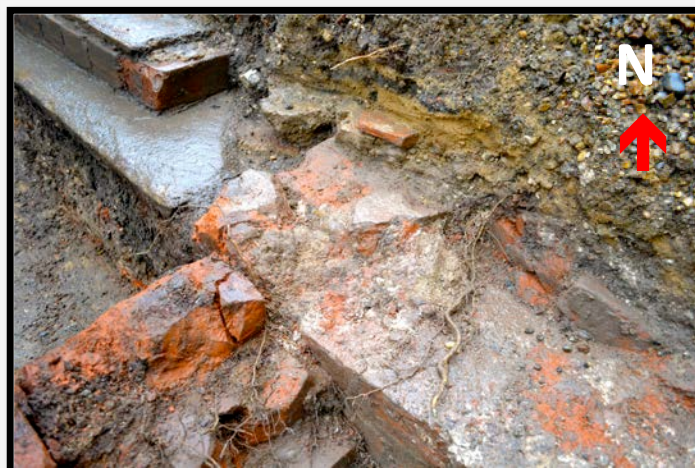
Fig.8. 105 Brick wall abutting 109 Flagstones and joined by north-south wall from Section 2

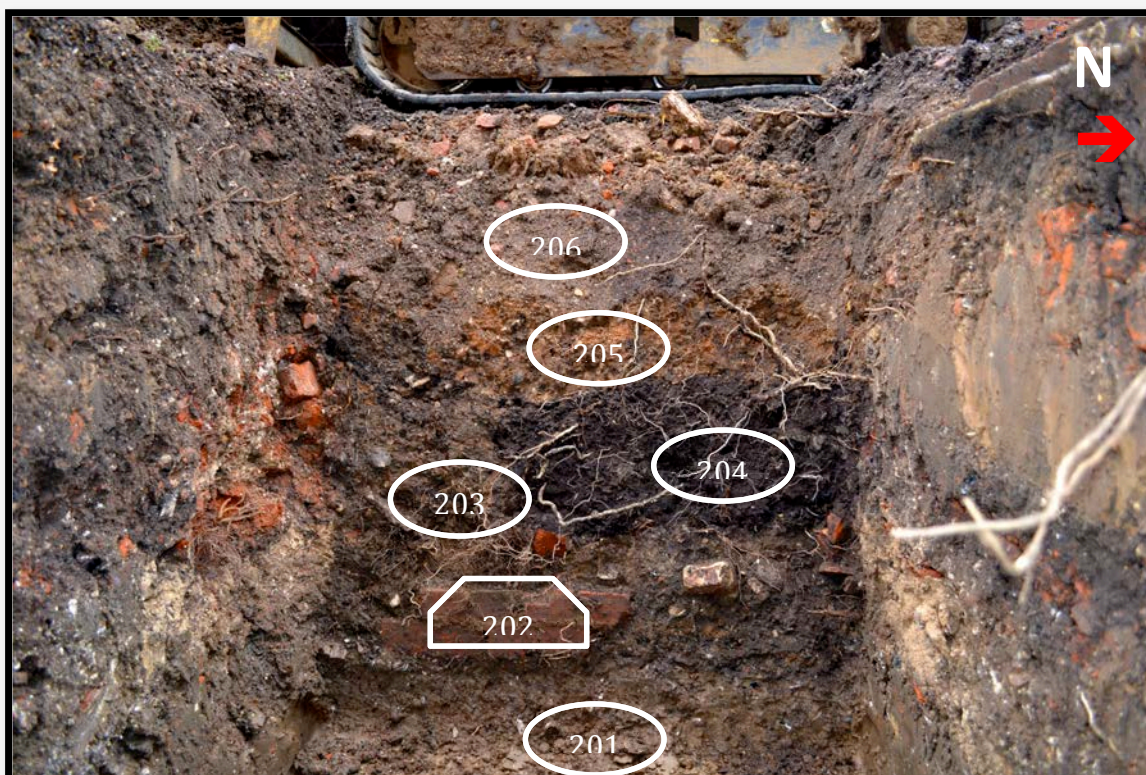
Fig.9. Site: FW14 – Area: A2 – Trench: 1 – Section: 2 - West

202 – South - Two courses of dark red brickwork with yellow mortar (two stretcher bricks on lower course, two header and one stretcher on upper course)

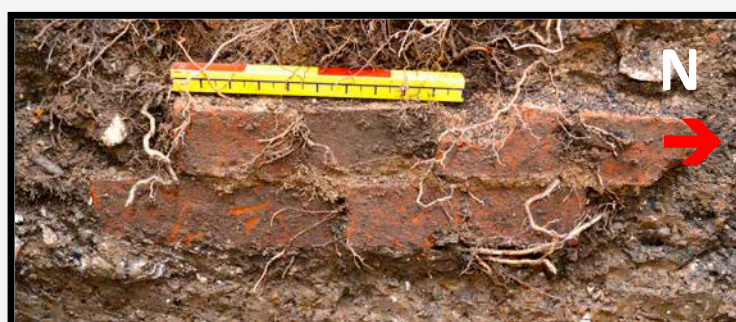
Fig.10. Context 202 - Brickwork

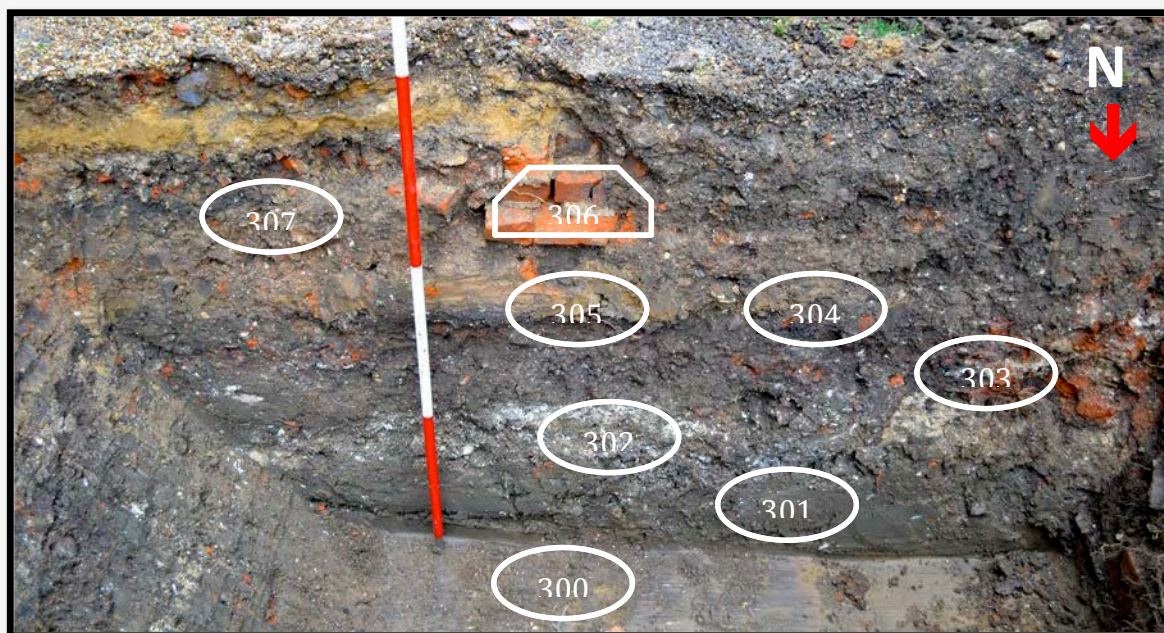
Fig.11. Site: FW14 – Area: B2 – Trench: 1 – Section: 3 - South

306 – East - Brick wall of three courses in English/English cross bond constructed from WH Bott bricks and yellow sandy mortar running north south.
Brick 230mm x 110mm x 70mm (three courses 10" or 254mm)

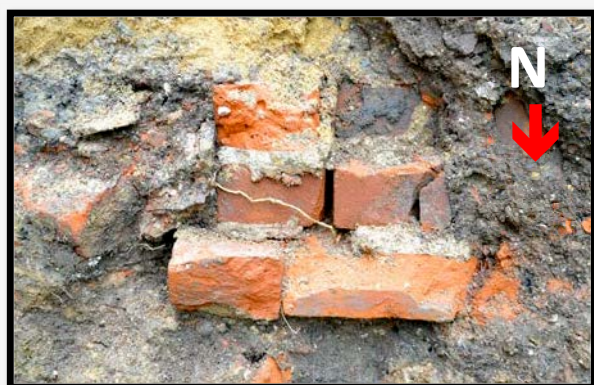
Fig.12. Context 306 – Brickwork

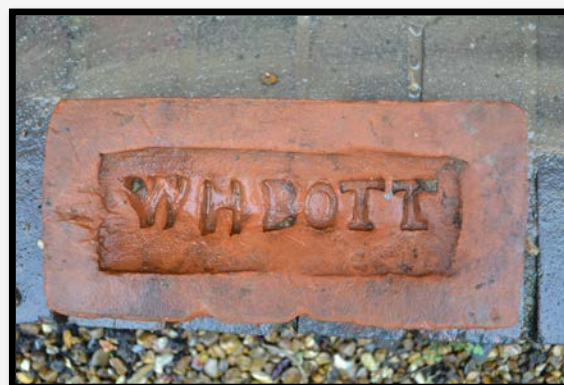
Fig.13. W H Bott brick

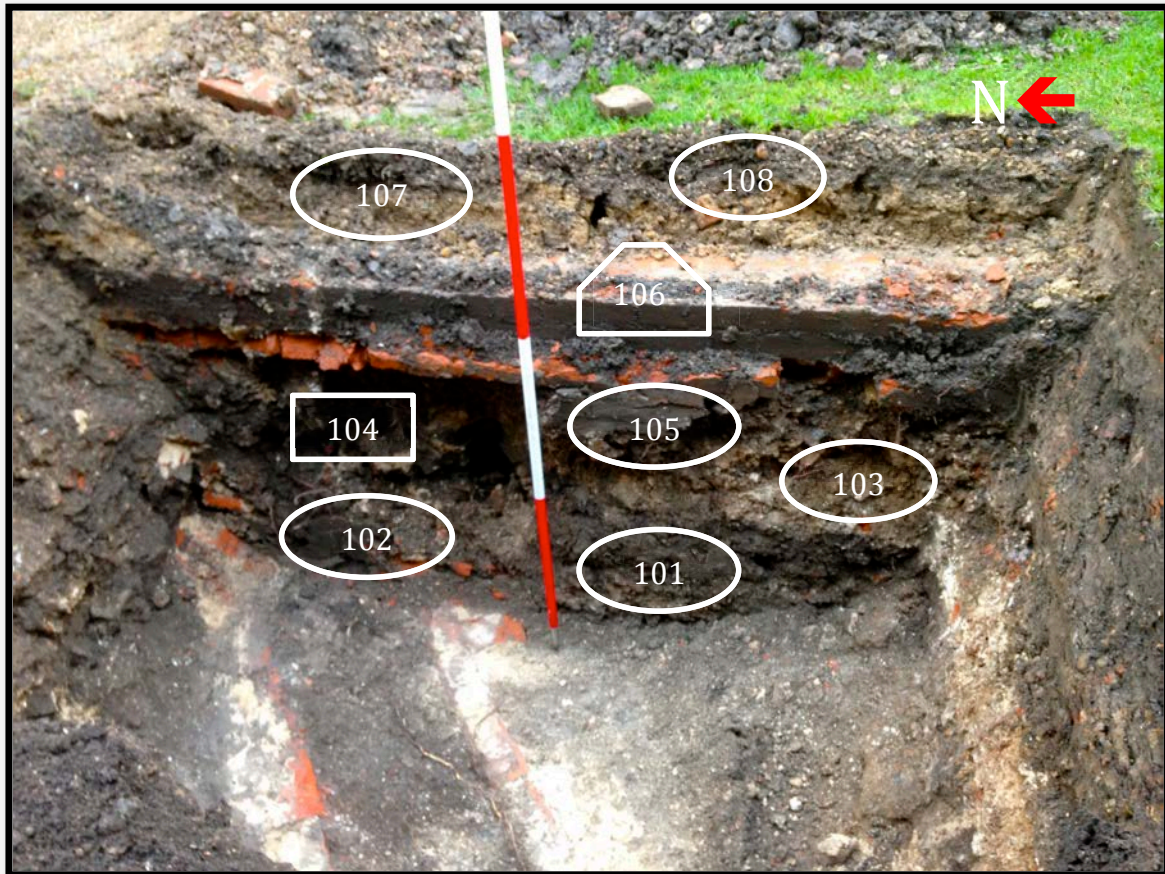
Fig.38. Site: FW14 – Area: B1 – Trench: 2 – Section: 1 - East

106 – 2 courses of brickwork, two bricks wide. Top course in header stretcher bond, lower course in header bond with yellow mortar.

104 – Void where Victorian drainage culvert was sited.

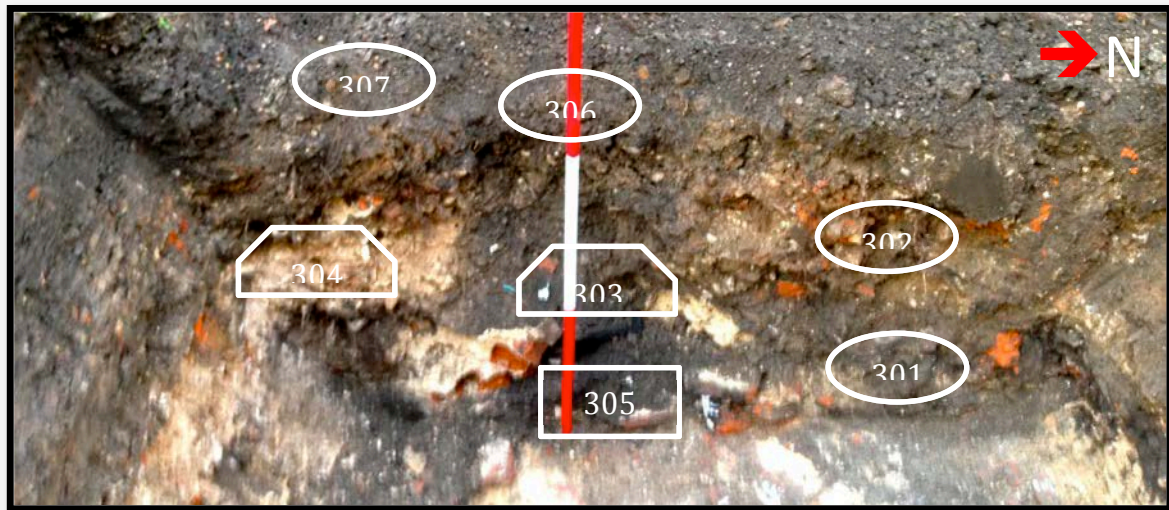
Fig.40. Site: FW14 – Area: B1 – Trench: 2 – Section: 3 - West

305 – Clean dark brown/black organic soil with roots filling damaged drainage culvert

303 – Arched Victorian Drainage culvert constructed from red brick and white mortar

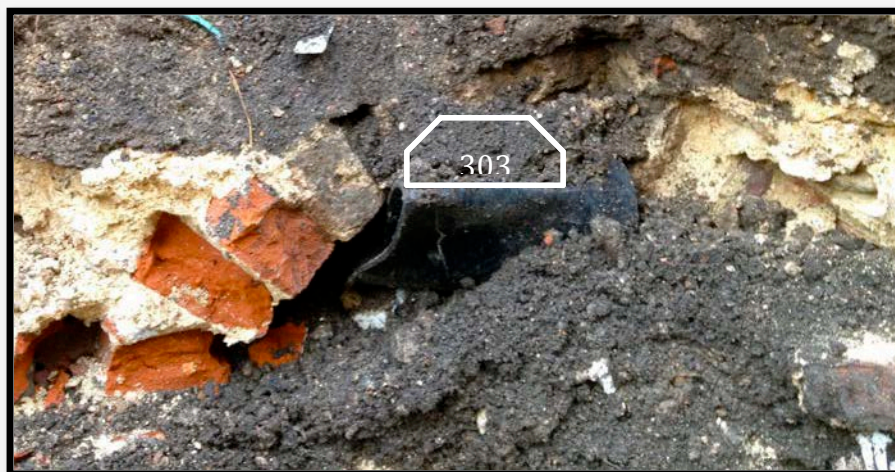
Fig.41. Remains of damaged Victorian arched drainage culvert filled with modern rubbish.

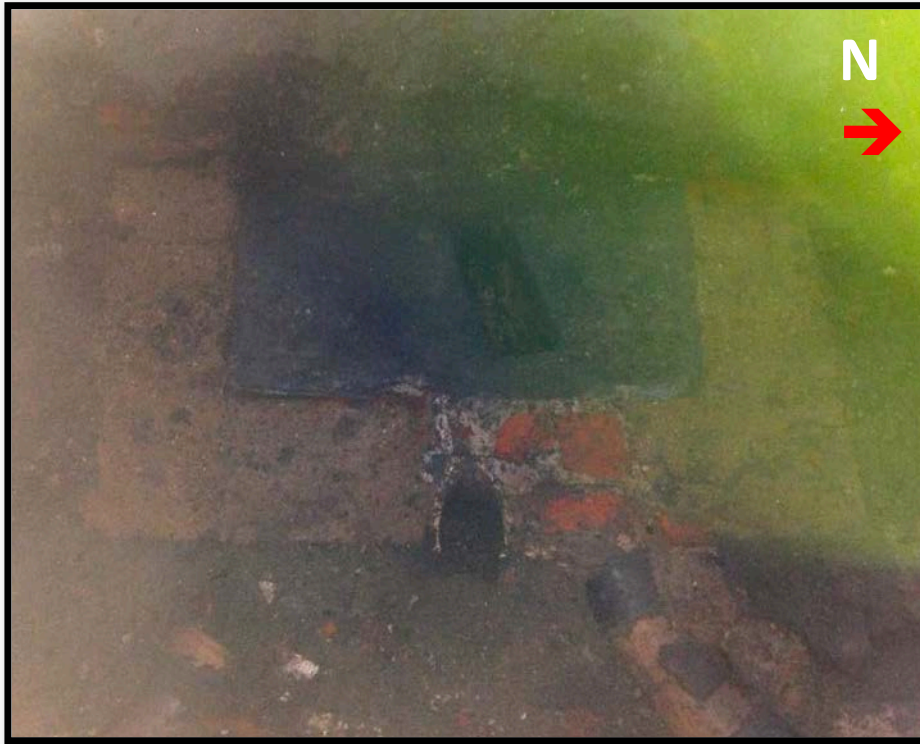
Fig.43. Site: FW14 – Area: B2 & B3 – Trench: 3

Trench 3 was excavated towards the end of the day. Within 300mm of the surface a drainage system was uncovered that dated from the 19th Century and was probably the remains of the laundry outbuilding that was in situ at about 1950. The drainage system had been adapted for modern use and then later left redundant. All finds evidence was 20th Century.

Due to the complexity of the system it was concluded that the damage to underlying layers would be significant and no further investigation was taken.
