# The 20<sup>th</sup> Century Garden Gate Restoration and Temporary Garden Bridge installation, Hampton Court Palace: An Archaeological Evaluation.

**Site Code: HCP141**

April 2016  
Alexandra Stevenson

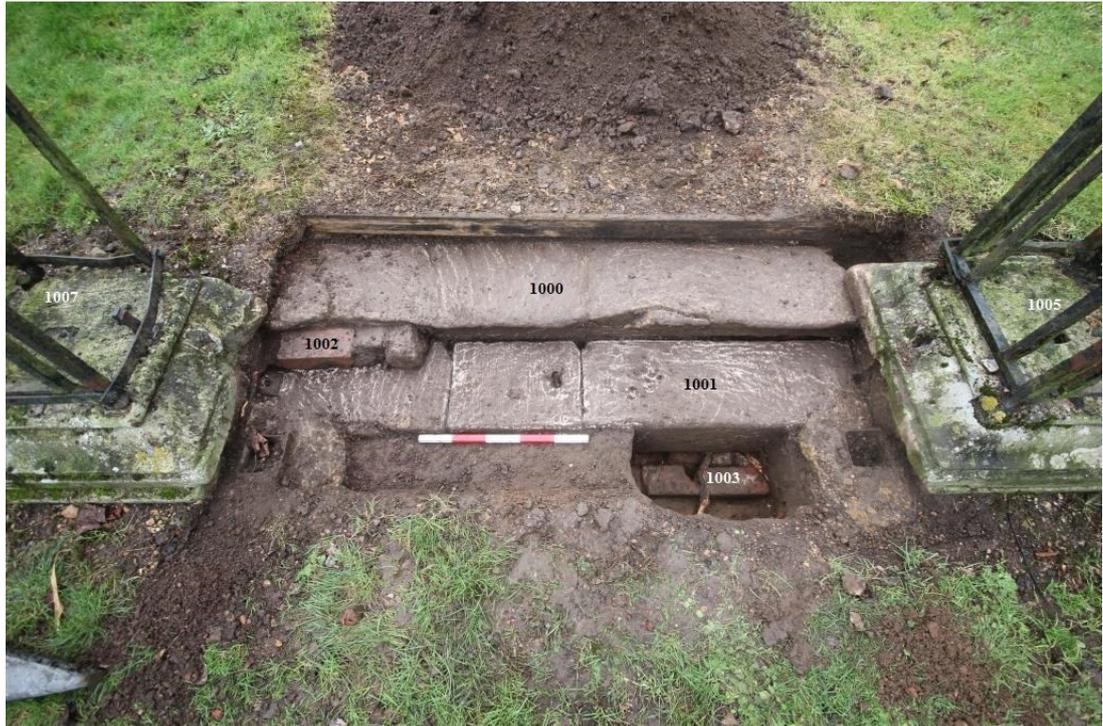
- 4.12 The lower portion of the threshold is represented by **context (1001)** (Figs. 2 and 3) which is comprised of three squared-Portland stone blocks measuring a total of 1.9 m x 0.3 m x 0.23 m. Each block is of a different size, the largest of which was subject to further investigation through the excavation of a small sondage on the far northern side of the threshold in order to determine its depth, which extended to 0.23 m. This portion of the threshold overlies the brick wall construction (**context 1003**) delimiting the 20<sup>th</sup> century gardens to the east. The lead fixtures used for the gate are visible at both ends of the masonry as well as in the central section. The hinge socket fittings at either end both measure 0.09 m x 0.09 m, the actual socket measuring 0.04 m in depth. As already mentioned, the fittings on the northern threshold step are not in line with the hinge fittings present on the plinth (**1005**) and are in fact off-centre by 0.04 m.

- 4.13 **Context 1002** (Figs. 2 and 3) directly overlies **1001**, and is composed of 4 aligned bricks bonded together with a friable sandy mortar (only three remaining bricks are visible in the photographic record). This alignment of bricks, measuring 0.4 m x 0.1 m (bricks: 220 mm x 60 mm x 100 mm), fit perfectly together and seemingly create a level surface. It would seem to correspond to some kind of crude repair to the second step of the threshold, which has clearly heavily weathered on the edge.

**Figure 2: West-facing view of the 20th Century Garden Gate threshold**

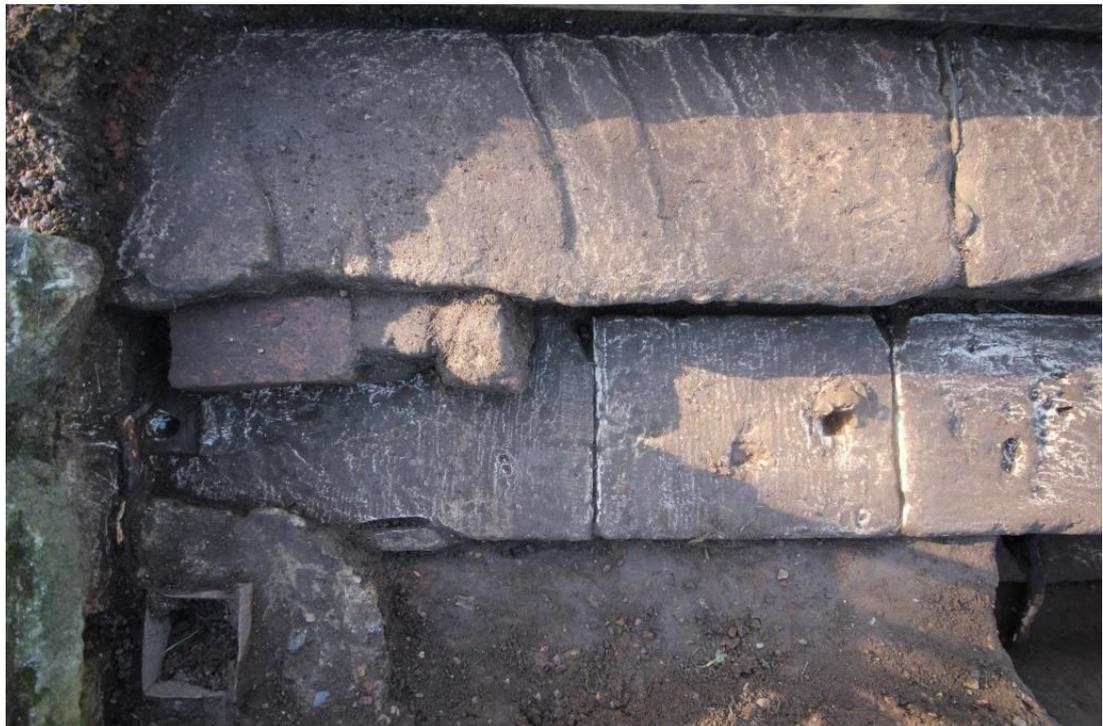
**Figure 3: Detail of the grooves present on the Ketton stone 1000, and the gate fixtures on 1001**

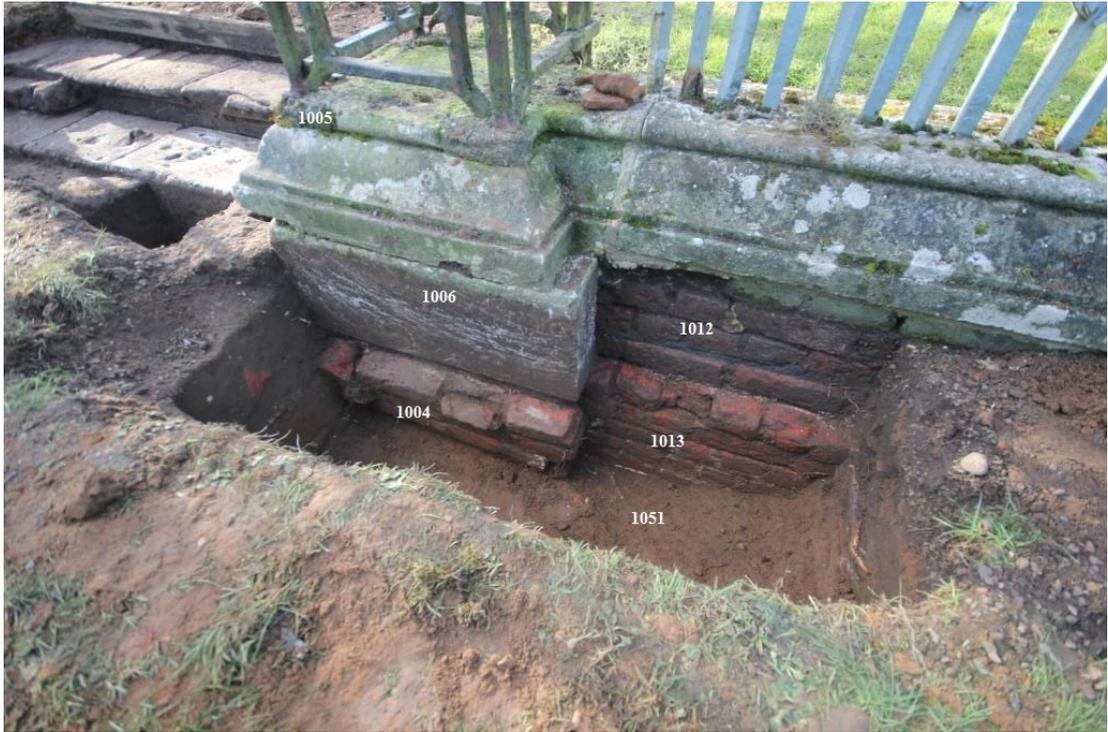
- 4.3 Stratigraphically, the earliest feature observed was the 17<sup>th</sup> century palisade that separates the Great Fountain Garden from Home Park and the 20<sup>th</sup> Century Garden, **context 1003** (Fig. 4). It comprises of the brick foundation **1013** and elevation **1012**. No construction cut was observed and the base of the foundation was not reached but a total of nine courses were exposed with consistent sized-bricks measuring 60 mm x 100 mm x 220 mm. The foundation was exposed to a depth of 8.83 m OD and five courses of brick were observed, arranged in an English Bond pattern. This section of the wall is offset by 0.06 m in relation to the elevation **1012**. The bonding material is composed of a soft creamy yellow, sandy lime mortar and the joints are neat measuring 150 mm in depth. The top course of the foundation is in a fairly poor state of conservation, with several bricks having crumbled away and cracked, perhaps because at some stage these courses would have been exposed to the elements. Sitting on top of context **1013** is the so-called elevation, **1012** measuring a total of 0.3 m in height and comprising of 4 courses of bricks arranged in an English bond pattern. The bonding material is different to that observed in the foundation level, composed of a friable to crumbly dark bluish grey sandy lime mortar with inclusions of fine gravels and charcoal flecks. This section of the wall is referred to as an elevation because up to 4 courses are exposed in many other places along the palisade. However, the ground level surrounding the 20<sup>th</sup> Century Garden Gate is particularly elevated, and appears to have been raised, thus obscuring the brick structure below the stone plinth.

- 4.5 Crudely built against wall **1003** and overlying **context 1051** is a construction comprising of 3 brick courses one brick deep measuring a total of 0.34 m in height and observed over a length of 0.68 m (**context 1004** – Fig. 4). The bricks measure 220 mm x 100 mm x 60 mm and are

bonded together with a mixture of sandy lime mortar and soft earth. It has a string course brickwork pattern. The construction is in a poor state of preservation, collapsing away from the main body of wall **1003**. Its purpose seems to be a support for the Portland plinthstone, **1006**, although it certainly does not seem to be particularly sturdy one. This rudimentary structure may be a later addition, although the bricks seem to be similar in type to those used to construct the boundary wall **1003**. It may simply have been hastily built against the main body of the foundation once it had been completed. The small sondage to the south of the plinth shows that it does not extend beyond the footings of the gate.

Figure 4: View of Trench I with the plinthstone and associated brick footings

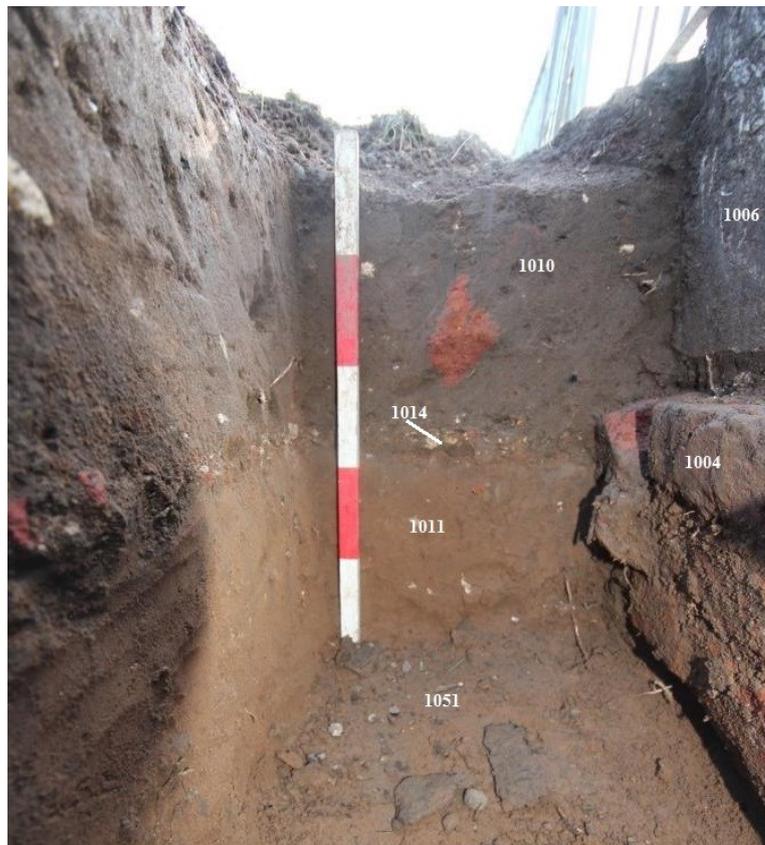
Figure 5: North-facing section in Trench I

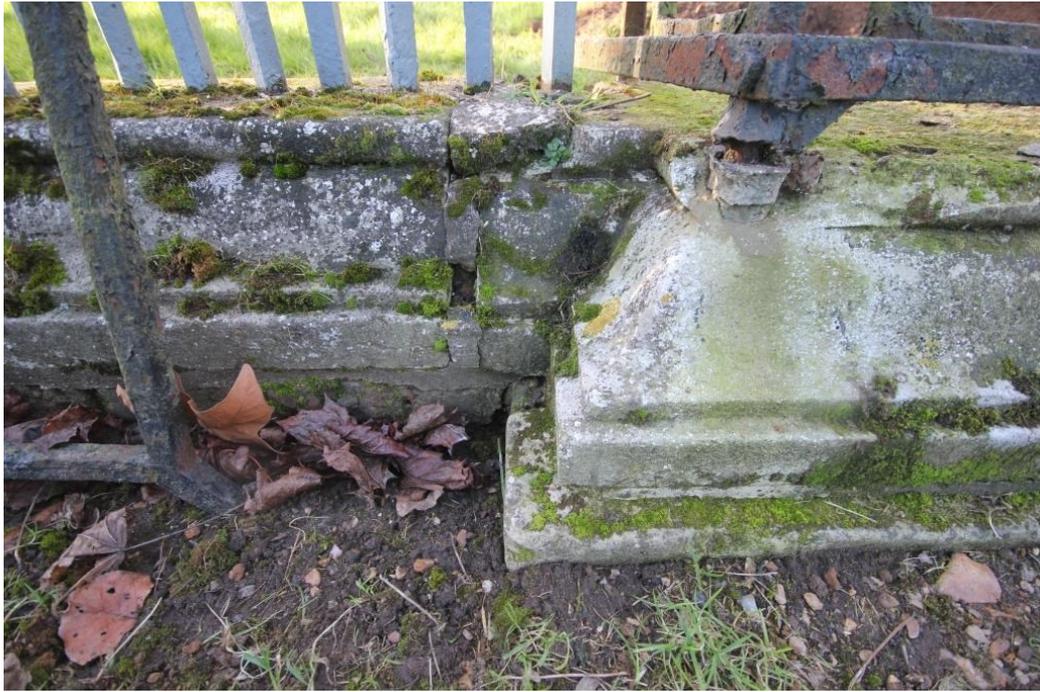
4.9 The plinth located to the south of the gate threshold, **context 1008** (Figs. 2 and 6), was not observed in its entirety but must be of the same quality and build as context **1006**. Unlike the north plinth, the groove present on the north face of the stone aligns with both the hinge socket fitted into the threshold stone **1001** and with the groove and installation on the plinthstone cap **1007**. Nevertheless, **context 1007** above does not align perfectly with the plinthstone below, sitting 0.03 m further to the west, overhanging the threshold. This southern plinthstone is in a fairly poor state of preservation compared to **1005**. Its western face is badly damaged and appears to have broken away, resulting in a reduced-sized block measuring 0.68 m x 0.58 m x 0.2 m.

**Figure 6: Break on the southern plinthstone**

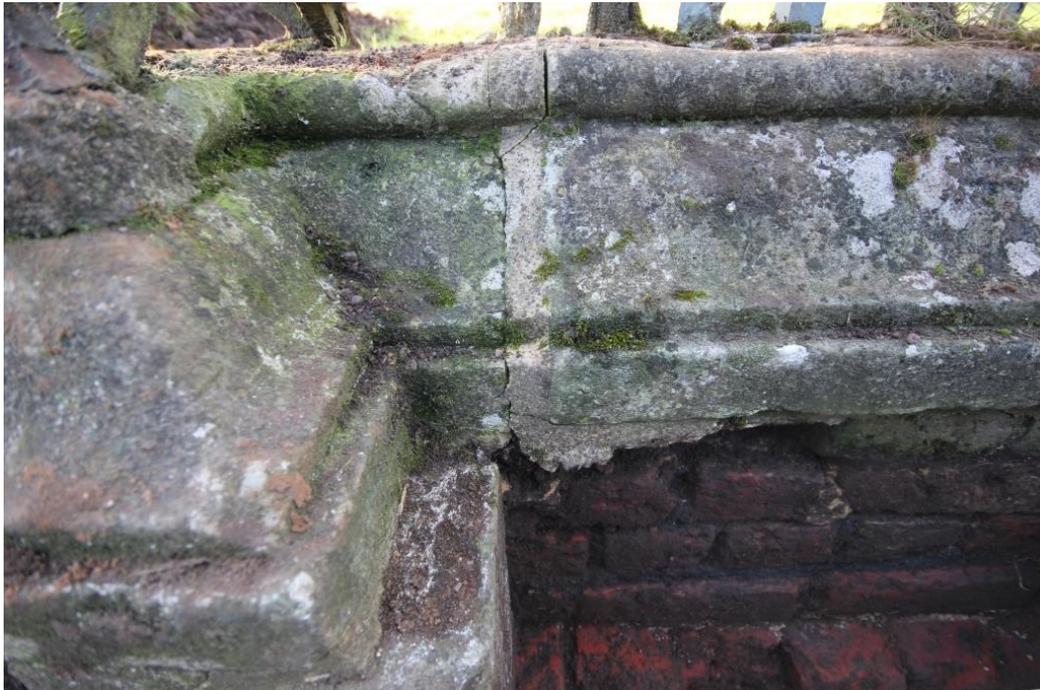
4.8 The plinthstone cap on the southern side (**context 1005**) measures 0.67 m x 0.67 m x 0.2 m and is comprised of a finely dressed Portland stone block with scotia-like mouldings (Figs. 2 and 7). A clear break in the stone was observed 0.2 m to the north of the main body of the plinth or footing similar to the one observed on the southern side associated with plinth **1007**. As mentioned in section 3.6, this plinth is around 0.05 m off-centre to the south in relation to the footing below. The groove visible on the south face of the plinth measures 0.04 m in width with a depth of 0.08 m. This feature is of course associated with the gate fittings but is no longer aligned with the hinge socket inserted into the threshold step **1001** or the grooves observed in the stone plinthstone **1006**.

**Figure 7: Break on the northern plinthstone**

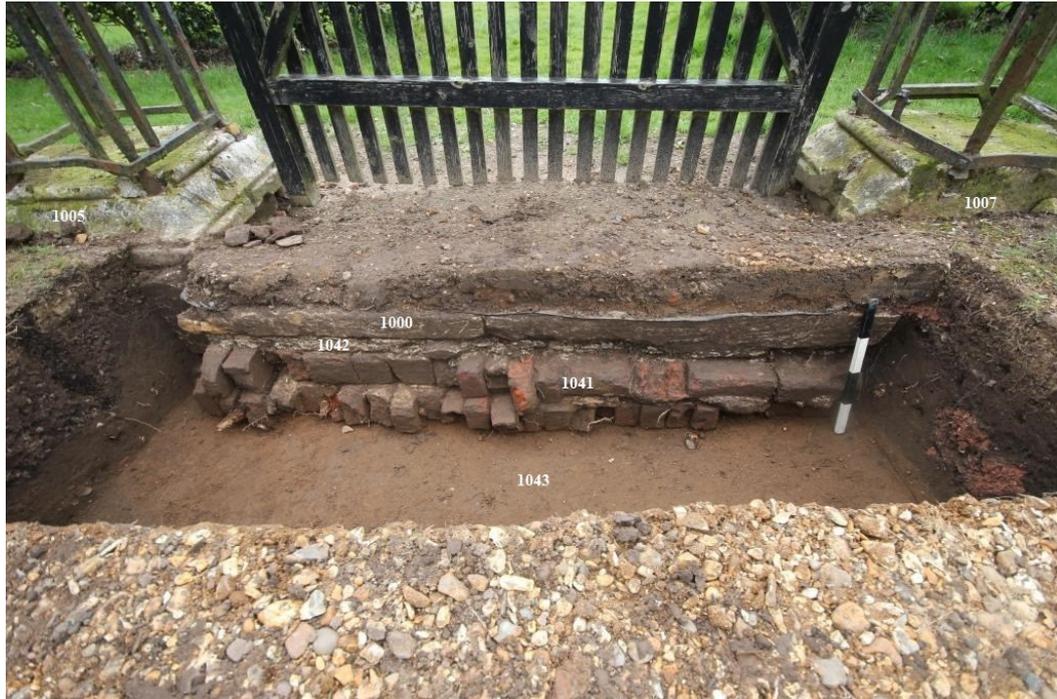
4.10 **Context 1041** was observed in Trench V and refers to a brick foundation supporting the Ketton stone step **1000** (Fig. 8). It measures a total of 1.85 m in length with a height of 0.24 m and roughly a width of 0.45 m. It is comprised of two courses of bricks which are roughly organised

Figure 8: Trench V on the western side of the 20th Century Garden gate threshold

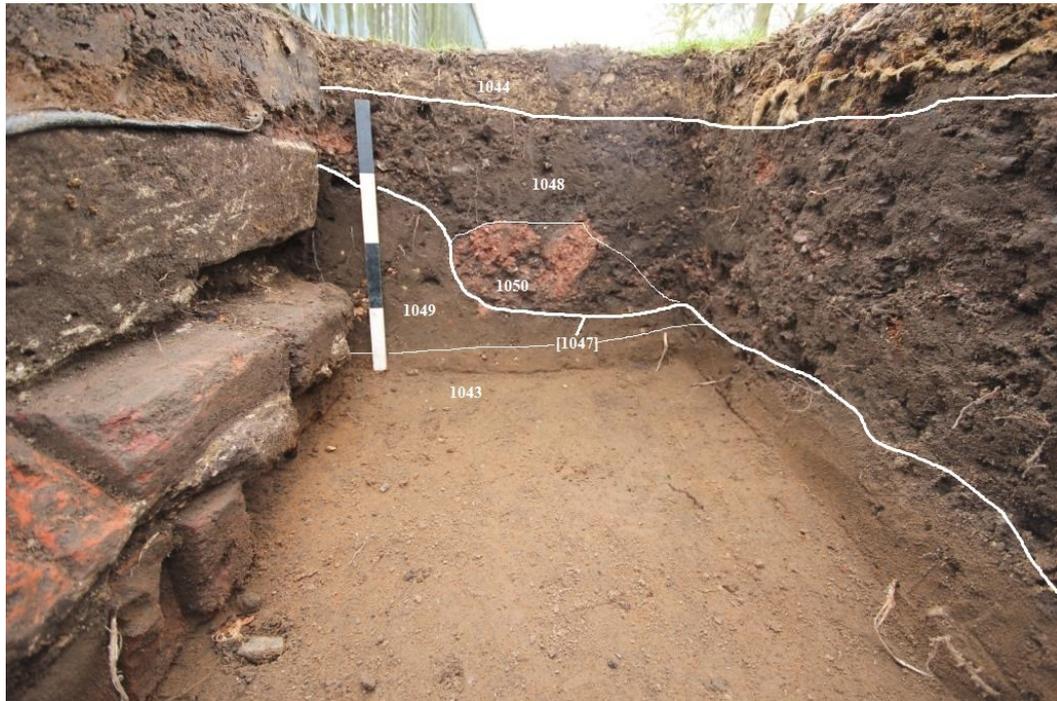
- 4.14 **Context 1047** is a later feature observed in Trench V that truncates context **1049**, a friable silty sandy layer with flecks of charcoal and occasional fragments of CBM, which is probably the equivalent of **1010** observed in Trench I. **Cut 1047** (Fig. 9) is a linear feature with a dissymmetrical profile and a rounded base, the extent in terms of the width and length is unknown but its depth was recorded at 0.34 m. It is filled at the base by **1050**, which was observed only in the north-facing section of Trench V, and is composed of coarse compact pinkish gravels in a clayey sandy soil, flecks of which could be seen further towards the surface of this linear feature, possibly reworked due to bio-turbation. The secondary fill is composed of

Figure 9: North-facing section in Trench V showing gully 1047

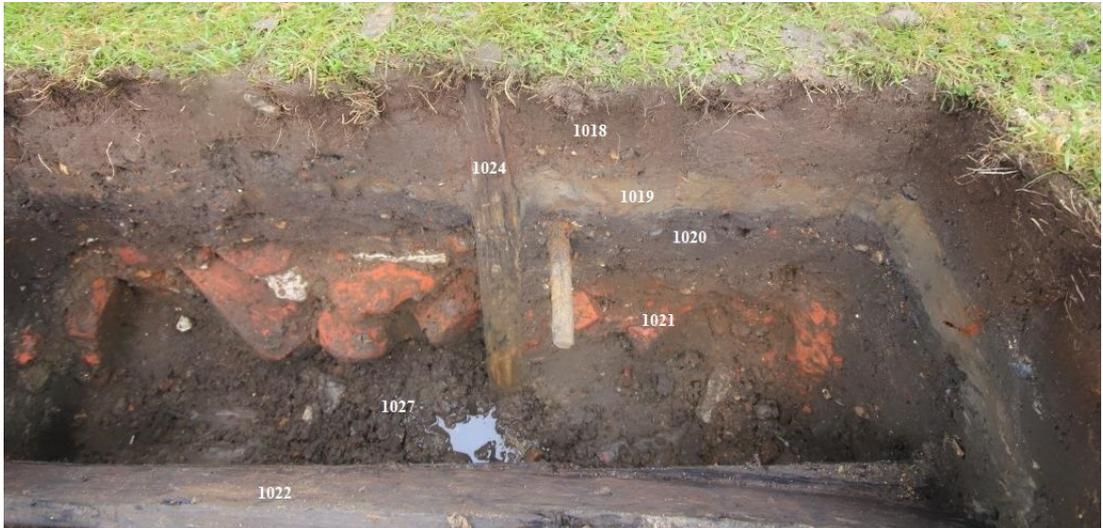
A total of 14 contexts were recorded in Trench II (**contexts 1015 – 1028**, Fig 11), which was excavated by one of the Hampton Court gardeners and located against the western side of the canal on the same line as the beech hedge in the 20<sup>th</sup> Century Gardens. The earliest feature recorded was the timber shoring, **context 1022**, which consists of a 0.11 m wide plank of wood with a thickness of 0.02 m and angled at around 70°. This sits on top of larger wooden planks measuring 0.22 m in width. This wooden structure is further supported by a timber post, **context 1023**, which measures 0.85 m x 0.85 m. The date of this construction is unknown but it would seem to be an earlier structure supporting the walls of the Fountain Garden canal, but whether this is the original shoring inserted during the Queen Anne's reign remains undetermined.

**Figure 11: Trench II, east-facing section**

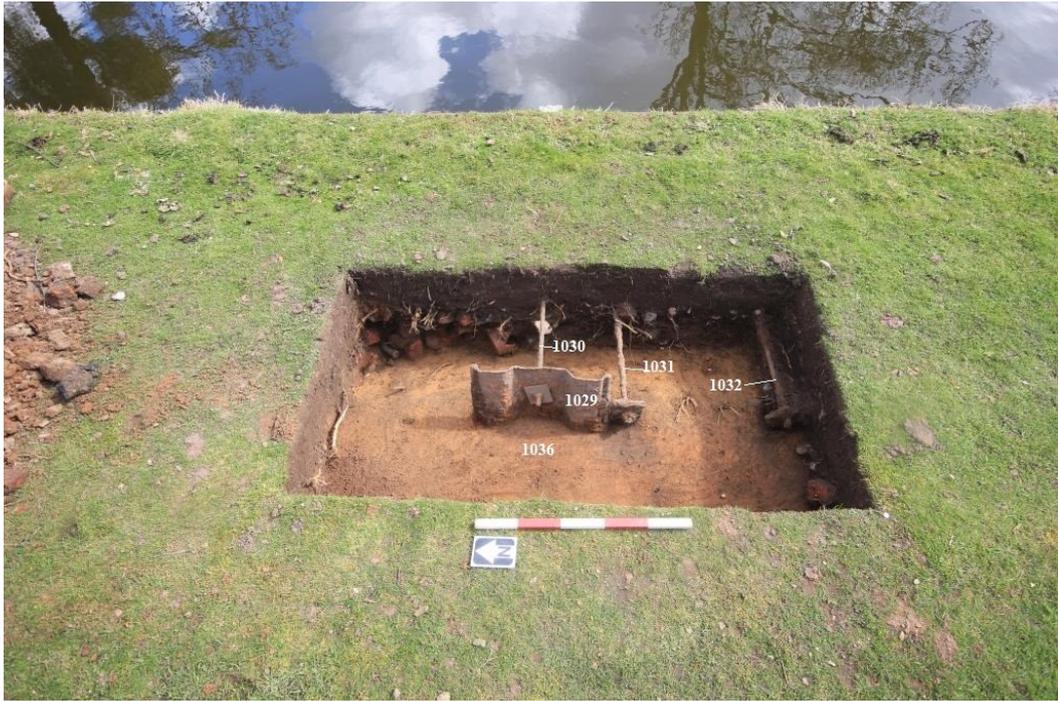
Trench III (Figs. 12 and 13) was located 0.85 m west of the western edge of the Fountain Garden canal directly in line with the 20<sup>th</sup> Century Garden Gate where the location of the temporary bridge footings has been proposed. The trench measured 2m x 0.8 m with a depth of up to 0.4 m. A total of nine contexts were recorded (**contexts 1029 – 1037**).

Figure 12: Trench III

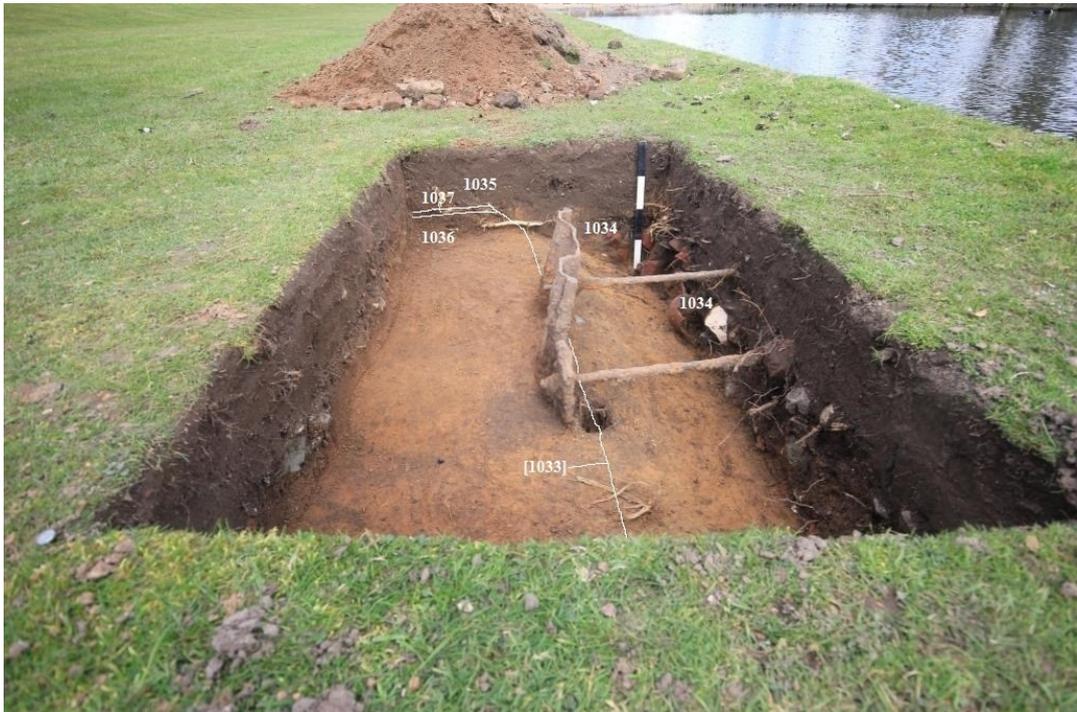
At the base of the trench a layer of coarse grained sand was uncovered showing high levels of bio-turbation. This is overlain by context **1037**, a thin patchy lens of silty sandy gravels containing a fair amount of CBM and sherds of pottery. Both these contexts are truncated by **cut 1033**, a north south linear feature with a depth of 0.19 m presenting a concave profile and a rounded base. The width and length of this feature is unknown. It is filled by **1034**, a silty sandy

Figure 13: Gully 1033 in Trench III

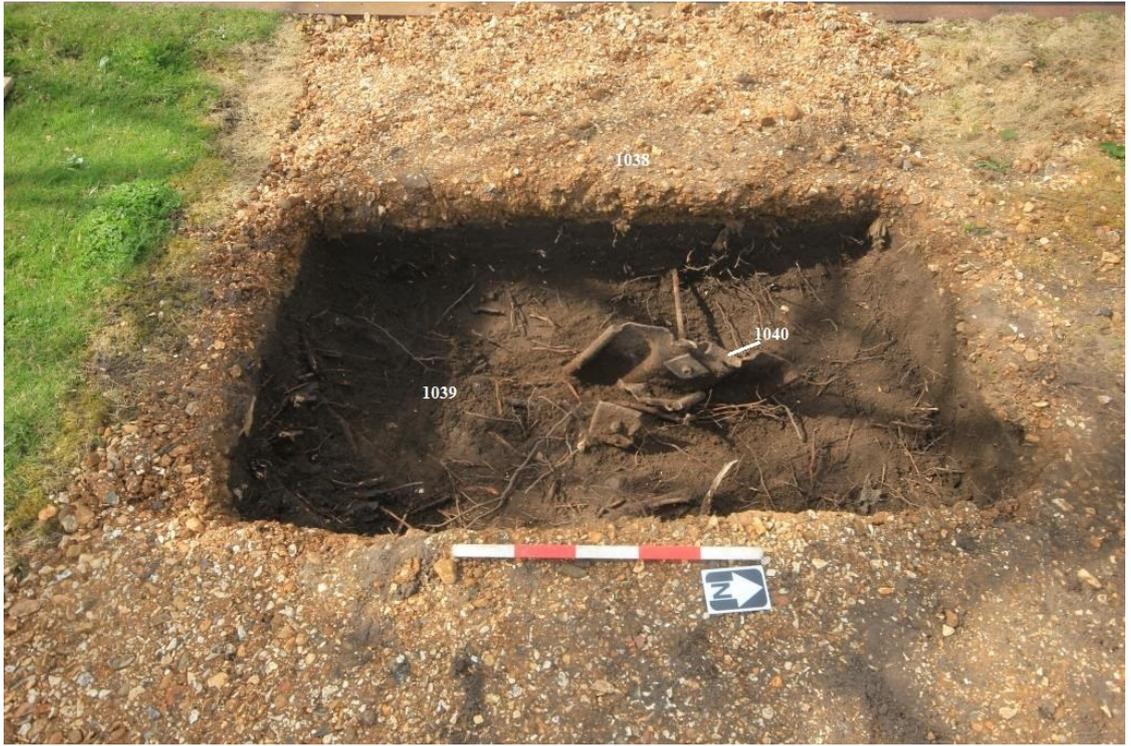
Trench IV (Fig. 14) was located directly opposite Trench III on the eastern side of the canal 0.85 m away from the edge and in line with the 20<sup>th</sup> Century Garden Gate. The trench measured 2 m x 0.65 m with a depth of 0.5 m. A total of nine contexts were recorded (**contexts 1041 – 1050**). This area is heavily affected by the presence of tree roots and the trench was not excavated beyond the topsoil (**1039**), which reached a depth of at least 0.4 m. However, sufficient depth was reached in order to observe the presence of the piling tie-back system (**context 1040**) also observed in Trench III on the western side of the canal. In this trench it appears to have been heavily affected by corrosion and disturbed by tree roots.

**Figure 14: Trench IV**
