**Nails from the wood panelled nave ceiling of
Peterborough Cathedral**

Nails from the wood panelled nave ceiling of Peterborough Cathedral

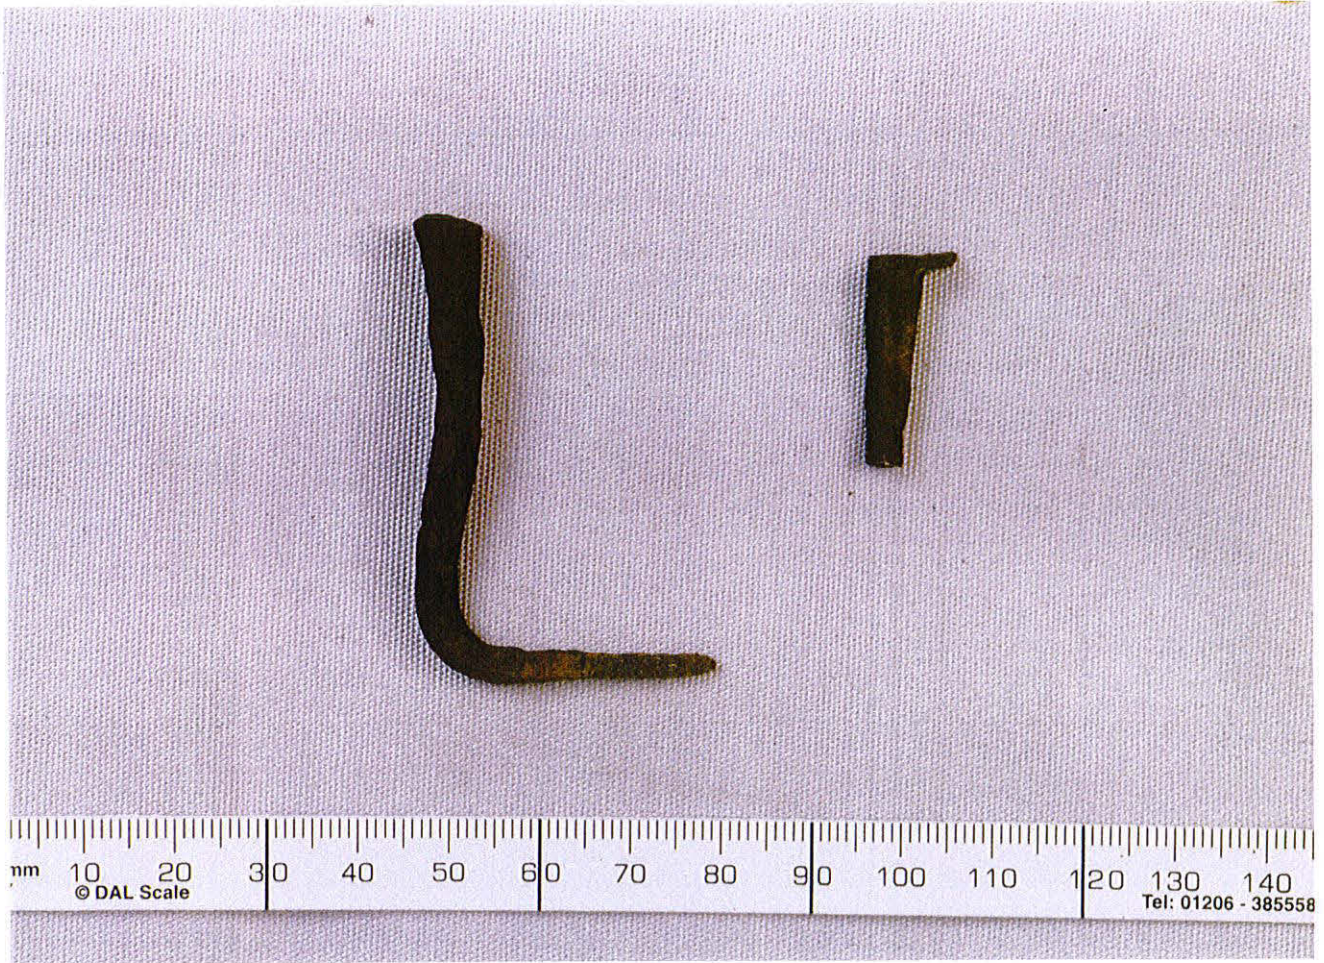
Fig 4. Nails from birds-beak joints of the longitudinal struts, part of the original ceiling construction above the wooden panels (most of heads missing).

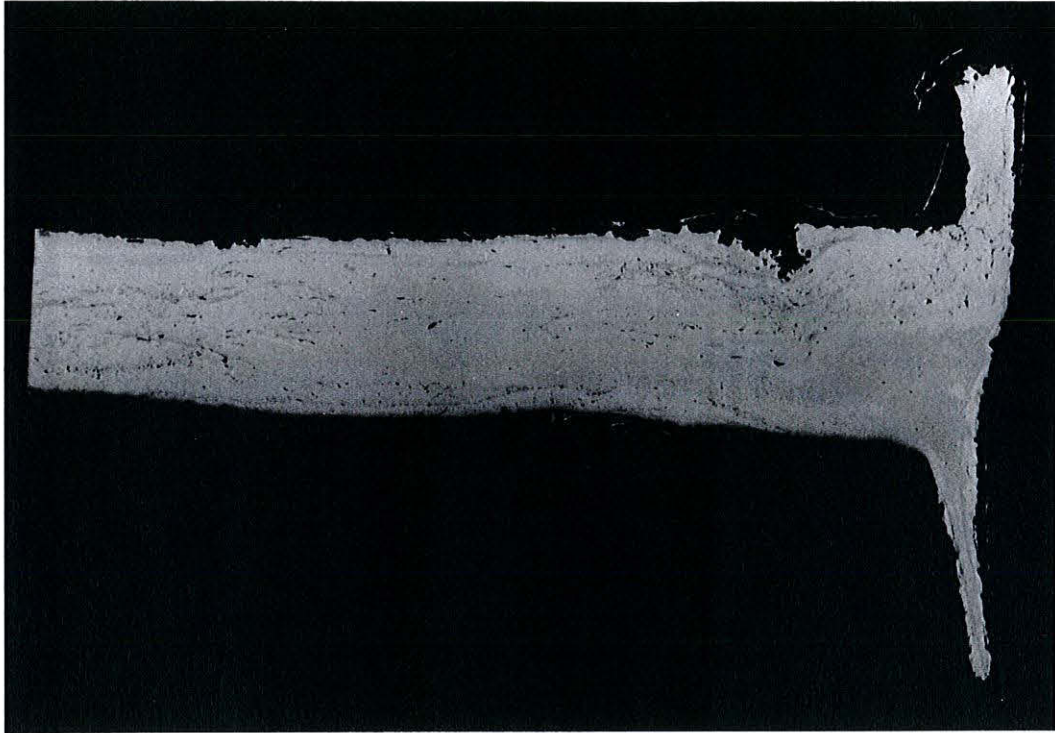
Fig 5a. Photomicrograph of a longitudinal section through one of the early 'birds-beak' fixing nails: magnification x 6; etched 2% nital.
