Lower Ponthendre, Longtown, Herefordshire

Heritage Statement

Report No. 1156

August 2013

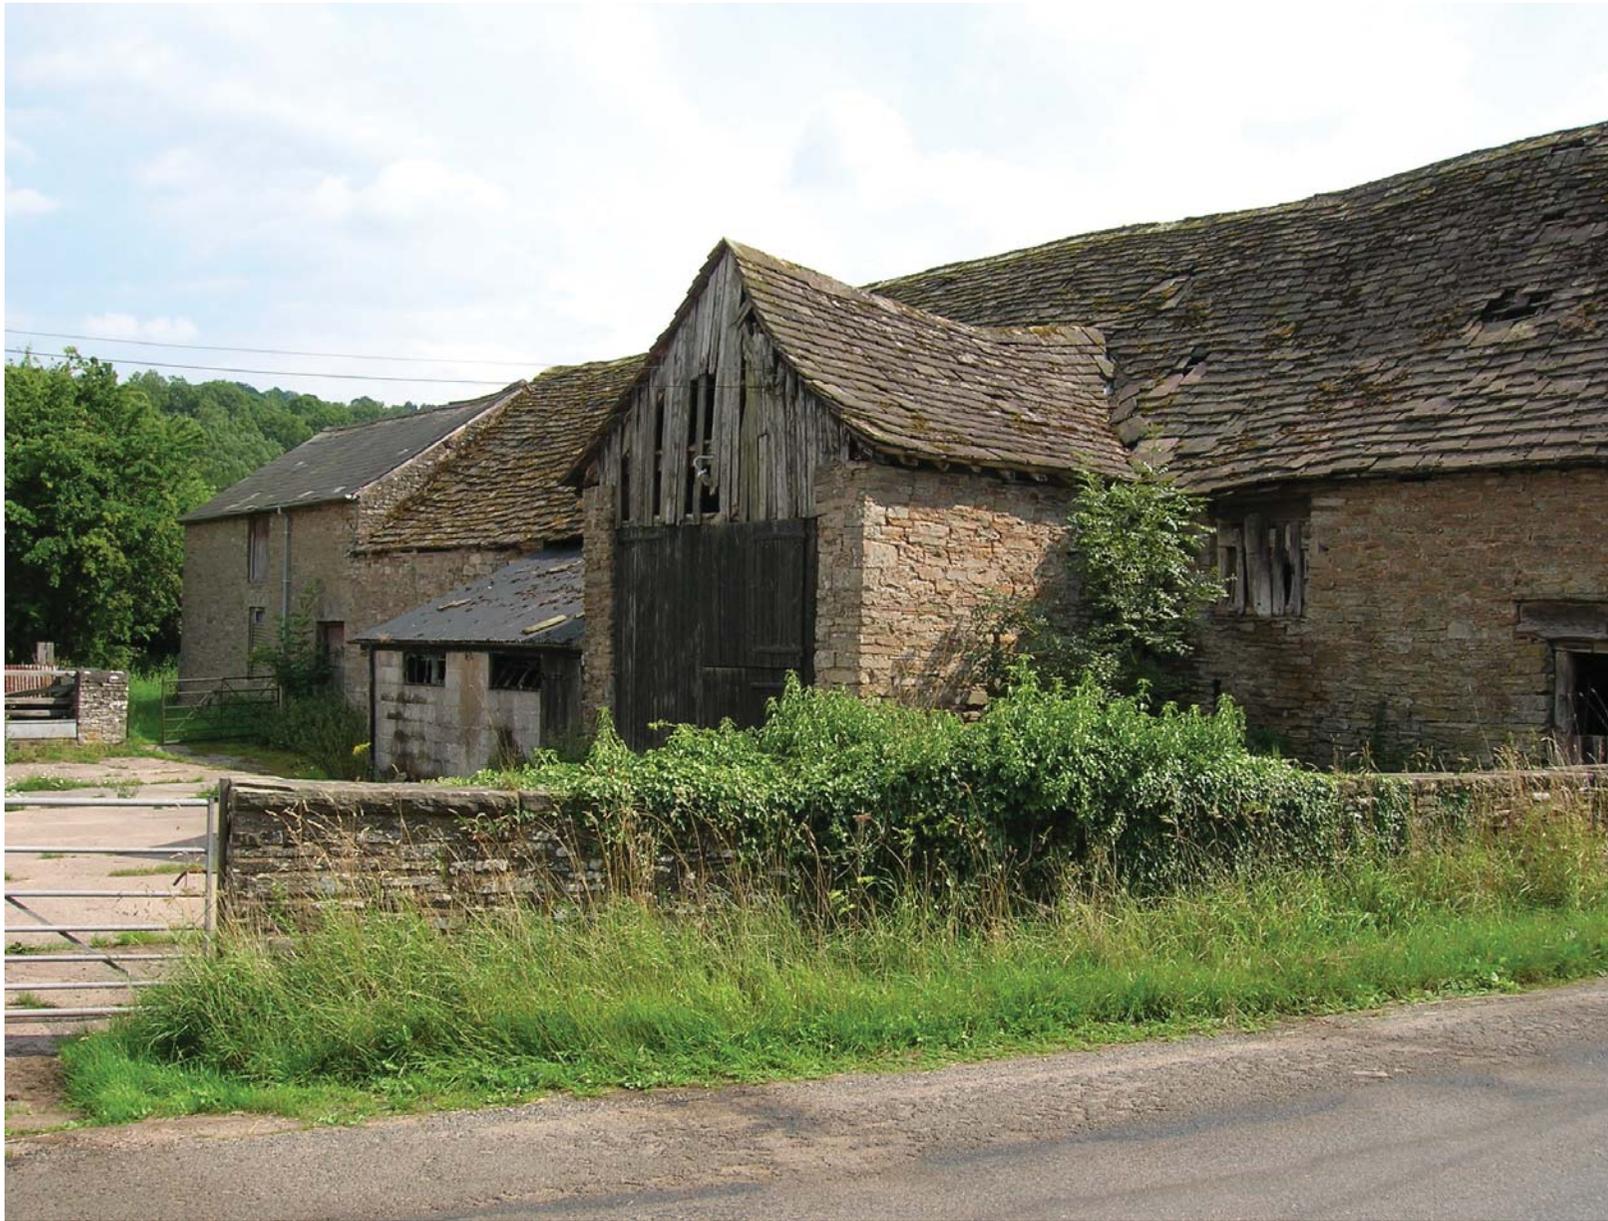
The barn is roughly oriented east-west and consists of sandstone rubble walls supporting a timber roof covered in stone slates (Plate 2). The external walls are about 2 feet thick. The western gable is built in stone. A double-storey cowshed or stable, with loft over, has been built against the eastern end of the barn.

The roof structure of the barn consists of principal rafters connected to tie-beams sitting on inner and outer wall plates. Within the first five bays there are some raking struts (at a 60 degree angle from the tie-beam) connecting the principal rafters and tie-beams with pegged mortice and tenon joints. There are also some straight collars with pegged lap joints to principal rafters. There are three sets of purlins. At the western end of the barn the purlins have been trenched into the principal rafters, with splayed scarf joints. The remaining purlins are staggered and may be 19th century replacements. There is a ridge purlin at the west end, with ridge planks in the eastern part of the five-bay barn. The common rafters appear to date from the 18th or 19th century. The rafters have been notched into the outer wall plates and extend to overhang the eaves by about a foot. The roof battens are 20th century and not substantial enough to support the stone roof tiles. The principal rafters, tie beams, struts, purlins and common rafters all appear to be in fairly good condition.

Plate 2: The 17th century barn

The main roof timbers are to be retained and the roof design and pitch is to remain unaltered. The rafter trusses and purlins date from the 17th century construction of the barn. The proposals include the potential addition of wooden or metal struts and/or collars for principal rafter trusses at the eastern end of barn. Some of the purlins might need to be strengthened and the ridge plank replaced at eastern end of the barn. It may be necessary to strengthen or replace some of the common rafters. Furthermore, the 20th century battens will need to be replaced with more substantial battens or boards. Like-for-like replacement may be required along sections of the inner and outer wall plates. Any additional or replacement timbers required for the roof will be subject to approval by the Conservation Officer. This work will ensure the long-term stability of the timber roof and the building as a whole.

The stone roof is to be repaired using locally sourced material. The slates are to be laid in the same style as existing. The materials (stone slates and mortar) used for the roof are to be approved by the Conservation Officer. The same overhang from the eaves is to be maintained over the barn walls and the two porches. No additional

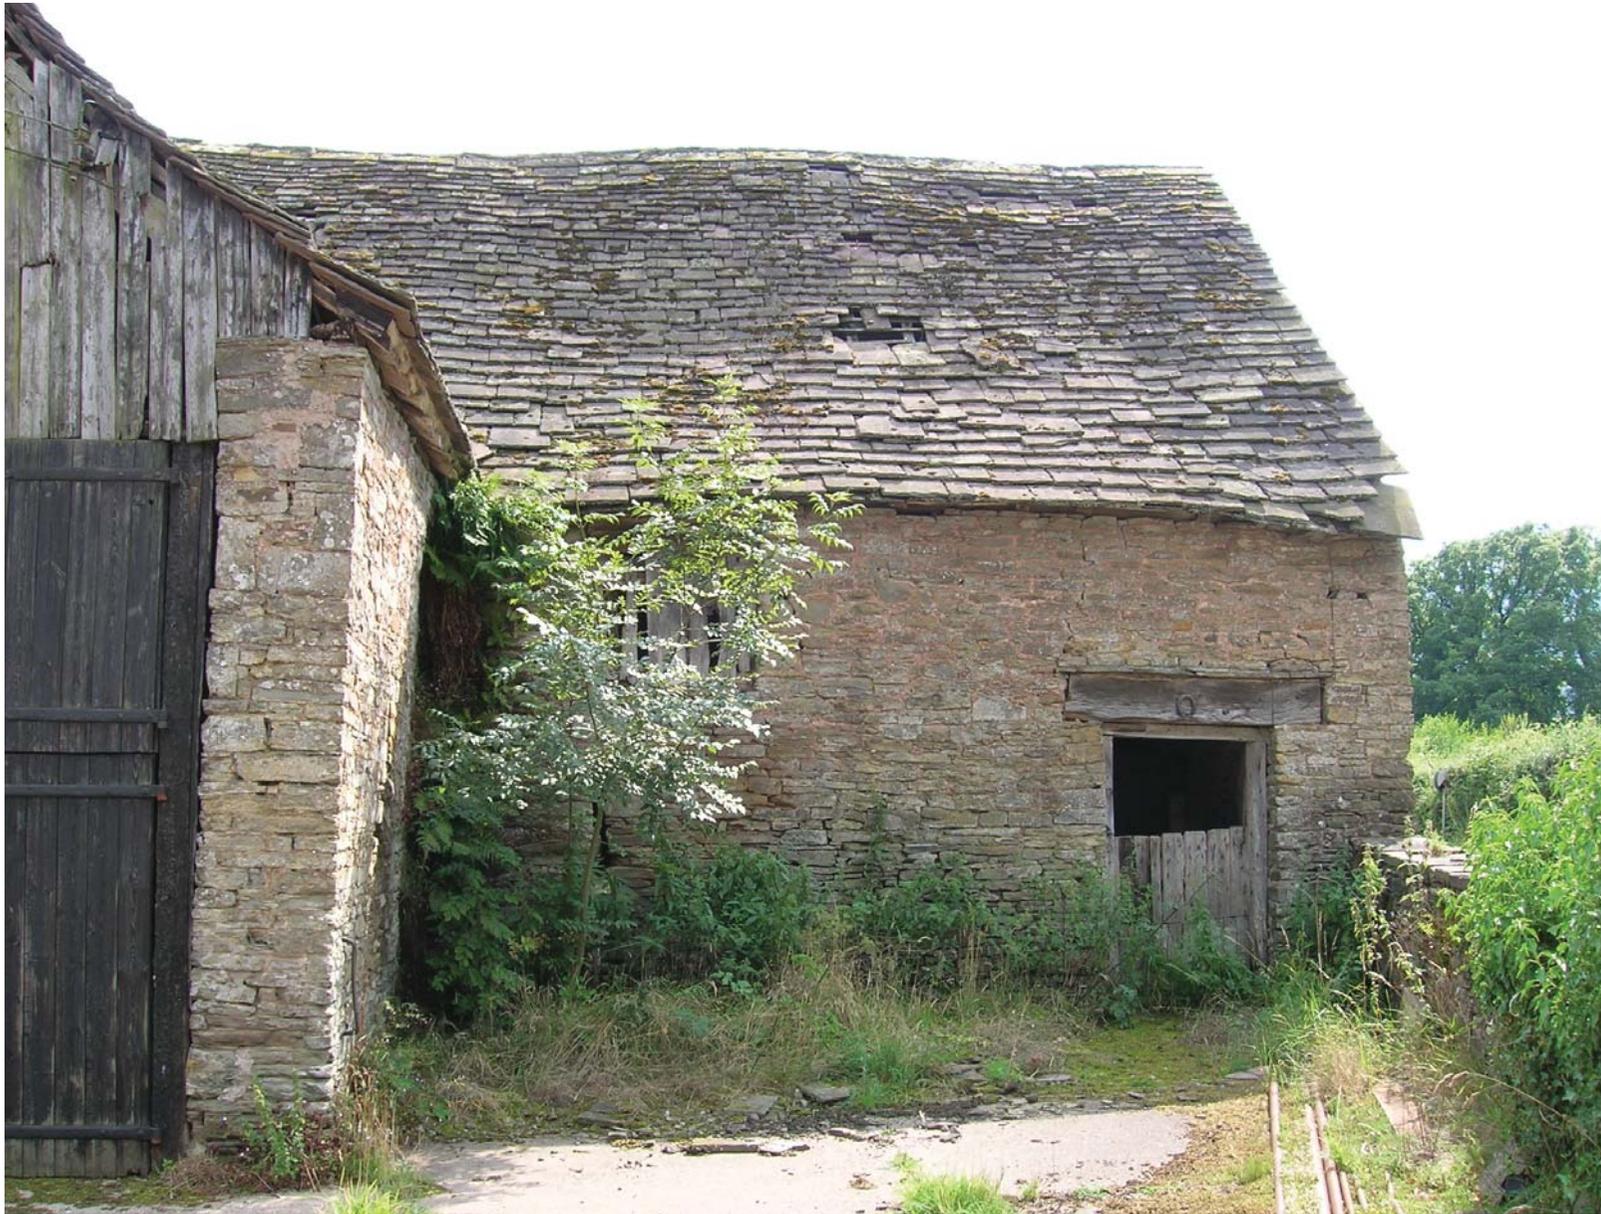
This structure appears to have been built as part of the barn (Plate 3). There is an internal stone wall (with substantial timber wall plate) separating the shed from the main barn. The planking against the wall plate and roof truss demarcate the hayloft above. There are doorways to this shed on the northern and southern elevations. A

window is located on the western gable as well as a pitch hole to the loft in the upper section of this wall. A wooden partition was noted within the shed as well as wooden feeding troughs and racks. The hay loft has substantial floor joists with boards over. The joists appear to be original.

Plate 3: The cowshed at the western end of the barn (17th Century)

The ceiling of the former cowshed is to be raised, necessitating the removal of the extant joists. These timbers potentially date from the 17th or 18th century. The benefits to the viability of Unit 1 arising from this proposal are considered to outweigh the harm caused to the building fabric.

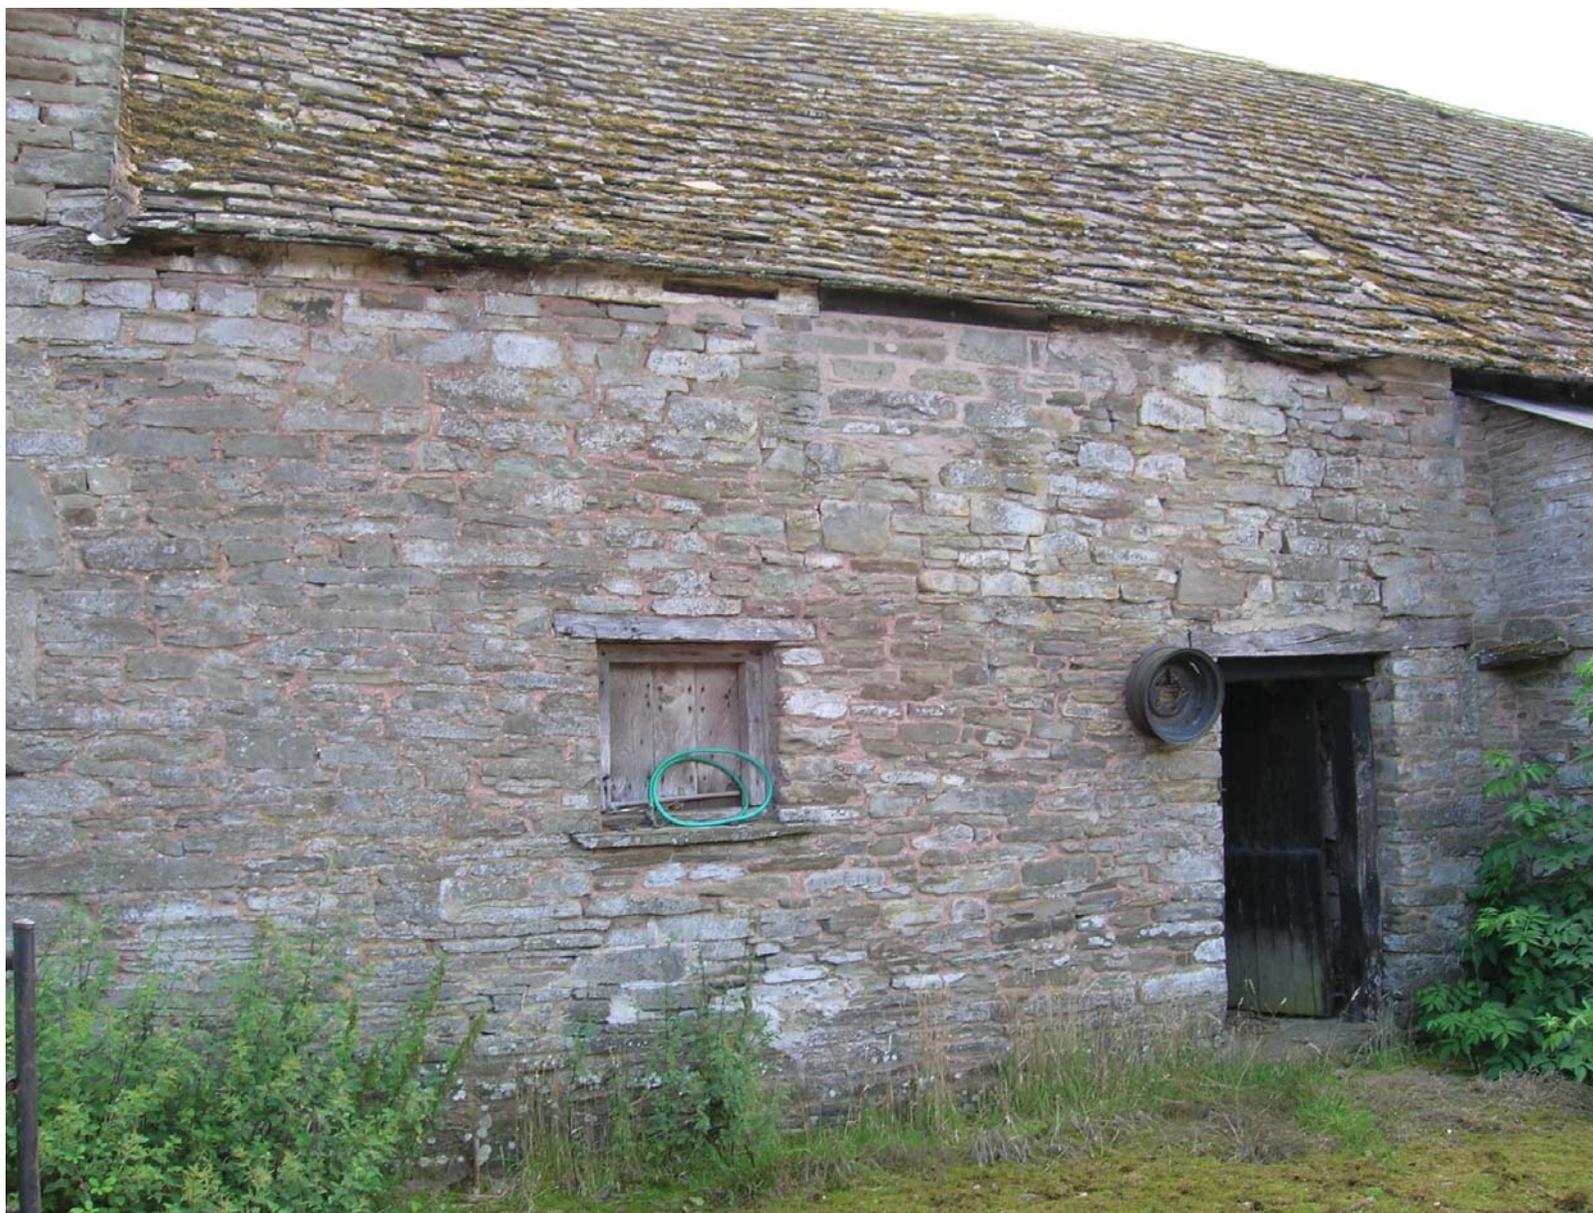
The doorway to this shed is on the northern elevation, leading off the main farmyard (Plate 4). There is also a small window of crude frame construction with a wooden shutter. The layout is designed to house two rows of cows at the northern and southern end of shed with a feeding passage between. There are no doorways to the rear (south) or at the end of the feeding passage (to the east). An opening is positioned on the western wall, leading to the barn; although it is not clear if this is original. Wooden feeding racks were noted along with at least one stone feeding trough. The floors are concrete with slurry drainage channels. The loft has substantial joists with boards over: this floor has partly collapsed. The extant floor joists appear original.

The northern wall of the cowshed appears to have been raised at some point, as the upper stonework is of different construction. This stone wall is about a foot wide, in contrast to the two foot thick barn walls. It is probable this upper section of wall was built to extend the barn roof to encompass the cowhouse. At present it is not clear how this end of the barn has been extended. There is no evidence for a stone gable at this side of the five-bay barn, which could mean that the western wall of the cowshed formed part of the eastern end of the five-bay barn. The cowshed abuts the northern wall of the barn, and the internal stonework is poorly tied into the main barn on the southern elevation.

The dormer above the cowhouse has been removed at some point as this opening has been infilled with new stonework (and roof tiles inserted above). The position of the old opening is clearly marked by a gap in the outer wall plate.

Plate 4: The cowshed at the eastern end of the barn (17th or 18th Century)

The stone wall that forms the southern elevation of the barn may need to be repaired as part of the works for the party wall. The stonework appears to be poorly tied together where the cowshed meets the original barn. The repair of this wall would lead to the long-term stability of the listed building. The methodology for tying together the stonework is to be approved by the Conservation Officer to ensure the stability of the barn wall during this work.

The ceiling of the former cowshed is to be raised, necessitating the removal of the extant joists. These timbers potentially date from the 17th or 18th century. The benefits to the viability of Unit 2 arising from this proposal are considered to outweigh the harm caused to the building fabric.

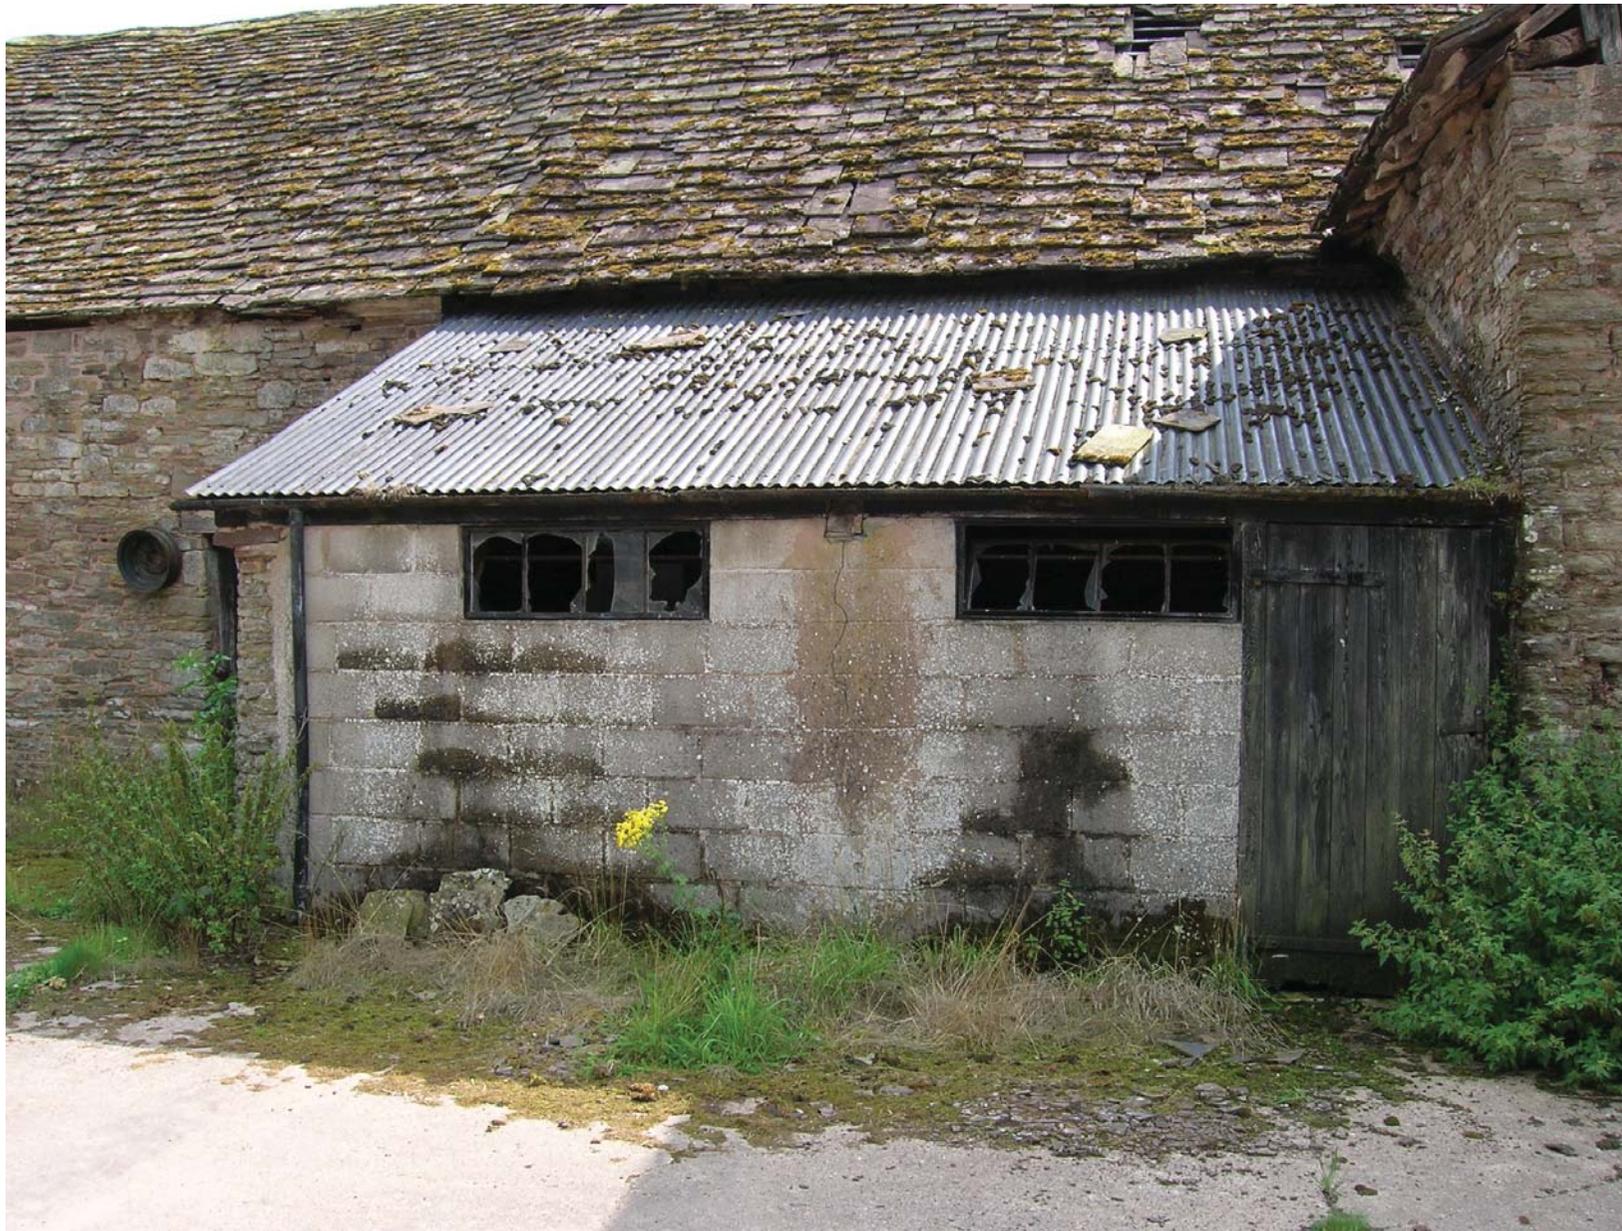
This single-storey structure appears to have originated as a shelter shed for loose cattle (Plate 5). This outshut would have been open to the main farmyard.

The roof structure comprises a single truss of contemporary size and construction as the main barn. Originally there were two purlins trenched into the principal rafter, but these have been replaced with 20th century timbers supporting a corrugated steel roof.

Plate 5: The shelter shed on the northern side of the barn (17th or 18th Century)

The main rafter truss is to be retained; this is of probable 17th or 18th century date. Additional wooden or metal struts or bracing is to be inserted subject to approval by the Conservation Officer. New roof are proposed and a new slate roof is to replace the existing corrugated steel (with the roof pitch unaltered). The rainwater gutters are

also to be repaired or replaced. The new roof will provide a significant visual improvement to the character of the listed building.

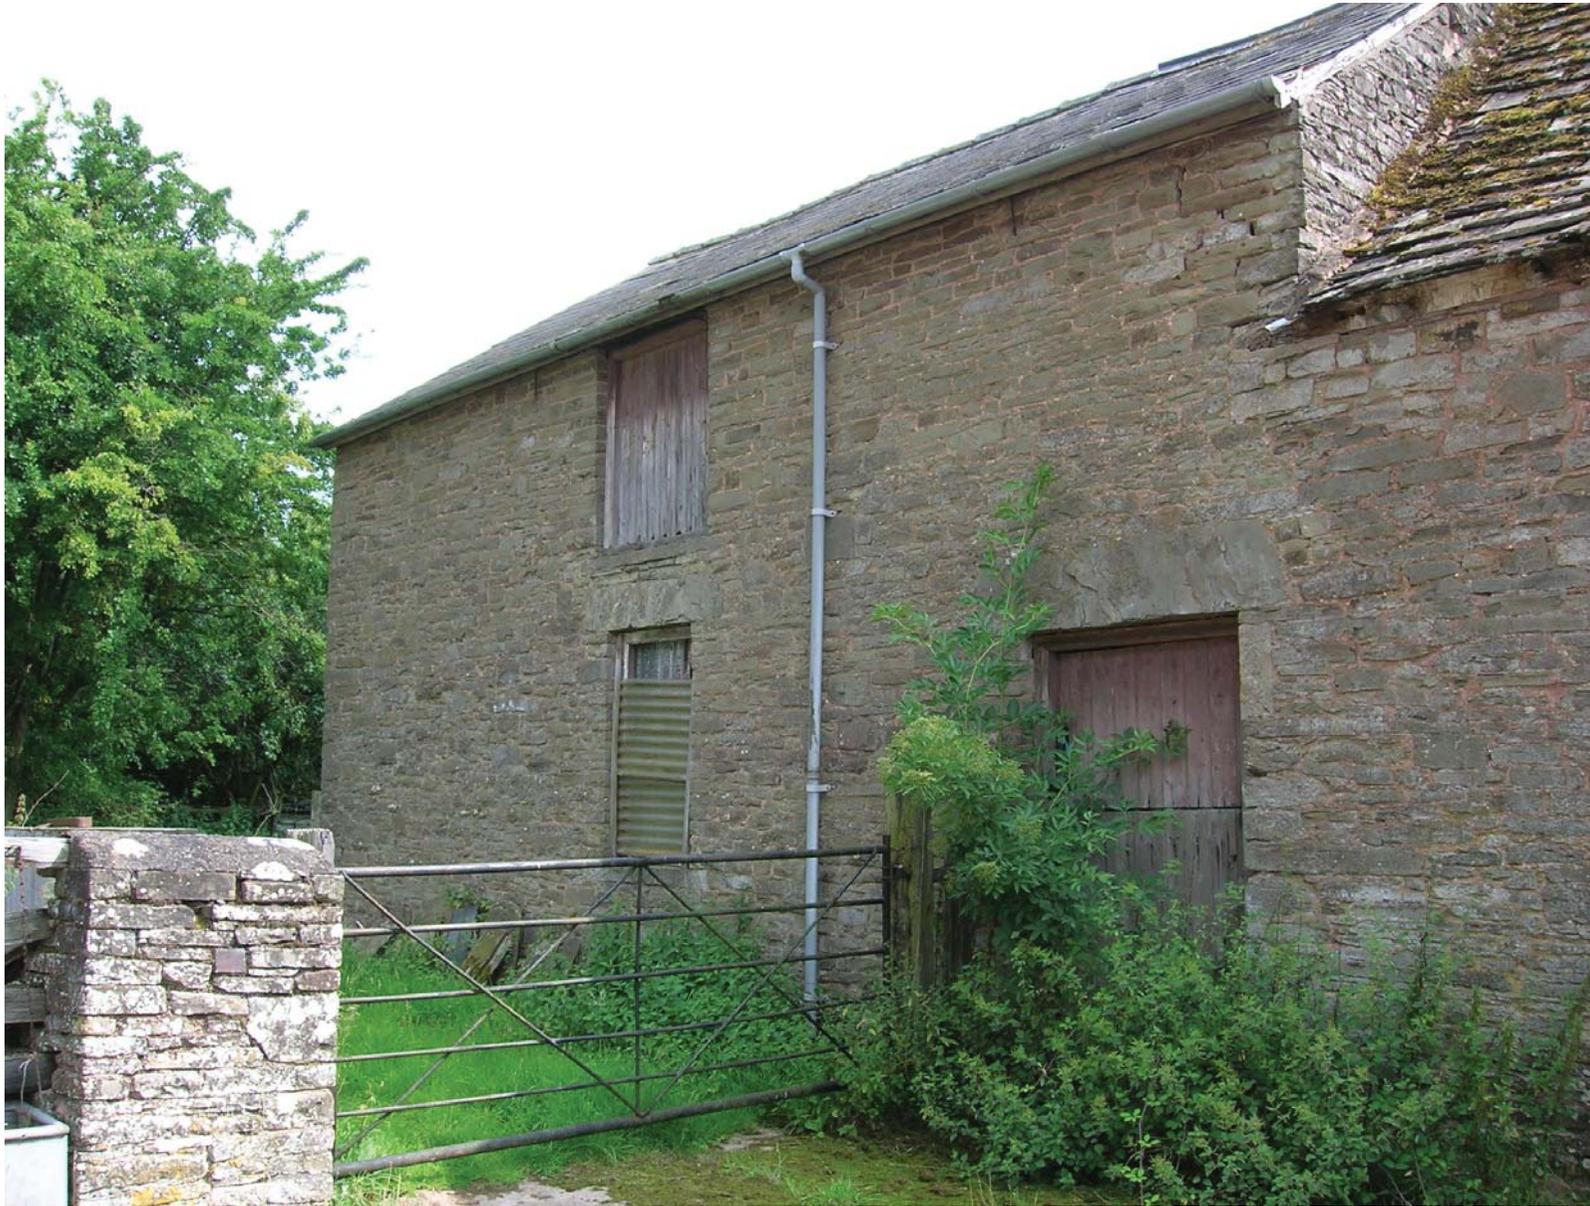
A large two-storey building is situated at the eastern end of the present eight-bay barn (Plate 6). This has been built in sandstone rubble, like the barn, with the stonework neatly tied into the pre-existing structure. The roof is of slate.

The lack of ventilation windows and the tall doorway located in the northern elevation suggest this building was used as stables with a hayloft above. The ground floor could also have been used for threshing, sorting or similar activity; it should be noted that part of a horizontal power spindle has survived on the eastern elevation. Further inspection of this building is required.

Plate 6: The 19th century stables adjoining the barn

The main roof timbers are to be retained. The purlins and rafters may need to be strengthened subject to the approval of the Conservation Officer. The roof design and pitch is to remain unaltered. The slate roof is to be repaired. The rainwater gutters are also to be replaced. This work will ensure the long-term stability of the timber roof and the building as a whole. The repaired roof will also be of visual benefit to the character of this building and the adjacent barn.

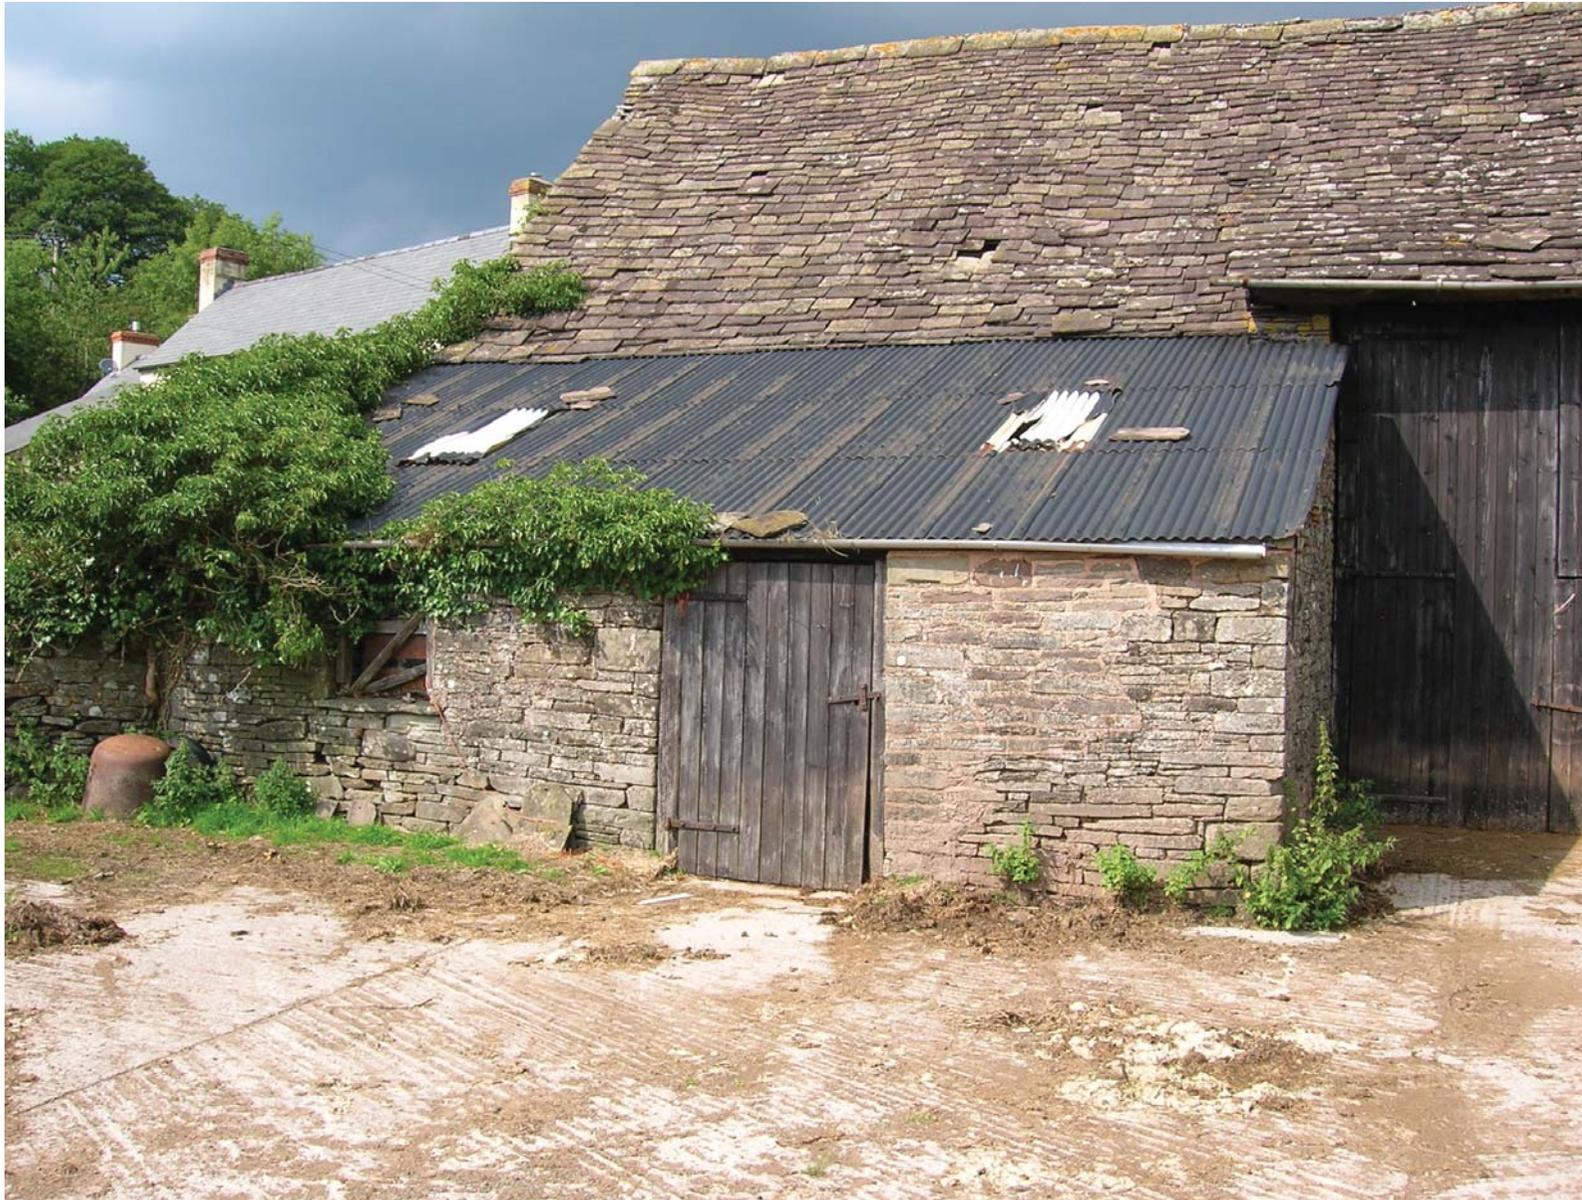
This outshut extends between the western end of the barn and the main double doors on the southern elevation (Plate 7). The walls are entirely built in sandstone rubble, with a low doorway to the yard at the south.

On the south side of the shed there is a small window, with a wooden shutter. The western wall abuts the gable end of the barn. The upper section of the eastern wall has been built off the wall flanking the main barn doors. This wall once had a window, but this opening and lintel above have subsequently been infilled with new stonework.

A low feeding trough was noted in the cowshed, set against the barn wall. The roof comprised 19th or 20th century rafters supporting sheets or corrugated steel or plastic.

Plate 7: The cowshed on the southern side of the barn (19th & 20th Century)

The remaining 20th century roof timbers are to be renewed. A new slate roof is to replace the existing corrugated steel with the roof pitch unaltered. The rainwater gutters are also to be replaced. The new roof will provide a significant visual improvement to the character of the listed building.

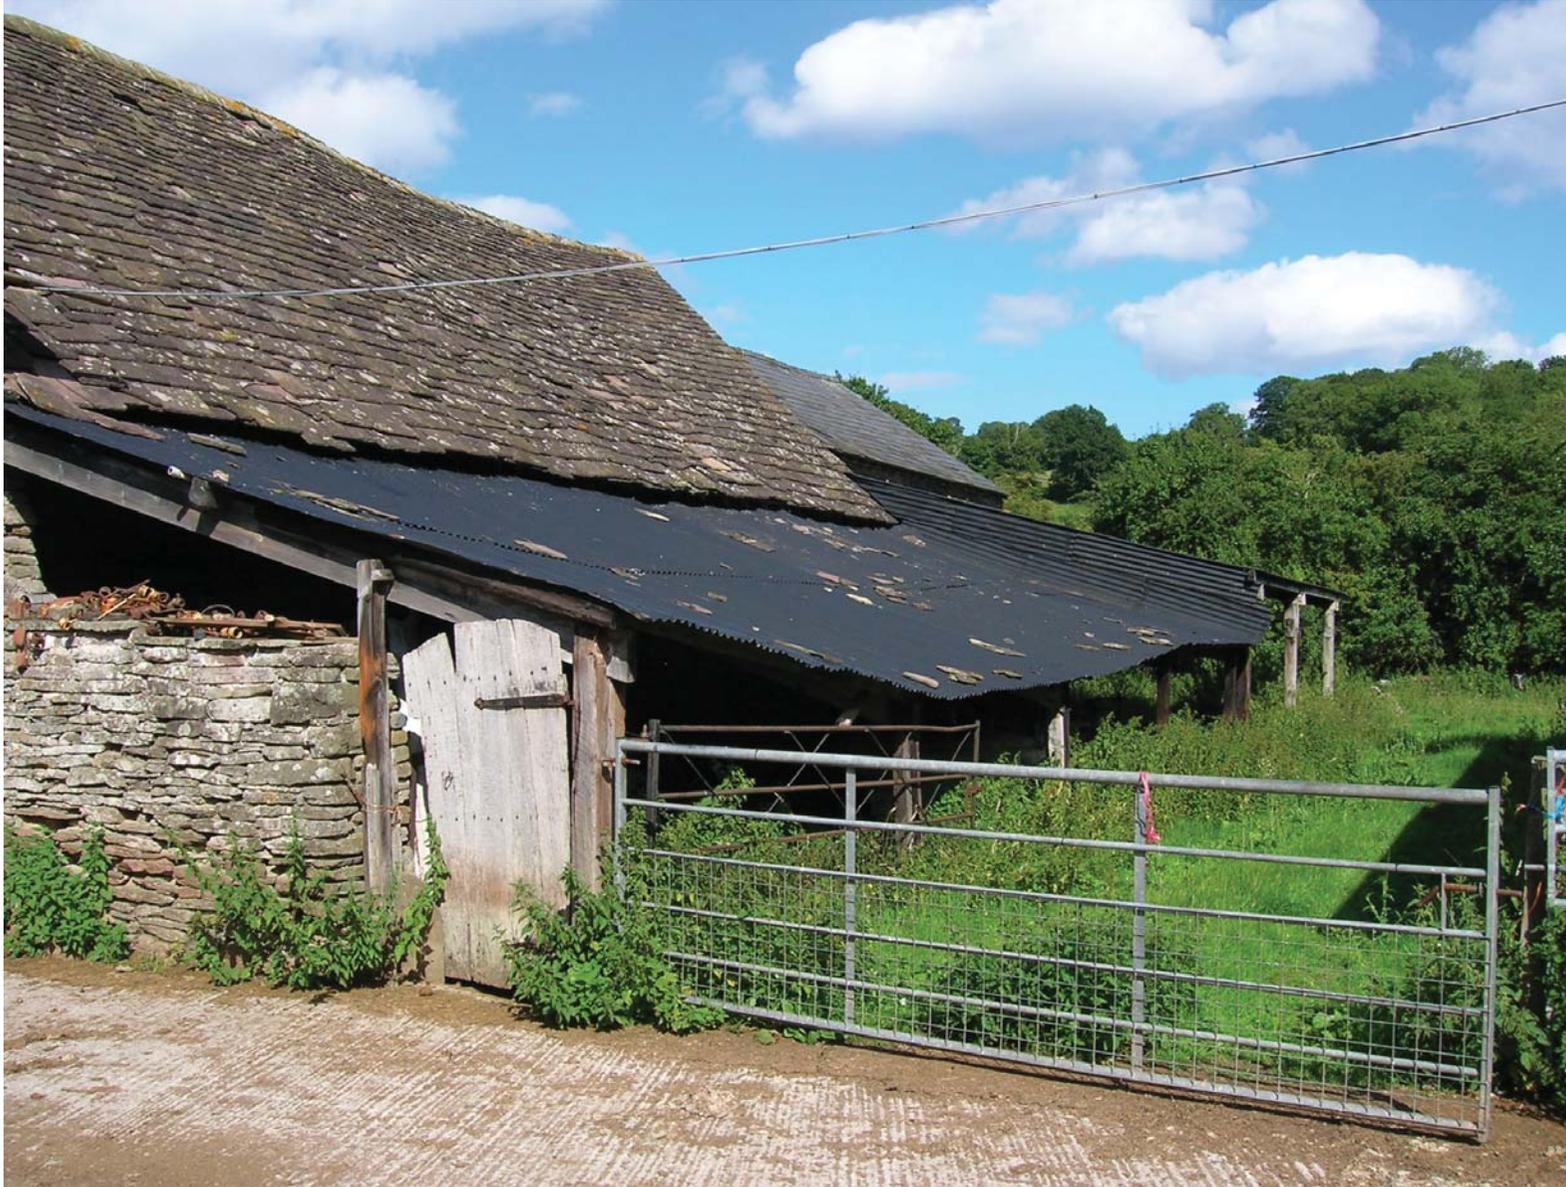
There are three open bays ranged along the southern side of the barn, east of the main barn doors (Plate 8). There are two additional bays on the southern side of the stables. The five bays are all of post-hole construction with 19th century and later timbers supporting a corrugated roof. These structures date from the late 1800's.

Plate 8: The cartlodge on the southern side of the barn and stables (19th & 20th Century)

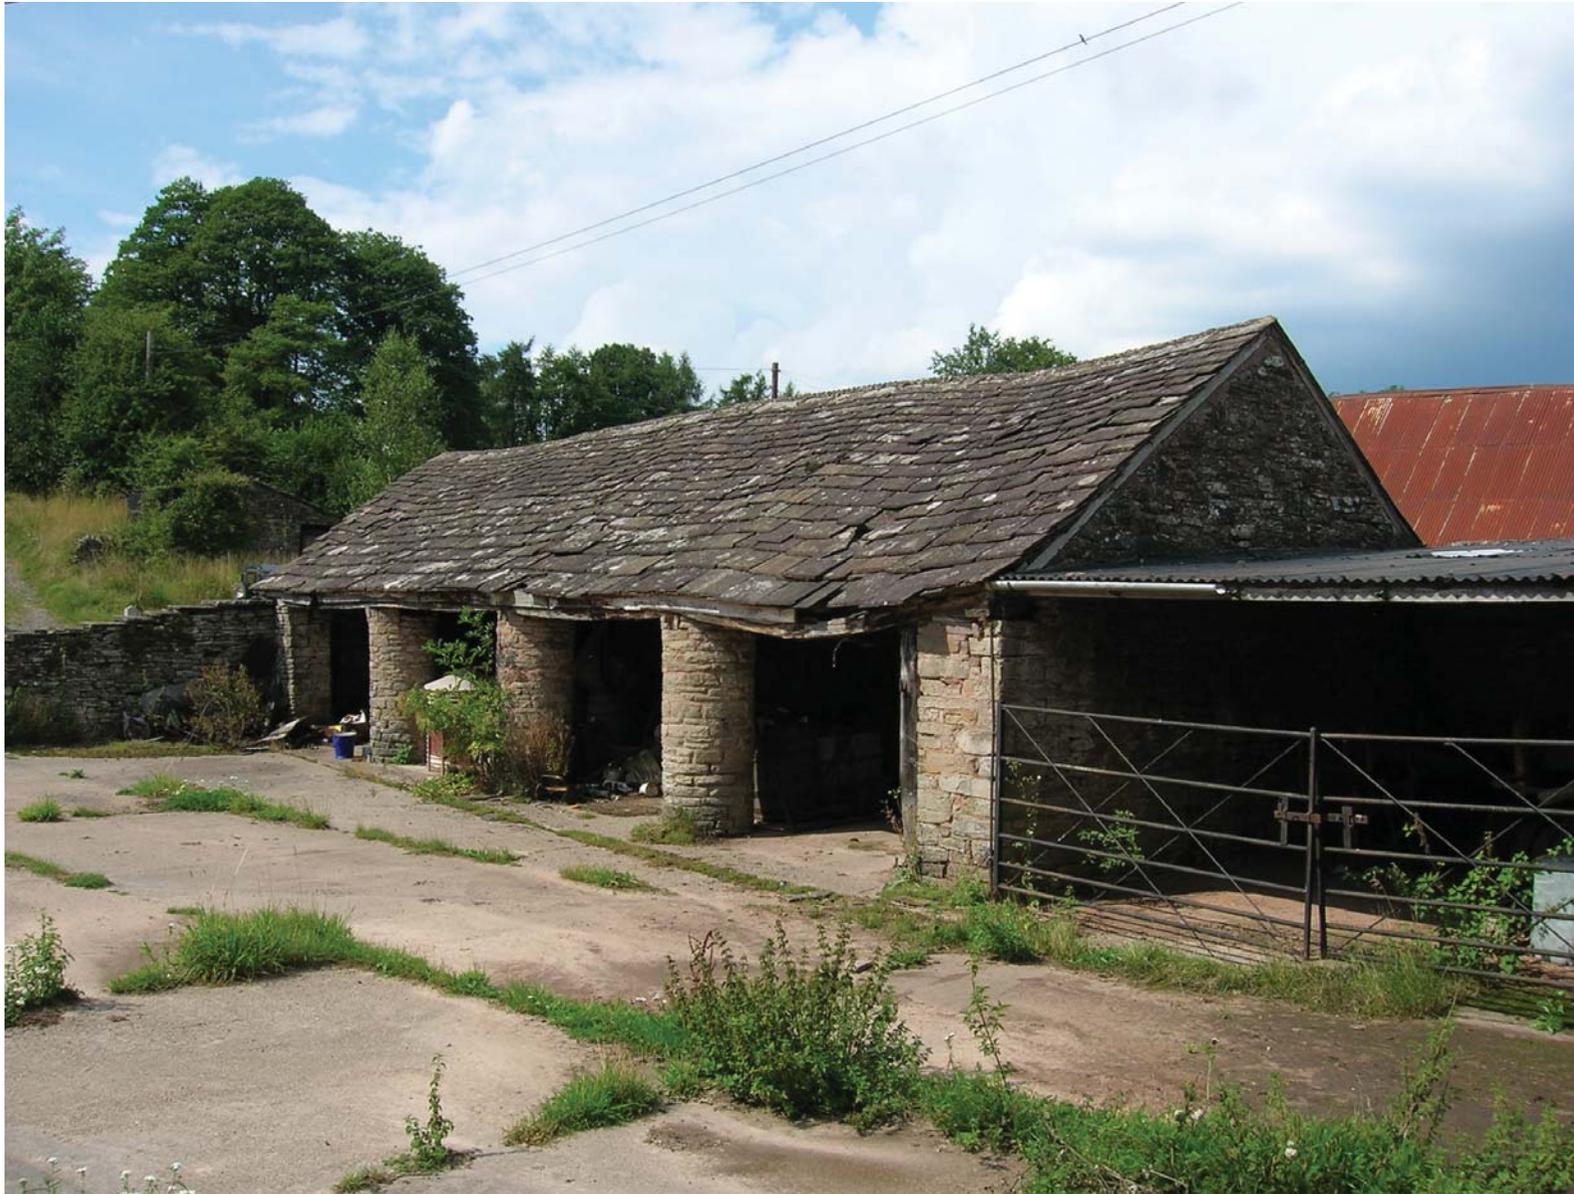
This shed is aligned roughly east-west, with the back (northern) wall and gable ends built in sandstone rubble. There are four open bays facing the main farmyard; formed by three circular stone pillars with timber lintels above (Plate 9).

The roof timbers significantly include two 18th century principal rafter trusses, and another truss of 20th century date. The original ridge purlin appears to have been replaced by 19th or 20th century timber. Only one purlin seems to be original. The remainder appear to be later replacements; these comprise staggered purlins fitted within the original trenches along the principal rafters. The common rafters have been notched into the outer wall plate along the back wall, and into the wooden lintels at the front, but do not overhang the eaves. The common rafters may be original, but these generally appear to be 19th or 20th century timbers. The battens look to be modern and do not appear to be substantial enough to support the stone slates above. There is a stone roof to the south whilst the northern pitch is covered by corrugated steel.

There is a lean-to on the eastern side of the shelter shed. The side wall of the lean-to is built of stone in Ordinary Portland Cement. The stone wall at the back looks to be much earlier, and may be contemporary with the listed shed. The roof consists of 20th century timber supporting corrugated steel.

Plate 9: The 18th century shelter shed to the north of the main farmyard

The main roof timbers are to be retained, many of which date from the 18th century. The roof design and pitch is to remain unaltered. The proposal includes like-for-like replacement of the wooden lintels that span the stone pillars on southern side of the shed. The purlins and rafters may also need to be strengthened, and the principal rafters may require additional wooden or metal struts or collars. It may be necessary to strengthen or replace some of the common rafters. The 20th century battens will also need to be replaced with more substantial battens or boards. Any additional or replacement timbers required for the roof will be subject to approval by Conservation Officer. This work will ensure the long-term stability of the timber roof and the building as a whole.

The stone roof is to be repaired and stone slates will replace the corrugated sheets on the northern side of this building. The slates are to be laid in the same style as existing. The repaired roof will be of visual benefit to the character of this building, the 17th century barn and the neighbouring historic buildings.
